# East West Rail Phase 2

**Technical Note: TDC 19-02830-TWAP - EWR2 application in principle to discharge draft condition**

**Document Number: 133735\_RW-EWR-XX-XX-RP-CH-000155**

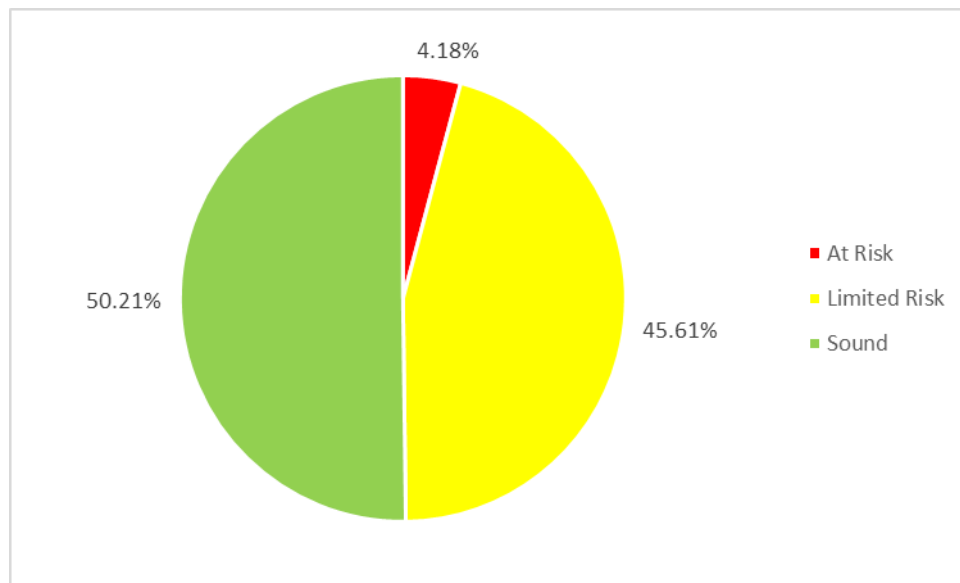
**Figure 1 – Pavement Surface Condition Identified from Video Survey Data**

Both Table 3 and Figure 1 indicate that there is only 0.10 lane-km within link 102 that is deemed to be “At Risk”, in terms of pavement surface condition. A surface condition risk map for link 102 is provided in Appendix C.

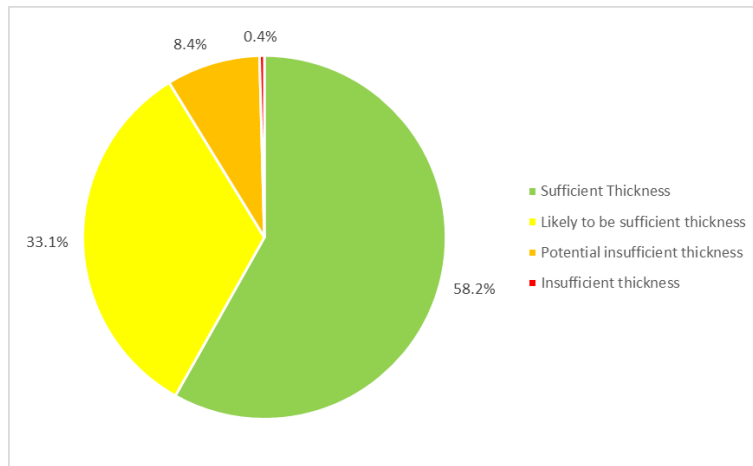
**Figure 2 – Pavement Thickness Range Identified from GPR Data**

- 2.18 lane-km sections within link 102 have sufficient construction thickness with regards to the low commercial traffic (0.51msa, as indicated in Table 1), comprising approximately 91.3% of the link in length;
- 0.20 lane-km sections within link 102 have been categorised as “Potential Risk” due to the construction thickness is between 150mm and 200mm. It should be noted that the “Potential Risk” category was initially proposed assuming the expected commercial traffic is 1msa. As the expected commercial traffic is estimated at 0.51msa there is a low risk of these 0.20 lane-km section to be structural insufficient to support the expected commercial traffic; and
- Only 0.01 lane-km section within link 102 is categorised as “At Risk” because it has a pavement construction thickness of less than 150mm.

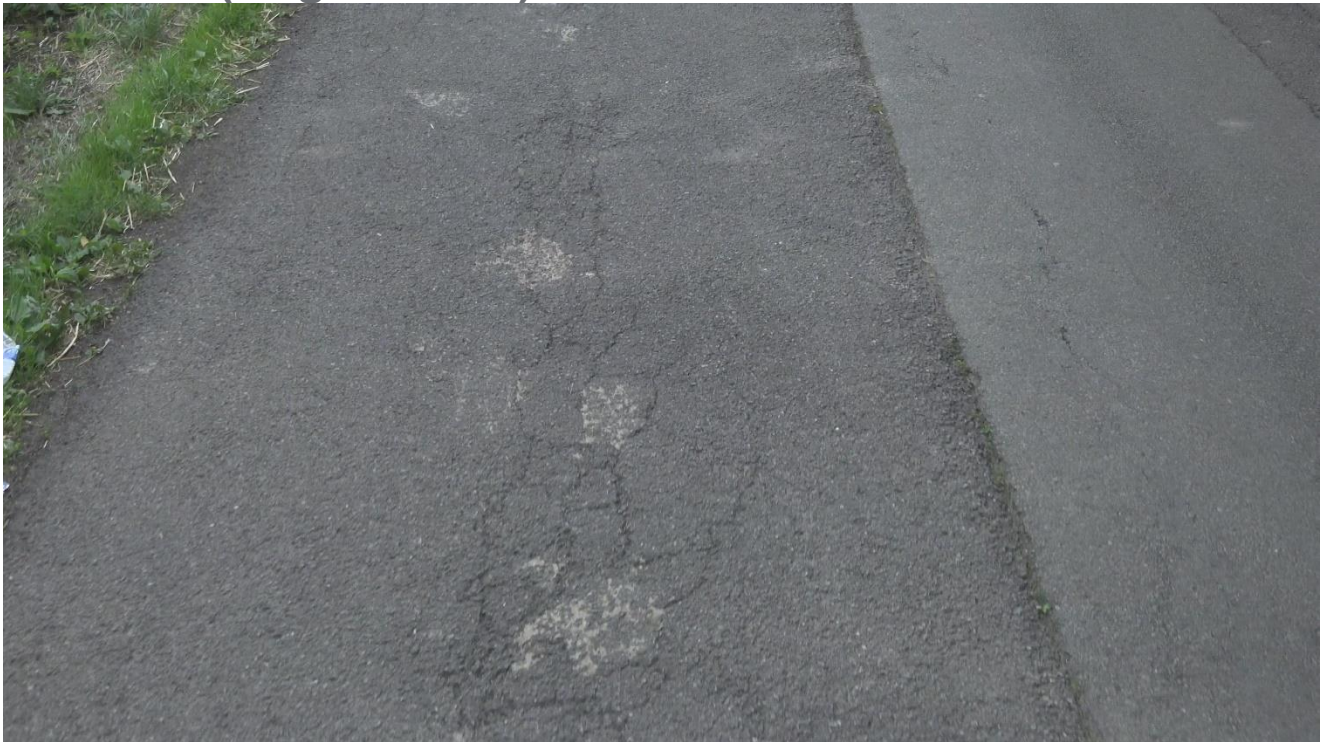
**Figure B-1 Surface Indicator of Pavement Risk “At Risk” Condition**

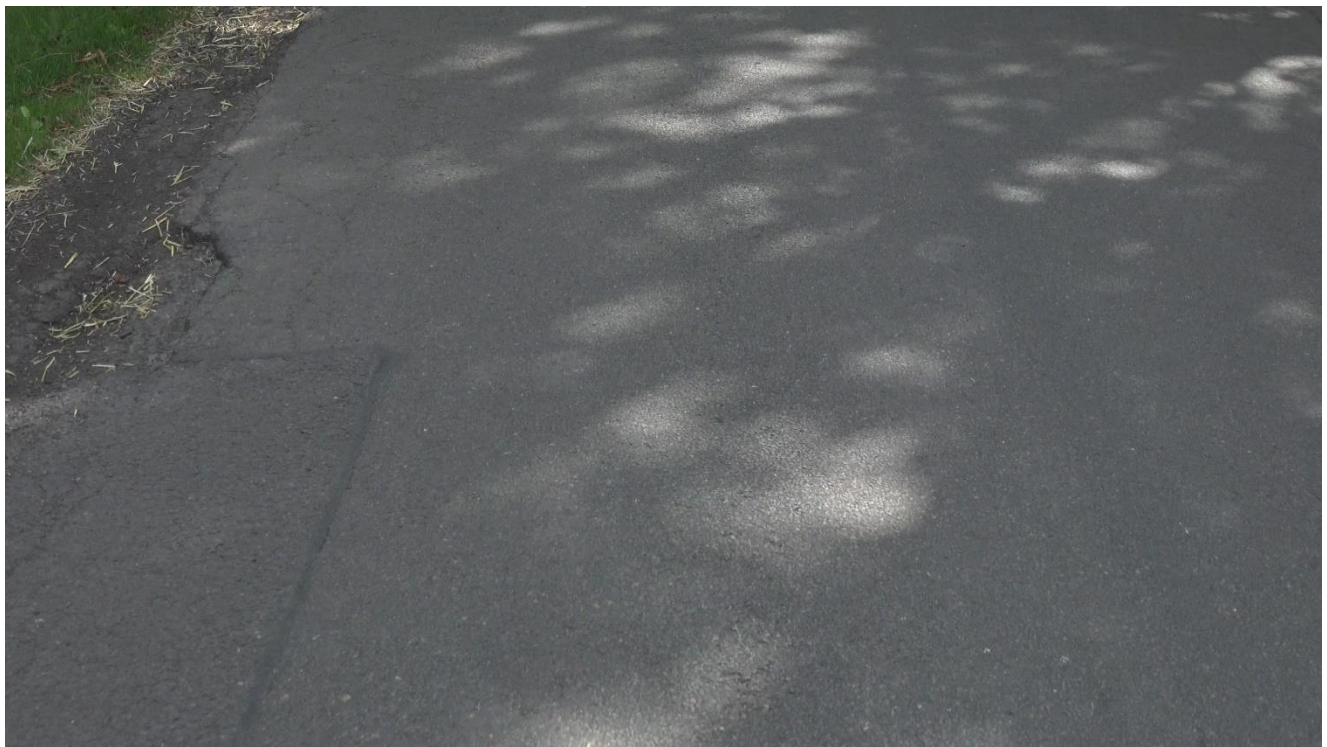
**Figure B-2 Surface Indicator of Pavement Risk “Limited Risk” Condition**

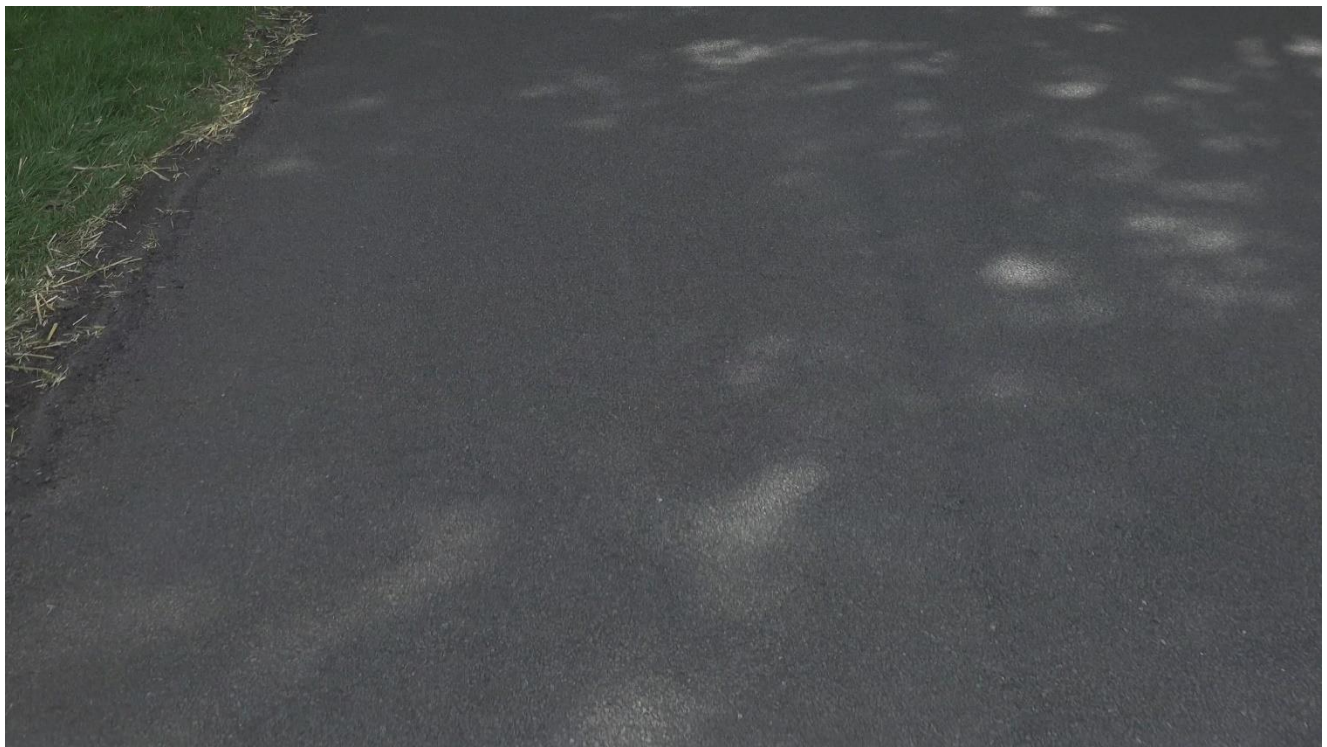
**Figure B-3 Surface Indicator of Pavement Risk “Sound” Condition**
