# Preliminary Geo-Environmental Risk Assessment

**Banbury 200, Southam Road, Banbury OX16 3AE**

**Presented to Lysander**

Delta-Simons Project No. 20-1787.02

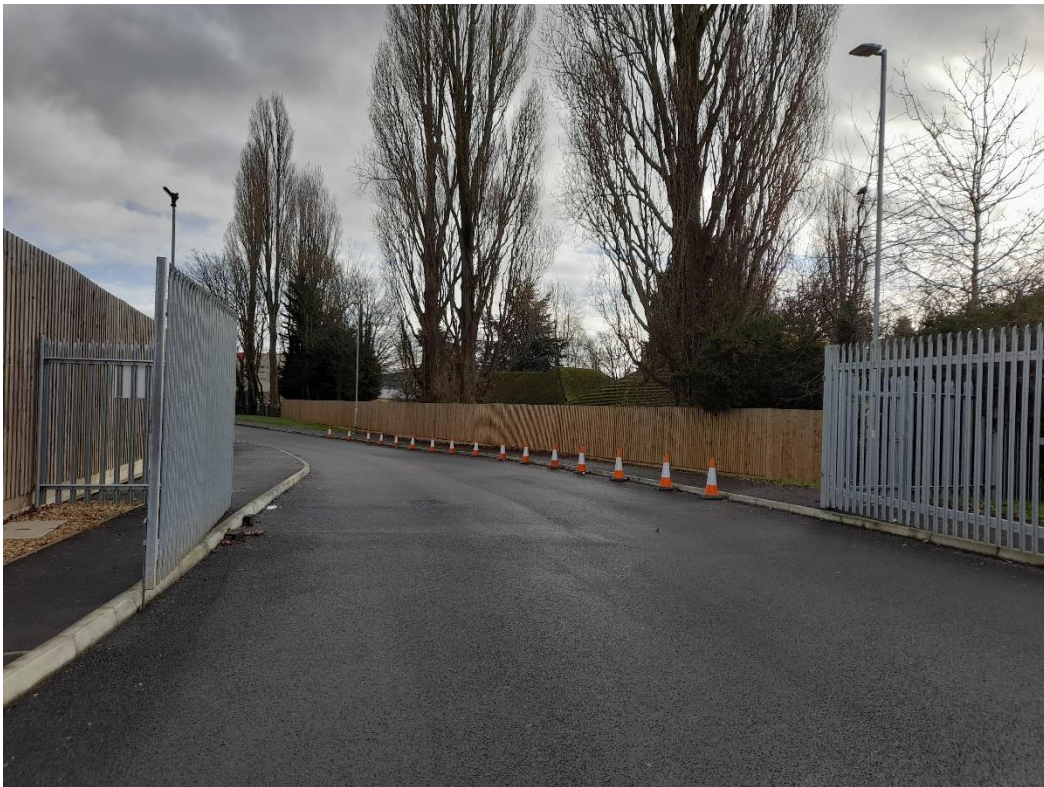
**Photograph 1 – Access road in the south-eastern corner off Southam Road**

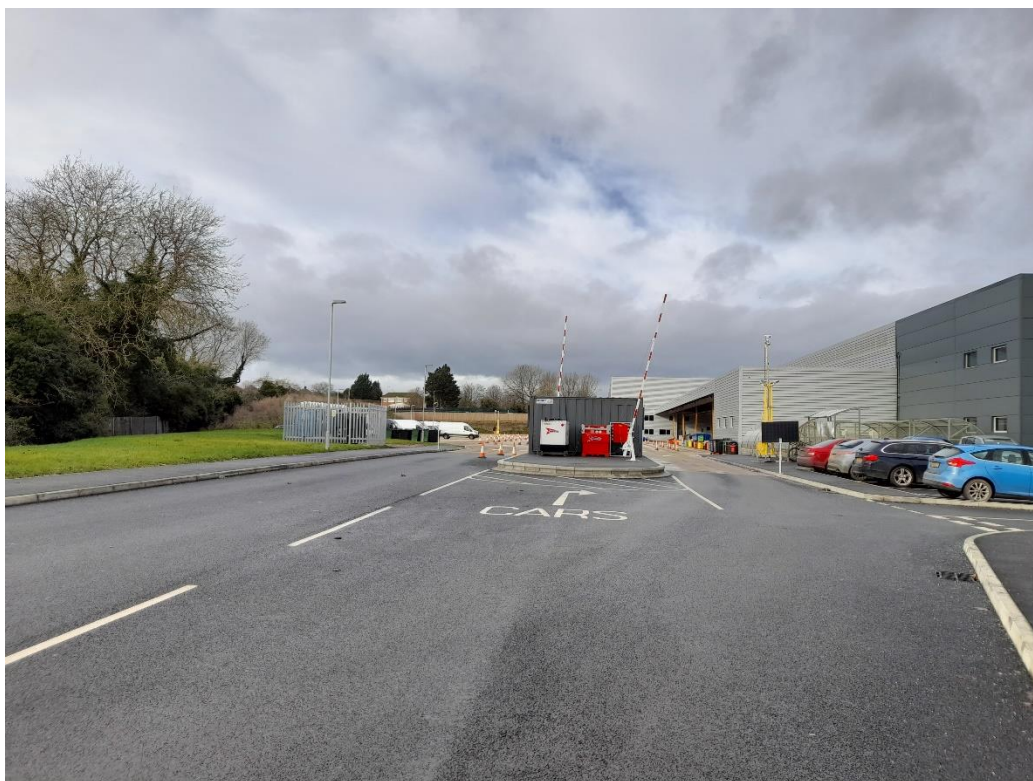
**Photograph 2 – Site extents looking north-west**

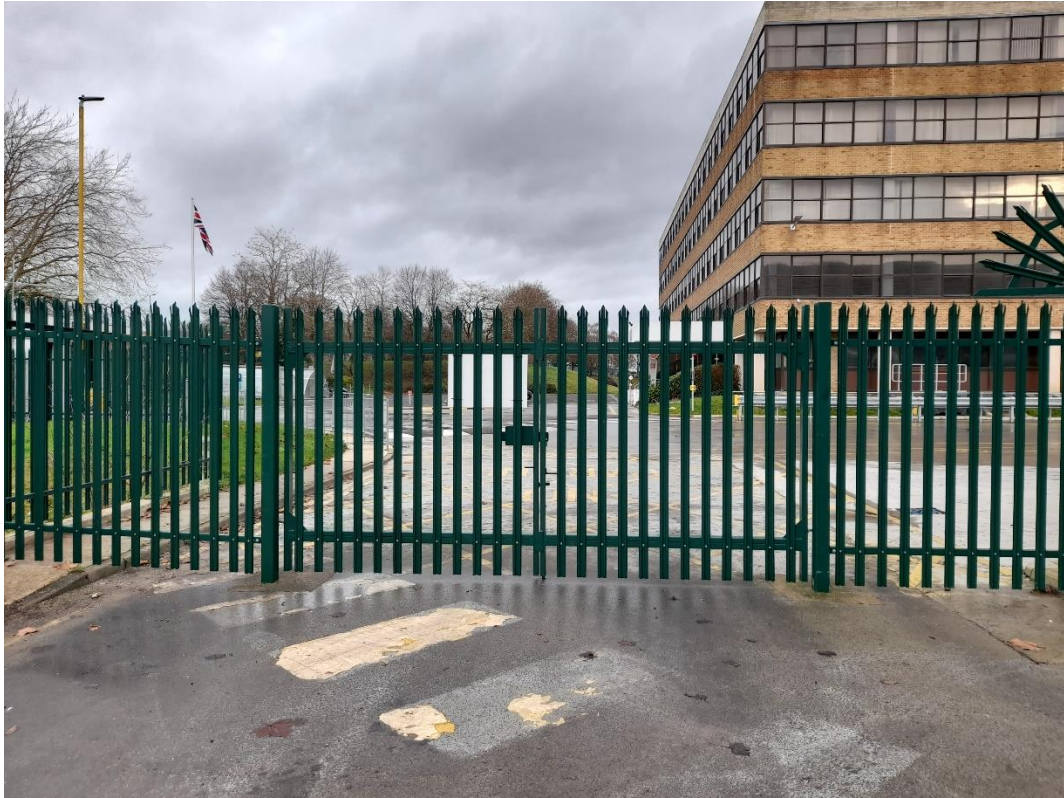
**Photograph 3 – Second access point in the north-western corner**

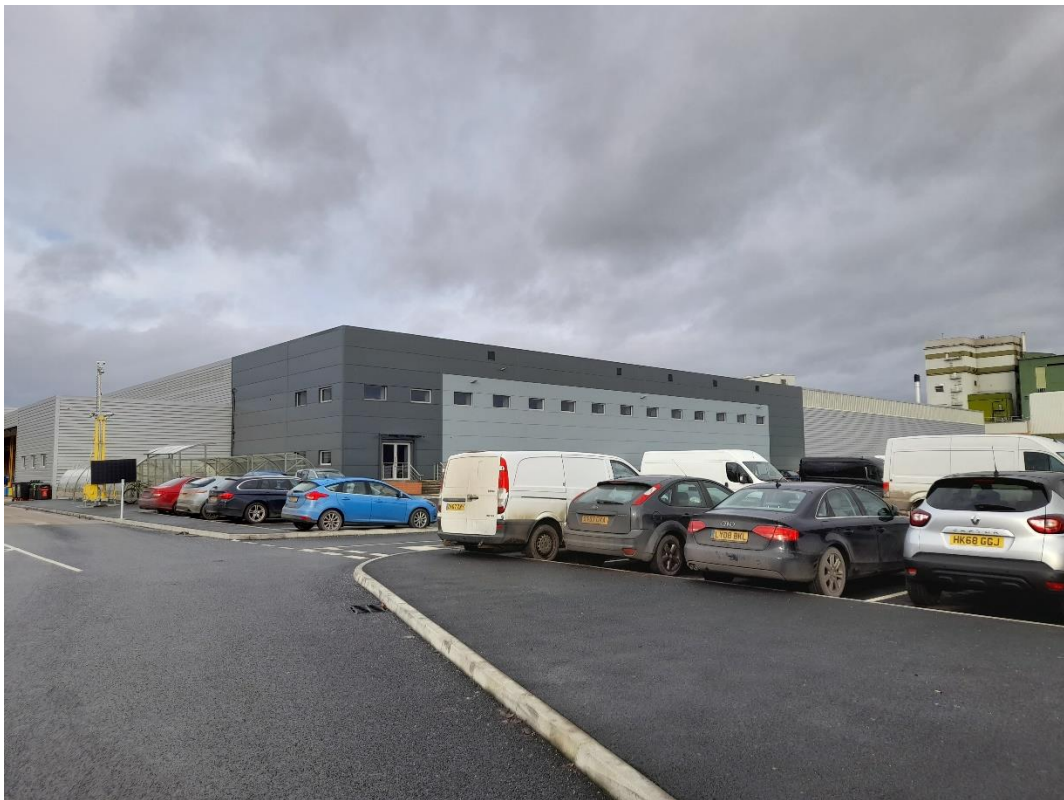
**Photograph 4 – Warehouse building looking north**
