Preliminary Geo-Environmental Risk Assessment

Banbury 200 Site, Southam Road, Banbury OX16 3AE

Issued: October 2021

Delta-Simons Project No: 21-1553.03

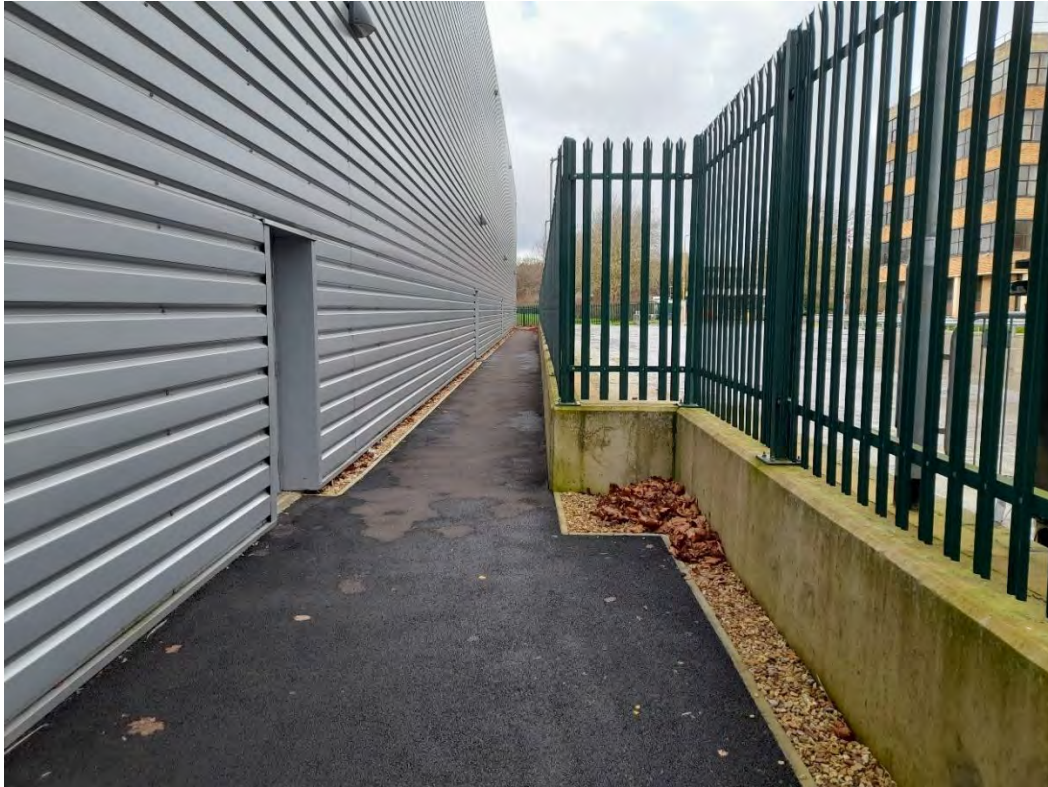
Photograph 9 – Levels of the adjacent plot (in the right of the photo) approximately 0.5 m higher than the subject Site. Looking north-west along the northern warehouse boundary.

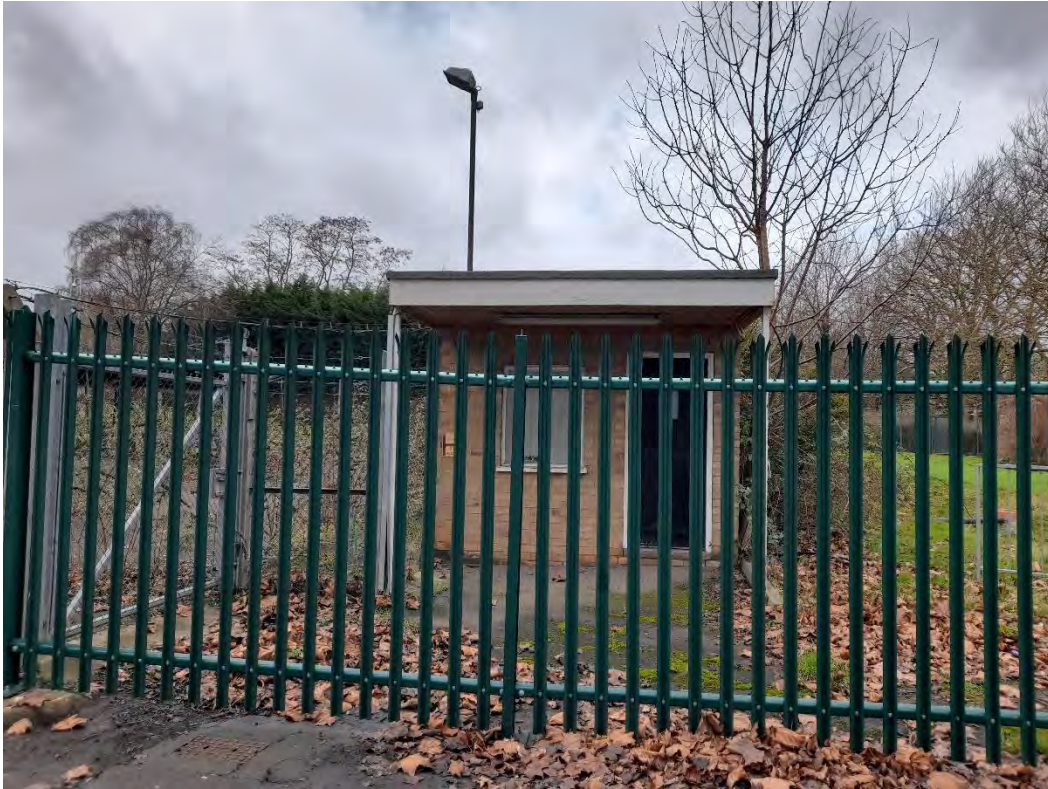
- ▲ A small maintenance building was present in the north-western part of the Site. Internal access was not available; however, plastic storage drums were observed via a small obscured window;

Photograph 13 – Maintenance building within car park area.

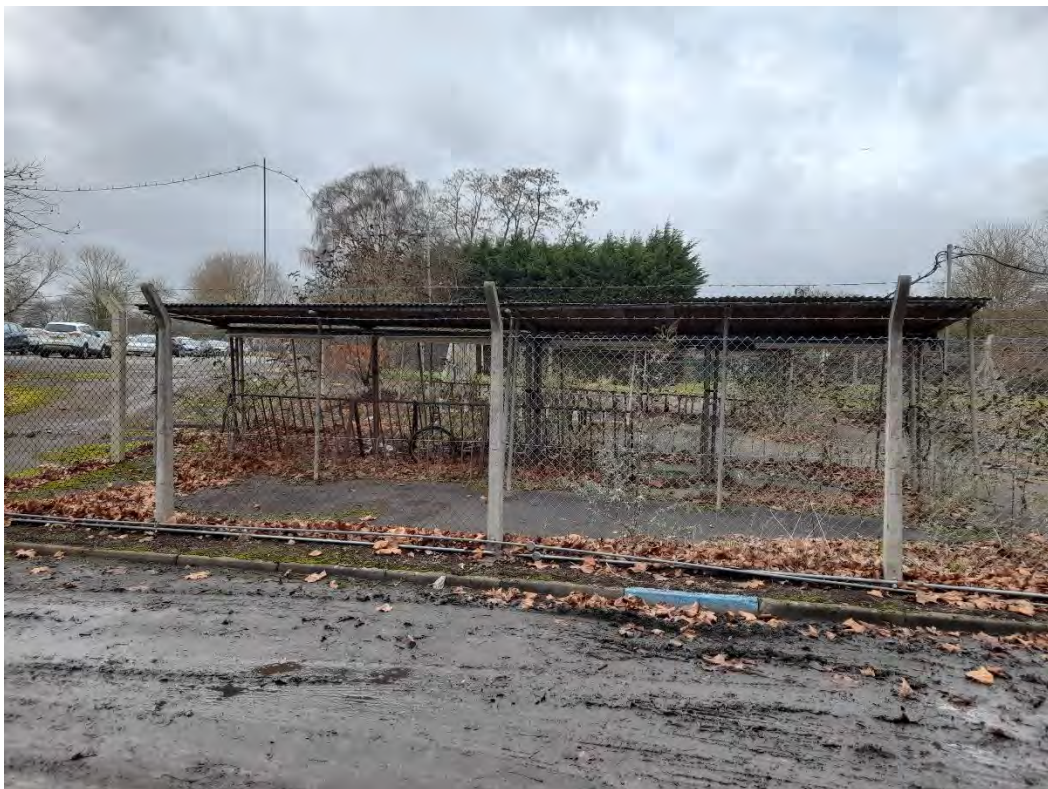
Photograph 14 – Disused bike storage area – possible asbestos containing materials.

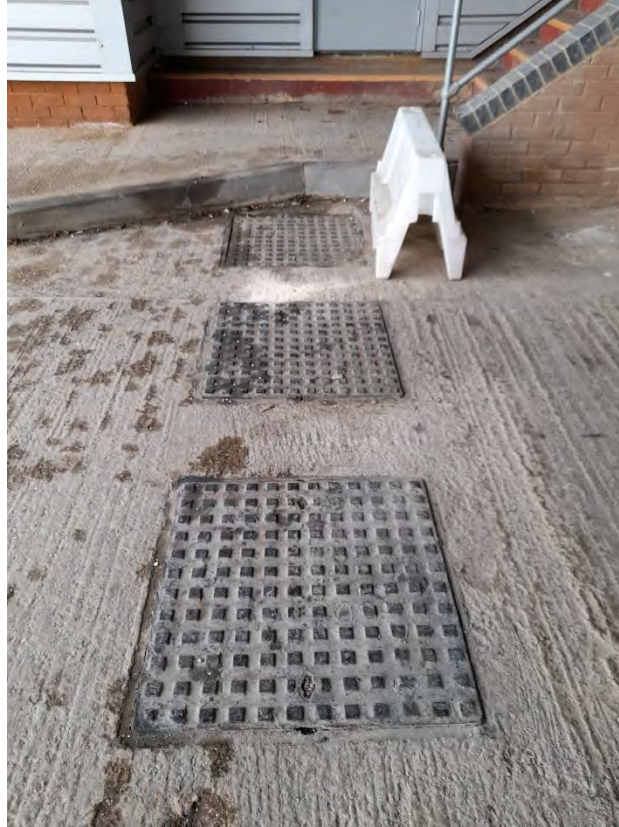
Photograph 17 – Potential Oil Interceptor in the south of warehouse area.

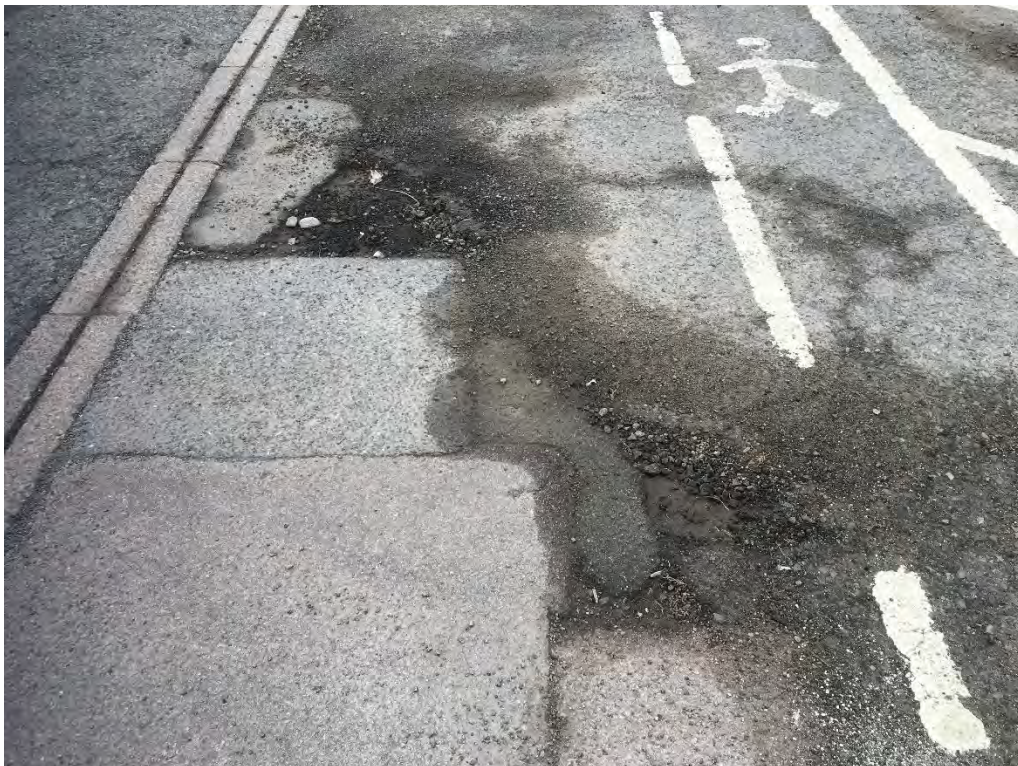
Photograph 30 – Asphalt with multiple patch repairs.

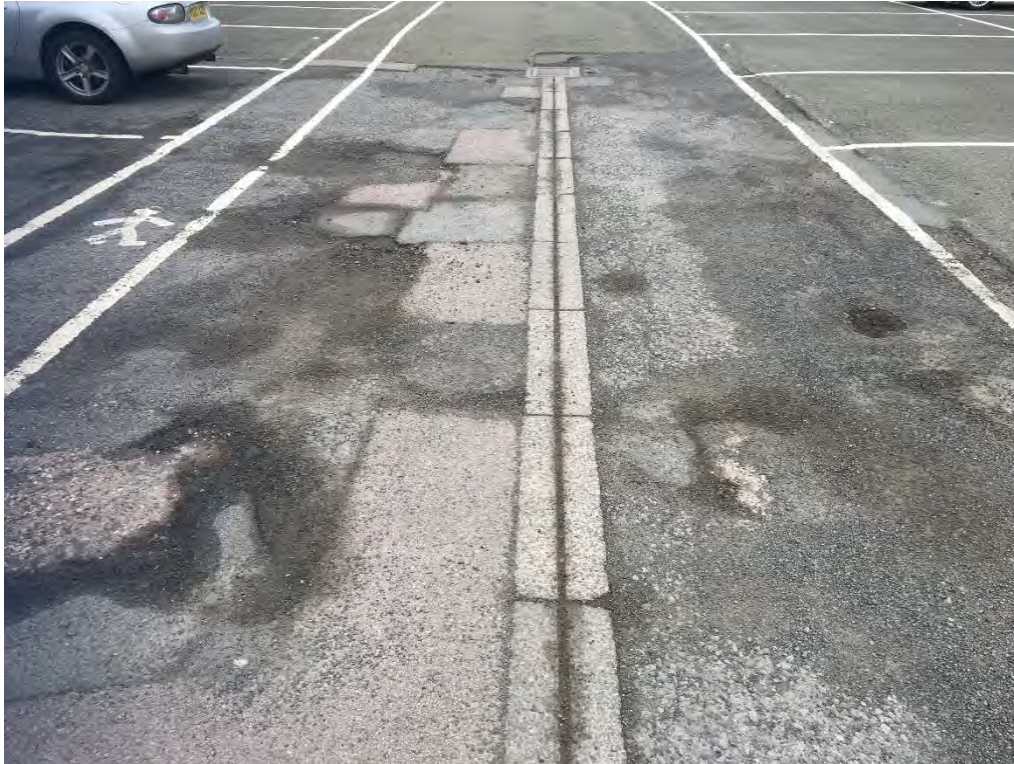
Photograph 31 – Evidence of wear and patch repair in asphalt surfacing in car park.

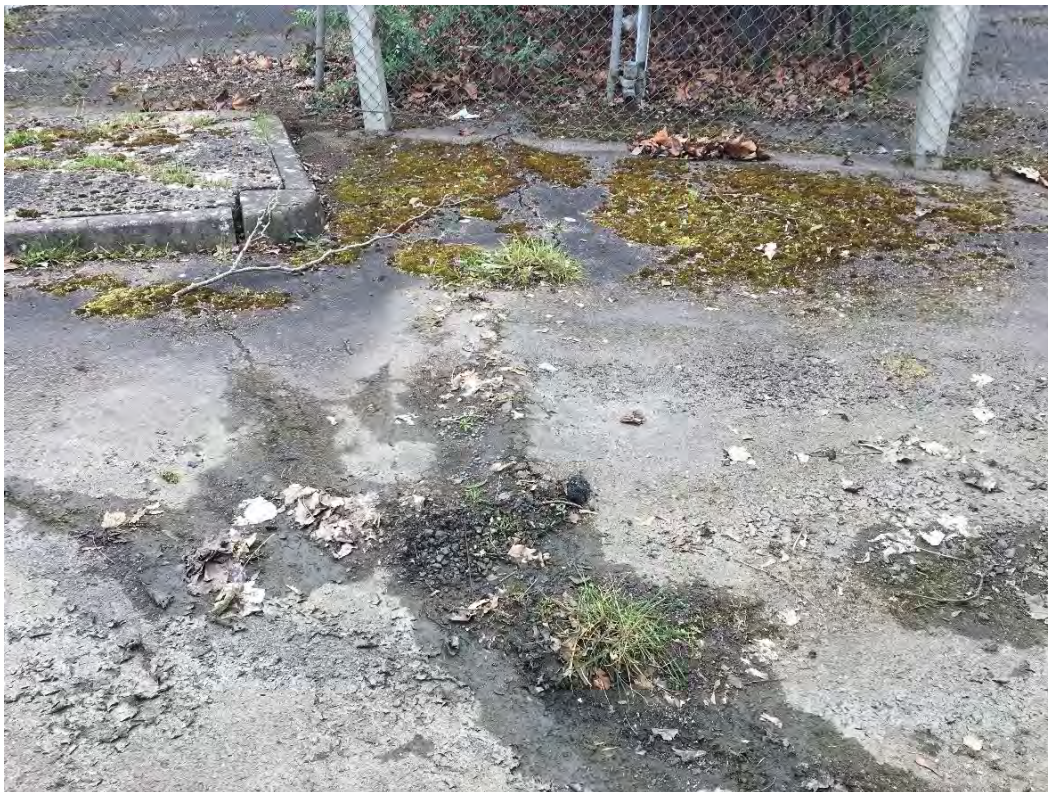
Photograph 32 – Cracks in asphalt possibly associated with nearby trees/vegetation.

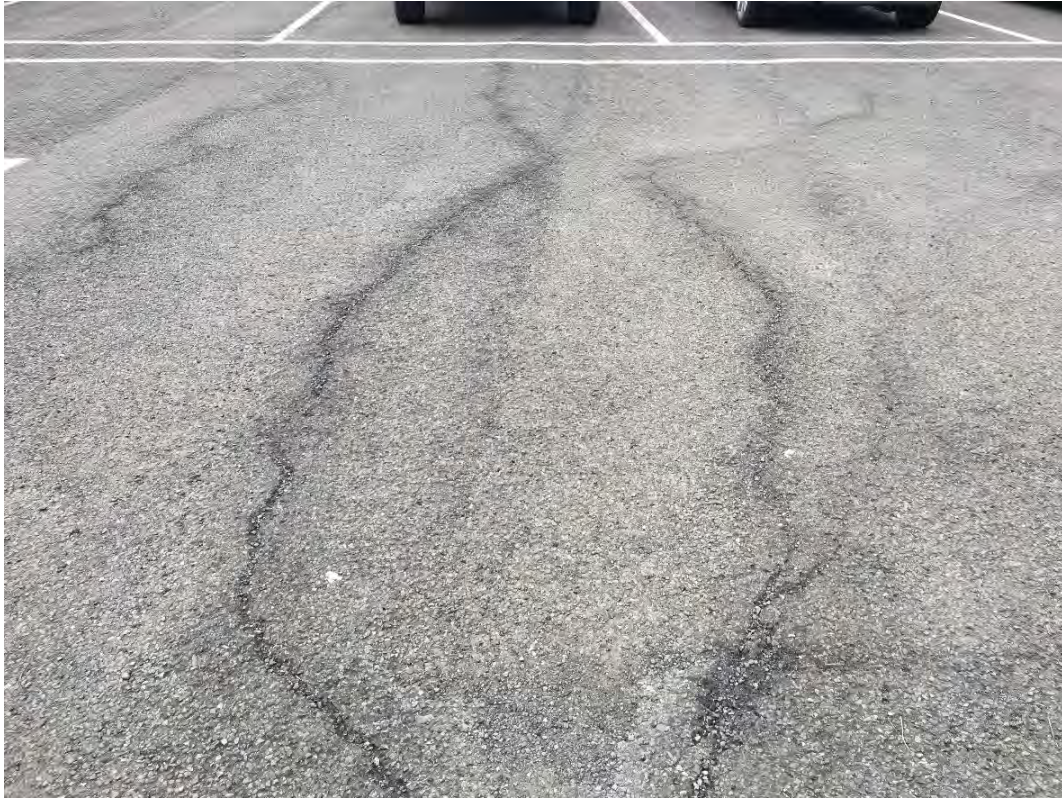
Photograph 33 – Wear in the asphalt surfacing.

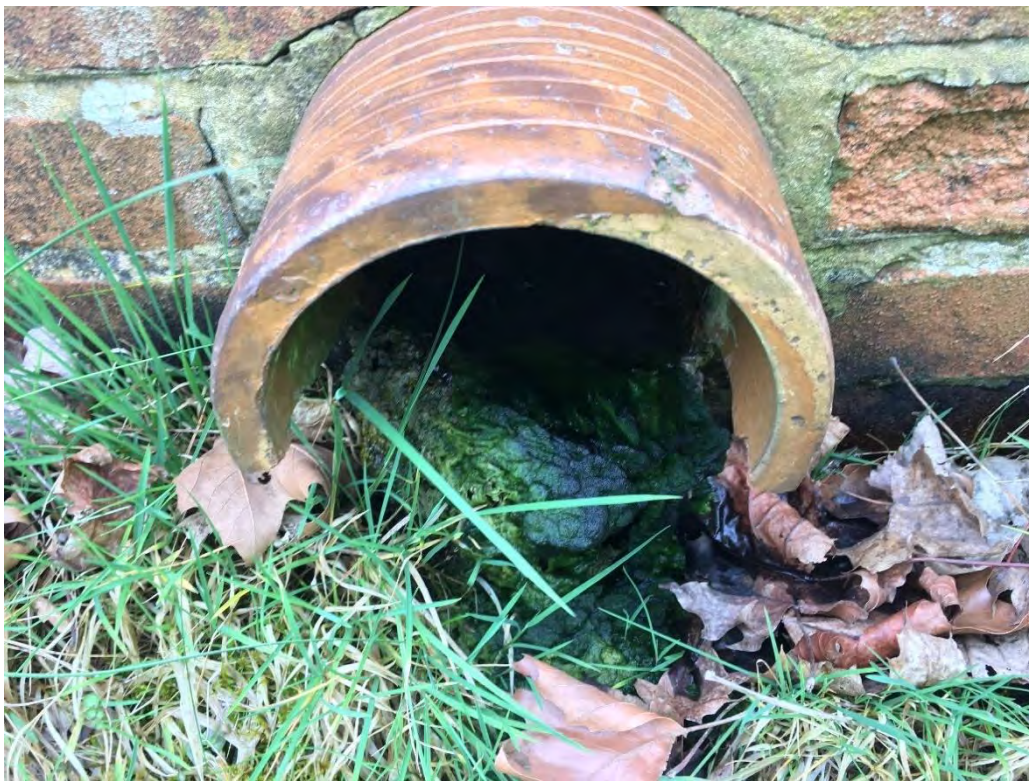
Photograph 38 – Pipe connecting to the stream with organic residue.

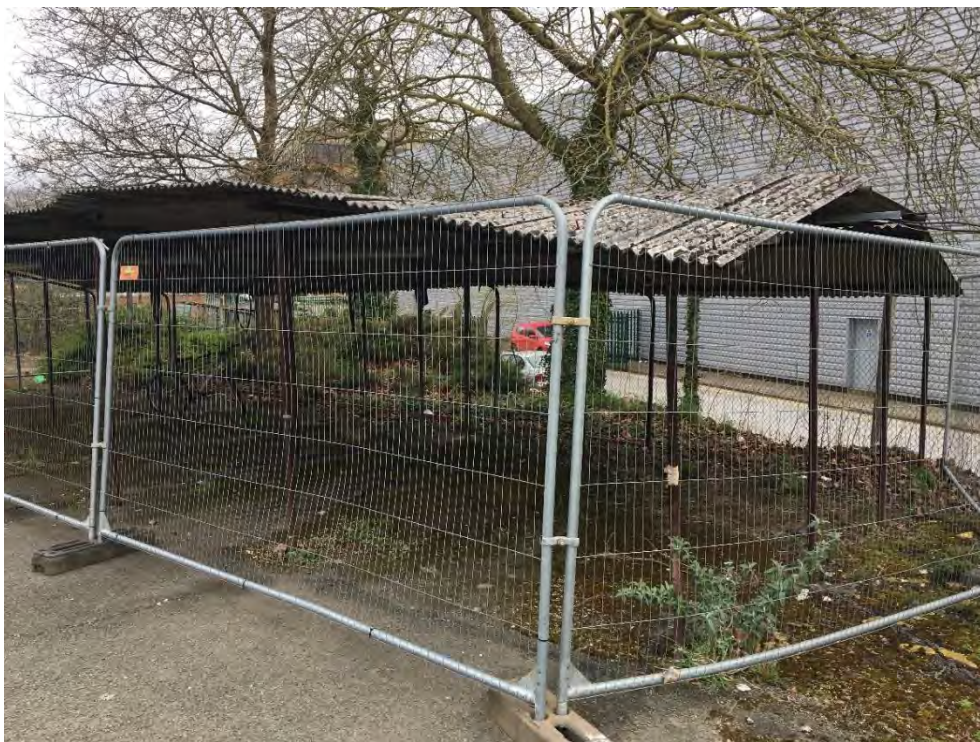
Photograph 44 – Fenced off bike shelter with possible asbestos containing materials.

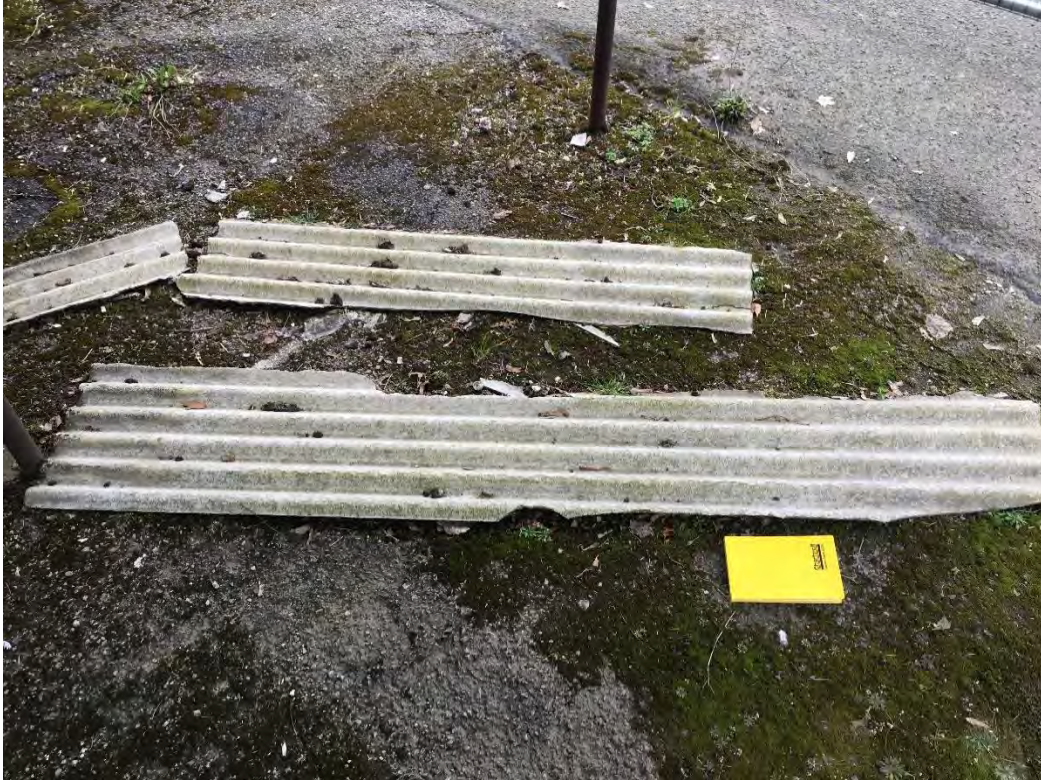
Photograph 45 – Fragments of suspected corrugated sheets containing asbestos.

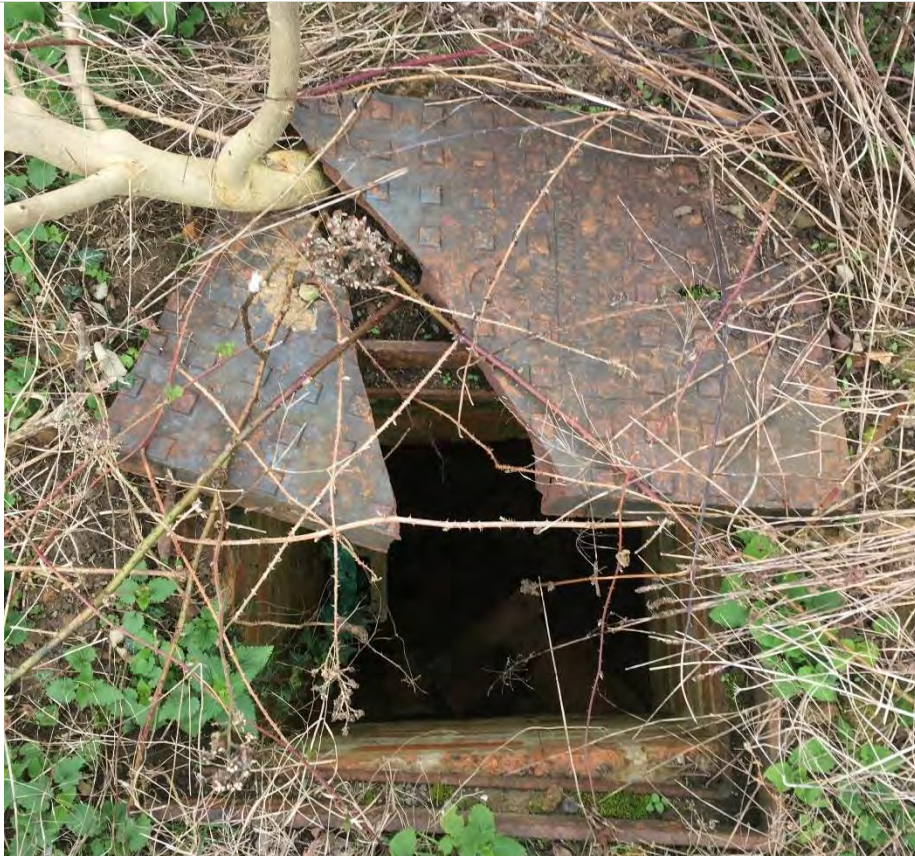
Photograph 46 – Damaged manhole cover in south-east of car park.
