Certificate of Reoccupation

REFURBISHMENT OF AN EXISTING WAREHOUSE WITH NEW CAR PARK AND RENOVATED SERVICE YARD AT BANBURY 200, SOUTHAM ROAD, BANBURY, OX16 2QU

PRE-CONSTRUCTION
PHASE CDM
INFORMATION RECORD
AND CLIENT
REQUIREMENTS

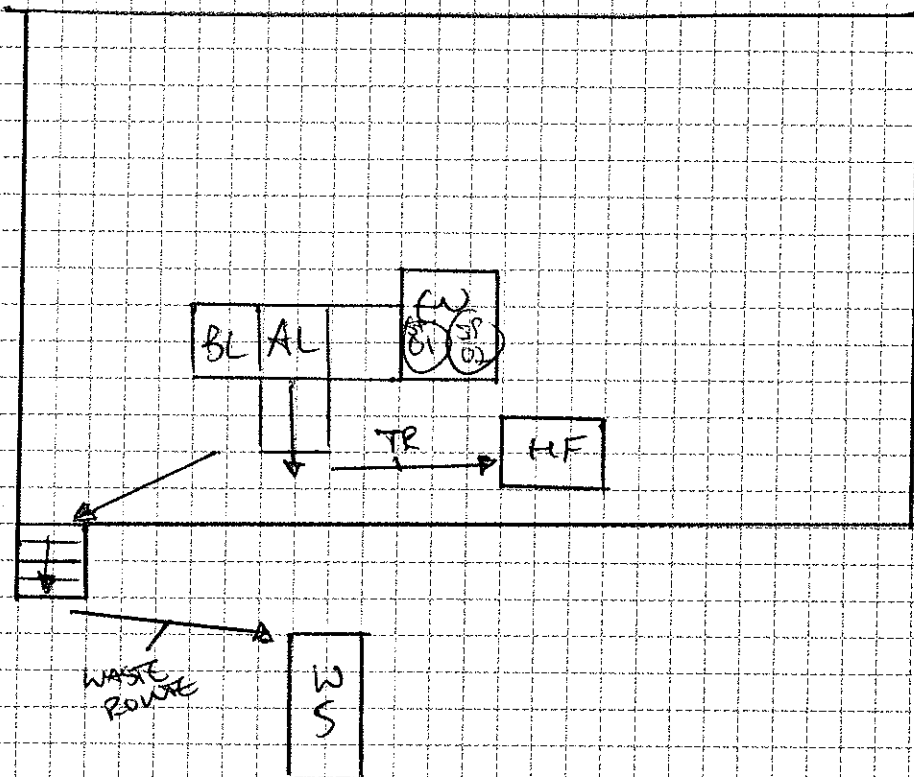
Layout diagram of asbestos removal site

ADDITIONAL COMMENTS: THE PIPE REMAINS PRESENT + WRAPPED IN POLYTHENE EXCLUDING A SMALL SECTION WHICH HAS BEEN STRIPPED OF THE LAGGING TO ALLOW THE CUT POINT. THIS AREA WAS FOUND TO BE CLEAN WITH NO VISIBLE LAGGING OR RESIDUES.

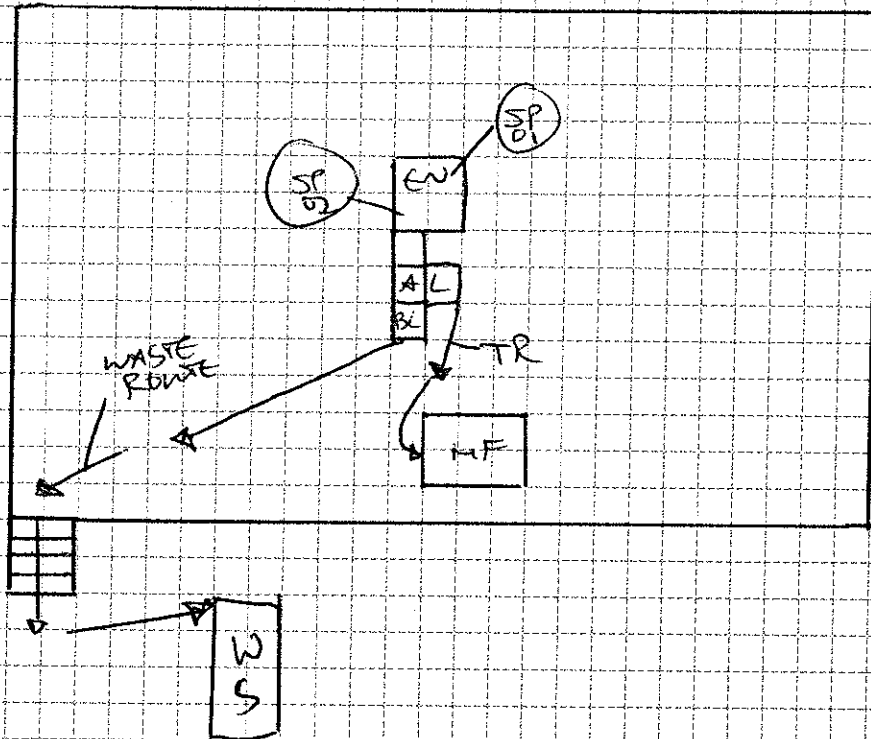
Layout diagram of asbestos removal site

ADDITIONAL COMMENTS: THE PIPE REMAINS PRESENT + WRAPPED W POLYTHENE EXCLUDING A SMALL SECTION WHICH HAS BEEN STRIPPED OF THE LAGGING TO ALLOW THE CUT POINT. THIS AREA WAS FOUND TO BE CLEAN WITH NO VISABLE LAGGING OR RESIDUES.

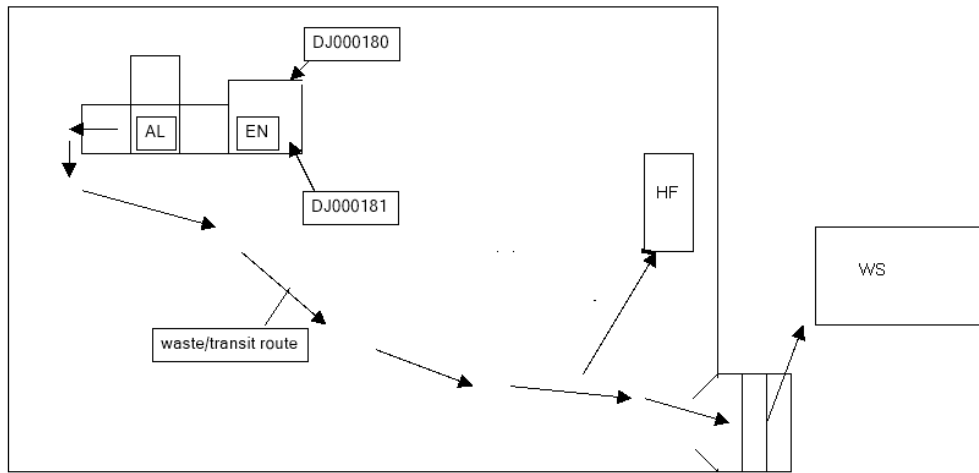
Finished Goods East Building

Stage 2 Comments:
The pipe remains present and wrapped in polythene excluding a small section which has been stripped of the lagging to allow the cut point. This area was found to be clean with no visible lagging or residues.

Stage 3 Comments:
Upon analysis clearance air sampling found to be satisfactory and below the limit of quantification (0.01f/ml).

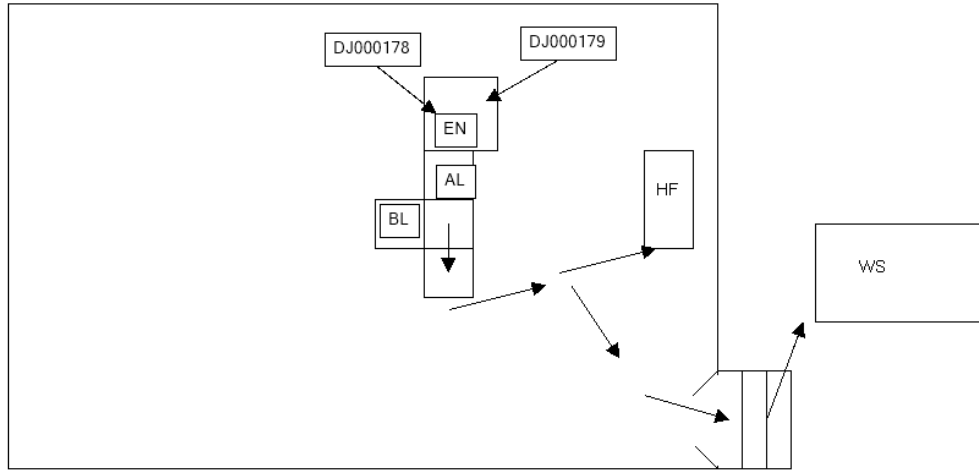
Finished Goods East Building

Stage 2 Comments:
The pipe remains present and wrapped in polythene excluding a small section which has been stripped of the lagging to allow the cut point. This area was found to be clean with no visible lagging or residues.

Stage 3 Comments:
Upon analysis clearance air sampling found to be satisfactory and below the limit of quantification (0.01f/ml).
