Report On Field visit to South West Bicester: Pingle Brook

Project No: 11011546

Date: June 23, 2006

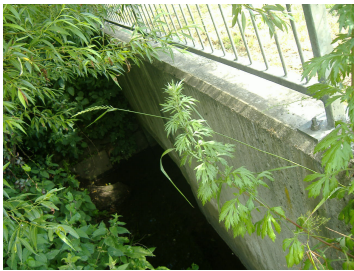
<p>Brook u/s of culvert (Looking towards d/s)</p>

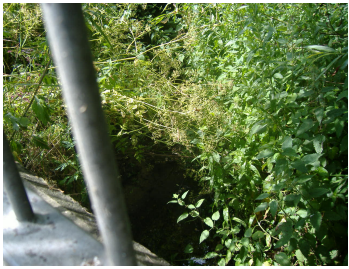
<p>Brook u/s of culvert (Looking towards u/s)</p>	<p>Brook u/s of Culvert on Oxford Road:</p> <ul style="list-style-type: none"> ○ The Brook flows perpendicular to the culvert entrance before being conveyed under Oxford Road. The Brook is almost entirely covered by trees, bushes and shrubs and not accessible from road or even from the farm. ○ Size of culvert: 1.60m wide, 1.2 m high, IL= 67.275m AOD ○ However, existing vertical opening is now only 0.8m and remaining 0.4 m has been silted . Moreover, the route of the Brook is diverted around the high land on its left hand bank which accounts for it elaborate route. ○ The Brook immediate u/s of the culvert is completely covered by bushes and shrubs and difficult to see its present condition approximately a reach of around 30 m u/s from Oxford road.

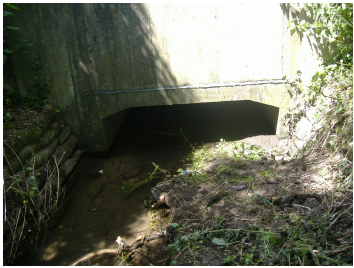
<p>Brook d/s of culvert (Looking u/s)</p>	<p>Brook d/s of Culvert on Oxford Road:</p> <ul style="list-style-type: none"> ○ Brook cross section downstream of the culvert on the Oxford Road is different than u/s. ○ Immediate d/s of the culvert the section is shown.

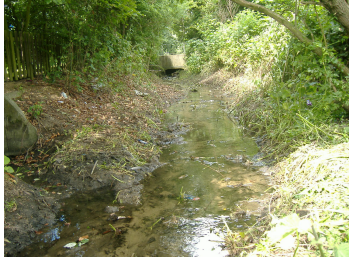
<p>Brook downstream of culvert (Looking d/s)</p>	<p>Immediately d/s of the culvert, the shape of the Brook is trapezoidal. The bottom width varies from 2 – 2.6m. Around 30 m d/s from the culvert, there are sheet piles (not shown in Picture) that are vertically placed. The section at this location is shown:</p>

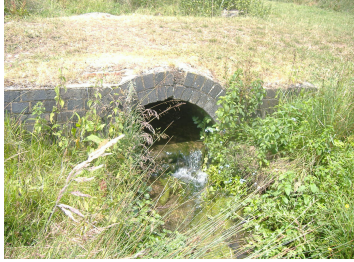
<p>Small culvert around 40 m u/s of Oxford Road culvert to the north east corner of the site, looking u/s</p>	<p>There is a small culvert (2.3 m length, 1.1 m width and 0.5 m high at centre) at the footway to the north east corner of the site. The Brook flows through a very narrow channel which is covered by bushes increasing resistance to flow along the channel up to this arch culvert.</p>

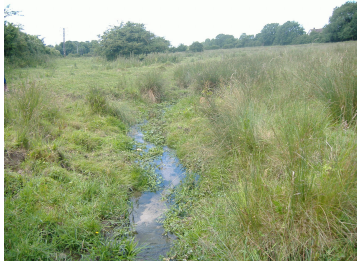
<p>D/S part of arch culvert, Looking d/s</p>

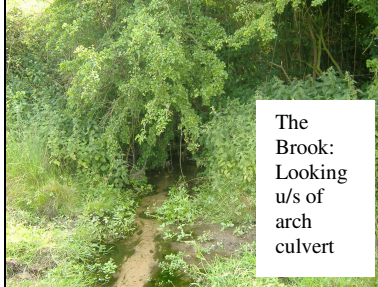
<p>The Brook: Looking u/s of arch culvert</p> <p>Downstream of arch culvert the Brooks flood plain is overgrown with bushes and tall grass resulting in significant floodplain resistance. Before entering the Culvert on Oxford Road, at least 30 m of the channel is inside the trees and bushes which was inaccessible in part. The Brook loses its channel shape within this area.</p>
