Oxford University Development Ltd

Begbroke Science Park

Addendum to Arboricultural Assessment

August 2021

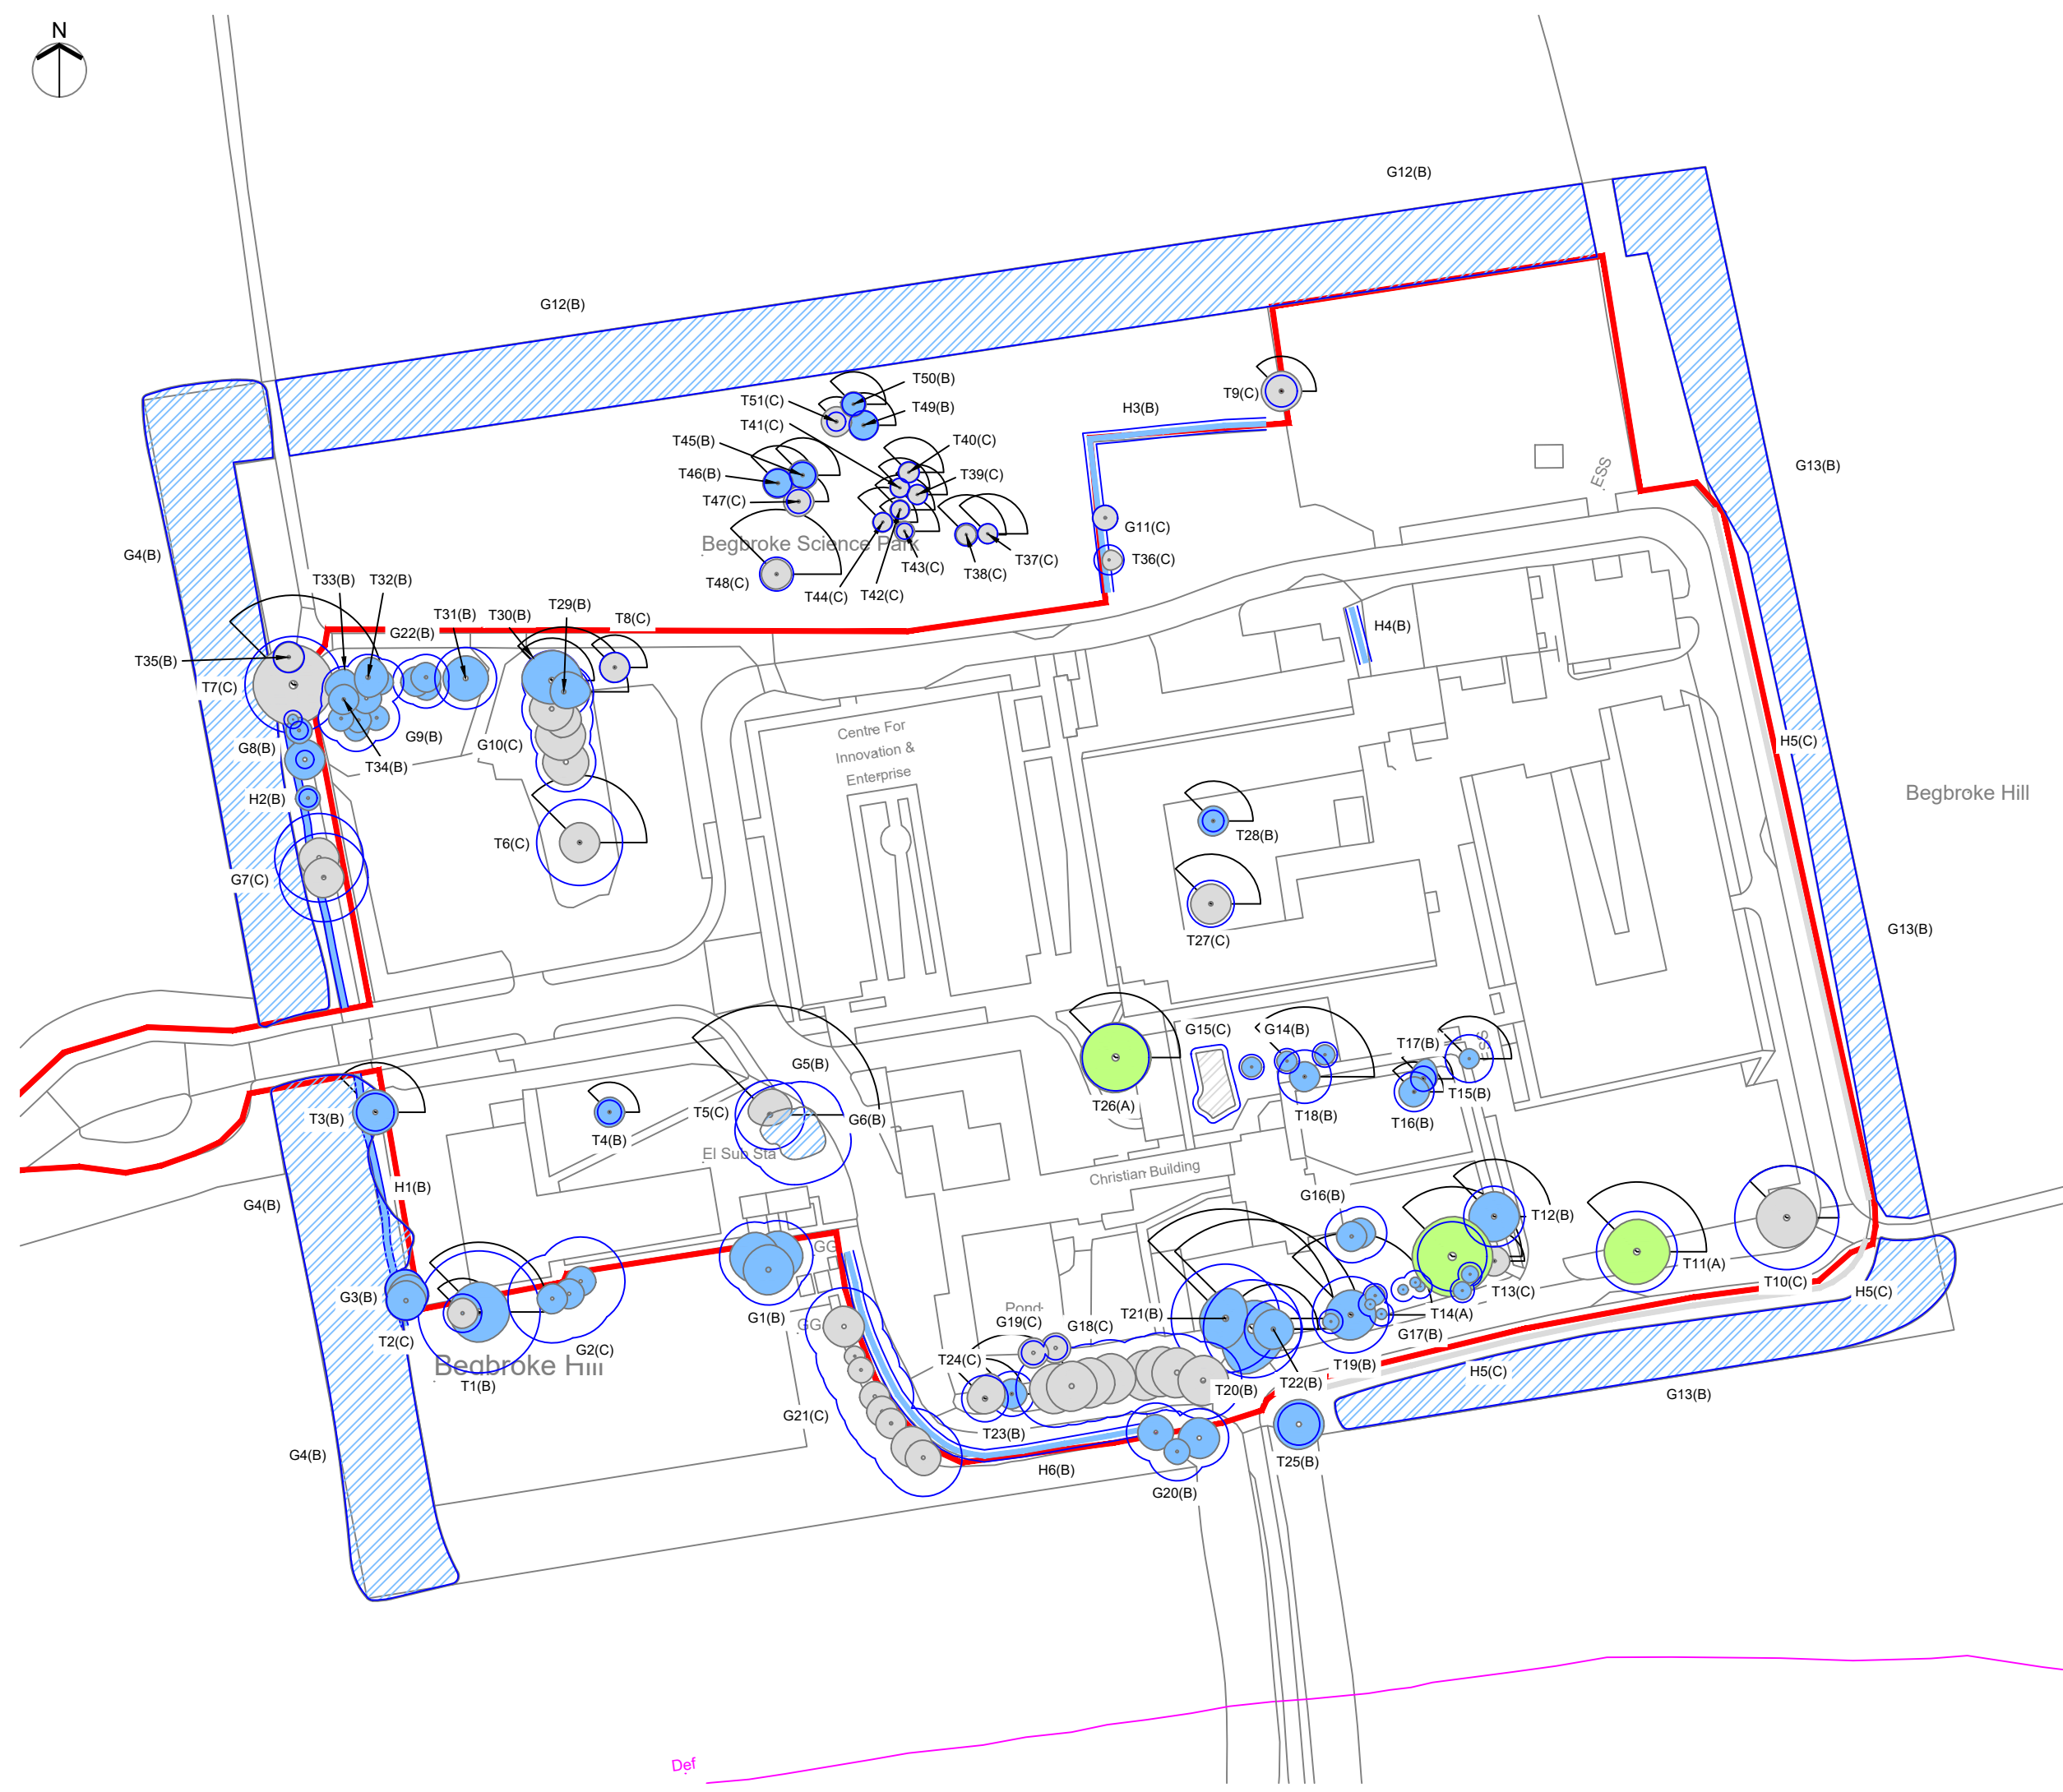
drawing title
TREE SURVEY PLAN

- 2.1 A total of 51 individual trees, 22 groups of trees and six hedgerows were surveyed as part of the updated assessment, some of which were outside of the Outline Planning Development Boundary, identified on the updated Tree Survey Plan (8296-T-02_A).

- 2.3 The individual positions of the trees, groups and hedgerows have been shown on the Tree Survey Plan. The positions of trees are based on a topographical / land survey, as far as possible, supplied by the client. Where topographical information has not identified the position of trees these have been plotted using a global positioning system and aerial photography to provide approximate locations. The crown spread, root protection area and shade pattern (where appropriate) are also indicated on this plan.

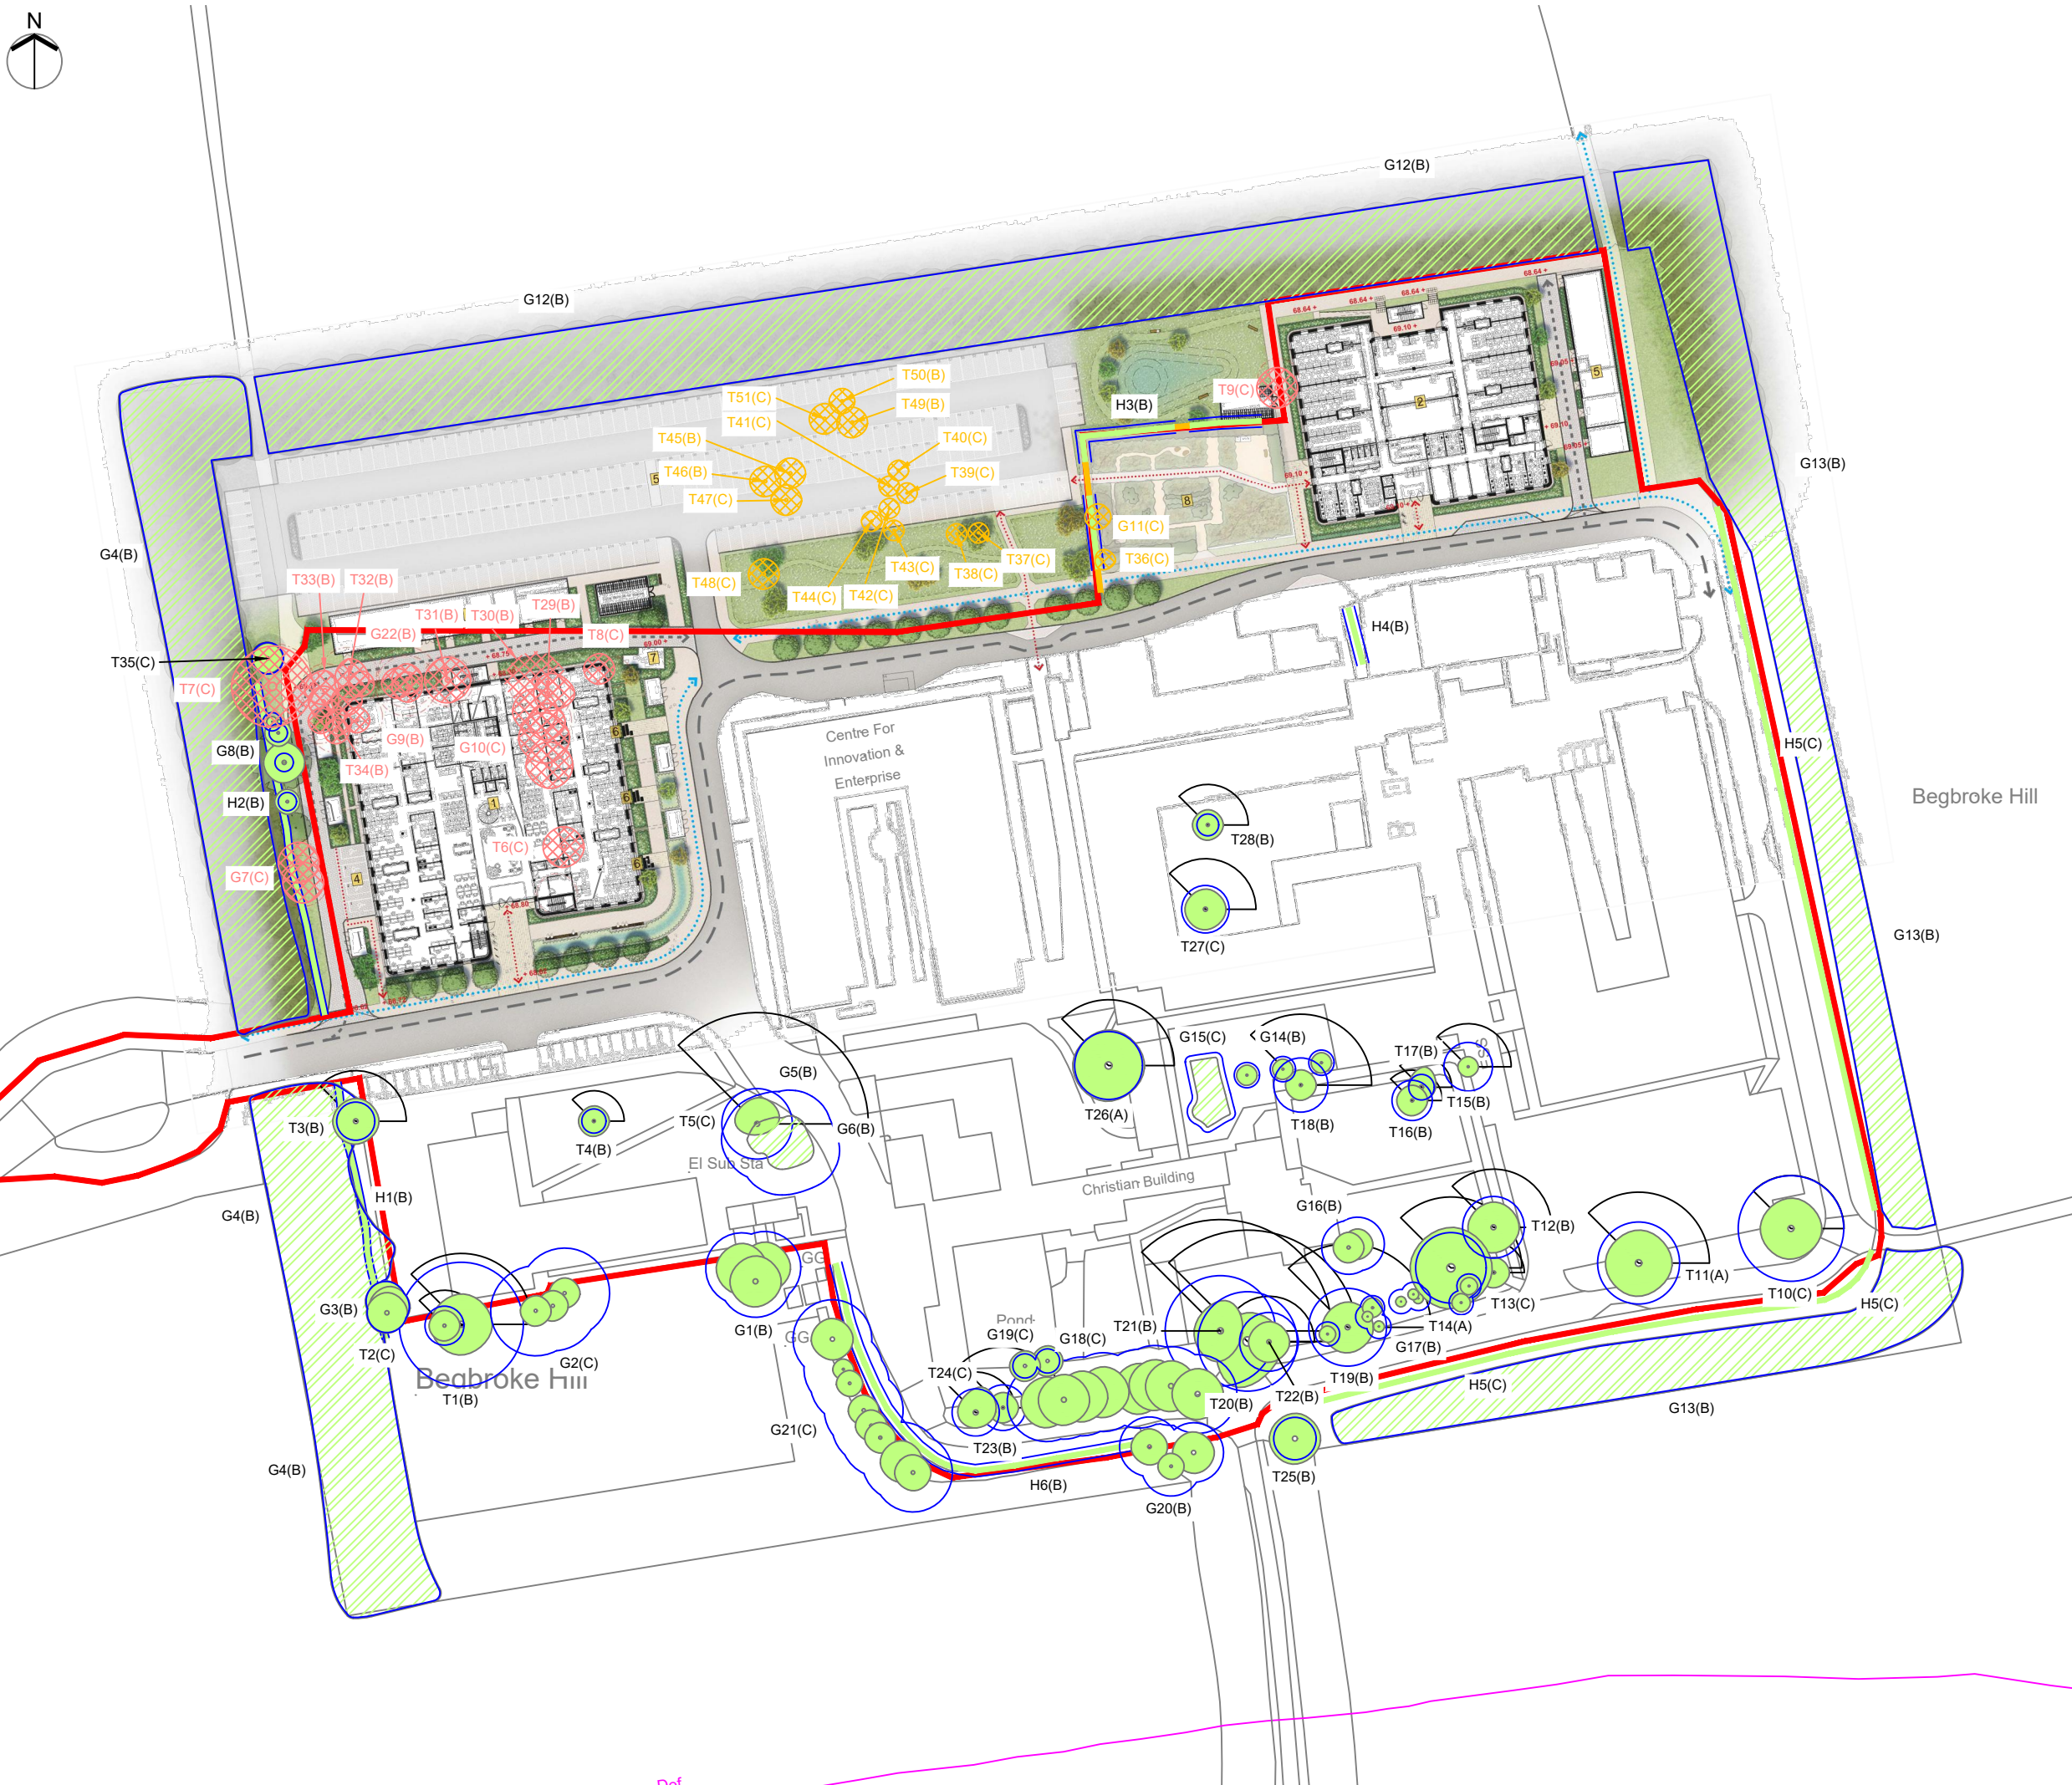
drawing title
TREE RETENTION PLAN

- 3.3 Following detailed design work, however it has become apparent that an additional individual tree T7, and single tree group G7, would also require removal, to allow for the installation of an access road along the western boundary, necessary to provide accessible parking spaces for the proposed Commercial Building and to retain a farm access track.

- 3.4 T7 a mature ash *Fraxinus excelsior* situated close to the site's western boundary, was considered of low quality due to its current condition and resulting reduced safe life expectancy. T7 displayed a sparse crown appearance which could be attributed to its over mature age or could be the result of ash die back *Hymenoscyphus fraxineus*, which although could not be confirmed, due to the time of year and the absence of leaf litter and fruiting bodies, was identified on young trees within buffer planted groups on the site boundary, identifiable by the characteristic diamond lesions and discoloration of twigs.

- 3.5 G7, a group comprising two mature Lombardy poplar *Populus nigra 'Italica'*, was again considered of low quality despite their mature size, due to a reduced safe life expectancy, by virtue of the short-lived nature of the species. The position of these trees close to the existing car park, would make their long-term retention, in the context of the current site use unsuitable, and both trees would likely require significant reduction, or be removed entirely, within the next 20 years, in the interest of safety.

- 3.6 Due to the limited space between the proposed Commercial Building and site boundary the proposed access road would need be positioned within the RPA of both T7 and G7 and the necessary excavation required to provide a sufficient subbase for this access road is likely to impact the rooting systems of both T7 and G7, potentially resulting in both trees being more susceptible to future failure and increase their rate of decline.

- 3.7 This subsequent increased risk of whole tree or branch failures as a result of these works, combined with the likely increased footfall beneath these trees and the proximity of the proposed Commercial Building would make the retention of both T7 and G7 unsuitable, in the interest of safety.

- 3.8 There should be no objection raised on arboricultural grounds to the removal of both T7 and G7, with both being considered of over mature proportions and in the context of the current site use, nearing the end of the useful safe life expectancy.

- 3.9 The removal of T7 and G7 could be mitigated for through new tree planting along the western boundary as part of the landscaping scheme, providing trees of higher quality which would be more suited to the future use of the site and would provide a new generation of tree cover to ensure succession to maintain and continue the tree'd landscape character of the site.
