Howes Lane/Bucknell Road/Lords Lane

Technical Review

Document Reference: 1000003465/TN/NB/01

Stage 3 Road Safety Audit

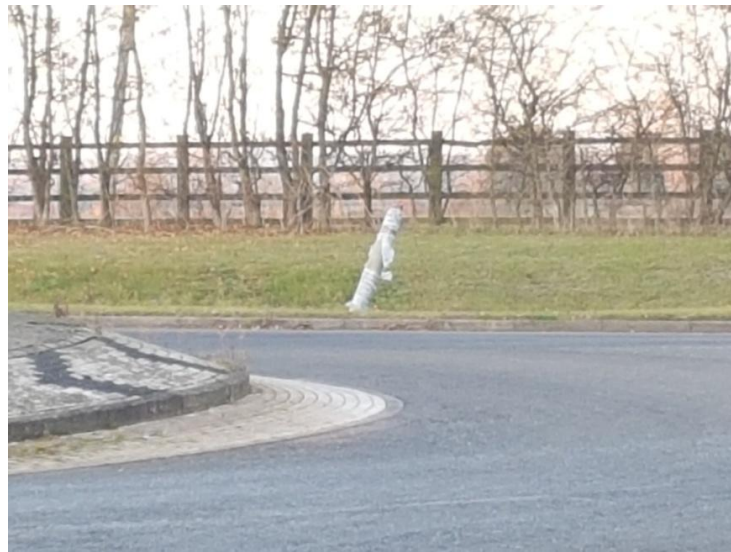
The Audit Team are concerned that the high entry speeds could result in loss of control collisions on the roundabout and rear end shunts on the entry arms due to sudden braking.

As detailed in photo 3.2.1 an existing lamp column located on the northern side of the roundabout has been struck.

Photo 3.2.1 Damaged lamp column

Recommendation: Investigate options to reduce speeds entering the roundabout and / or provide greater levels of control to encourage drivers to slow / stop before undertaking the turn.

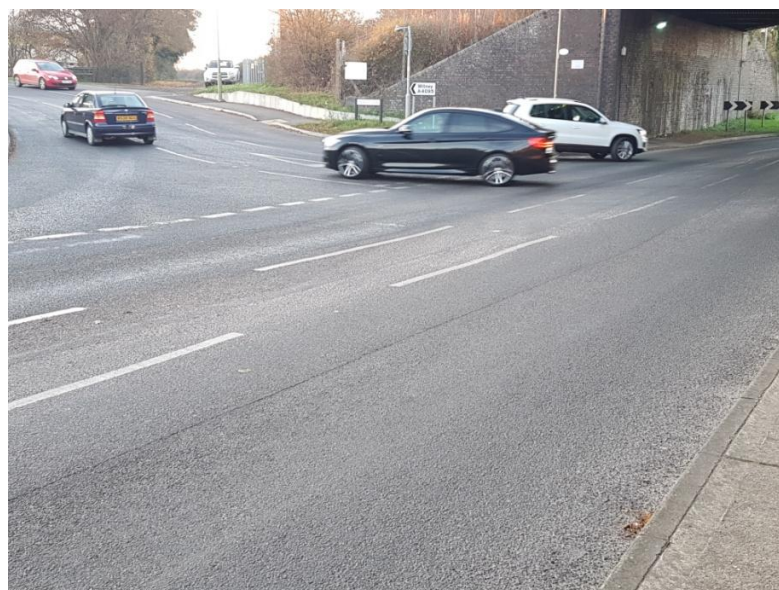
Details: During the course of the site visit vehicles turning right into Howes Lane were regularly observed cutting the corner and entering on the wrong side of the road as seen in photos 3.2.2 and 3.2.3. During free flow conditions right turn movements were sometimes undertaken at speed to avoid having to stop for a vehicle approaching on Bucknell Road.

Photo 3.2.2 Example of right turner cutting corner

The Audit Team are concerned that vehicles turning right at speed on the wrong side of the road could come into conflict with vehicles approaching in the right turn lane resulting in a collision occurring.

Recommendation: Assess the existing layout of the junction and investigate options to discourage vehicles turning right from cutting the corner into the path of oncoming vehicles or to encourage them to stop and wait before turning to enable them to observe oncoming traffic and turn safely.

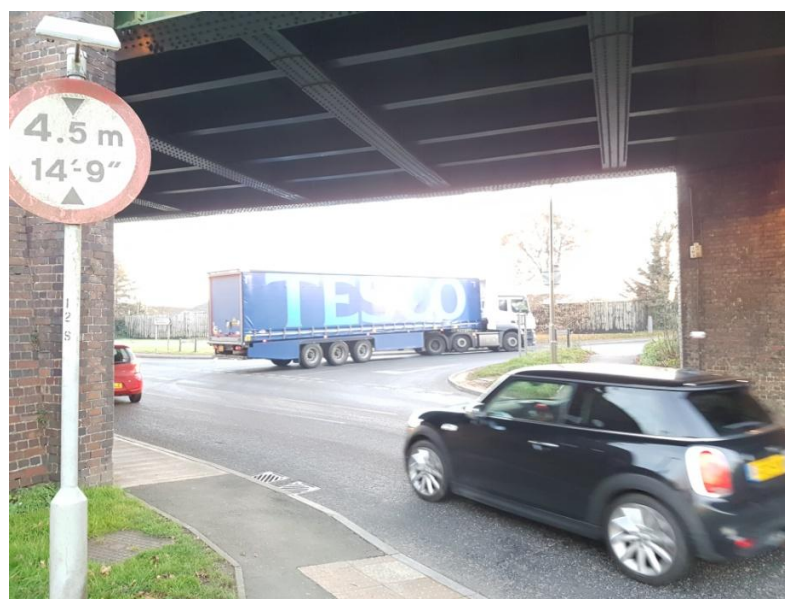
Photo 3.2.3 Example of HGV on wrong side of road turning right

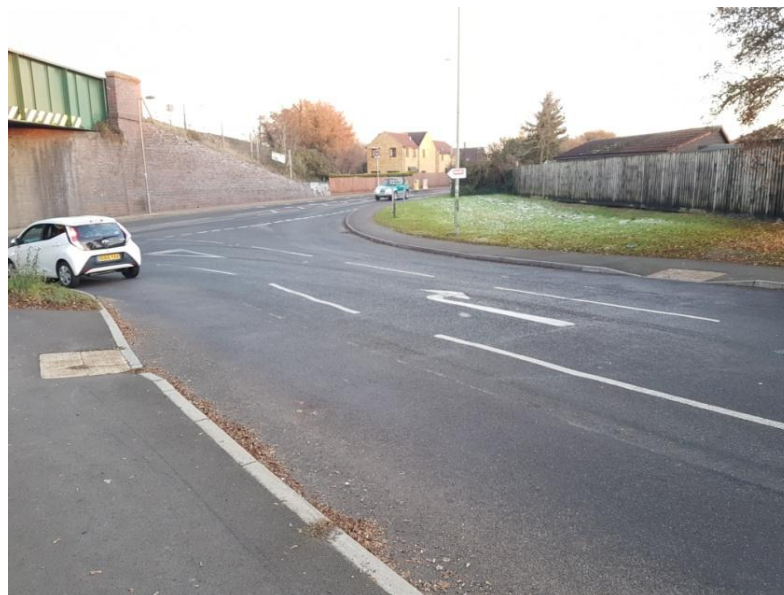
Detail: There are existing dropped kerbs with tactile paving on A4095 Howes Lane just west of its junction with Bucknell Road as detailed in photo 3.3.1.

Photo 3.3.1 Location of dropped crossing on Howes Lane

The carriageway is wide at this location with two north eastbound lanes approaching the junction and one in the opposite direction. During peak times there are few opportunities for pedestrians to cross in a single movement. The Audit Team are concerned that a pedestrian could find themselves within the carriageway waiting to cross between stationary and moving vehicles resulting in a collision.

In addition, vehicles were observed turning left into Howes Lane from Bucknell Road at speed. The crossing is set away from the junction and a pedestrian waiting to cross or crossing may not be immediately visible to the driver of a vehicle turning left. The Audit Team is concerned that if a pedestrian stepped into the road or was in the process of crossing the road that a vehicle turning left at speed will not have sufficient time to stop resulting in a collision.

Recommendation: Investigate options to reduce vehicle entry speeds and investigate option to improve crossing facilities for pedestrians.

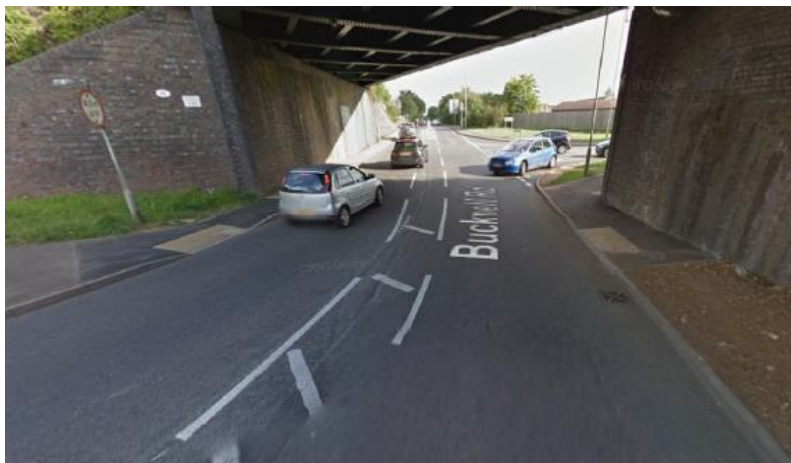
Detail: There is an existing dropped crossing located under the railway bridge on Bucknell Road as detailed in photo 3.3.2.

Photo 3.3.2 Dropped crossing under Railway Bridge (@googlemaps)

Pedestrians waiting on the west side of the carriageway to cross the road have restricted visibility (approximately 1 car length) of vehicles waiting at the junction of Howes Lane as detailed in photo 3.3.3. Pedestrians need to be aware of vehicles coming from several directions including coming off the roundabout, straight along Bucknell Road and out of Howes Lane, and particularly at peak times when traffic flow is high, meaning a lot of activity to account of and resulting in it being difficult to find a safe period to cross. The site visit was undertaken during school finishing times and traffic volumes were high. The Audit Team did not feel comfortable trying to cross at this location during this period.

Furthermore, the visibility of the pedestrians waiting to cross on the west side is restricted for drivers pulling out of Howes Lane. A drivers focus is naturally to the right to determine a safe period to pull out rather than to the left where pedestrians may be waiting to cross.

Recommendation: Investigate options to improve crossing facilities including the provision of a controlled crossing and / or relocating the crossing to a point with better visibility.

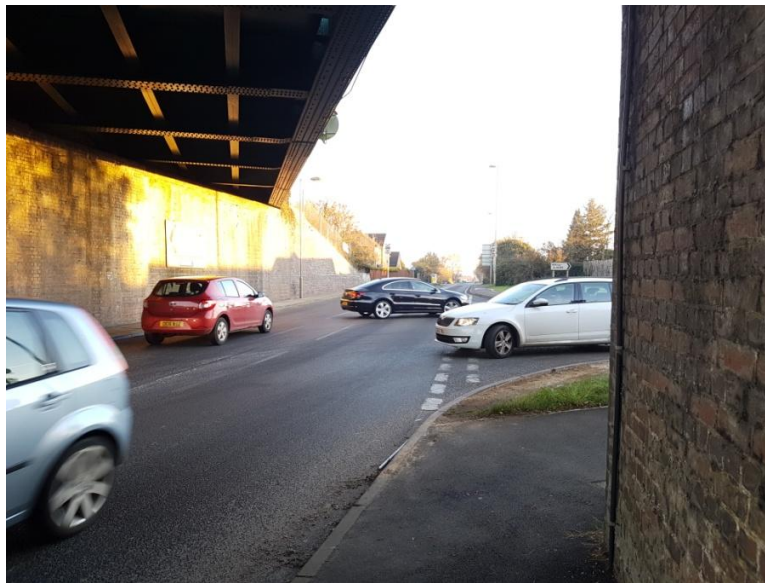
Photo 3.3.3 View from dropped crossing (looking away from the roundabout)

The Audit Team are concerned that during peak times when traffic flow is fairly constant that drivers will be focussed on trying to get out of the junction, resulting in them being unaware of a pedestrian waiting to cross or stepping into the carriageway and a collision occurring.

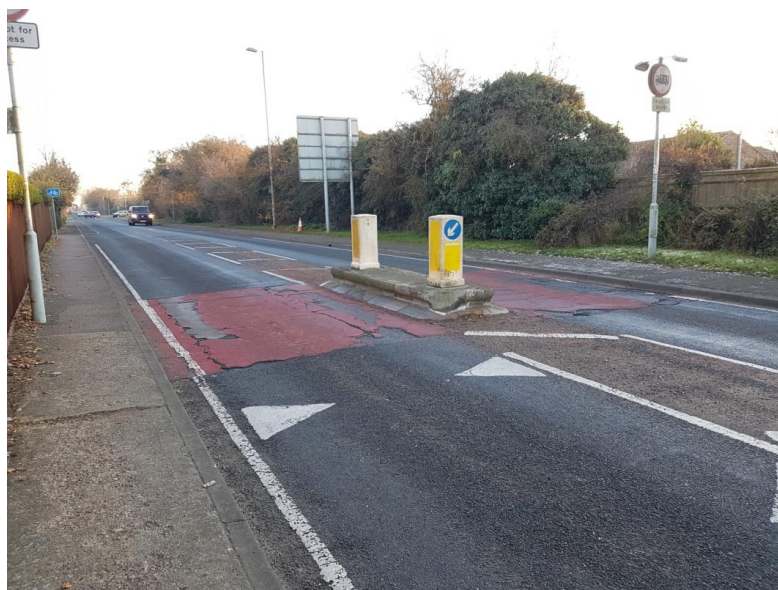
Detail: There is an existing double height kerb central island located south east of the junction with Howes Lane which appears to act as a gateway into the weight restricted area as detailed in photo 3.3.4.

There are no crossing facilities on Bucknell Road south east of Howes Lane and the Audit Team are concerned that pedestrians may try to use the central island to assist them in crossing the road. The double height kerbs are such that pedestrians could fall off or step awkwardly off the island resulting in them becoming unsteady and falling into the road and into the path of an oncoming vehicle.

Photo 3.3.4 Existing Central Island

Recommendation: Investigate options to provide pedestrian crossing facilities on Bucknell Road south east of Howes Lane.
