Report on the Condition of

**CHANCEL COTTAGE
FIR LANE
STEEPLE ASTON**

ORIGINAL ISSUE DATE:
November 2013

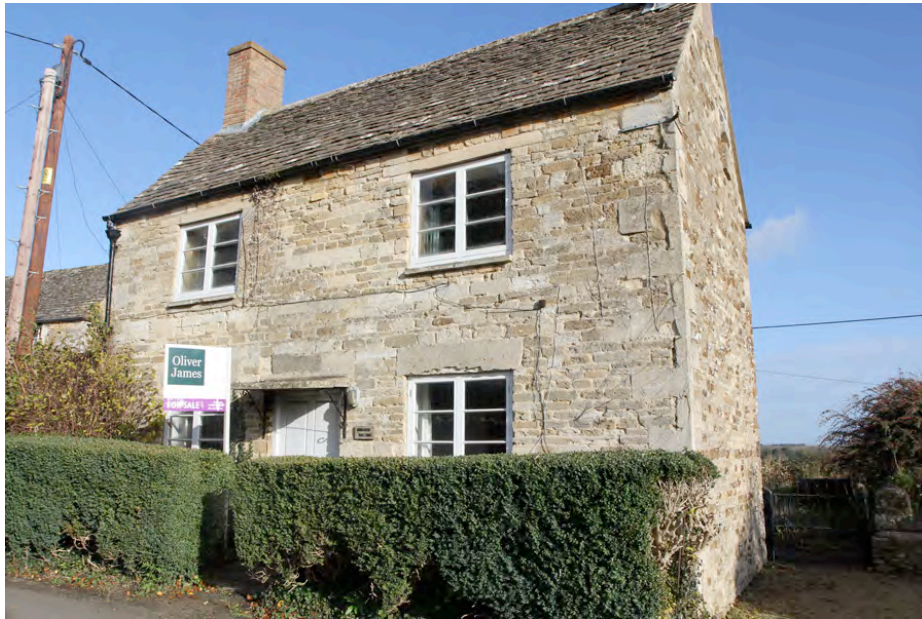
7.1 West Elevation

The wall is coursed limestone with ashlar dressing, which is affected by ivy and vegetation growing at low level to either side of the doorway, the general clearing out of this is required. This is clearly not assisting with the damp internally. There are open joints generally to the wall, particularly beneath the windows and between the windows. Local overhaul of the stonework and repointing is required to an area of approximately 30 sq. metres. To the ground floor there are two 2-light windows, which have been replaced which are in fair condition but will require redecoration. Both have stone lintols which have been rendered, the render is breaking off to the window to the south and replacement will be required. The general making good is required around the lintol and to the lintol to the window to the north. It may be possible to reinstate the stone lintols but investigation to the removal of the render is required.

To the centre of the elevation is the 4-pannelled doorway, which is in reasonable condition but will require redecoration. There is some rot occurring to the lower rail to the door and to the weatherboard. Over the door there is a stone slab, which forms the porch supported off two cast iron brackets, which is in fair condition. The lintol over the door is again rendered and scribed which has been inserted over a stone lintol. General making good to this is required.

The first floor has two 2-light windows, which have been replaced and are in reasonable condition. Both have concrete cills, which have been lined with lead and rendered, the render is breaking off to the window to the north and general repair is required, as it is to the pointing beneath this. The lintol to both are stone which are in reasonable condition. There are open joints beneath the eaves, which require repointing. As noted internally there has been some outward movement to roof, which has caused the eaves

The quoin stones on the south side are affected by some movement to the outer face of the wall to the east gable. Repointing is generally required in conjunction with repairs to the gable.

To the north of the wall is a plastic gutter on a timber fascia which discharges into a cast iron downpipe with hoppers. The gutter requires general cleaning out. The downpipes themselves are in fair condition but again the cleaning out and redecoration is required.

The roof is formed in stone slates in diminishing courses. The roof has been relaid. There is some slippage to the slates beneath the ridge and around the chimneys. The recovering will be required. The stone ridge is in fair condition. Both end stacks are in brick with a lead lining. There are open joints around the lining from the west slope to the chimney to the east, clearly repairs are required. There are several missing small bricks to this chimney and slates missing under the flashing. Overhaul and repointing is required to the stack. The stack to the north is in brick, which appears to be generally sound.

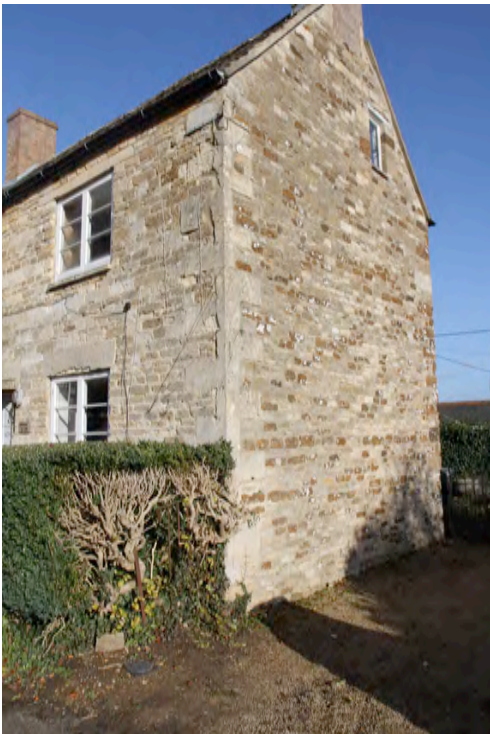
7.2 SOUTH GABLE

The south gable to the main range is in limestone rubble and ironstone, there are open joints to the corner to the west and at ground level, which require urgent repointing. The wall itself has been pointed in a hard cement mortar and some decay, consideration should be made to the replacing of this.

At high level there is the single light window with timber lintol and stone cill. The window is metal, general overhaul of this is required together with re-puttying. The lintol appears to be in reasonable condition. The cement dubbing has broken away allowing the mortar to ingress behind the flashing which is causing the damp internally. The verges are formed with a tiled overhang and pointing which are in reasonable condition.

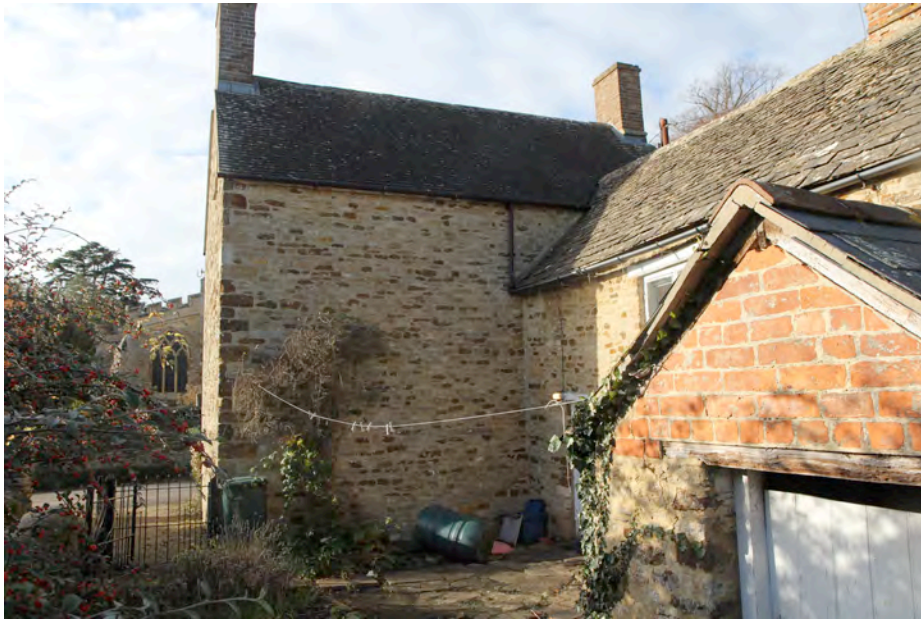
7.3 EAST ELEVATION TO THE FRONT SECTION

At ground level void there is the lightwell to the window to the basement, which requires general clearing out and repointing together with the ground floor replacement of the window. As noted internally there should be some arrangement for ventilation made.

There is a blocked window with a timber lintol and cill remaining.

The roof is formed with a fascia and plastic gutter and downpipe, which discharges into the gutter extending along the outbuilding. As noted previously there is brickwork cracking to the chimney to the south and general repair is required together with replacement of the flashing. Attention is required to the flashing to the chimney to the west where the chimney itself is in reasonable condition.

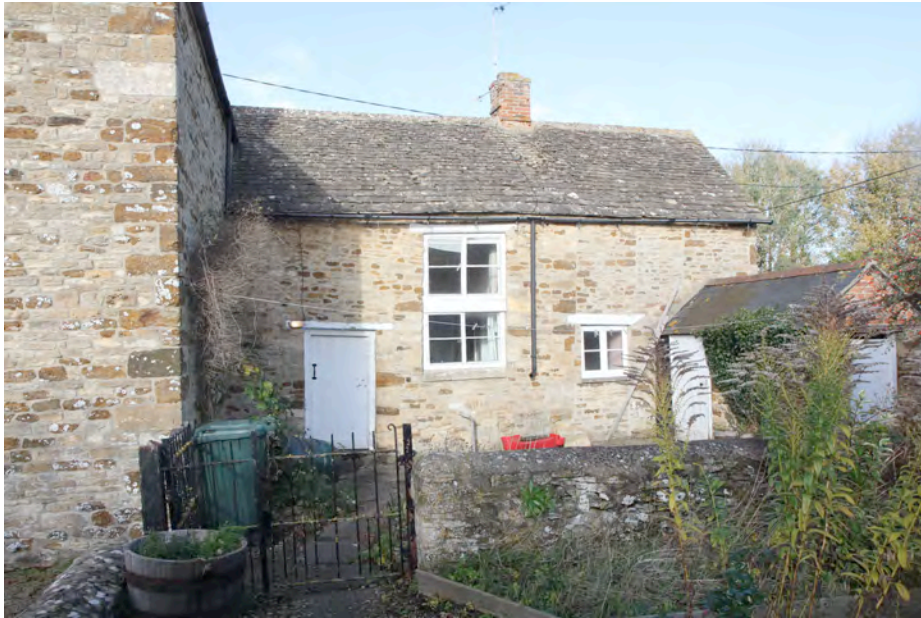
7.4 SOUTH ELEVATION TO REAR WING

The elevation is a mixture of limestone and ironstone, which has been flush, pointed. The stonework generally requires overhaul and repointing. There is a movement crack to the main building, which has been repointed in a hard cement mortar, which is coming away, and further movement cracks beneath the eaves. The movement has occurred to the centre of the wall where the central window has distorted. There is damage to the stonework to the junction with the gable wall to the bathroom section. Clearly there has been outward pressure from the roof. The general tying in and repointing is required. There is a substantial bow to the wall. Investigation should be made into the ground conditions in this area.

Returning to the stonework, there are open joints and movement beneath the window to the kitchen. The stonework to the section appears to be in reasonable condition although repointing is required. To the west of the wall is the boarded entrance door, which is decoratively in poor condition. There has been some rot to the lower members of the frame, which has been replaced in the past. Overhaul, repair and redecoration is required.

The kitchen window had repairs in the past, which had been pieced into the cill, this is decaying. The metal replacement opening light appears to be in reasonable condition. Over this is a timber lintol to which there is settlement to the lintol. The general overhaul and repair is required. There is a plastic gutter on rise and fall brackets which has discharged into a rainwater pipe, which is now removed. Improvement of the drainage system here is urgently required.

The roof is formed in stone slates in diminishing courses, which is in poor condition, and recovering is required. To the ridge there is a brick chimney to which the brickwork is

spalling and the pointing is poor. The general overhaul of this is required in conjunction to any new roofing scheme.

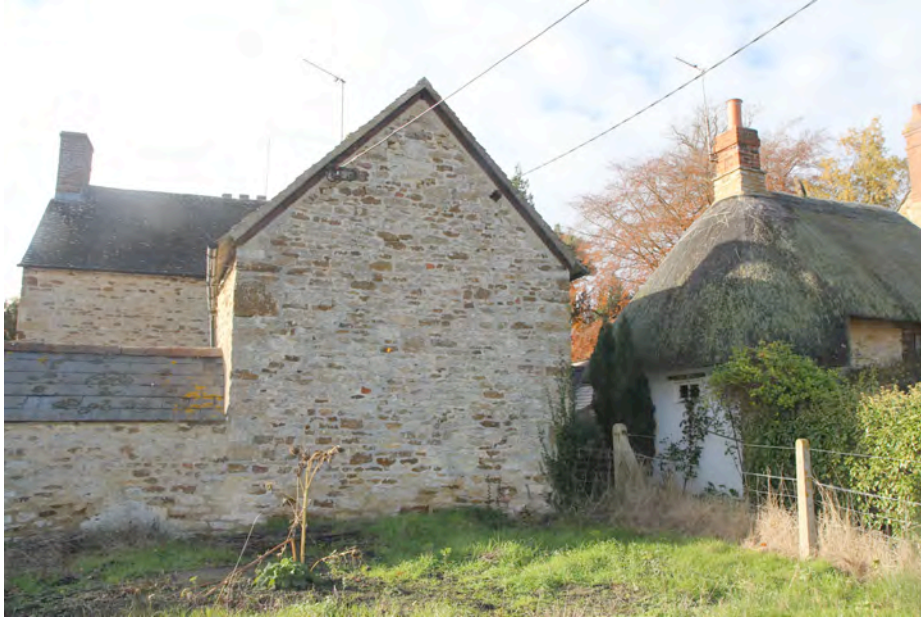
7.5 EAST GABLE

The stone gable has considerable opening joints and movement cracks which extend down the centre of the wall to both corners. General repointing is required and overhaul to the gable complete and local replacement of stonework. The verge is formed with timber boarding with overhanging slates, which are in fair condition. The incoming electrical mains is fixed to the purlin end which is clearly not helping the condition of the movement of the gable and the replacement of this by an underground supply is strongly recommended. The installation of a land drain at the base of this wall should also be considered.

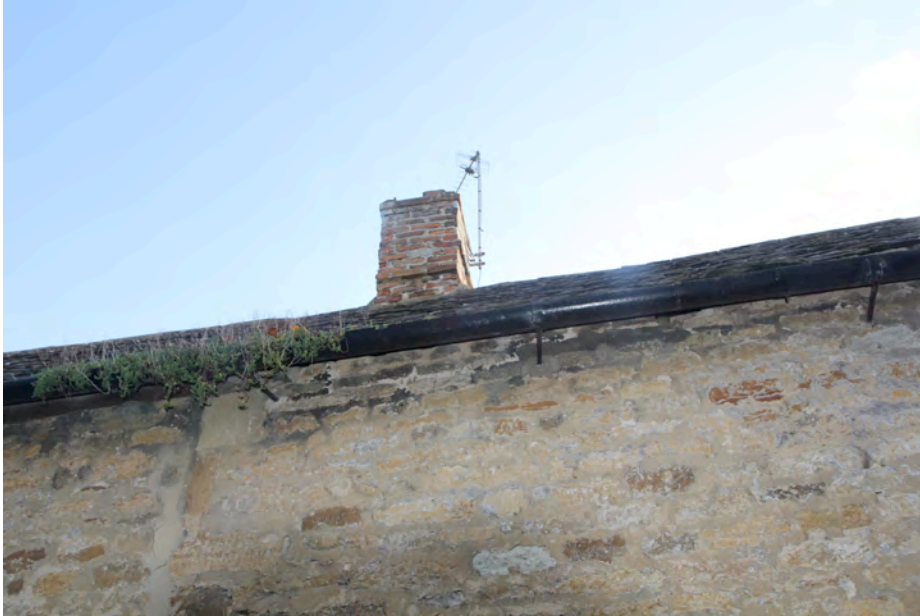
7.5 NORTH ELEVATION TO THE REAR WING

There are movement cracks evident to the bathroom, the general making good and repointing is required. The window, which is a timber 2-light casement window, is in fair condition, although the overhaul and redecoration is required. There is a timber lintol, which is affected by furniture beetle, and a tiled cill.

To the kitchen section again general repointing is required. There is an open joint, which has been pointed in a hard cement mortar between the extension and the main gable, this should be repointed and monitored for continuing movement.

The roof eaves is formed with overhanging tiles. There is an aluminium gutter on rise and fall brackets, which is blocked, the general cleaning out of this is urgently required. The roof is in stone slates, which are in poor condition, and the general recovering is required. As noted previously, the chimney sack is in poor condition and the overhaul and replacement of brickwork generally is required.

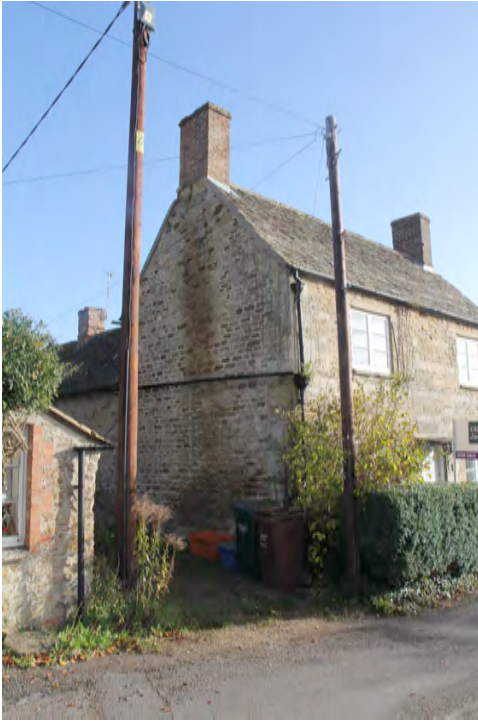
7.7 NORTH GABLE FRONT SECTION

The main house gable is stone. There has been some movement to this, particularly to the corner to the west. The general repointing here is required together with the removal of vegetation. The chimney stack has decayed stonework beneath the brick chimney stack, replacement of this and general repointing is required to an area of approximately 30 sq metres. Extending across the elevation is the aluminium gutter which discharges into the copper grating to the front elevation. The replacement of this is required in conjunction with improvement of the system.

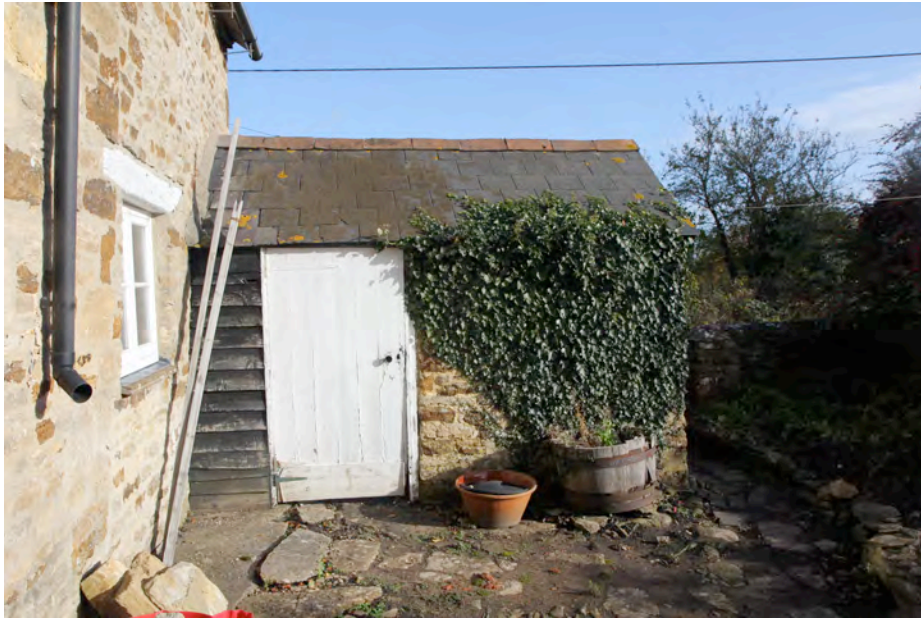
7.7.1 WEST ELEVATION

The elevation is boarded as it adjoins the main building and stonework to the south of the doorway. The general repointing and removal of ivy is required to the outbuilding. The door is boarded which is generally in poor condition and repair is required. The stone gable requires repointing. There is the boarded door with timber lintol, the timber lintol is affected severely by furniture beetle and treatment is required. The door itself is of poor quality and rotting at the base, replacement is required.

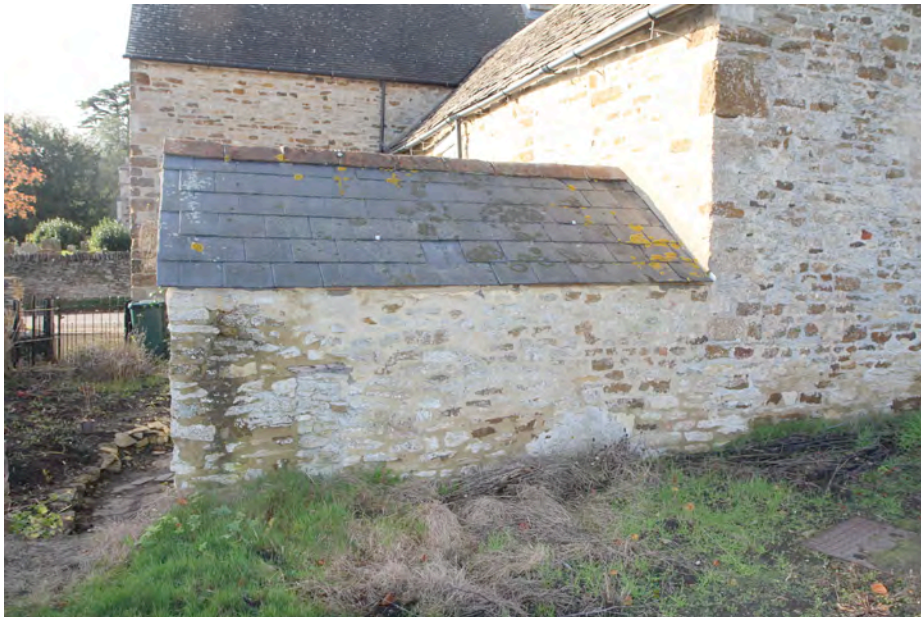
7.7.2 EAST ELEVATION

The east wall above ground acts as a retaining wall. There are slight movement joints to this to the corner to the south, general repointing is required. There is no gutter fitted to this outbuilding and this is recommended. The roof is slate with clay bonnet tiles, which is in fair condition.

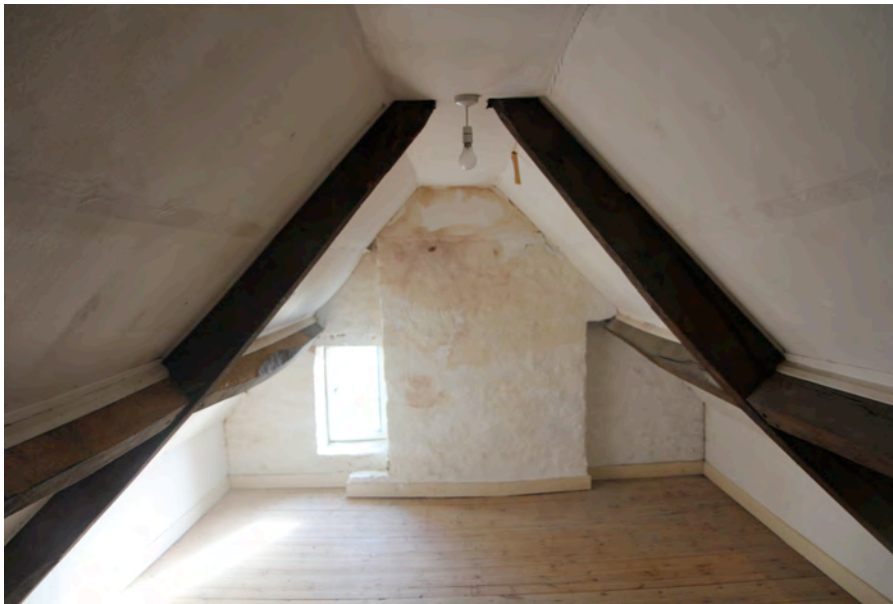
8.1.1 BEDROOM 4

The Bedroom is formed into the roof space, which includes two trusses, with a central purlin to each slope. To the gable to the south there is a small single light window. The roof is formed into the roof space, which is lined with insulation board, this is taped to the joints and peeling and generally sagging, the upgrading of this is necessary. There is a small section of flat ceiling to the ridge. Water is ingressing to the centre of the roof.

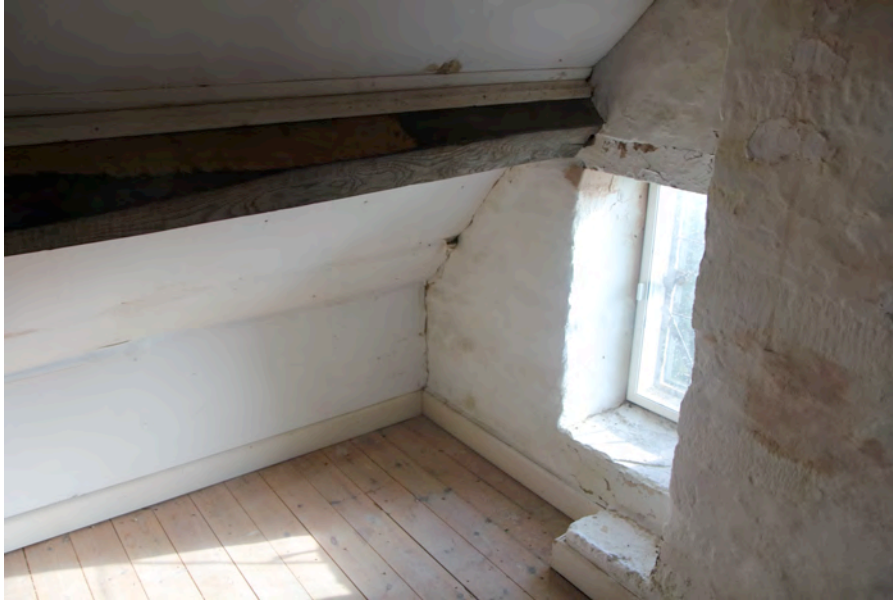
Photo showing the damp ingress to the south gable

The south gable contains the chimney breast to which there is staining to the plaster, repairs are necessary externally. There has been slight movement of the gable moving outwards due to lack of restraint from the roof beams. The provision of such restraint is required to both purlins.

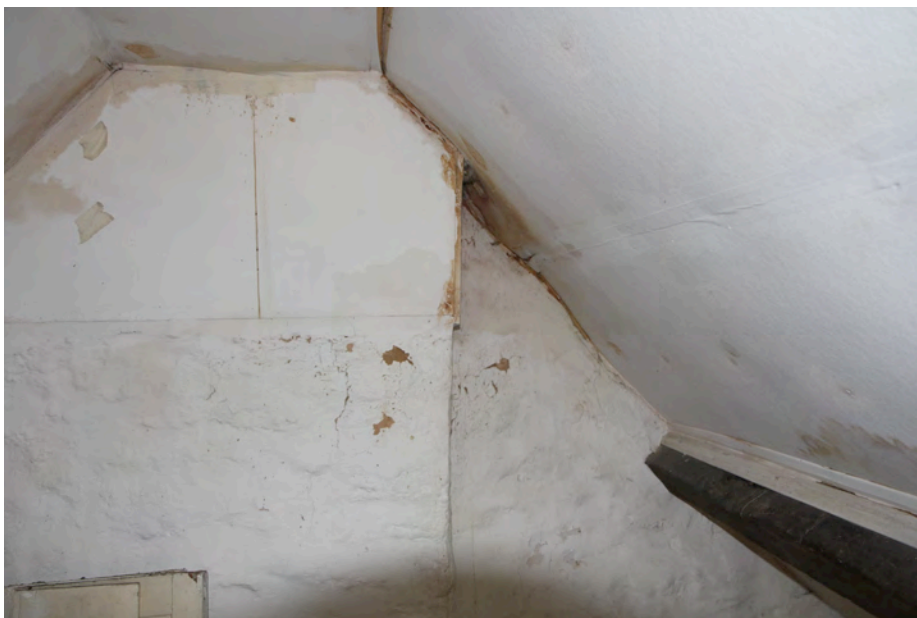
Photo showing the damage ingress to the north gable

The gable to the north is plastered to just below the ceiling where insulation board has been fitted, again damp is ingressing at high levels around the chimney breast. There is slight movement of the gable where it has moved outward due to lack of restraint.

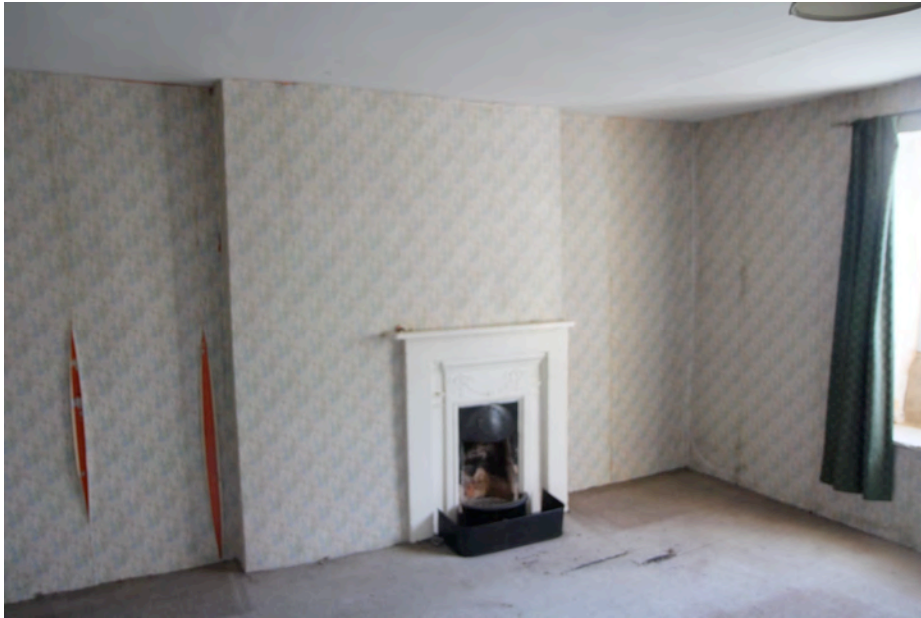
8.2.1 BEDROOM I

The floor is boarded with a fitted carpet, which is in poor condition. The floor boarding has been lined with hardboard, generally this appears to be in fair structural condition, but affected by condensation.

The walls are plastered and papered and the decorations are in poor condition. To the west elevation there is a 2-light window in fair condition, but water is ingressing and to the lintol of the window, which is affecting the wall, plaster which has become de-bonded, particularly around the north side of the window.

The north wall is papered, on lathe and plaster, this is generally sound. There has been some slight movement to the wall to the west end where there is an open joint between the wall and the west wall, this has been made good but cracked again. To the wall there is an original 4-panelled door, which is in fair condition. There is a rim lock fitted to this. The door is warped slightly.

The south wall is affected by damp to either side of the fireplace. Due to poor pointing externally. This is particularly severe to the corner to the west. The wallpaper is generally peeling. There is a chimney breast with timber surround and a metal fireplace with fire bricks, which is in sound condition, although decoratively poor.

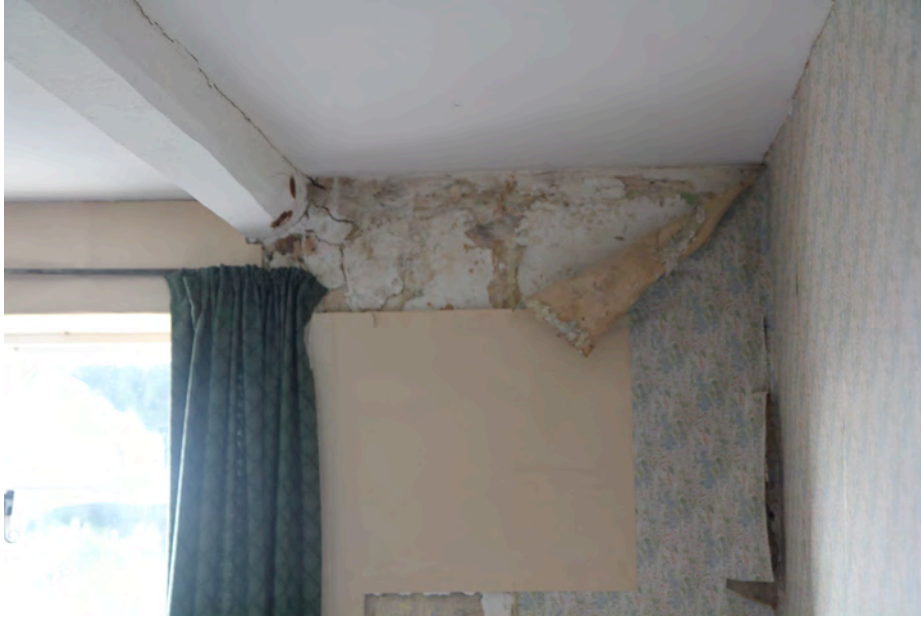
There is a cross beam spanning from east to west, which is in fair condition, the ceiling in lath, and plaster that has been lined with plasterboard and skimmed. It is unclear as to the condition of the lathe and plaster beneath this. There is some movement to the west wall where there is cracking to the plaster over the window, due to the wall moving outwards caused by the outward thrust of tying in of this is required.

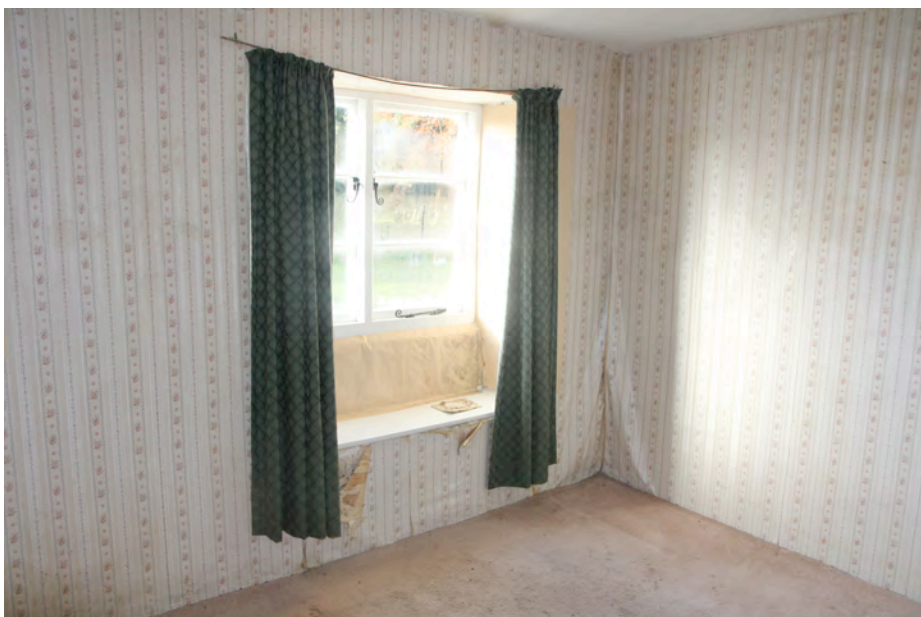
8.2.2 BEDROOM 3

Bedroom 3 is in similar condition to Bedroom 1. The floor is carpeted which is laid on an underlay. The floor is boarding which appears to be in fair condition. There is a cupboard to the corner to the north west, which is in reasonable condition. The walls are plastered and paper but generally the paper is peeling from the walls.

To the west wall there is a 2-light window, which has been renewed. There is damp ingressing beneath this to the window seat and to the window reveals due to the external pointing. There is damage to the plaster at skirting level.

The ceiling is lathe and plastered with a single cross beam, which is chamfered. Generally this is in fair condition, there has been outward movement of the west wall which has affected the beam, tying is required. The ceiling has been lined with paper, which is peeling, particularly to the junctions to the west wall and to the corner to the north west.

As noted in the comments on Bedroom 1 and Bedroom 4, there is no restraint to the roof in the form of collars to the second floor. There has clearly been some outward thrust of the wall over the years which has caused both the east and west wall to move outwards. This has damaged the plaster to the ceiling. In any refurbishment the addition of some form of restraint to the roof to arrest this movement, is necessary.

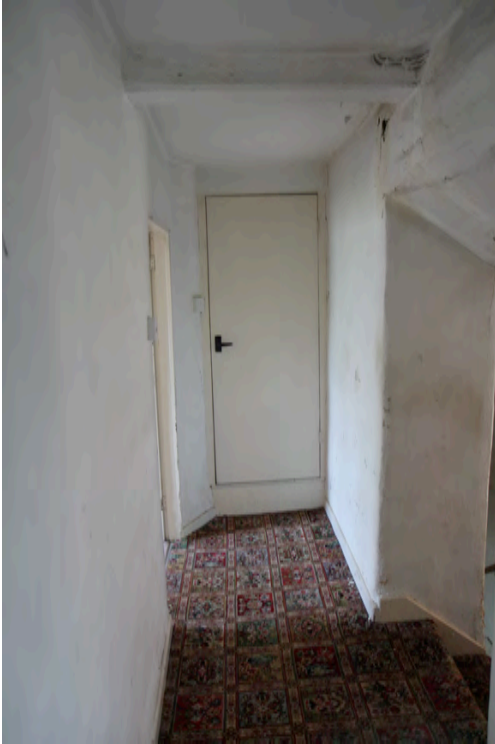
8.2.3 CORRIDOR OUTSIDE BEDROOMS 2 AND 3

The floor is boarded with a fitted carpet, which is sound structurally. The walls are plastered.

The west wall is in fair condition but decoratively poor. To the north of the wall there is a 4-panelled door which leads to Bedroom 3 which, as noted previously, is in fair condition, but general adjustment and overhaul is required. There is a slight crack where the stud partition has sunk slightly over the doorway. The north wall has the flush door, which leads to the staircase to the second floor Bedroom. This is of poor quality and as noted before contains no fire separation.

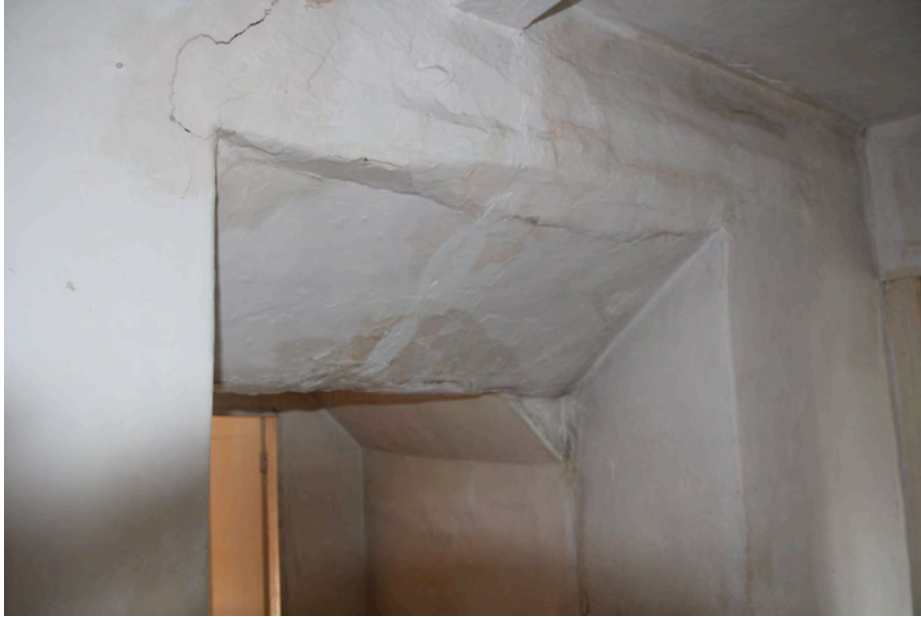
Photo showing the lintol and the opening to the staircase

The east wall at the opening leading to the staircase. There is some damage to the plaster to the lower side of the chamfered opening and to the north of the beam. The removal of the plaster to identify the cause for this is necessary.

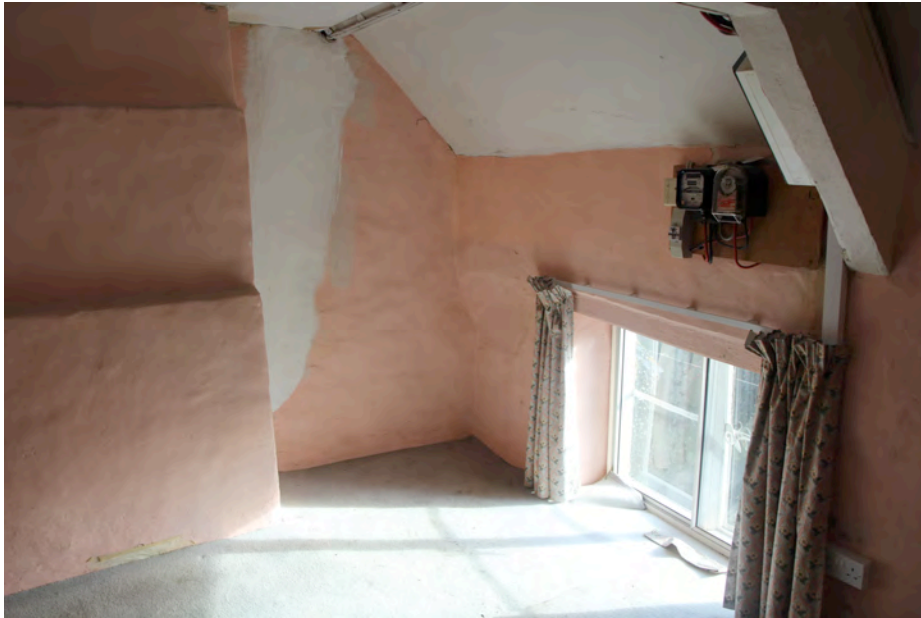
8.2.4 BEDROOM 2

The floor is boarded with a fitted carpet. The floor has been lined with hardboard. There is considerable sag to the floor where settlement has occurred to the corner to the south east. The settlement to the extension is evident where the door has deflected and a make-up piece added.

The movement is thought to relate to settlement caused by the ground water conditions being affected by the faulty rainwater disposal system.

There are cracks to the corner to the south of the door head.

The north wall is plain plastered. There are movement cracks extending down the corner to both corners and the plaster is debonding around the central feet of the truss. The settlement is more evident to the corner to the east. The east wall again has movement cracks and there is a movement crack extending down the corner to the south, which has been made good, this appears to be stable. There is further evidence of making good of plaster to the corner itself. To the centre of the wall there is a stepped chimney breast, which is plastered and appears to be in reasonable condition. The plaster is cracked to the corner to the east and there are horizontal cracks to the section of the wall to the west.

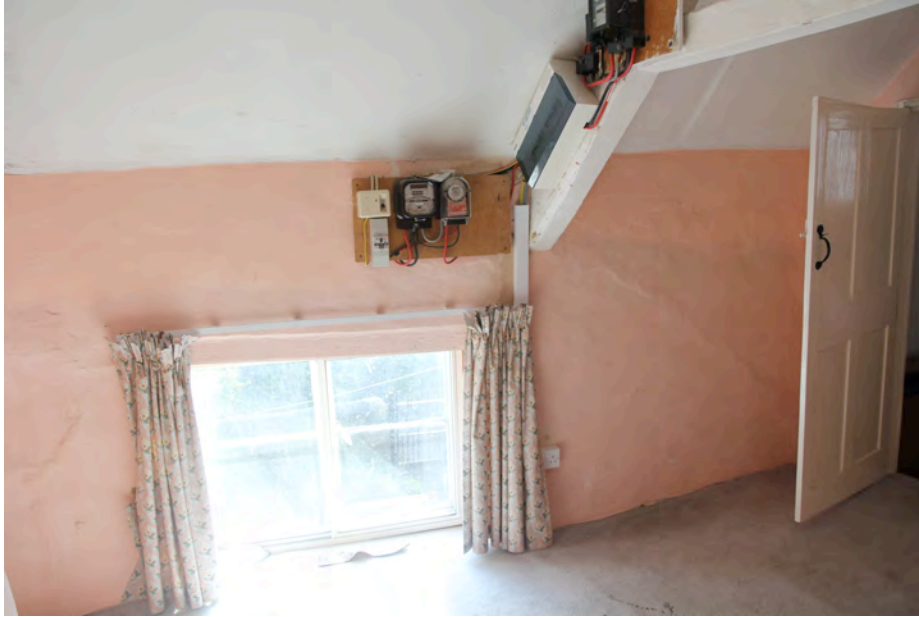
Photo showing the electrical incoming mains and distribution boards

To the area is the incoming electrical main, which is fixed to the roof purlin and truss. To the south wall are the electrical meters, which include the provision for night storage heating. There is an RCD distribution board fitted to the base of the truss. This was installed in 1962 and last inspected in December 2007. The electrical system is mainly exposed surface fitted wiring. The distribution board was installed in 2002. The decorations to the area are poor.

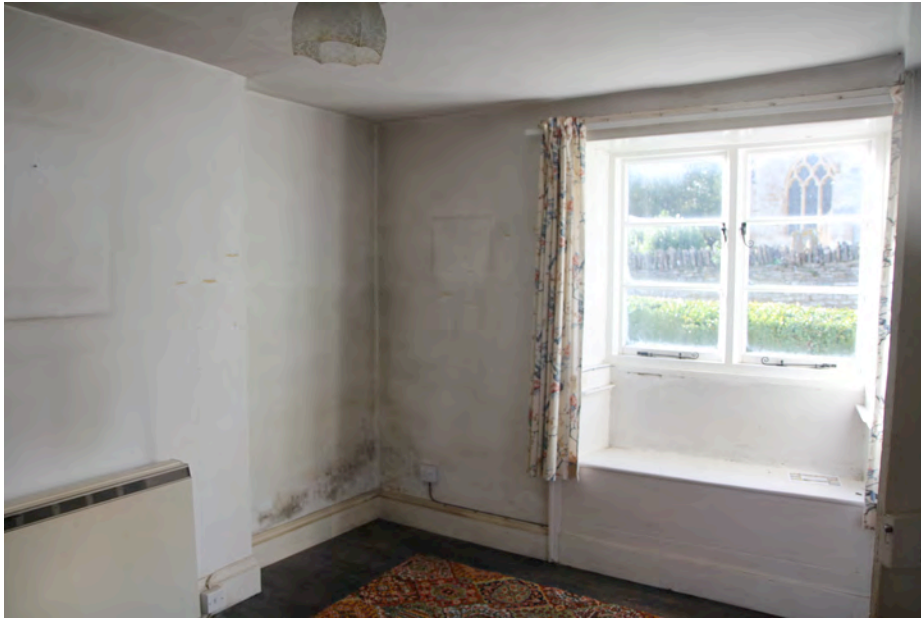
8.3.1 DINING ROOM

The floor is boarded which has been stained around the perimeter. The boarding generally is in fair condition. There are slight undulations to this. The walls have a moulded timber skirting fitted.

To the west wall there is a 2-light window, which has been replaced. A window seat has been formed beneath this. The window itself is in fair condition, but there is a high level of damp to the reveals. There is further damp ingress at low level to the corner to the south, which extends fully up the wall.

The door to the north is the original 4-panelled door with 'L' hinges, which is in fair condition. There is slight splitting to the panels. The door has sunk, adjustment is required. The door is of historic interest. The east wall is plain plastered, and again damp is ingressing from low level to the corner to the south. There is a shelf unit fitted at low level.

The south wall has damp, as noted, to both corners at low level. To the east is a wide cupboard with single panelled door with 'L' hinges. The redecoration of this is required. The knob is missing to the lock to the cupboard. Internally the cupboard has three shelves fitted. The plaster is generally in place but decorations are poor. To the centre

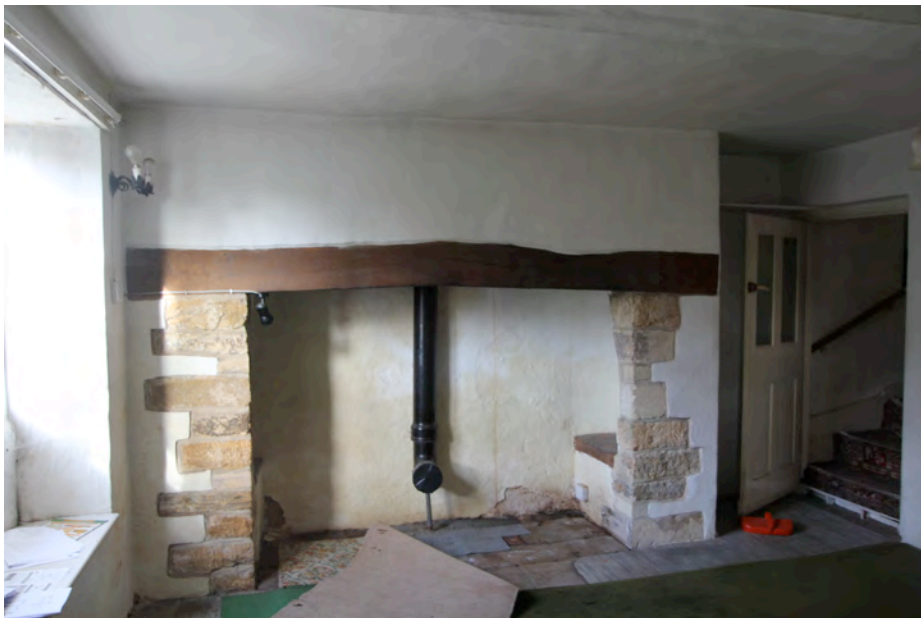
8.3.1 SITTING ROOM

The floor is stone flagged which has been overlaid with hardboard and carpet, the stone flagging appears to be generally in reasonable condition except where it extends into the fireplace now removed was fitted. Here the floor is affected by damp to the centre of the area where there was a wood burning stove. The floor and the fireplace which has been reformed but replacement of the brickwork to the fireplace is recommended together with repointing.

To the east to the doorway, which leads to the kitchen, this is heavily worn. The walls are plastered without a skirting and there is damp ingress to the corners particularly, and to the wall to the north to the inglenook fireplace.

The north wall has the inglenook fireplace, which has two stone reveals, which have been repointed in a hard cement mortar and a timber bressumer beam. There are two timber seats within the inglenook. Generally the inglenook opening is in reasonable condition but the wall inside the inglenook is affected by damp, which is causing damage to the plaster itself. There is a flue central to this, which related to a stove now removed.

The east wall has, to the north, the 4-panelled half glazed door which leads to the staircase which is in serviceable condition but of a poor quality. There is a 4-panelled door, which leads to the kitchen, which is of similar construction. As noted previously there are high levels of damp rising into the wall to the corner to the south east. The wall to the south is a stud partition with lathe and plaster, which appears to be in reasonable condition. There is an opening blocked to the corner to the east of the wall. To the west of the wall there is the 4-panelled door leading to the Dining Room, which is in fair condition. There is a slight movement crack to the head of the doorway, which has caused damage to the plaster. General making good of this is required.

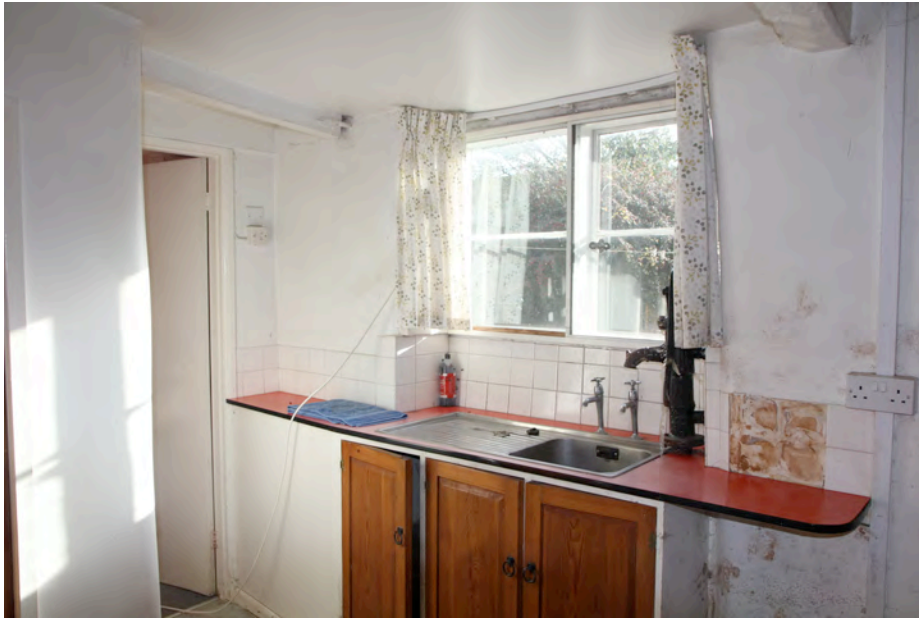
8.3.3 KITCHEN

The floor is concrete to which thermoplastic tiles and then a thermoplastic sheet have been added, the condition to this cannot be ascertained but clearly there is damp ingress affecting the wall and floor around the perimeter, particularly to the north and south walls. In any refurbishment the investigation and improvement of this will be required. The walls are plastered and part-tiled. To the west of the wall there is the 4-panelled door leading to the Sitting Room, which is in reasonable condition. The general overhaul and redecoration is required. As noted, the threshold requires general improvement. Over the door there is a timber lintol, which appears to be in reasonable condition. To the north of the staircase there is an enclosure to the staircase leading to the basement. This has a set of double boarded doors, which are in fair condition. To the north is a brick wall, which is part lime, washed and part white tiles, this appears to be sound but the tiling is of poor quality.

The north wall is plastered. To the centre of the wall there is a blocked window opening, which has damp evident around the reveals. The plaster has been damaged by the removal fittings, but is generally sound.

The east wall has to the north a fitted cupboard with two modern 2-panelled doors. The cupboard is formed within the original fireplace, which presumably contained a range. There is a bread oven within the cupboard to the north, which is formed with brick walls, and a brick arched lintol, which is in reasonable condition. The walls within the cupboard are plastered and generally affected by damp and mildew. To the south of the wall is a flush door, which leads to the bathroom. There has been historic movement related to the walls, which is evident in the room above.

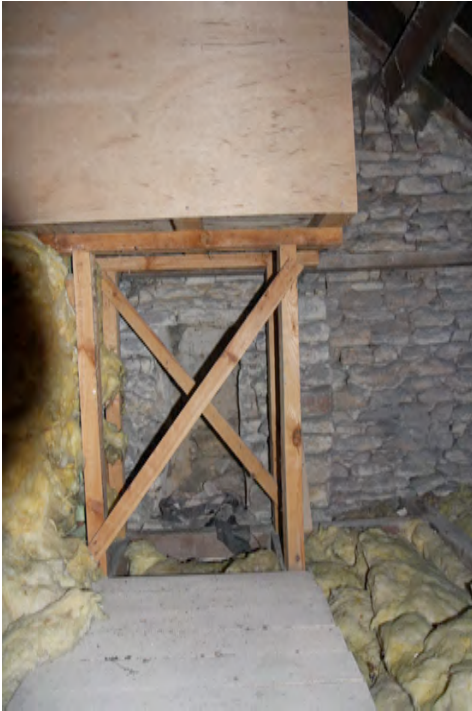
8.3.7 ROOF SPACE OVER THE BATHROOM

The ceiling joists to bathroom to WC have been replaced beneath the original timber beams, which span east to west, with a glass fibre quilt, which is disturbed and requires replacement. The walls are stone. To the west wall there is the gable wall, which contains the chimney breast. There is damp ingress from around the chimney. There are further movement cracks beneath the purlin. The water ingressing at the ridge has affected the end rafter to the roof where the ridge has rotted away.

The west wall is stone approximately a metre high. There is movement to the corner, but generally sound, repointing is required.

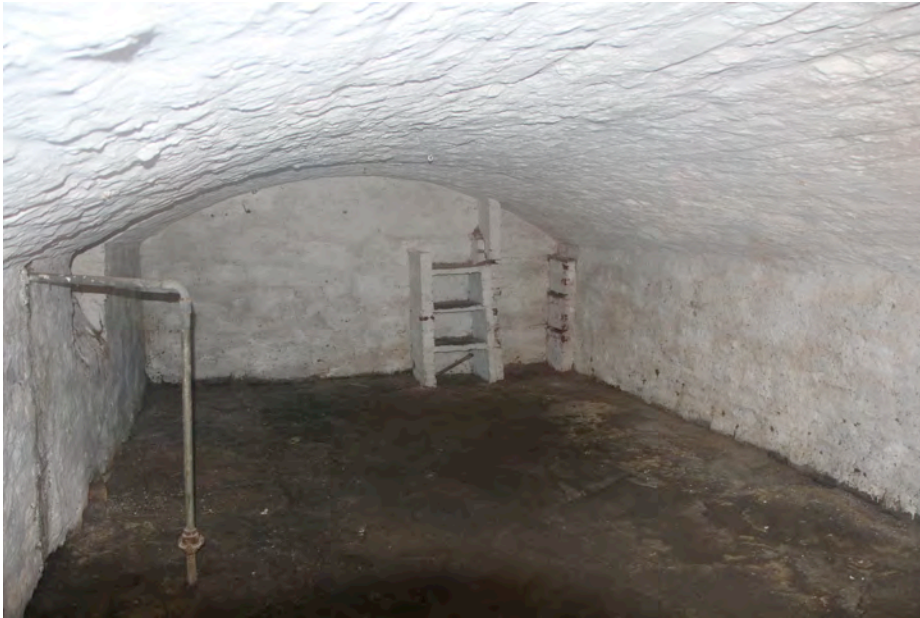
8.4 BASEMENT

The basement is approached by a stone staircase, which is formed of winders to the centre section. This is in reasonable condition. The walls are part painted stone and part plastered to the staircase itself and in reasonable condition. The ceiling to the staircase is formed by the winders to the main staircase, which is limewashed and is in reasonable condition.

The cellar itself is formed with a stone flagged floor, which is in reasonable condition, although damp. The walls are limewashed stone. To the west the wall is affected generally by damp at low level, but generally sound.
