Report on the Condition of

**CHANCEL COTTAGE
FIR LANE
STEEPLE ASTON**

On behalf of Justin Granger

ORIGINAL ISSUE DATE:
November 2013

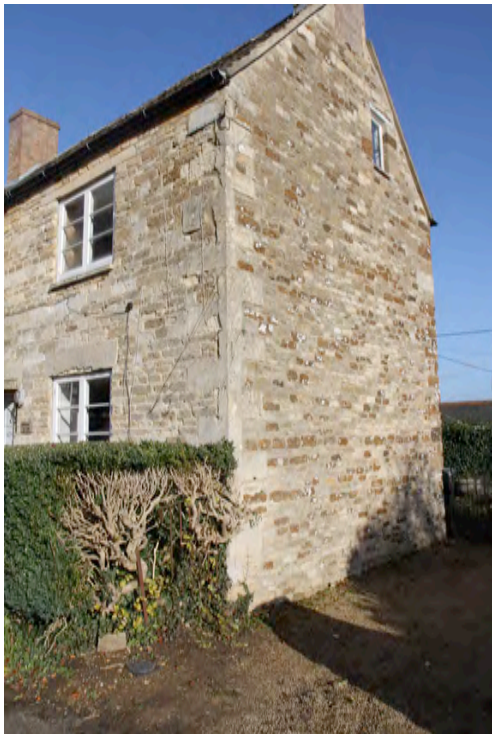
7.2 SOUTH GABLE

The south gable to the main range is in limestone rubble and ironstone, there are open joints to the corner to the west and at ground level, which require urgent repointing. The wall itself has been pointed in a hard cement mortar and some decay, consideration should be made to the replacing of this.

At high level there is the single light window with timber lintol and stone cill. The window is metal, general overhaul of this is required together with re-puttying. The lintol appears to be in reasonable condition. The cement dubbing has broken away allowing the mortar to ingress behind the flashing which is causing the damp internally. The verges are formed with a tiled overhang and pointing which are in reasonable condition.

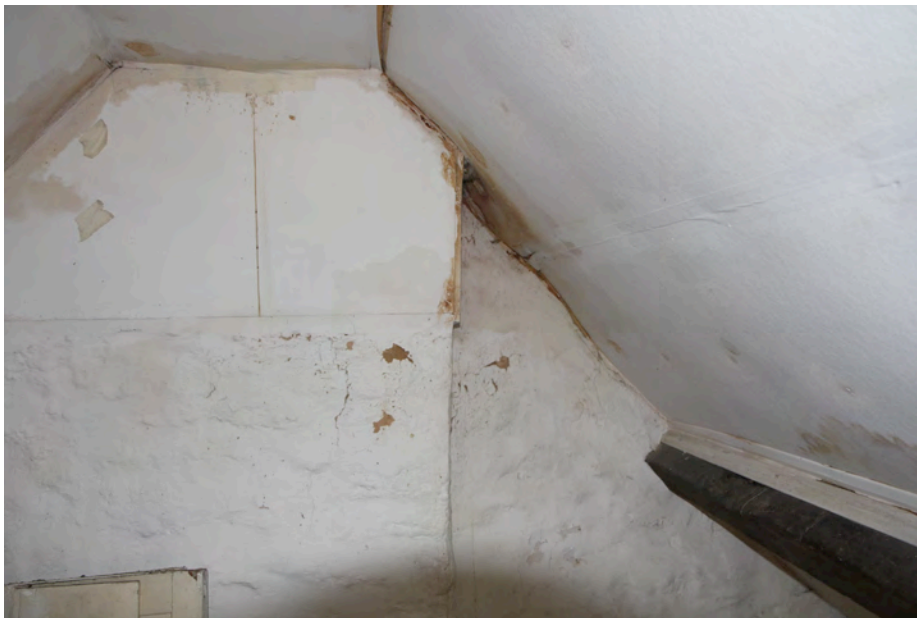
Photo showing the damage ingress to the north gable

The gable to the north is plastered to just below the ceiling where insulation board has been fitted, again damp is ingressing at high levels around the chimney breast. There is slight movement of the gable where it has moved outward due to lack of restraint.

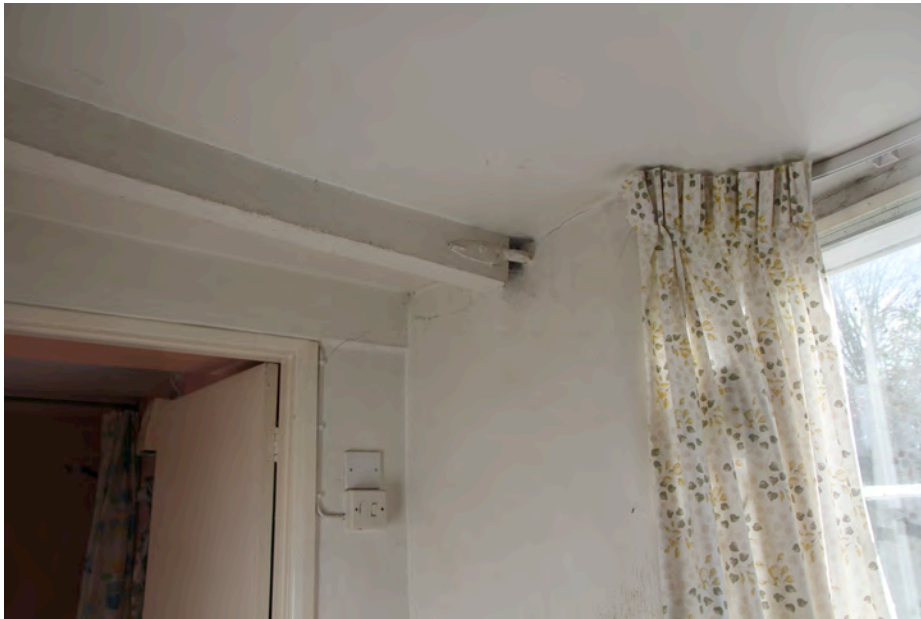
Photo showing the beam to the kitchen ceiling affected by the wall leaning outward

The ceiling, which is supported off a central beam and in reasonable condition. To the west of the wall the ceiling is formed with the soffit of the landing to the staircase. This has suffered some slight settlement and sagging and there is some cracking to the plaster, generally making good and strengthening is required. To the east of the room there has been substantial settlement to the ceiling and there is a beam, which expands across the opening the function of which is unclear. This no longer adjoins the wall, a metal strap has been added. Clearly in any refurbishment the improvement of the detail this area is required.

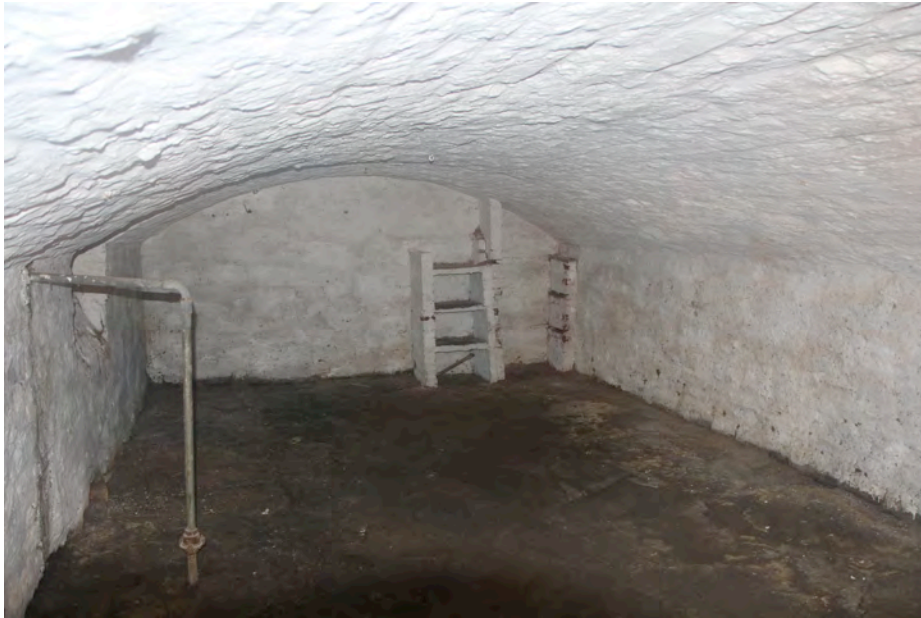
8.4 BASEMENT

The basement is approached by a stone staircase, which is formed of winders to the centre section. This is in reasonable condition. The walls are part painted stone and part plastered to the staircase itself and in reasonable condition. The ceiling to the staircase is formed by the winders to the main staircase, which is limewashed and is in reasonable condition.

The cellar itself is formed with a stone flagged floor, which is in reasonable condition, although damp. The walls are limewashed stone. To the west the wall is affected generally by damp at low level, but generally sound.
