# **Single Tree Report**

# Kingsmere Estate, Vendee Drive, Bicester

Gavin Jones Ref: MT18-130a/RF/Vendee Drive, Bicester

Site inspection undertaken: 8<sup>th</sup> March 2018 Report prepared: 30<sup>th</sup> May 2018

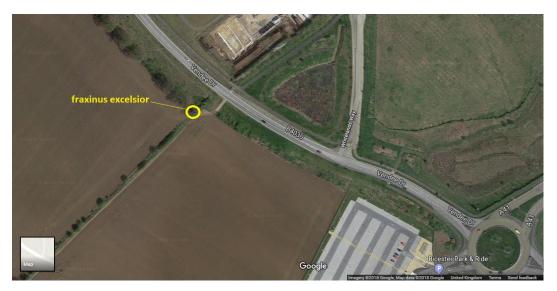
Figure 1. Location of the inspected tree.

The tree is located to the south of Vendee Drive and north of public footpath (Figure 1).
