## Tree Condition Survey 2019

### Pingle Brook “ash tree”

Kingsmere, Bicester, OX26 1RS

Gavin Jones Ref: MSURV/CV/Pingle Brook “ash tree”/2019

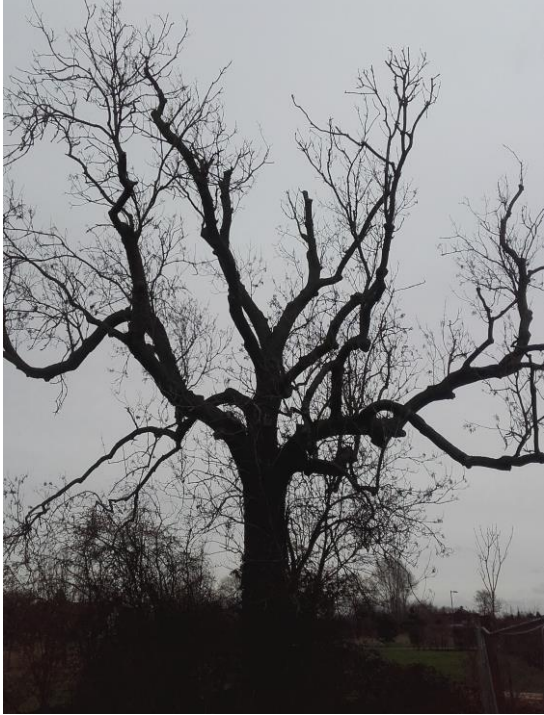
The inspected tree is a single mature ash tree located within open grounds and is approximately 8m from a newly built private property. Historically, the tree was crown reduced quite hard some time ago possibly to facilitate the construction of the new dwelling. When looking at the tree from a distance, it can be observed that the tree has died back since being reduced and major dead wood has formed over the old pruning points (see figure 1).

<p><b>Figure 1:</b> Showing ash tree crown dieback/major dead wood within the crown following the reduction.</p>

Unfortunately, due to the extent of decay within the roots and stem base and furthermore due to position of the tree being within falling distance of the adjacent property I would recommend the tree to be removed as soon as it is practically possible to make the area safe.

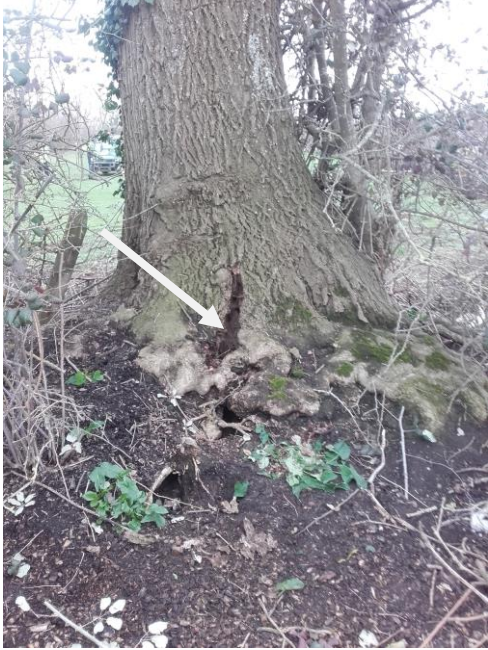
Further to the above, a small cavity was noted at the base of the tree to the west of the stem (see figure 2) and after removing the bramble covering the area an invasive investigation was carried out within the cavity to establish the extent of the decay present and size of the cavity. Unfortunately, the small cavity was much bigger than anticipated (see figure 3) and has spread within the majority trunk and probably up to 1m up the stem. The trunk is hollowing out and has done for quite some time (see figure 4), this is the result of fungal activity within the root and stem base area possibly from honey fungus, although no fungal fruiting body was found during the inspection. It is difficult to establish what triggered the colonisation of the fungus but whilst surveying the tree it was noticed that various rabbit burrows were present adjacent to the trunk. The rabbit's activity could have damaged some of the roots when tunnelling the area and the damaged caused might have been the point of entry for the fungal infection which then spread to the whole of the base of the tree.

<p><b>Figure 2:</b> Showing small cavity at the base of the tree where the arrow is pointing.</p>

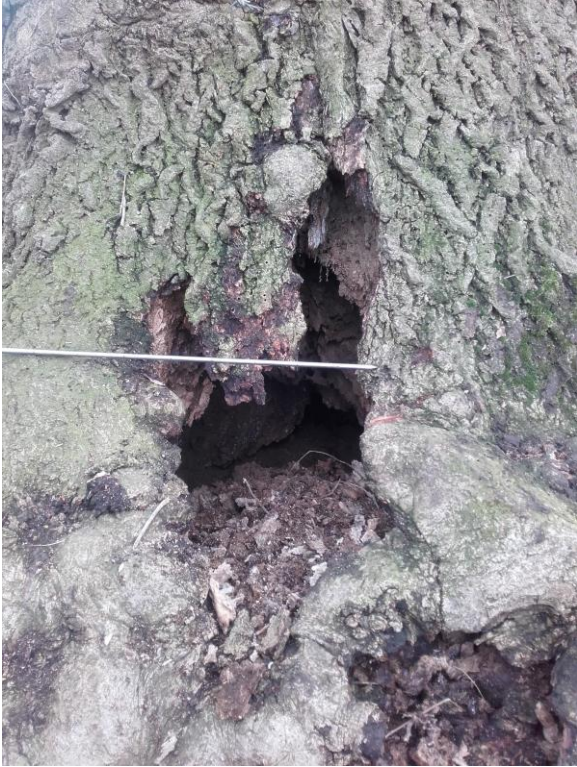
<p><b>Figure 3:</b> Showing the collapse of the timber surrounding the cavity during the invasive investigation.</p>

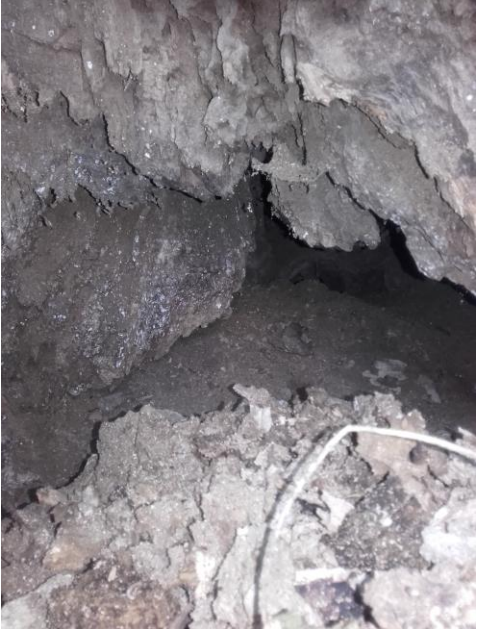
<p><b>Figure 4.</b> Showing the inside of the trunk viewed from the cavity. Please note that the decay has spread for the majority of the trunk base and extending upwards to approximately 1m from the ground.</p>
