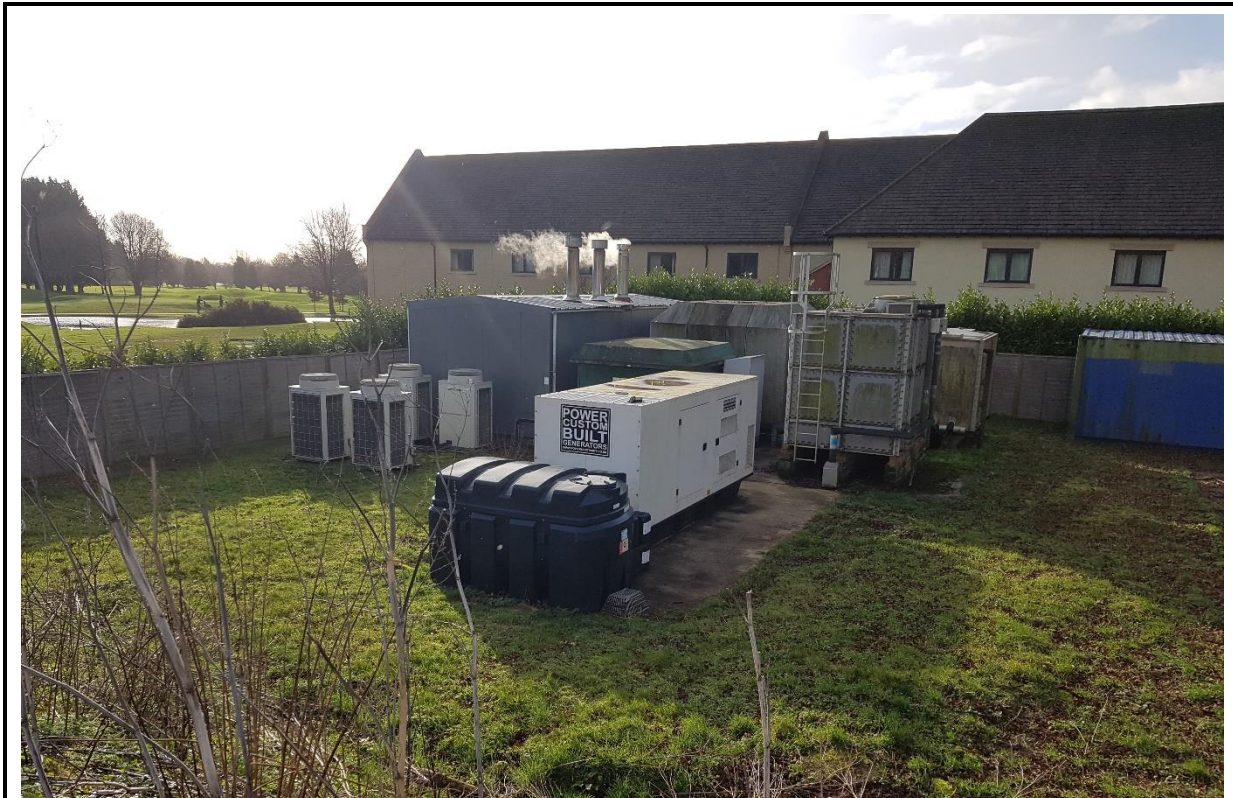
Photo 5: View of the air conditioning units, bunded oil tank, generator, electricity substation, gas house and water tanks immediately north of the clubhouse

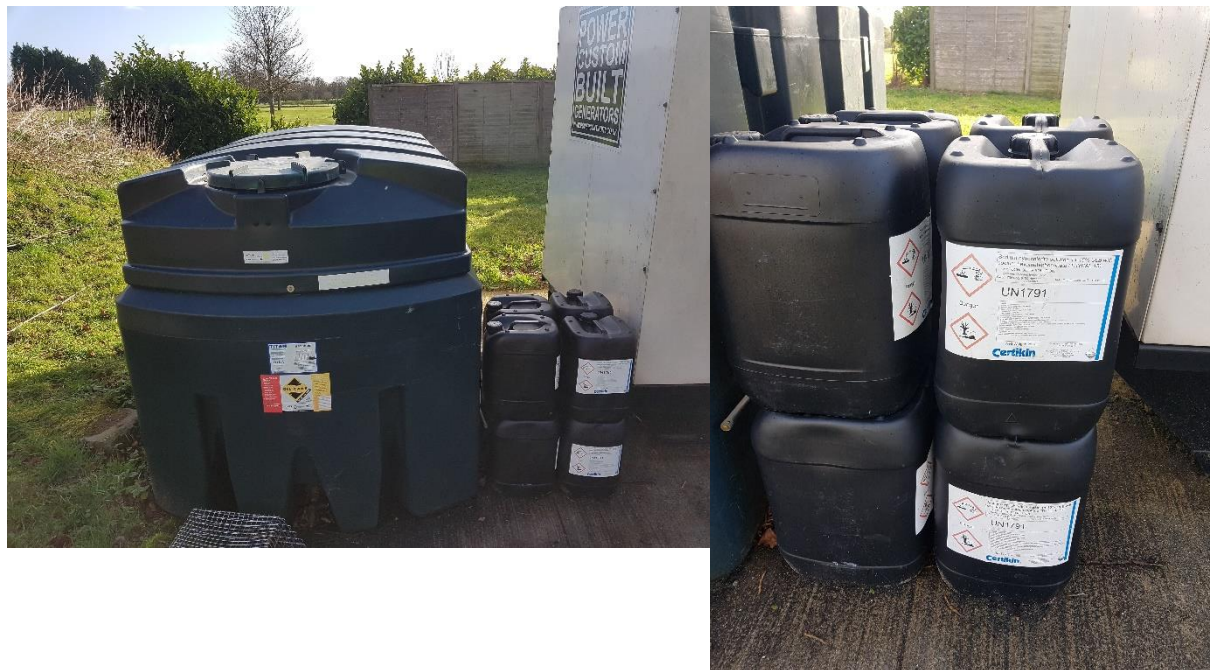
Photo 6: View of the bunded oil tank and sodium hypochlorite bottles immediately north of the clubhouse

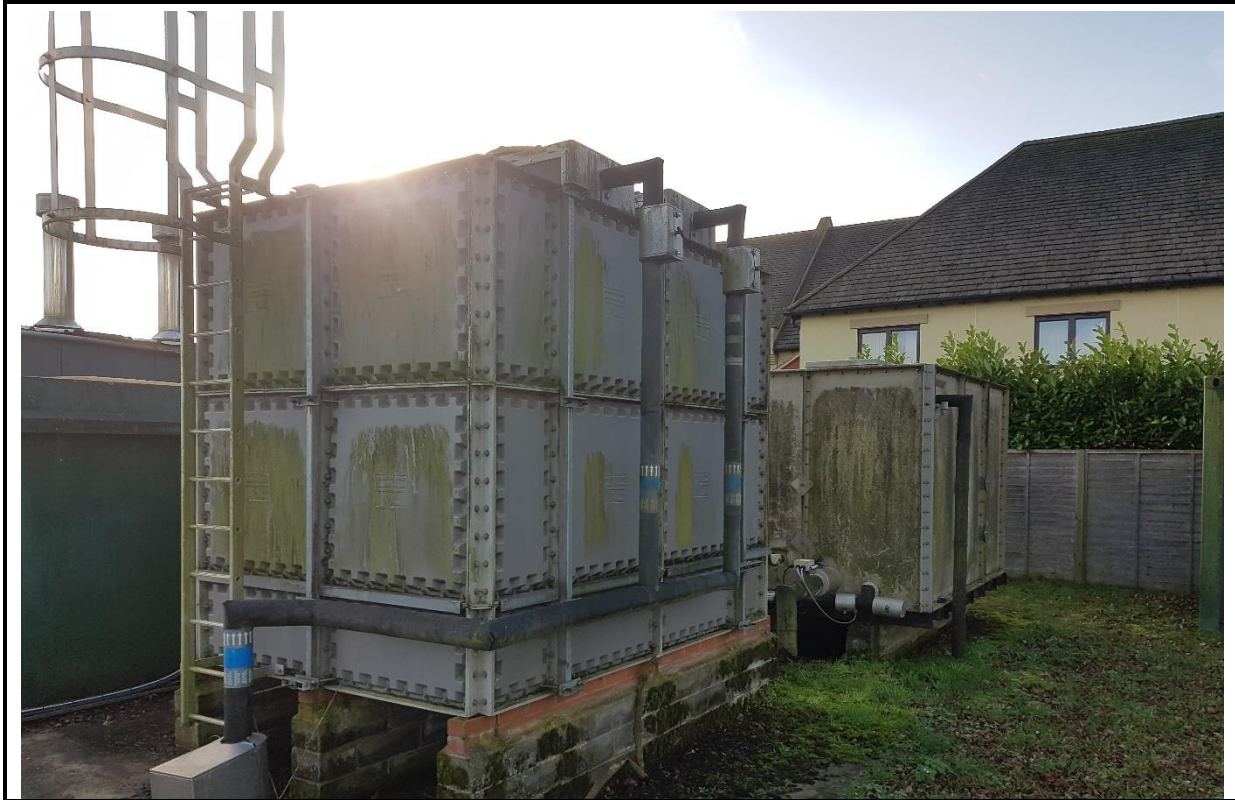
Photo 7: View of the water tanks immediately north of the clubhouse

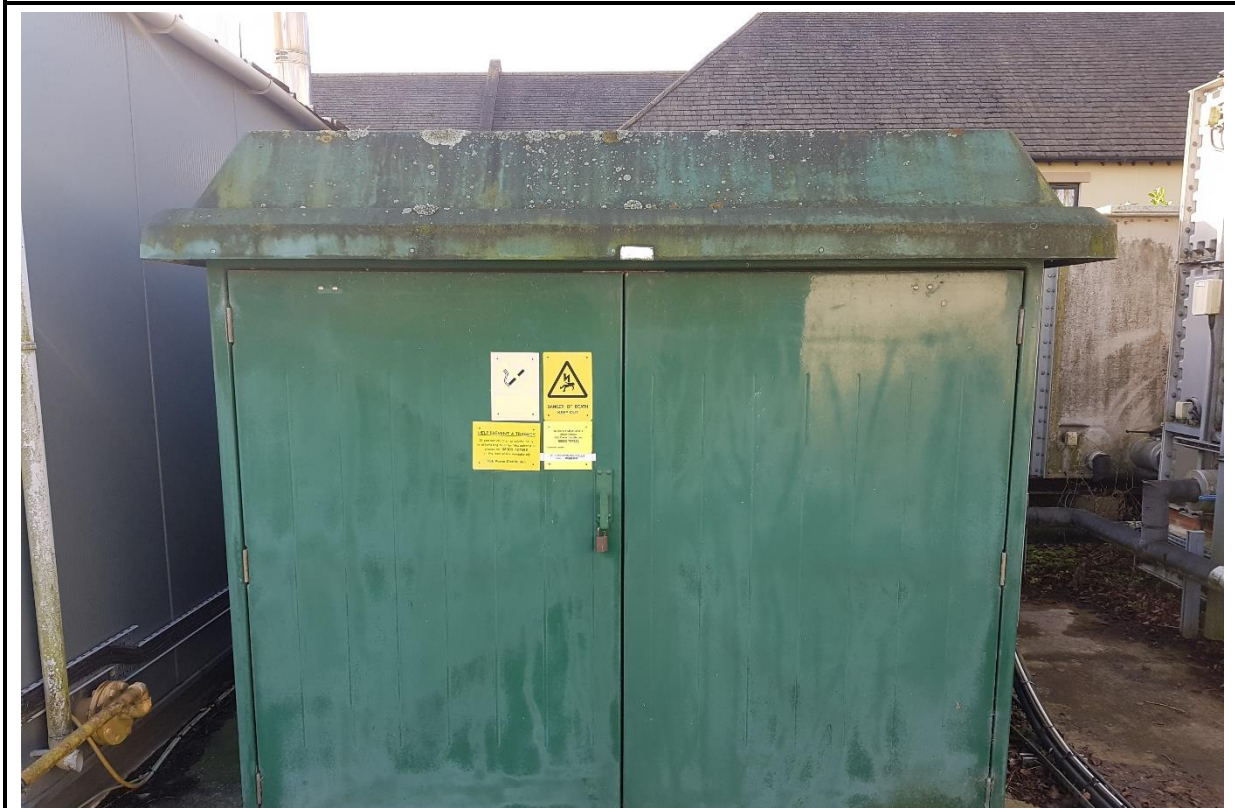
Photo 8: View of the electricity substation immediately north of the clubhouse

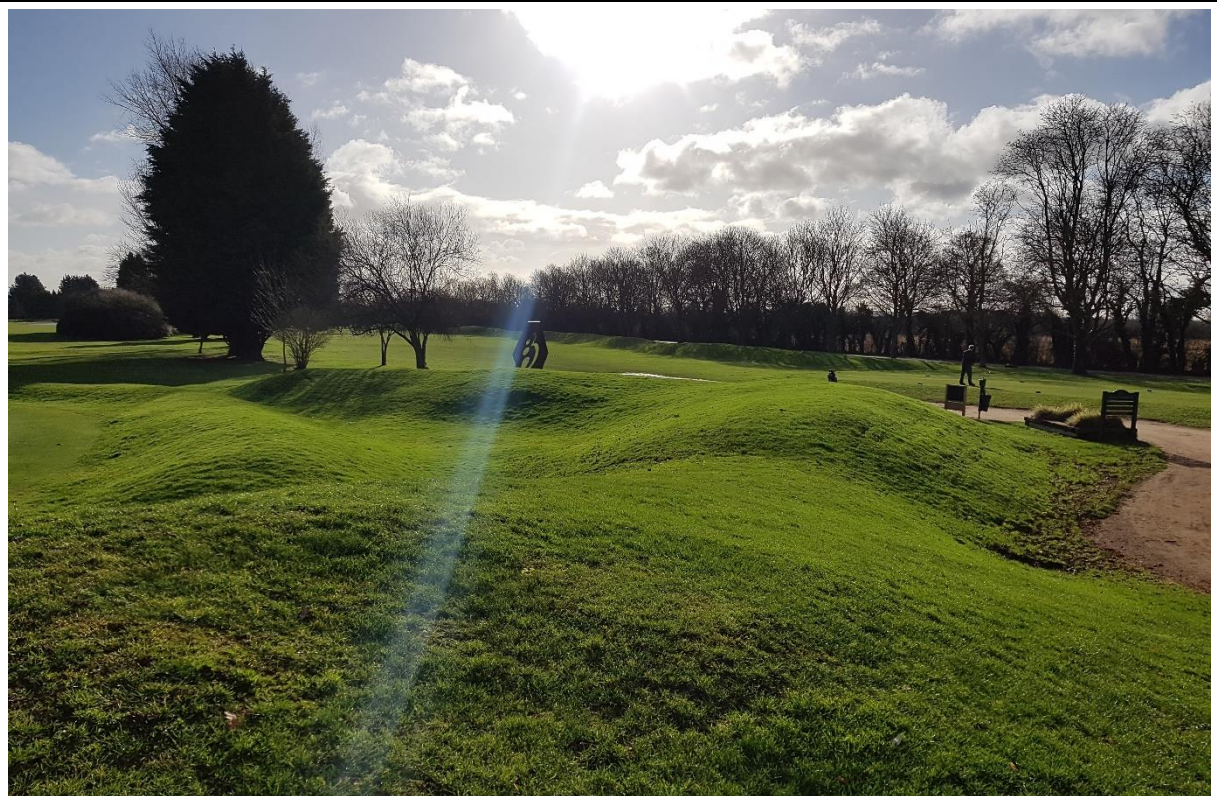
Photo 9: View south-east of the golf course from the clubhouse

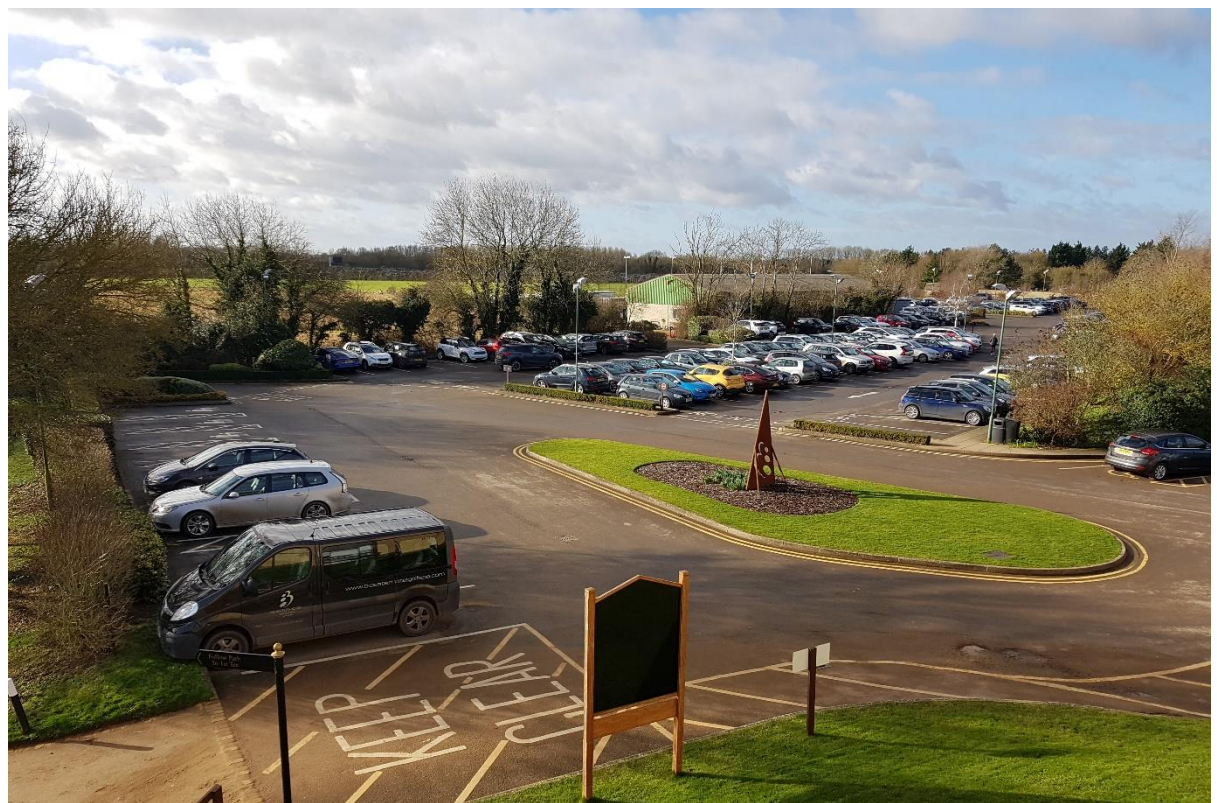
Photo 10: View south-west of the car park with the maintenance building beyond, from the clubhouse

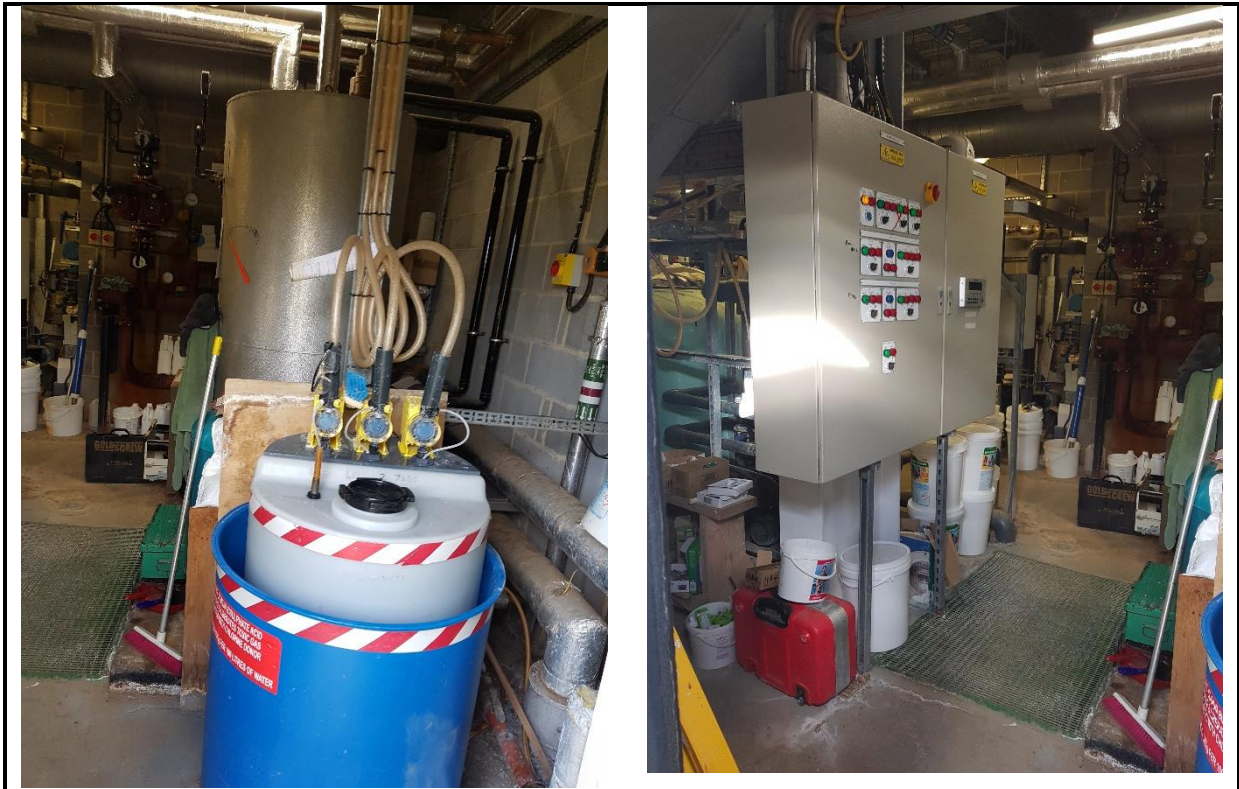
Photo 11: Plant room located in the south-east corner of the clubhouse buildings

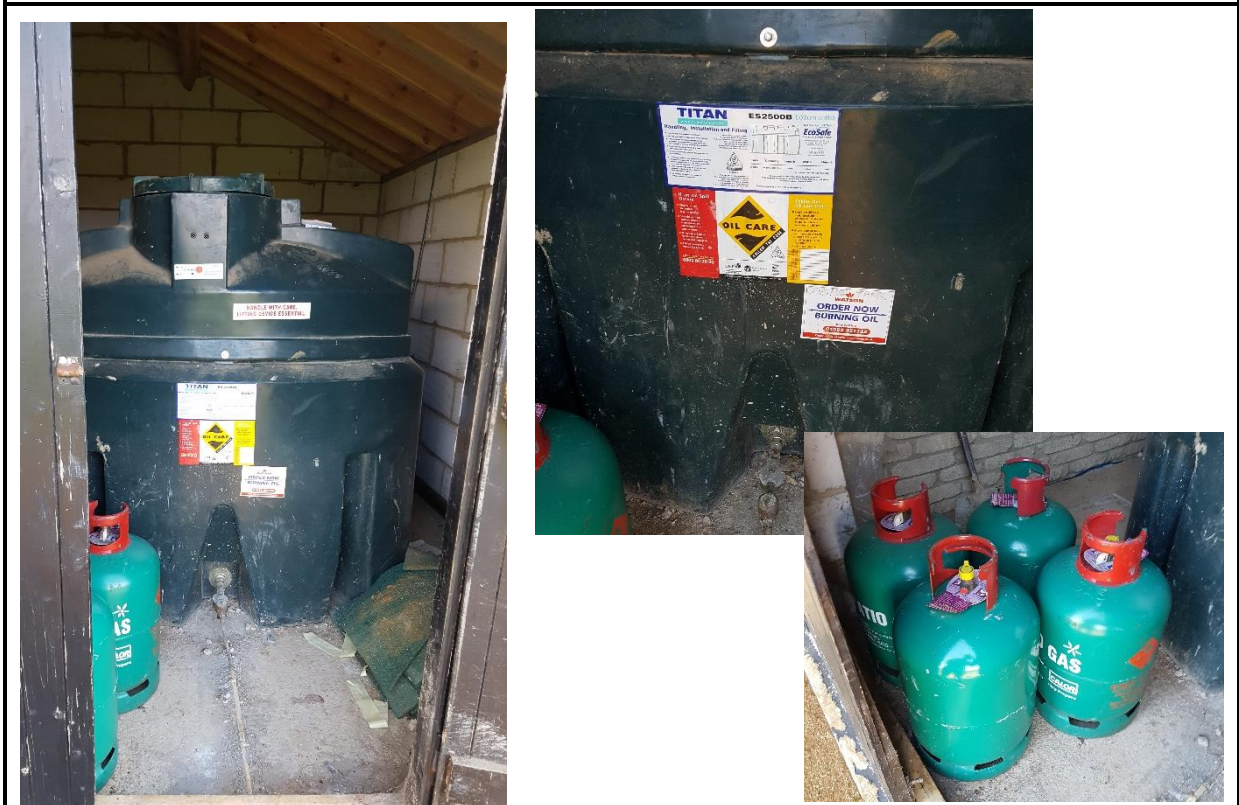
Photo 12: Bunded tank and gas bottles located in the south-west corner of the clubhouse buildings

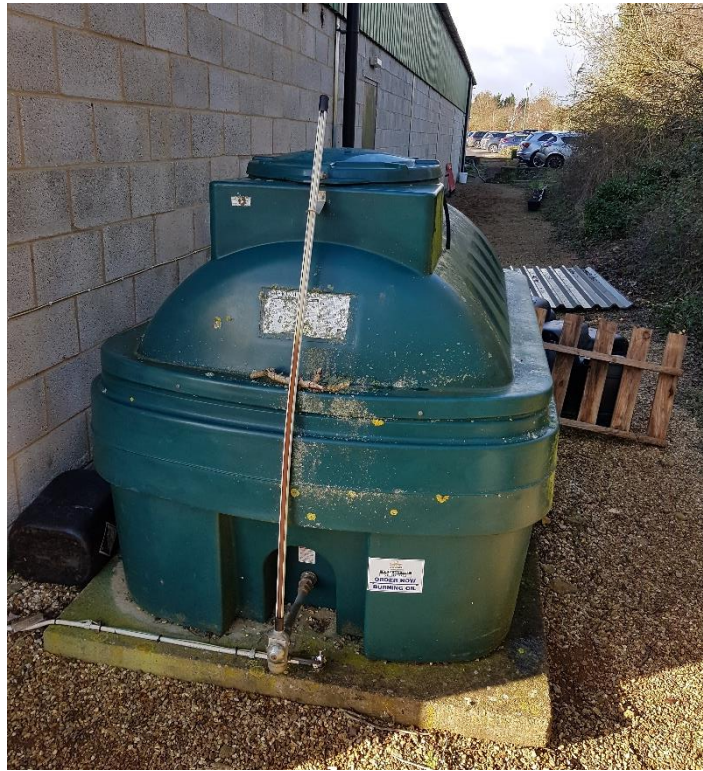
Photo 13: Bunded oil tank located immediately north of the maintenance building

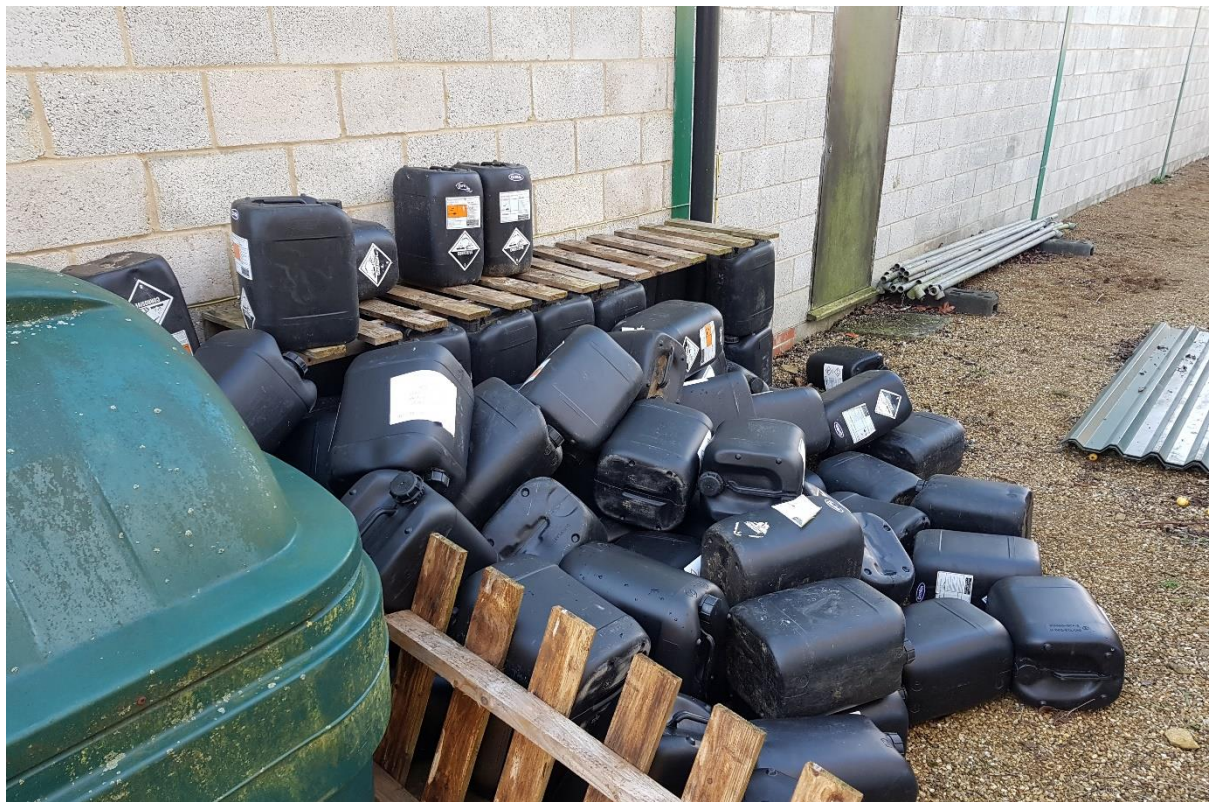
Photo 14: Sodium hypochlorite bottles located immediately north of the maintenance building

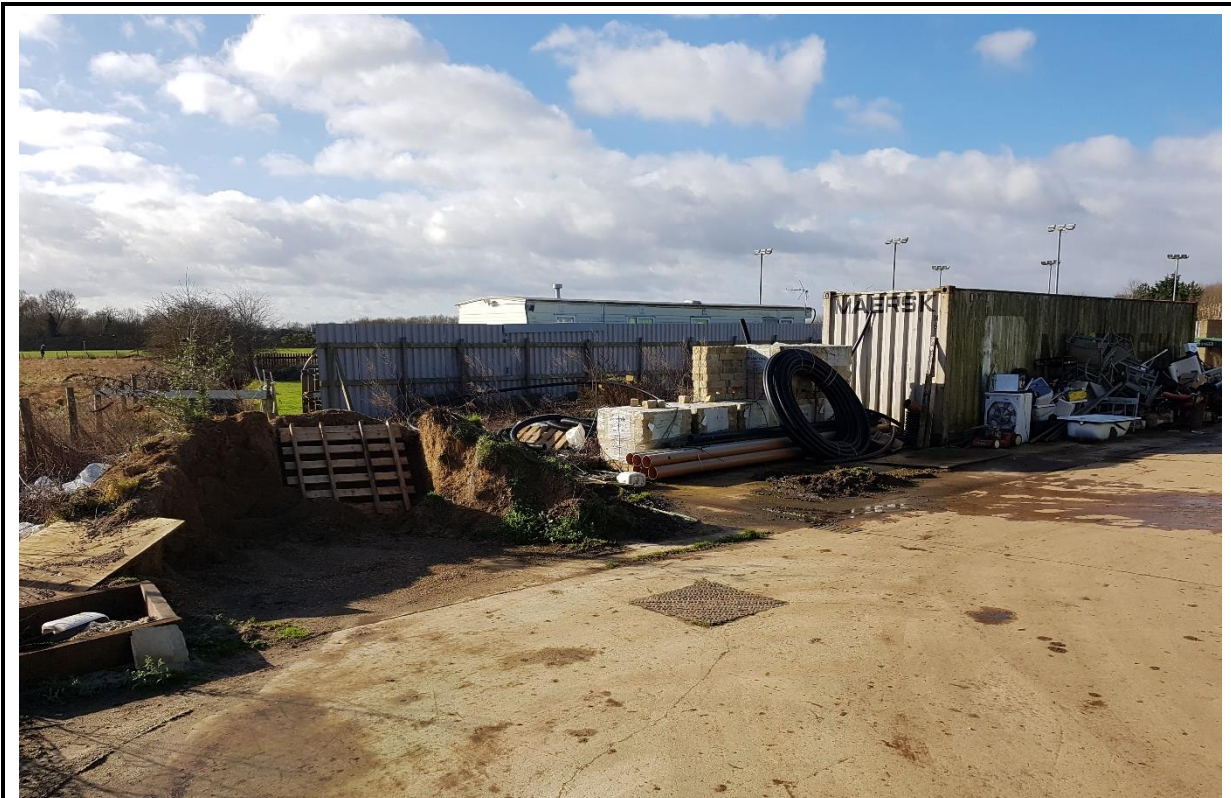
Photo 15: Waste and materials storage area immediately south of the maintenance building

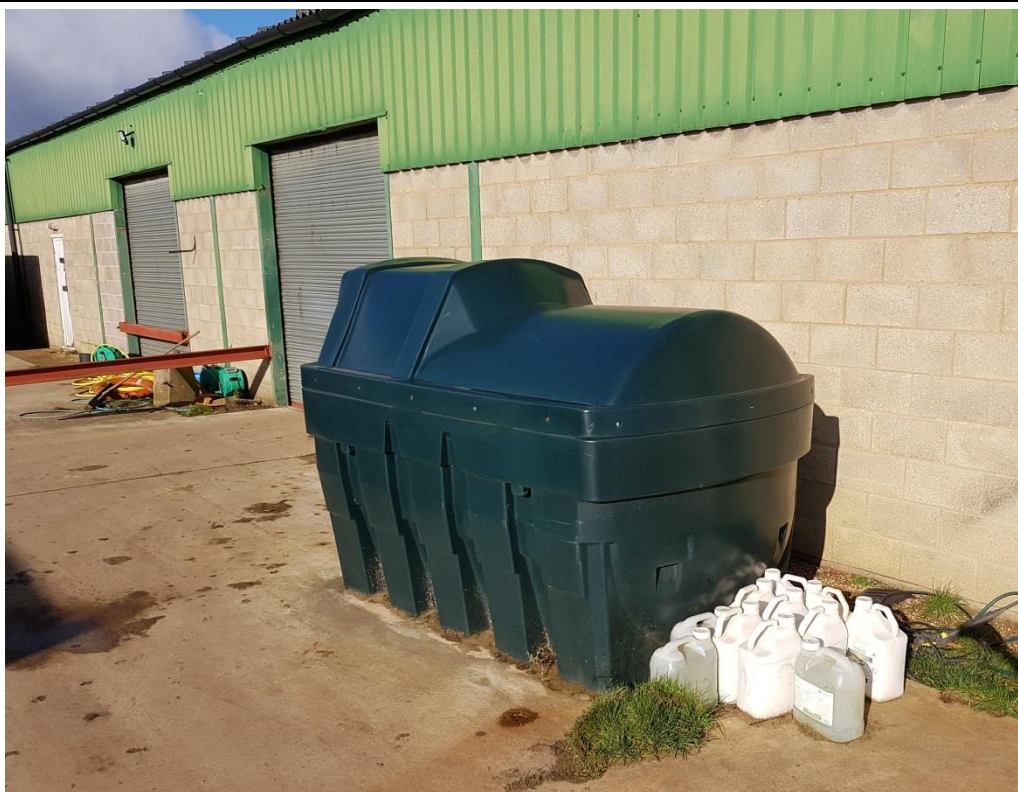
Photo 16: Bunded oil tank and fertiliser bottles immediately south of the maintenance building

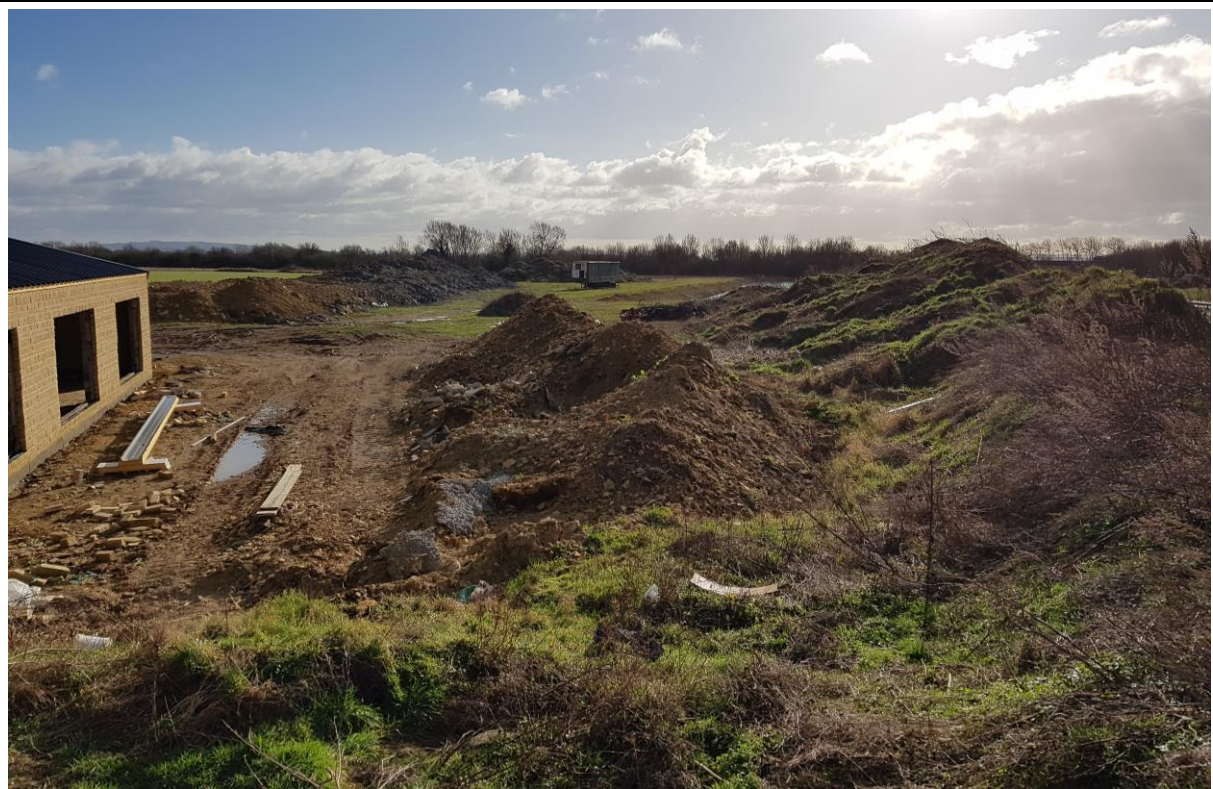
Photo 17: View south along the western boundary of material stockpiles, with a recently constructed building in the foreground.

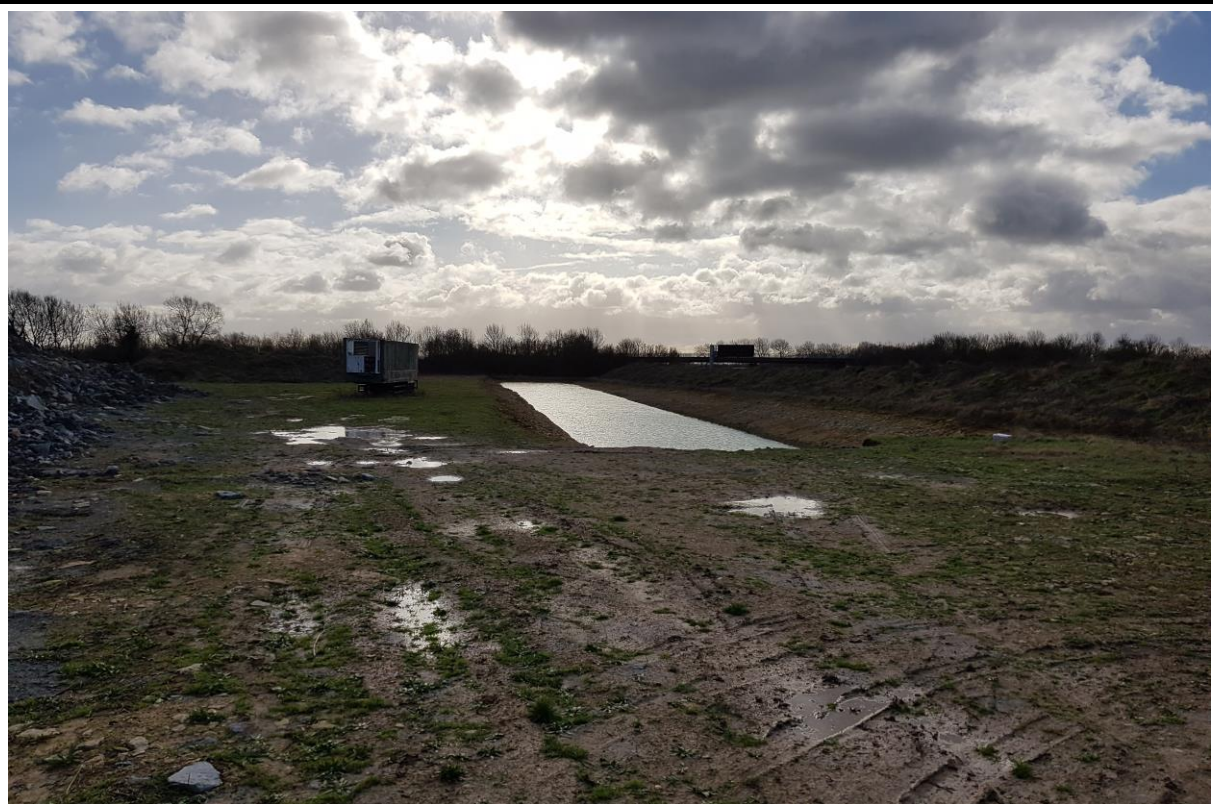
Photo 18: View south of the artificial swale excavated into the bedrock located in the south-west corner

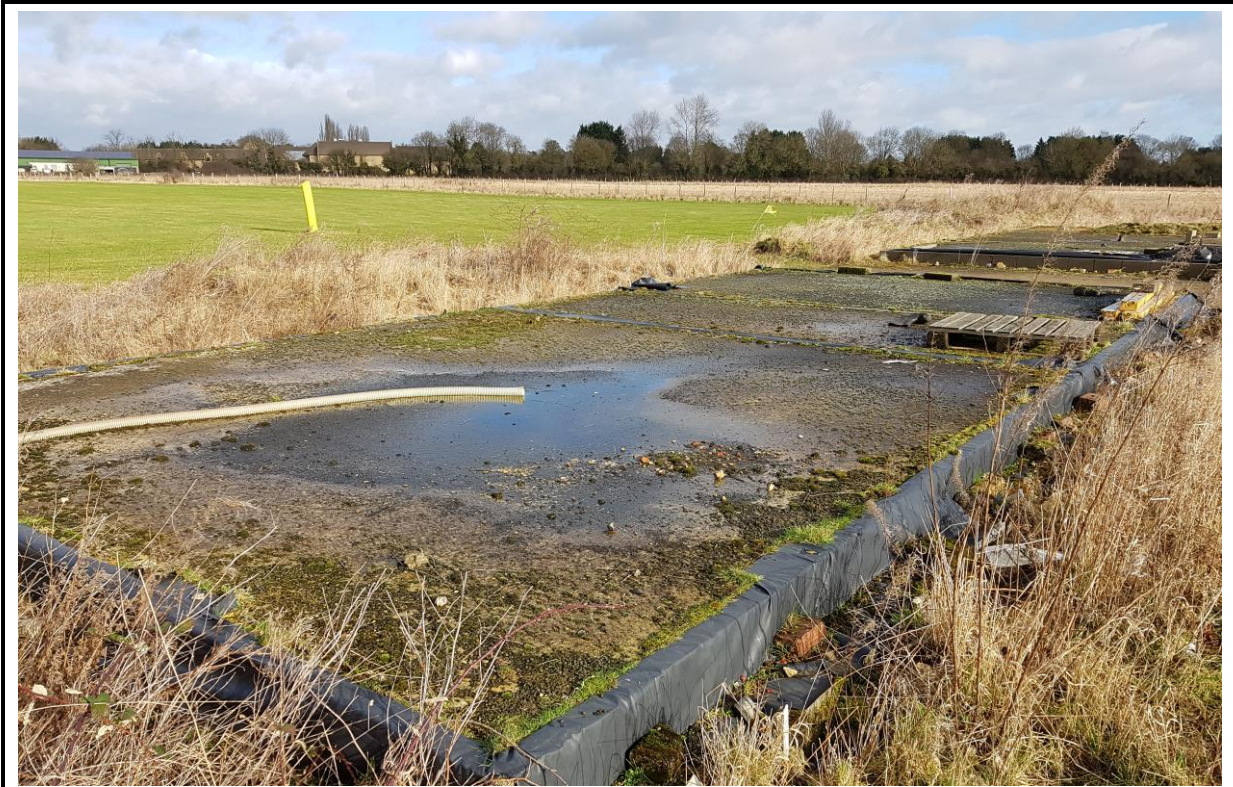
Photo 19: View north-east of a concrete slab of assumed former buildings with the disused driving range beyond

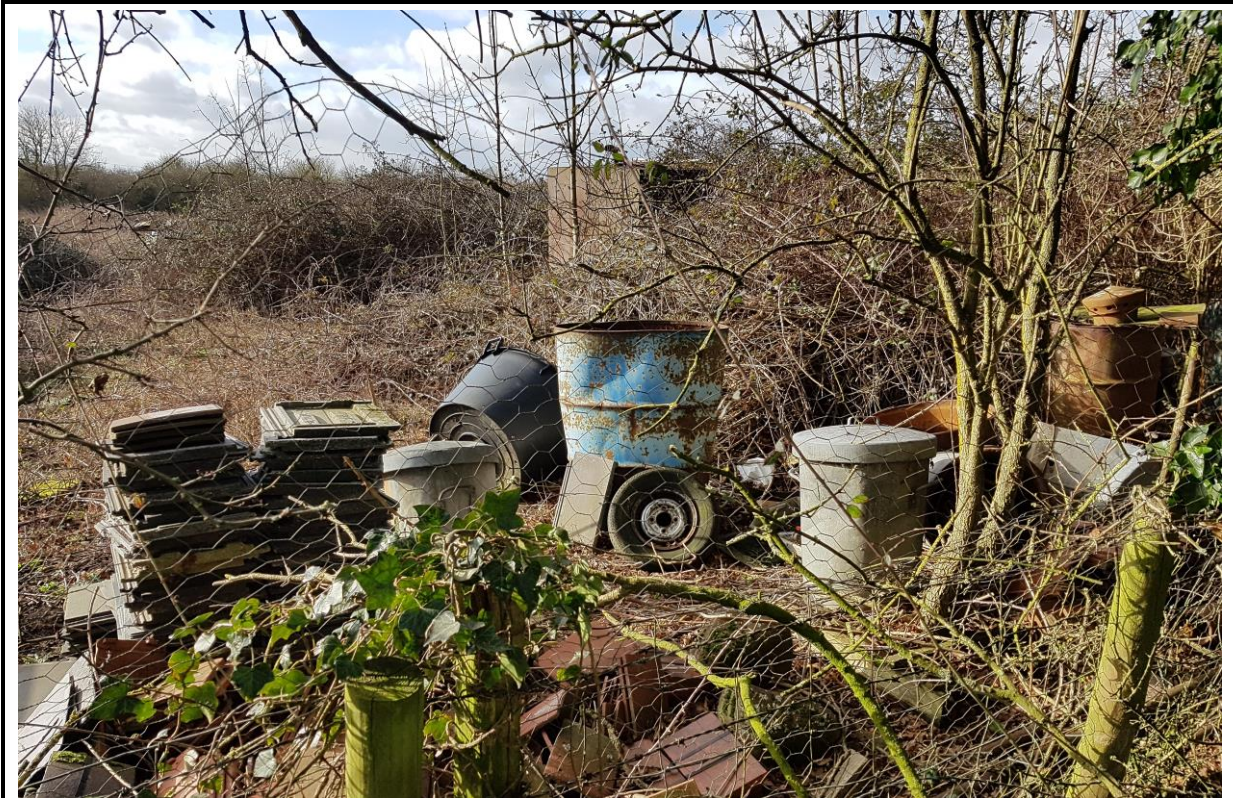
Photo 20: View west of steel drums and waste materials within the WIG Engineering land, adjacent to the site boundary

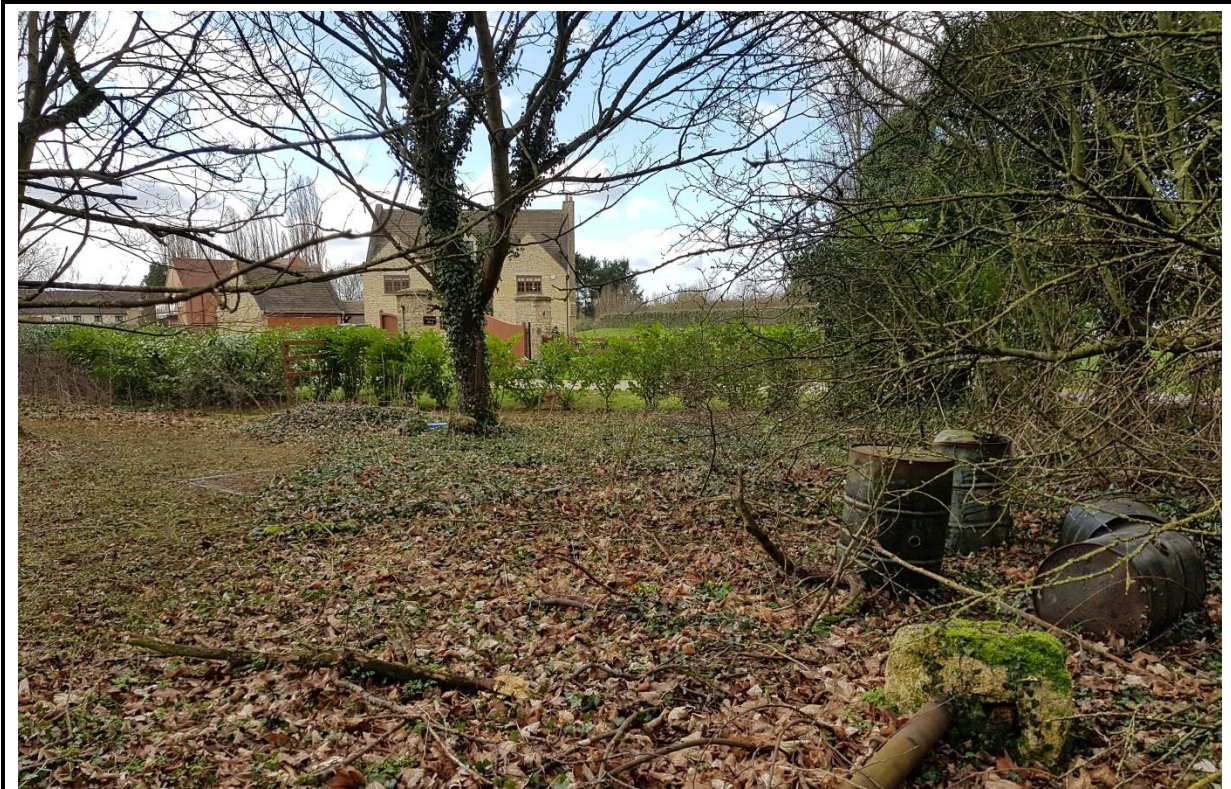
Photo 21: View west along the northern boundary of steel drums and Tanora Cottage beyond

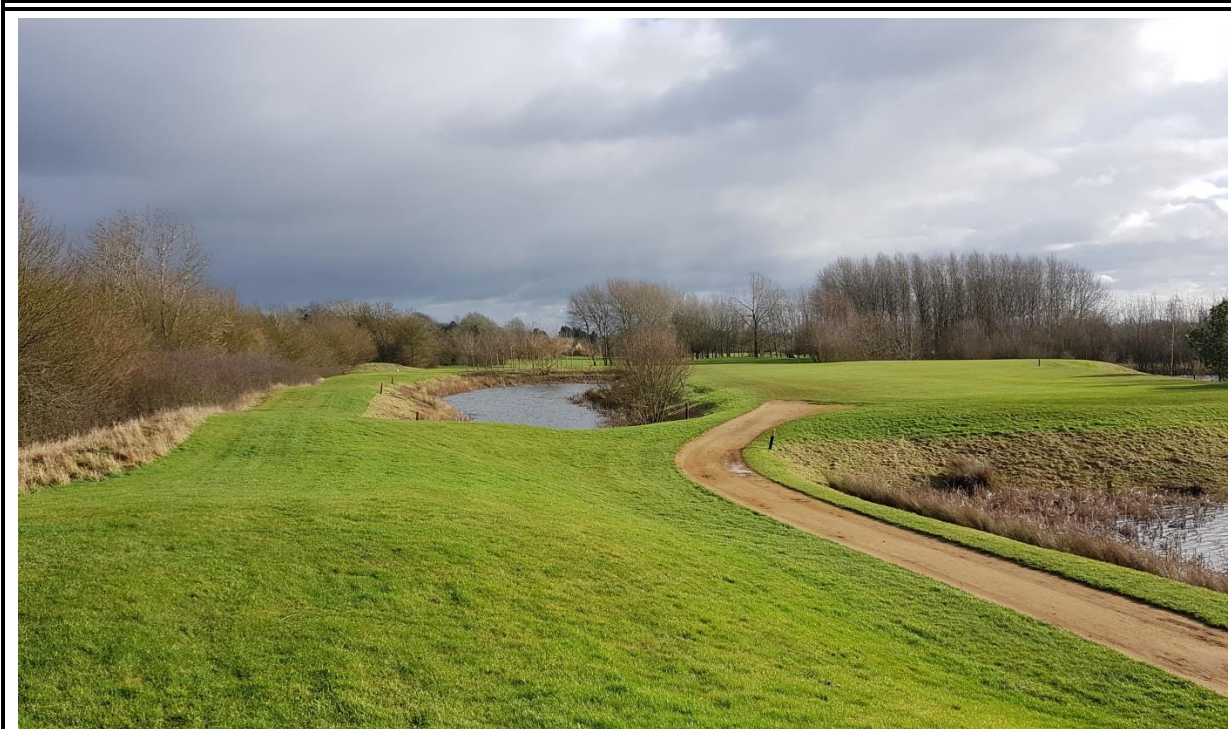
Photo 22: View east along the northern boundary of the golf course from the north-west corner
