NON-MOTORISED USERS AUDIT

FRINGFORD ROAD

BICESTER

NON-MOTORISED USER AUDIT

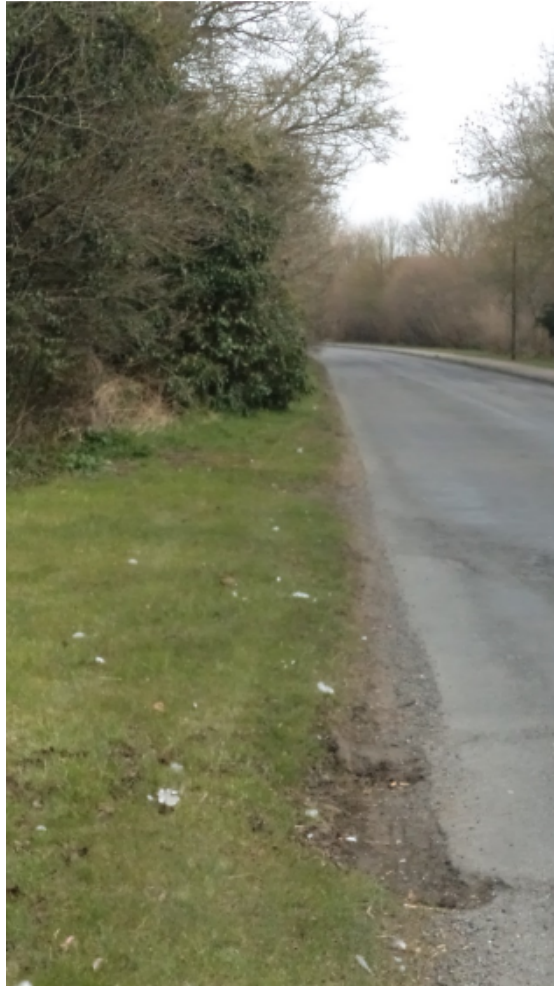
5.1 Fringford Road north of the site, northbound

In the vicinity of the proposed site entrance Fringford Road's western side consists of grass verge and lacks a footway. However, there are no potential destinations on this side of the road, therefore it is unlikely that future residents will require pedestrian routes in this location.

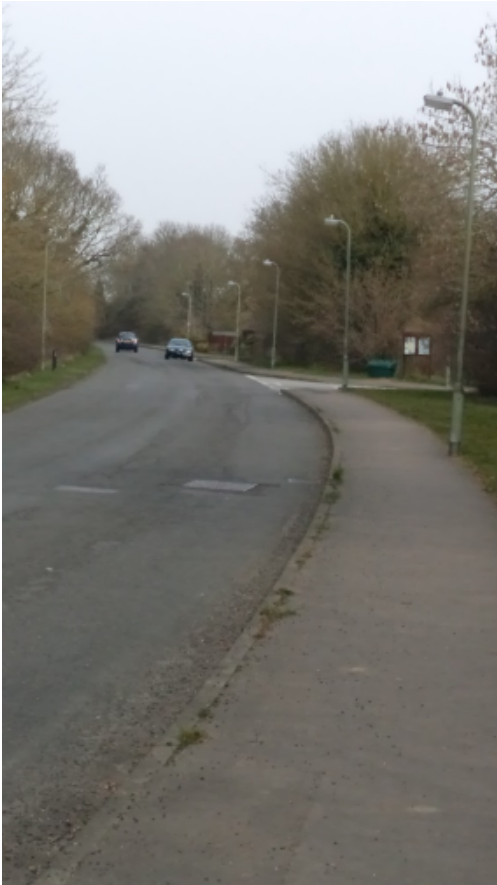
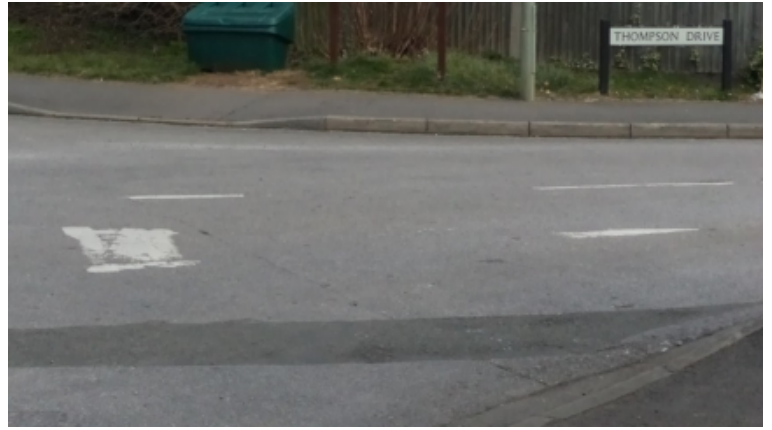
5.2 Fringford Road north of the site, southbound

5.2.1 This section of road commences at the junction of Fringford Road with Thompson Drive, on which bus stops are located. Thompson Drive itself is well-established and residential in nature, providing suitable footways throughout. Dropped kerbs are provided at the junction of Fringford Road with Thompson Drive.

5.2.2 The length of Fringford Road between Thompson Drive, southwards to Skimmingdish Lane, is provided with a footway of about 1.5m in width. It is generally in good repair and there are no defects of note. There is no street lighting.

5.2.3 There are no pedestrian crossings on this section of Fringford Road.

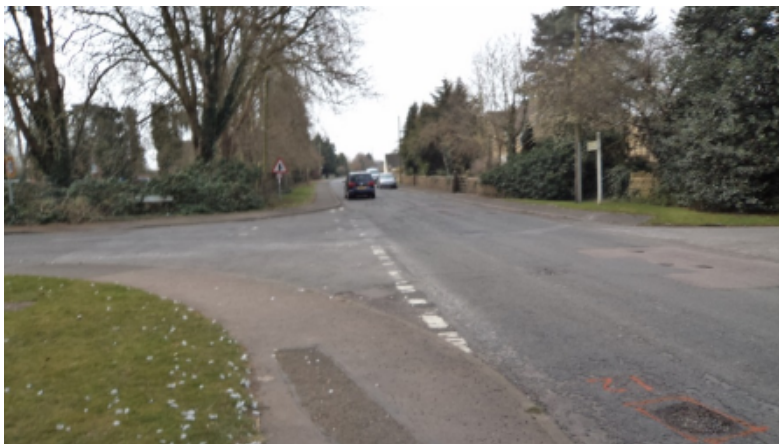
5.3.1 The junction of Skimmingdish Lane with Fringford Road is equipped with dropped kerbs and, although patchy, the footway here is in generally good repair.

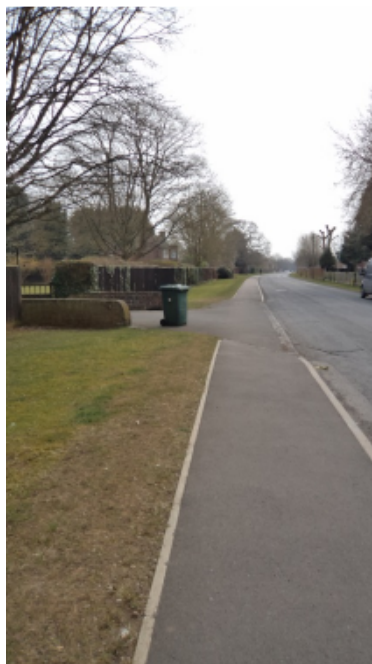
5.3.2 The entire length of Skimmingdish Lane is provided with a narrow footway of about one metre on its northern side. However, additional width is provided by a well-kept grass verge 2m – 4m in width, providing an opportunity to pass where necessary without encroaching onto the carriageway.

5.3.3 The footway is in good repair, with no noticeable defects, although no street lighting is present.

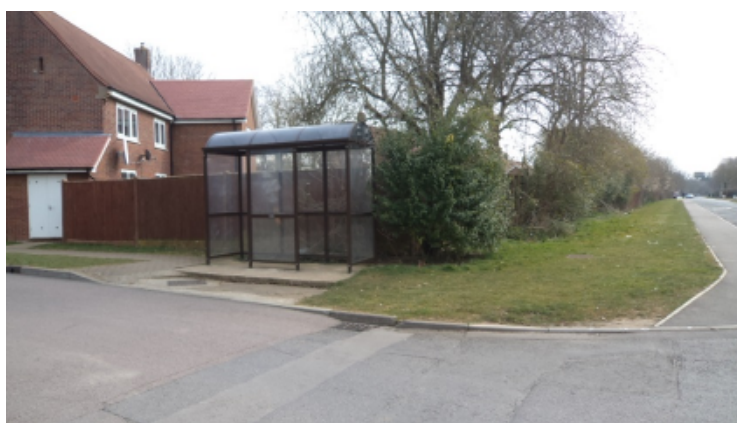
- 5.3.4 The bus stop, at the junction of Skimmingdish Lane with Paynes End, is provided with a shelter, although no seating is available and no timetables in evidence.

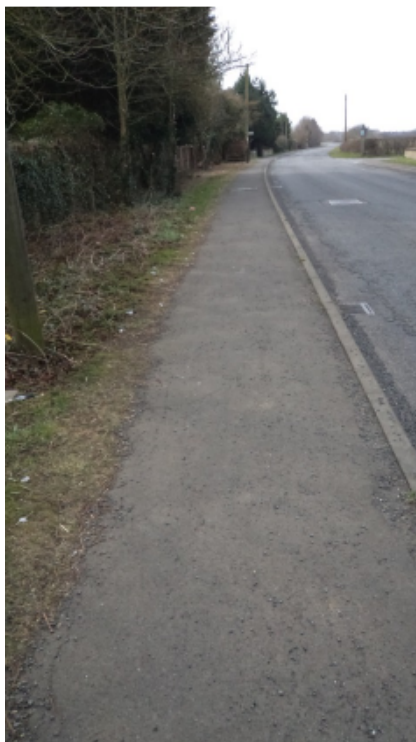
- 5.4.1 This section of road is equipped with a footway on its eastern side only, approximately one metre in width.

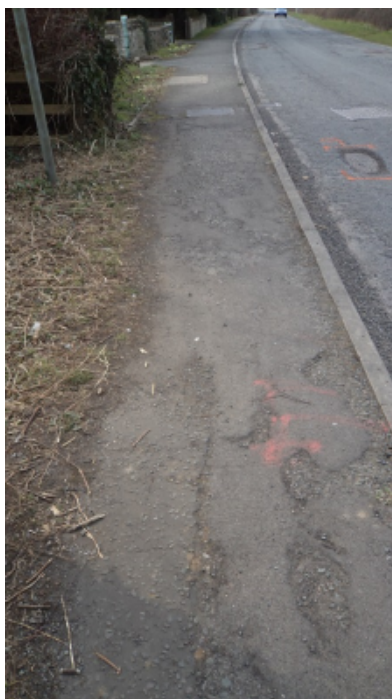
- 5.4.2 Although much of this route is in a satisfactory state of repair, there is a short section where potholes are in evidence. However, it is noted that these have been marked for repair by the local highway authority.

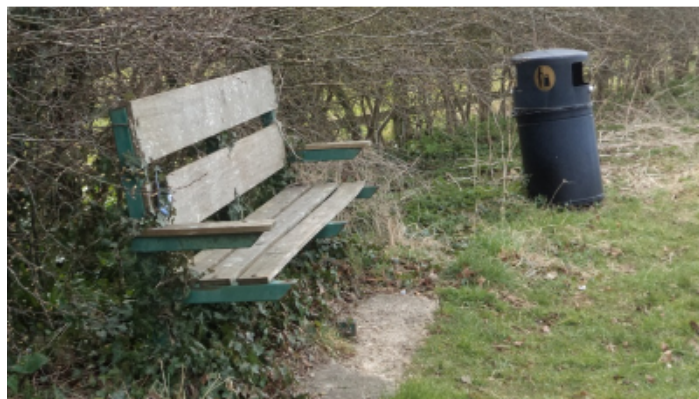
- 5.4.3 Towards the end of Fringford Road a bench has been provided, together with a waste bin, for use by pedestrians. The seat itself is in satisfactory repair, although some vegetation is encroaching on it.

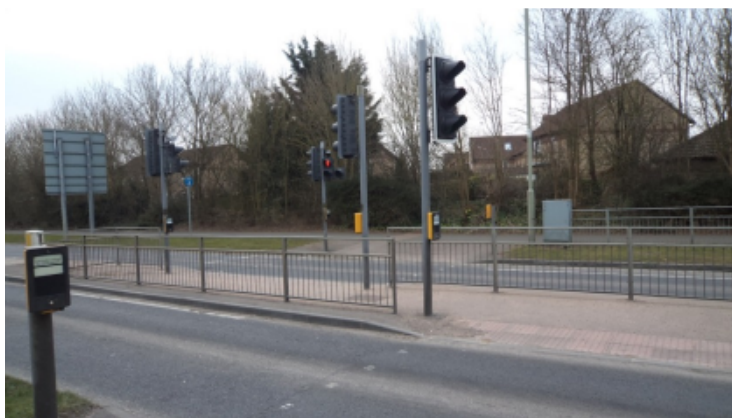
- 5.4.4 The remainder of the pedestrian route to the A4095 is in good repair. A signalised crossing is provided across the A4095, providing a direct and easy link with the shared pedestrian and cycle routes along the bypass, and to the town centre.

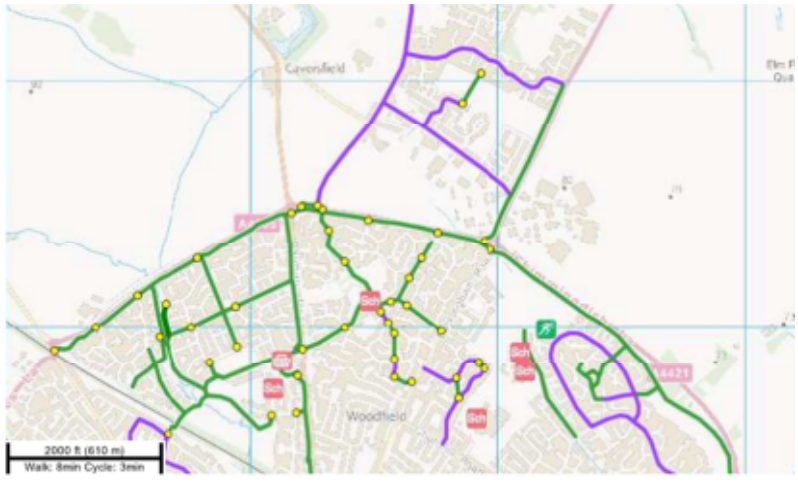
- 5.5.1 Fringford Road and Skimmingdish Lane have been designated by Sustrans as on-road cycle routes and, as such, may be deemed to be suitable for use by cyclists. However, at present this route is badly pot-holed, but is marked for repair by the local highway authority.
- 5.5.2 800m south of the site, Fringford Road links with the A4095 as described in Section 5.4.4, providing crossing facilities and an opportunity for cyclists to join the dedicated cycleway/footway that encircles a large part of the town, providing links to major cross country cycle routes and the town centre itself.
- 5.5.3 The traffic-free cycle routes surrounding the town are in excellent repair, whilst the quiet residential streets radiating from the town centre afford good cycle access to the amenities that the centre of Bicester offers, as well as the local shops and schools.
