White Post Road, Bodicote, Banbury

Road Safety Audit Stage 1

TMS reference no: 12522A

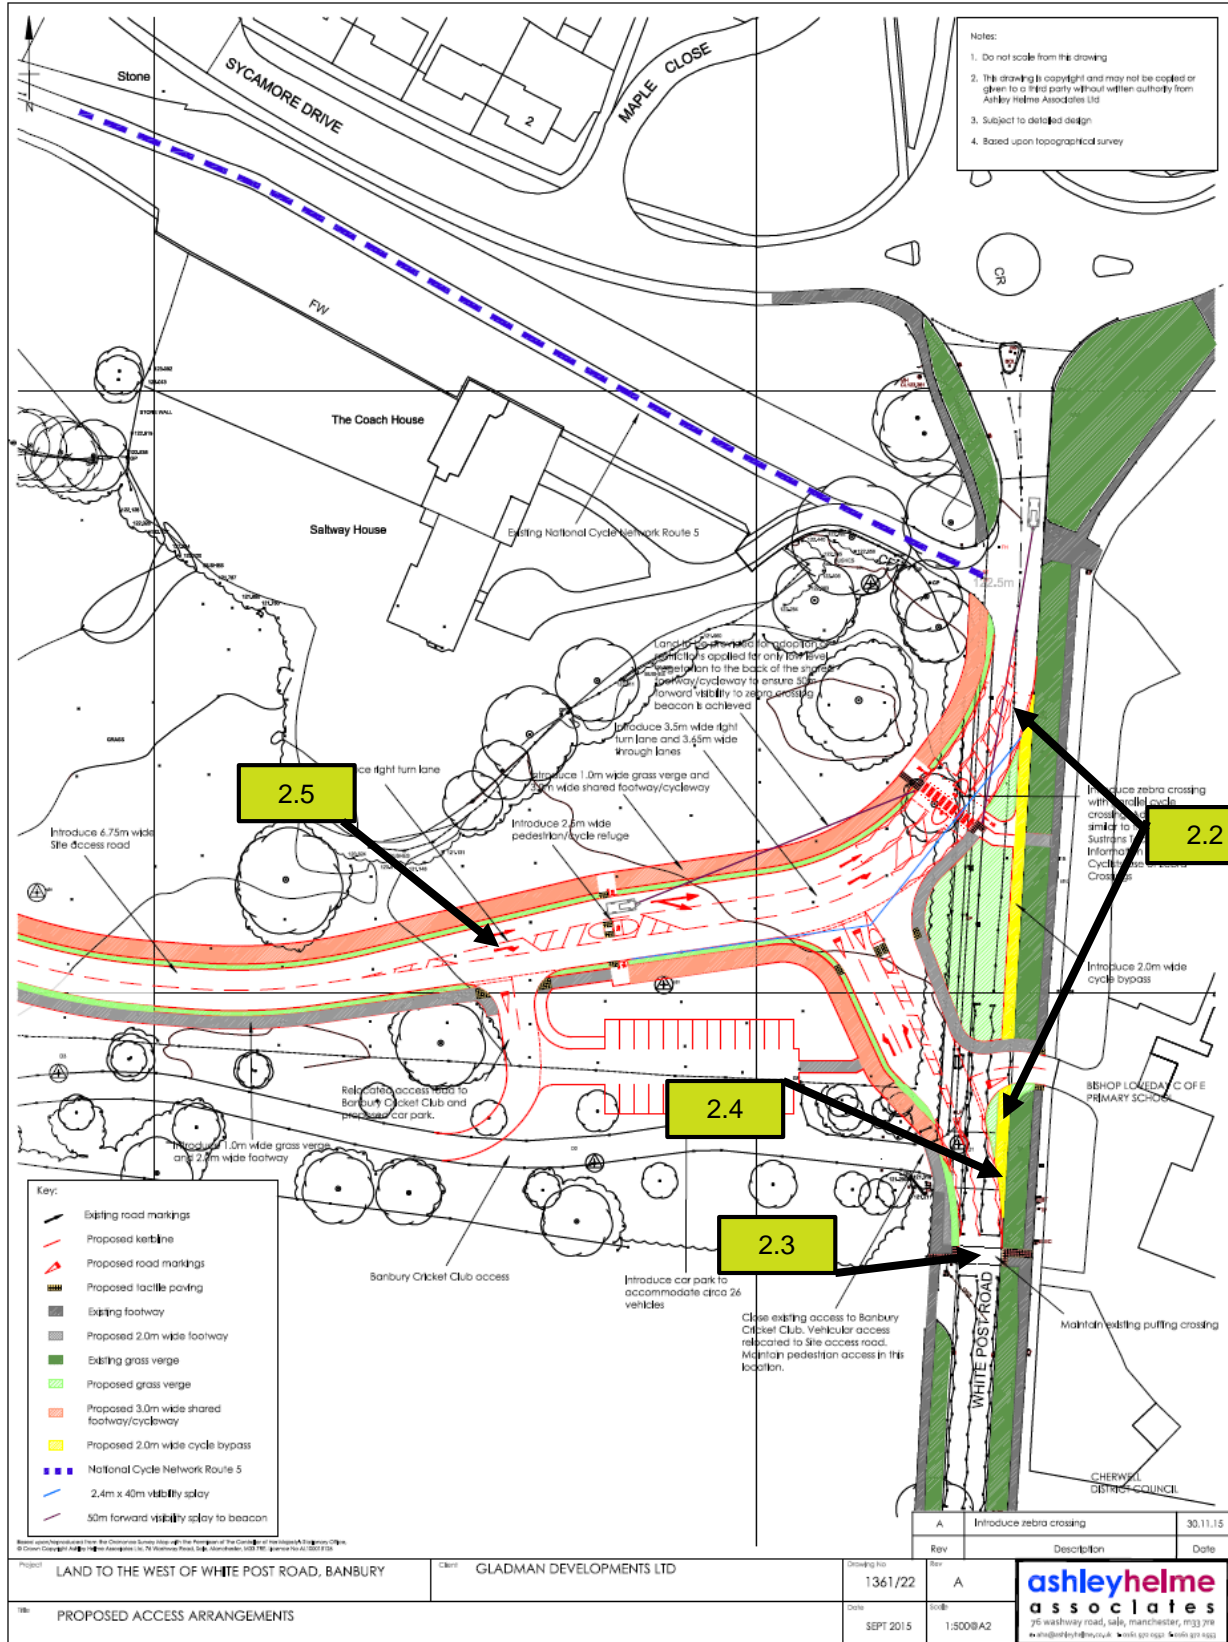
Appendix B

Please refer to the following page for a plan illustrating the locations of the problems identified as part of this audit (location numbers refer to paragraph numbers in the report).
