ARBORICULTURAL REPORT

& Impact Assessment

Land at
Berry Hill Road,
Adderbury,
Banbury,
Oxfordshire

Reference: *AWA3254*

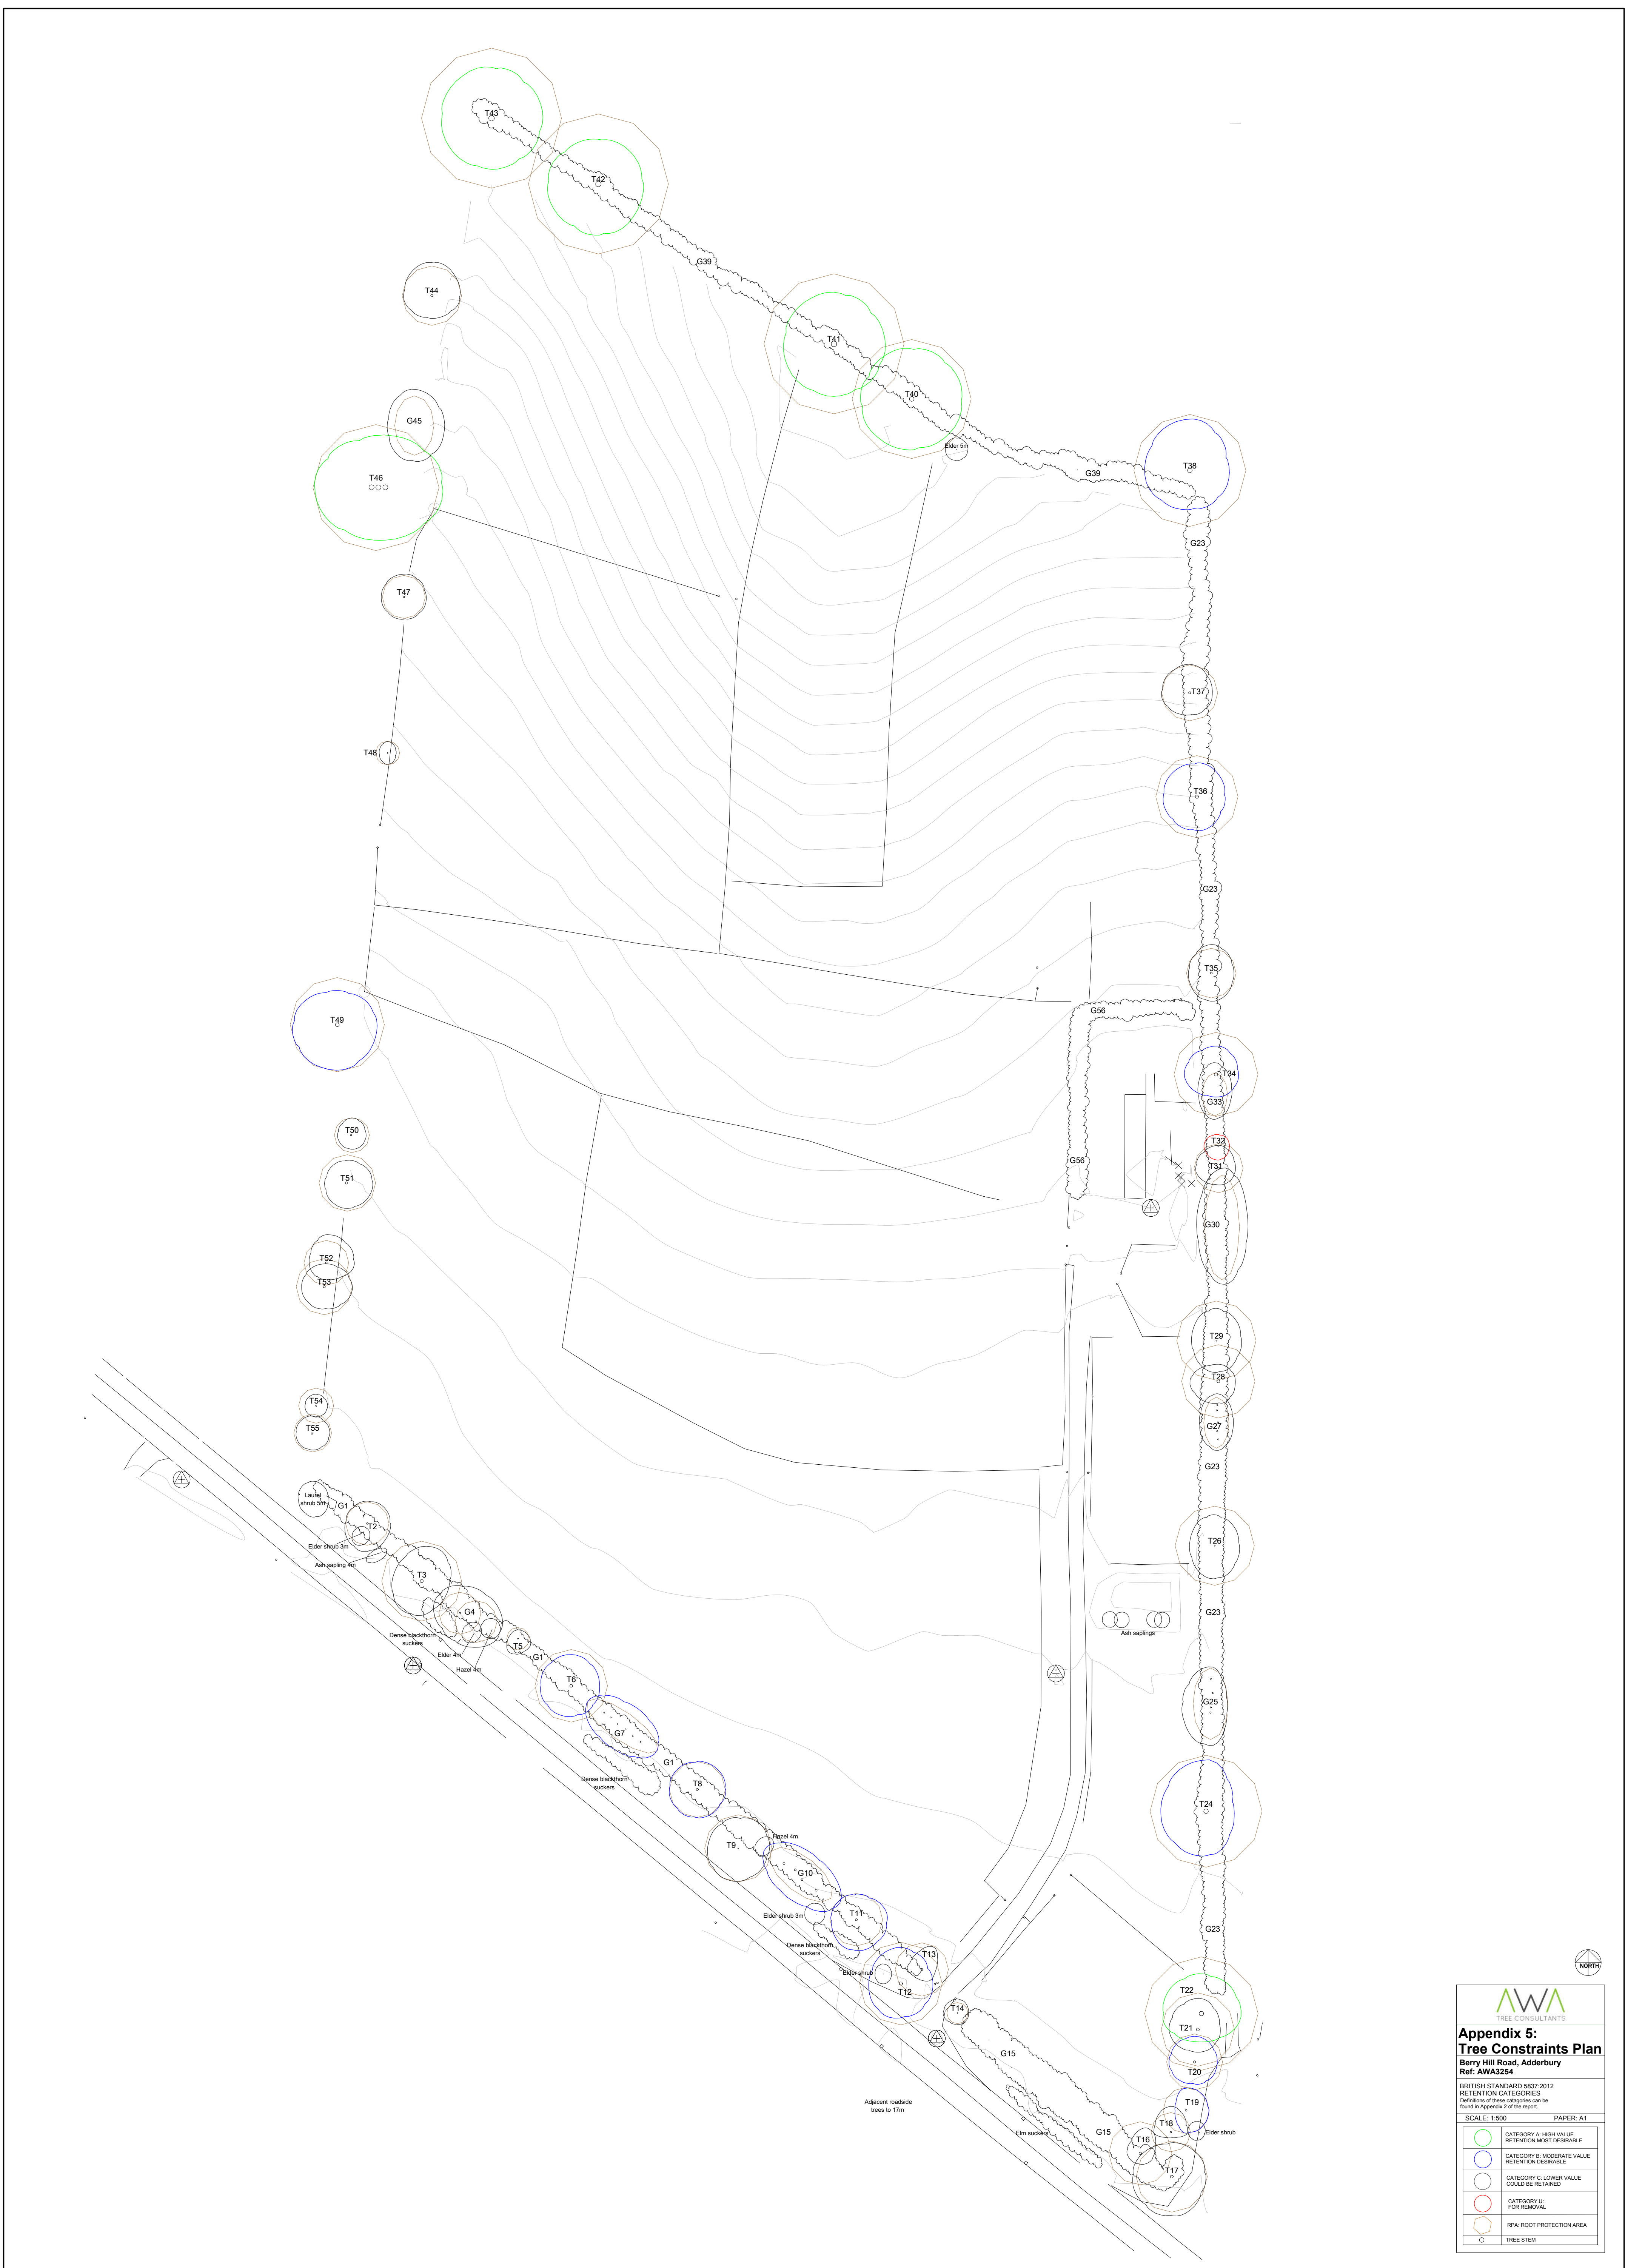
Appendix 5:
Tree Constraints Plan
 Berry Hill Road, Adderbury
 Ref: AW3254

- 3.2.13 The tree Root Protection Area (RPA) is detailed on the Tree Constraints Plan at Appendix 5. The RPA for each tree has been plotted as a polygon centred on the base of the stem. Due to the presence of roads, structures, topography (and past tree management) the RPA is likely to be a simplified representation of the tree roots actual morphology and disposition.

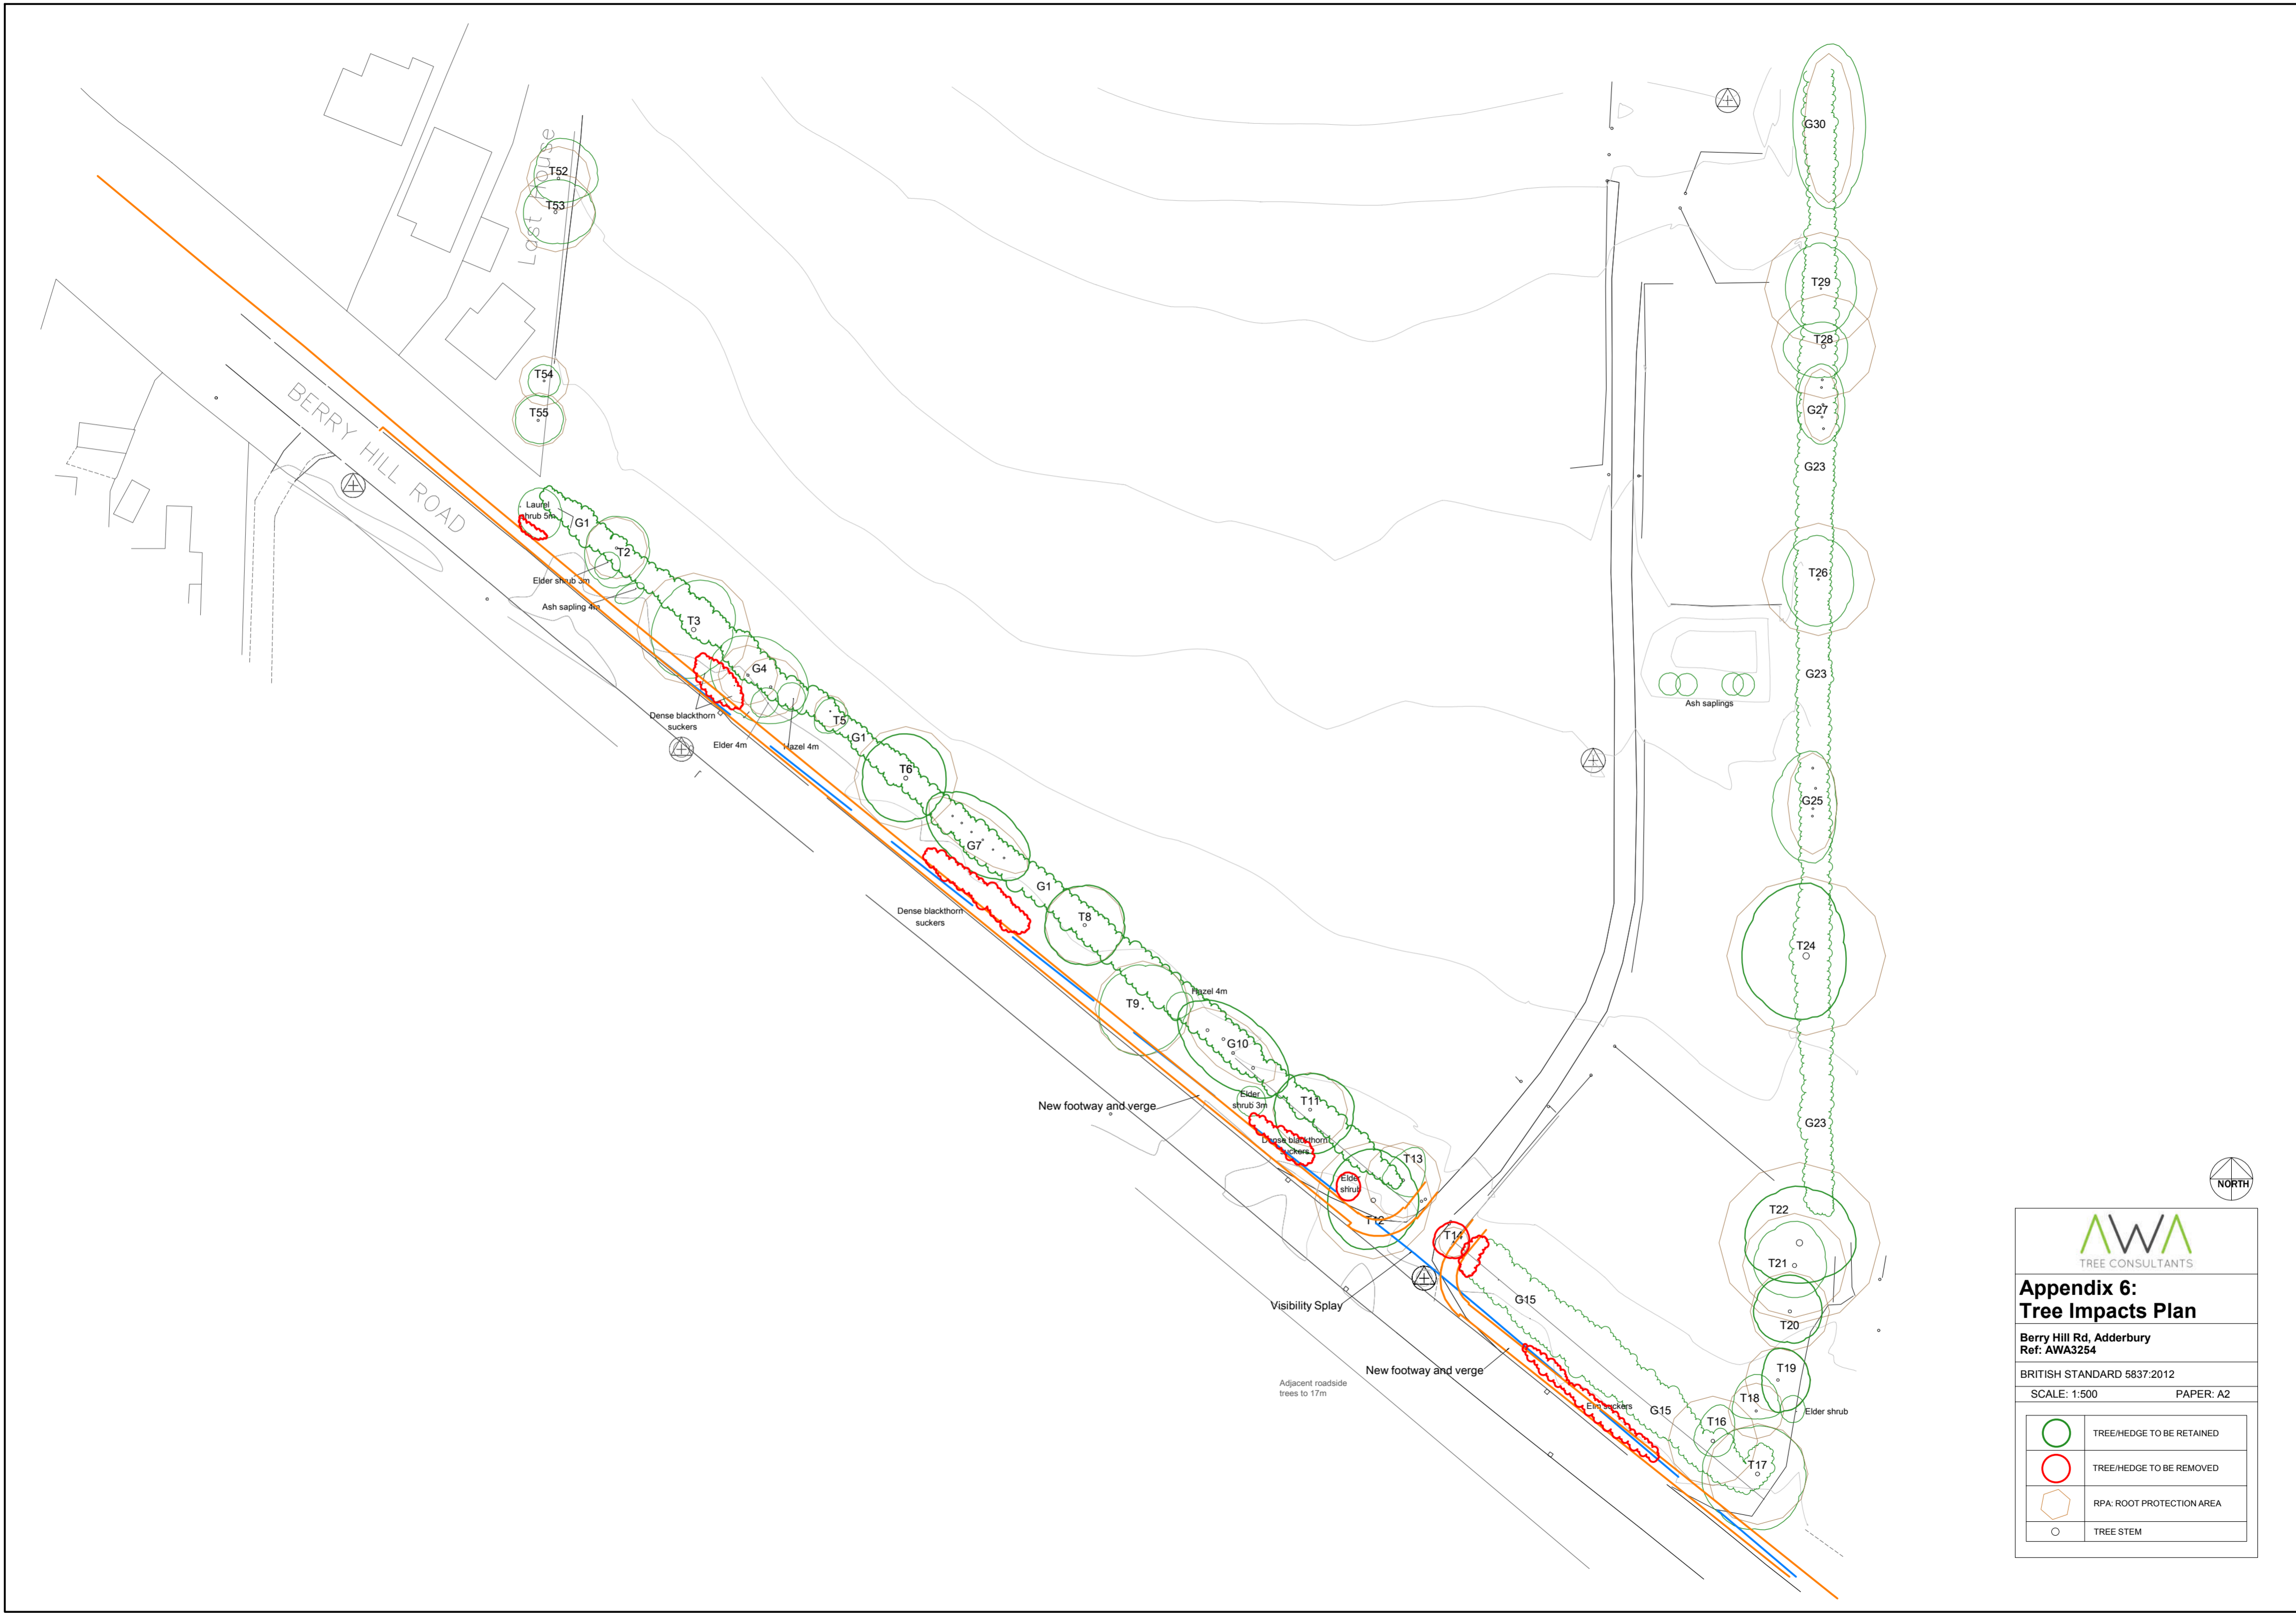
**Appendix 6:
Tree Impacts Plan**

- 4.2.1 From assessing the new development proposals, no significant trees will require removal to facilitate the new access arrangement. One Hawthorn shrub (T14) will require removal as it is situated in the footprint of the new access footway and retention and protection throughout the development is not suitable.

- 4.2.2 The individual Hawthorn T14, that requires removal, is of very low value, retention category 'C' and the removal will have little negative arboricultural impact at the wider site.

- 4.2.3 The pruning back of a 2m section of the unmanaged hedge group G15, to provide access, will have no negative arboricultural impact.
- 4.2.4 The overhanging crown of Horse Chestnut (T9) will require minor crown lifting to avoid obstructing access under the new footpath. The tree will readily tolerate the work and the amenity value and prospects will not be negatively impacted.

4.2.6 Occasional low value shrubs, not of a size to be included within the tree survey, have been indicatively identified of the Tree Impacts Plan and require pruning back to facilitate the new footway. This work will have no arboricultural impact.
