**REPORT ON
GROUND INVESTIGATION
AT
THE PROMISED LAND FARM,
BICESTER**

Client:	Albion Land Ltd
Report Title:	Report on Ground Investigation at The Promised Land Farm, Bicester
Report Number:	AG2875-18-AF37
Report Status:	Validated Issue 1
Date:	November 2018

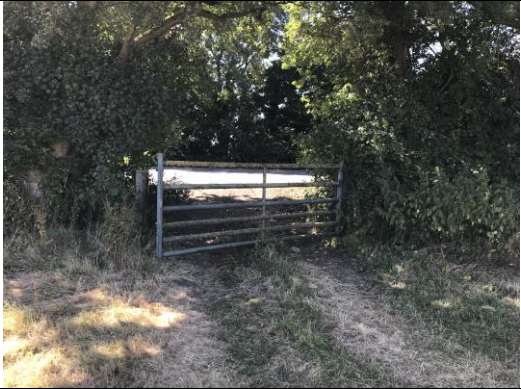
Gated entrance to the site in the northwest	Pylons with associated overhead cables in the west of the site
