Tree Survey Summary and Masterplan Assessment

Deerfields Farm, Bodicote

Date of inspection: 22nd March 2018

Report Ref: 3406.Bodicote.RHDHV.TSS

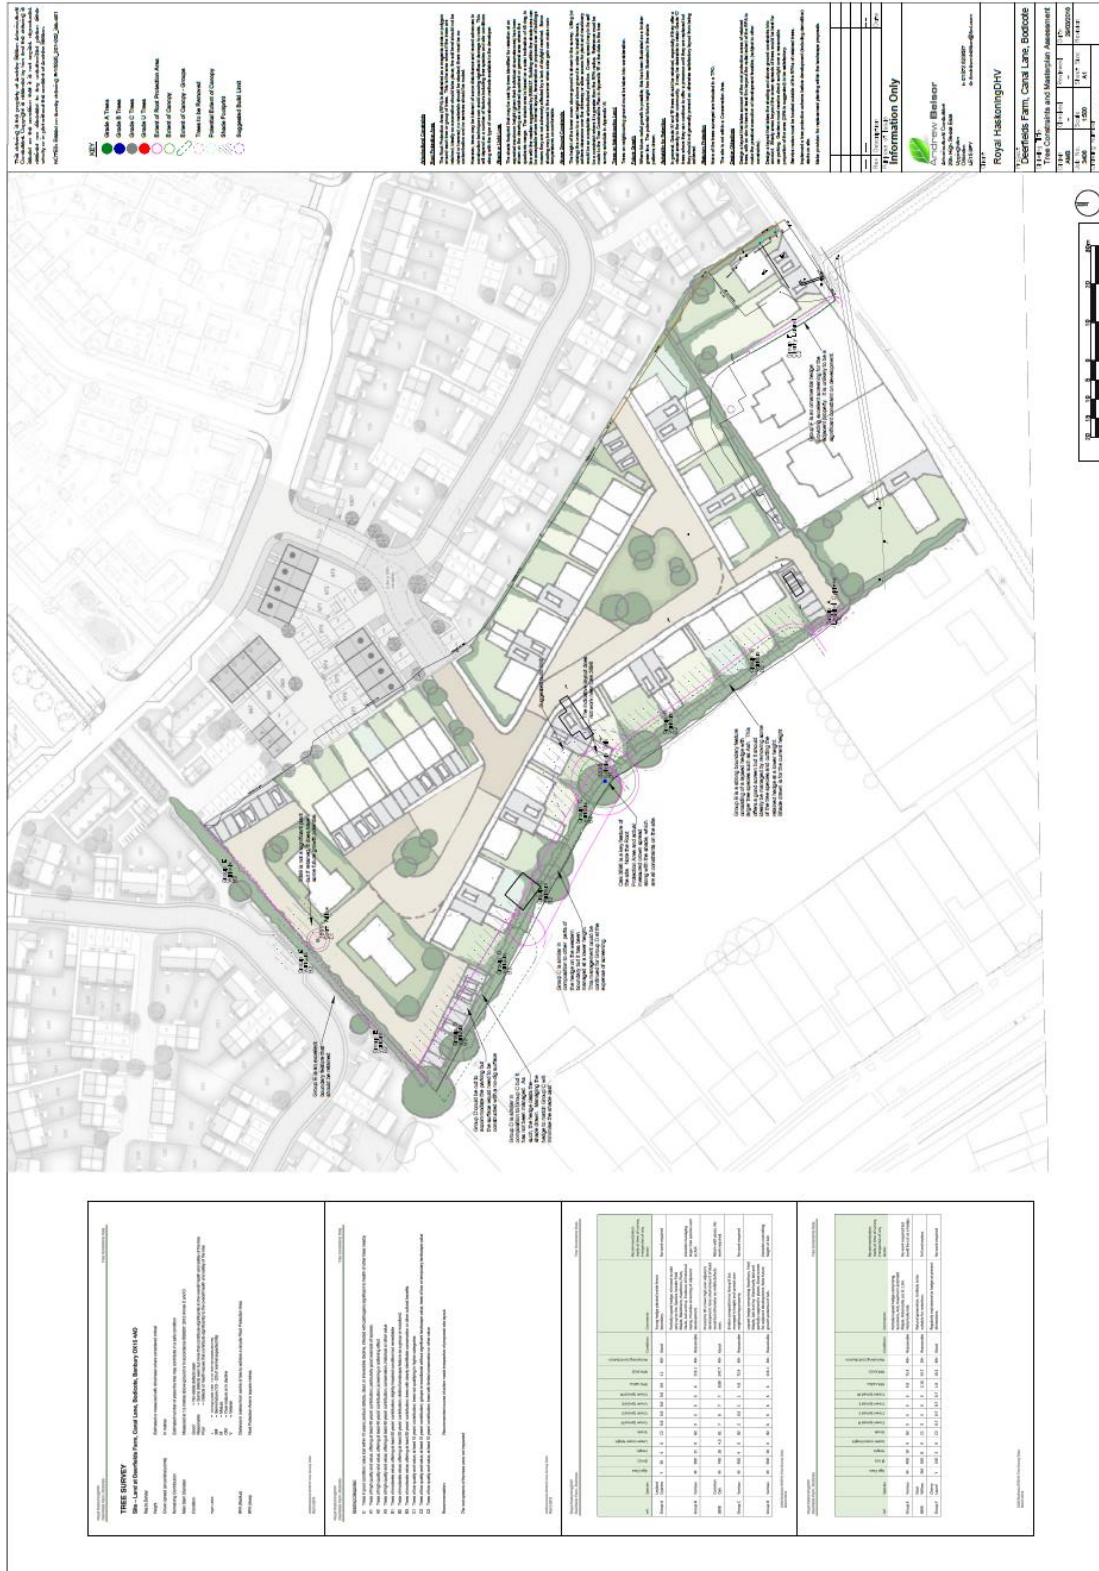
APPENDIX B – TREE CONSTRAINTS AND ASSESSMENT PLAN

8.1.1 The indicative layout shown on drawing 17/24/02 'Site Layout Option 2' is broadly acceptable but it will need to be adjusted in the region of Oak 3898 in order to successfully incorporate the tree into the layout.

8.3.1 The indicative layout is broadly acceptable from an arboricultural perspective but I consider that more space needs to be given between Oak 3898 and any residential buildings, and any garages should be located outside of the tree's RPA.

8.3.2 Goat Willow 3899 cannot be retained in this scheme but I do not consider that to be a significant issue.

8.5.2 Consideration must be given in the layout so that soakaways for dwellings near Oak 3898 can be excavated outside the tree's RPA.

- 9.1.1 Retain hedges B – E; cut to a height that balances privacy against garden usability
- 9.1.2 Avoid any construction within Root Protection Areas.

- 9.1.3 Allow a greater distance beyond the edge of the Root Protection Area of Oak 3898 to take account of the tree's size.
- 9.1.4 Assume Goat Willow 3899 can be removed.

- 9.1.5 Design a layout that takes account of the root protection areas of hedges, with an aim to leave at least 2m beyond the radial extent of the RPA to make the practical execution of development feasible, (subject to other constraints)
