Our ref: R9675/rs

Date: 30 September 2019

**Buildings for conversion – Mawles Farm, Sibford Gower.**

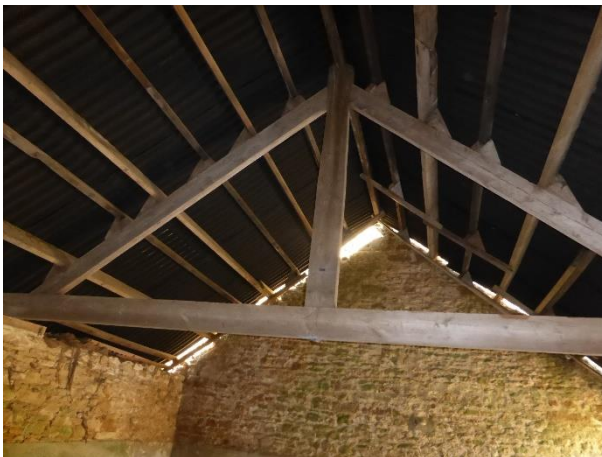
- 3.1.1 Building 1 is covered with corrugated fibre sheeting supported by softwood purlins spanning between walls and an intermediate king post-type truss. The walls are solid stone. The floor is solid.
- 3.1.2 The roof structure is not substantial enough to accept a slate or tiled roof covering. It will require upgrading.

Building 1 roof

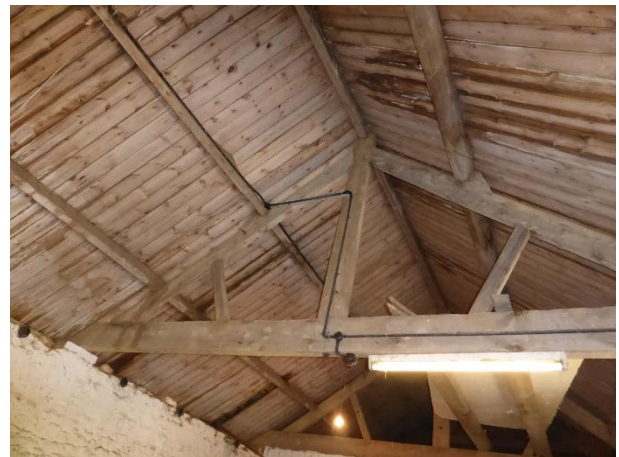
Roof elsewhere

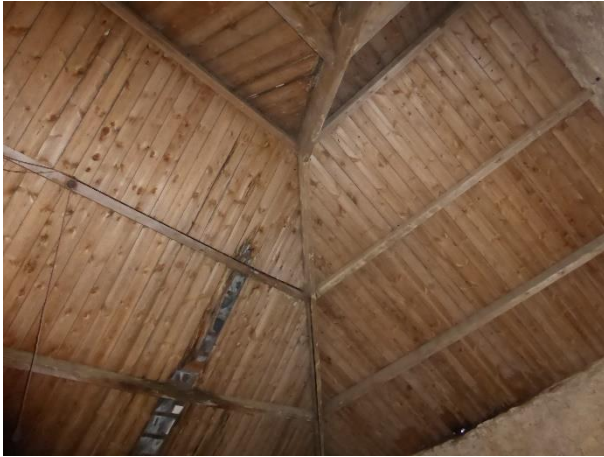
- 3.2.1 Building 2 is covered with natural slates on tongue-and-groove boarding supported by purlins. The two rows of purlins in each slope and the ridge pole gain intermediate support from king post trusses. The external walls are solid stone. There is one timber framed internal partition below a truss. The floor is concrete.
- 3.2.2 The south west quarter of the floor steps down some 1.2 metres to the level of Pound Lane – there is a vehicle exit through the south end of the west wall to Pound Lane. The east end of the step is retained by a brick wall. It is not clear what retains the north edge of the step, although what is there appears to be working.
- 3.2.3 The hip and valley blades are unrestrained. A tie will be required between their feet.
- 3.2.4 There is localised rot in the roof boarding which will require treating.

Unrestrained hip & valley

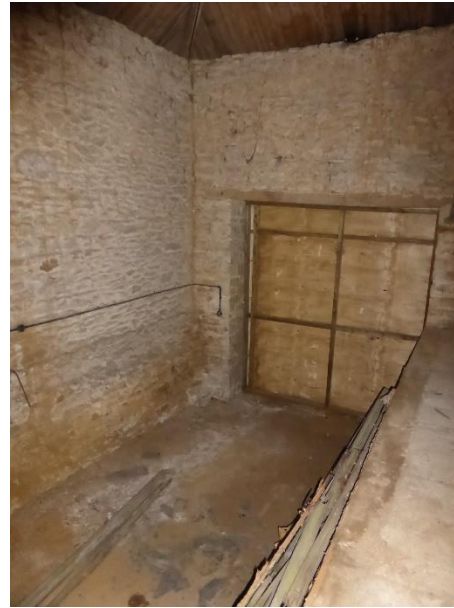
Step in floor

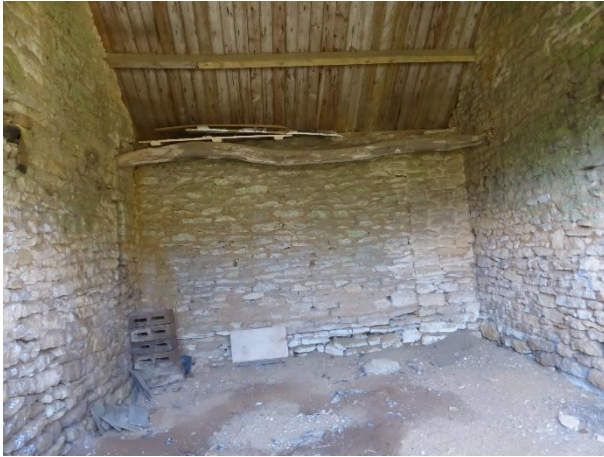
- 3.4.3 The west elevation has been infilled with stone to match elsewhere. Each end of the infilled panel is butt-joint to the original adjacent walls. Restraint will need to be added across these joints, which could be done by, for example, stitching in helix bars.

Drivethrough wall infilled

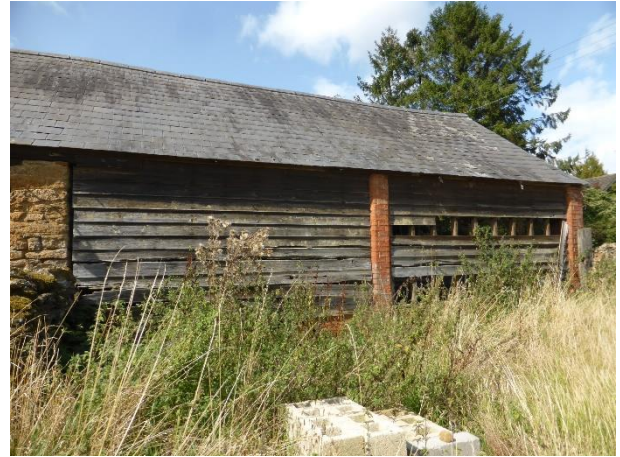
Timber panelling

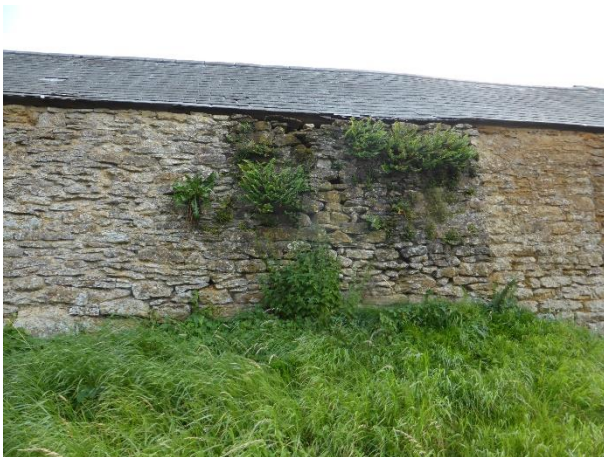
Vegetation

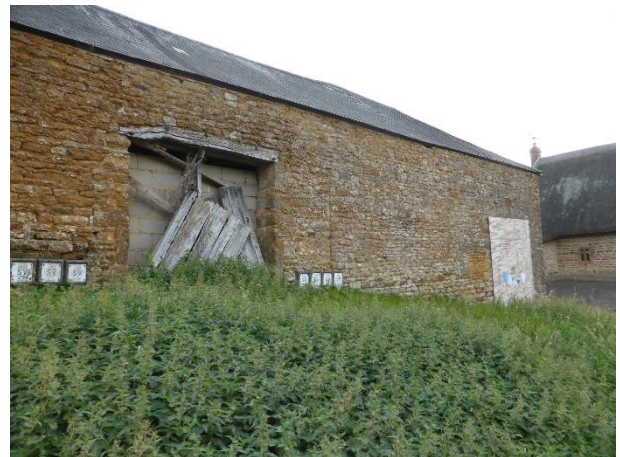
Blocked up opening
