**Arboricultural Report and Tree Condition Survey  
for the Proposed Development  
at  
Mawles Farm,  
Sibford Gower,  
Banbury.  
OX15 5RW**

**Prepared for: Ian O'Brien Studio**

**Peter Wilkins BA (Hons) MArborA  
Our Ref 1119-8073  
November 2019**

## **Tree Condition Survey for Mawles Farm, Sibford Gower, Banbury. OX15 5RW**

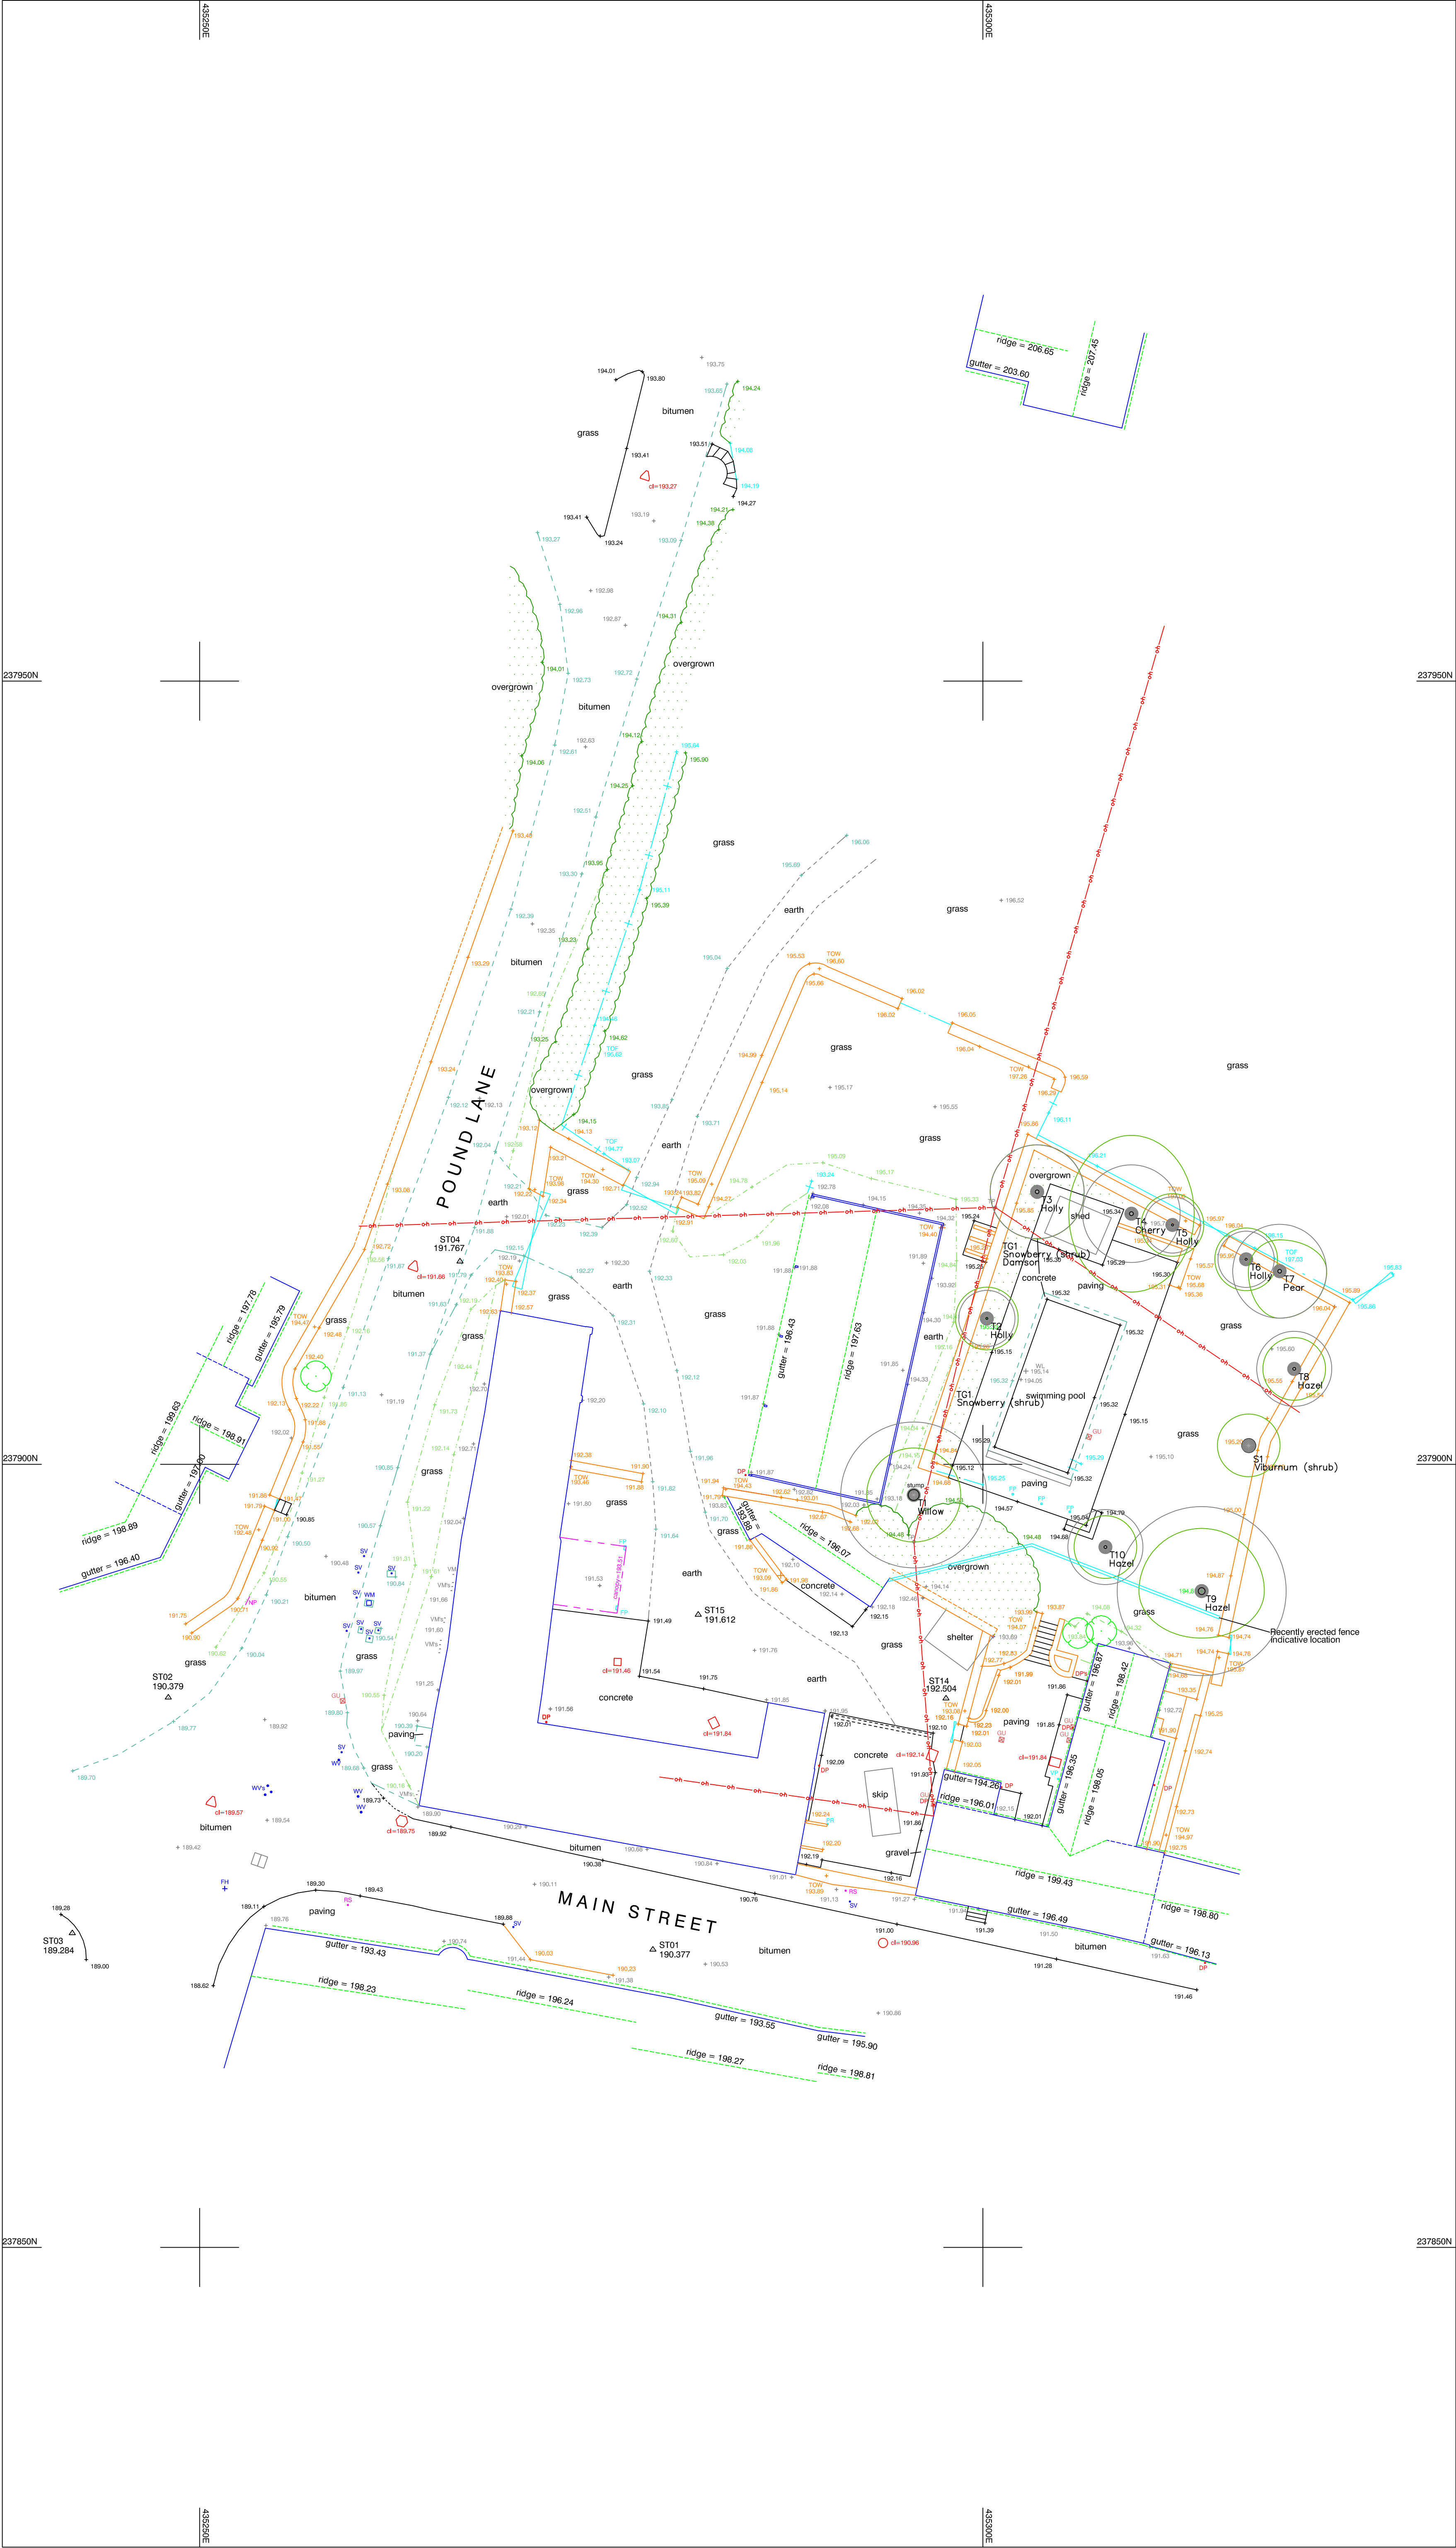
## **Tree Survey Plan**

- 5.4 The trees and shrubs to be removed to allow for the proposed development are identified within the Tree Condition Survey and shown on the attached Tree Removals Plans. The trees to be removed include the regrowing willow stump T1, 2 Hollies T2 and T3, an area of snowberry shrubs and a Viburnum shrub S1.

Tree No.	Species	Hgt (m)	Dia. @ 1.5m (m)	No of stems	CS N (m)	CS E (m)	CS S (m)	CS W (m)	ER CY	Vig.	Form	Age Class	Description	Proposed Works	BS Cat
T1	Willow	4	700	1	3	3	3	3	20-39	A	A	SM	A stump from a willow tree that is regrowing. This stump is located close to the south-eastern corner of the barn. This stump is located beneath overhead cables and if retained ongoing management would be required	Remove to allow for proposed development.	C2
T2	Holly	6	150	1	2	2	2	2	40+	A	A	SM	A semi-mature holly growing within the unmanaged shrub bed TG1 which runs to the western side of the swimming pool.	Remove to allow for proposed development.	C2
T3	Holly	8	250*	1	3	3	3	3	40+	A	A	EM	An ivy-covered, early-mature holly growing to the northern end of the unmanaged shrub bed TG1 which runs to the western side of the swimming pool. This tree has a limited live canopy and is covered in dense ivy. It is immediately to the northern side of the pole for the overhead cables with the pump house to the eastern side.	Remove to allow for proposed development.	C2

T4	Cherry	9	260	1	5	4	5	4	40+	A	A	SM	A mature tree growing within the unmanaged vegetation which runs along the northern side of the swimming pool. This tree is in close proximity to the pump house for the swimming pool. There is a low stone /concrete retaining wall running to the southern side of this tree.	No Works	C2
T5	Holly	5	150	1	2	2	2	2	40+	A	A	SM	A semi-mature tree growing within the unmanaged vegetation which runs along the northern side of the swimming pool. There is a low stone /concrete retaining wall running to the southern side of this tree.	No Works	C2

Tree No.	Species	Hgt (m)	Dia. @ 1.5m (m)	No of stems	CS N (m)	CS E (m)	CS S (m)	CS W (m)	ER CY	Vig.	Form	Age Class	Description	Proposed Works	BS Cat
T6	Holly	5	150	1	2	2	2	2	40+	A	A	SM	A semi-mature tree growing within the unmanaged vegetation which runs along the northern side of the swimming pool. This tree has a limited live canopy and is covered in dense ivy. There is a low stone /concrete retaining wall running to the southern side of this tree.	No Works	C2
T7	Pear	8	250*	1	2	3	3	2	0-9	P	P	OM	A declining, ivy-covered fruit tree with a limited live canopy. T7 is growing within the vegetation to the northern side of the swimming pool. The dense ivy prevents a full inspection of this tree.	Sever ivy to allow full inspection of this tree.	C2
T8	Hazel	2	200	m/s	2	2	2	2	40+	A	A	SM	A small, multi-stemmed hazel growing within the vegetation to the eastern side of the swimming pool.	No Works	C2
T9	Hazel	4	450	m/s	4	4	3	4	40+	A	A	M	A multi-stemmed hazel growing within the vegetation to the eastern side of the swimming pool.	No Works	C2

T10	Hazel	3	200	m/s	2	2	2	2	40+	A	A	SM	A small, multi-stemmed hazel growing close to the south-east corner of the swimming pool.	No Works	C2
S1	Viburnum	2.5	150	m/s	3	3	3	3	10-19	A	A	M	A multi-stemmed shrub growing within the vegetation to the eastern side of the swimming pool.	Remove to allow for proposed development.	C1
TG1	Snowberry and Damsons	2.0	50	m/s	2	2	2	2	10-19	A	A	M	A dense narrow unmanaged shrub bed running to the western side of the swimming pool. This is dominated by snowberry towards the northern end are some young damsons.	Remove to allow for proposed development.	C1
