STAGE 1 ROAD SAFETY AUDIT

Pedestrian Facilities
Land at South Side
Steeple Aston, Oxfordshire

Prepared for: Rectory Homes
Ref: TR8171225/GT/018
Issue 1: 5 November 2019

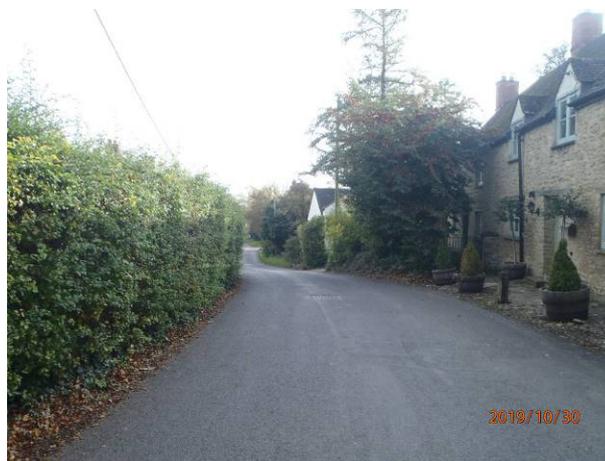
2.1 Problem 1

Location: Eastbound approach to priority give way and build-out and continuing east.

Summary: Risk of obstructed forward visibility leading to vehicle / vehicle head-on collisions leading to possible personal injury.

The existing nearside hedgerow on the eastbound approach to the proposed priority give way line and east of the proposed build-out was noted to partially obstruct forward visibility. This may result in drivers passing the give way line whilst having insufficient sight of on-coming vehicles travelling east to west along South Side. As a result, vehicles travelling west to east may be unable to sufficiently clear the proposed kerbed build-out, giving rise to a risk of either vehicle / vehicle head-on collisions or collisions with the build-out, both with possible personal injury occurring.

*View from proposed position of give way line
(looking east along south Side)*

It is recommended that the existing hedgerow is trimmed back along its length at least as far as the highway boundary, if this can be easily defined. Future growth shall be monitored and trimmed as required as part of an on-going maintenance programme. It is also recommended that the build-out is not kerbed but is instead constructed to be fully or part over-runnable thereby providing larger vehicles with additional carriageway width to take avoidance action if required. The proposed sign assembly to be installed within this build-out should be relocated as a result, whilst ensuring that sufficient horizontal clearance is provided.

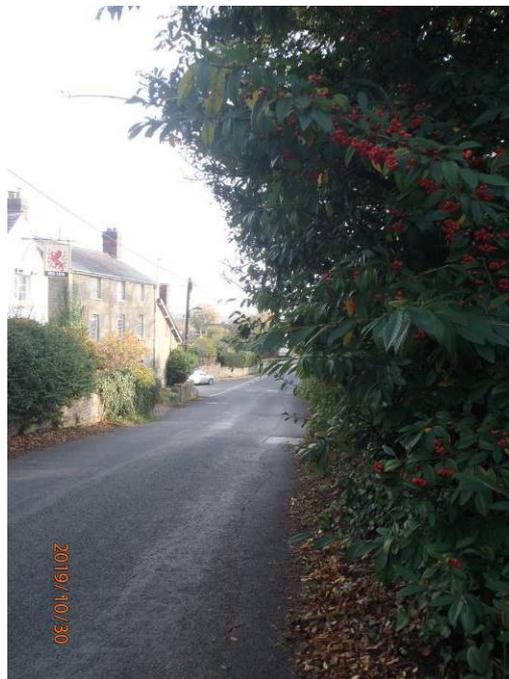
2.5 Problem 5

Location: Virtual footway.

Summary: Risk of injury to pedestrians owing to overhanging vegetation leading to personal injury.

Existing vegetation currently overhangs the route of the proposed virtual footway. This will cause obstruction leading to pedestrians having to step into the carriageway giving rise to a risk of vehicle / pedestrian collisions with possible personal injury occurring.

Overhanging vegetation

It is recommended that overhanging vegetation is extensively trimmed back to ensure that the full width of the virtual footway can be used by pedestrians travelling in either direction.
