Structural Report

Burdrop Farm House, Burdrop

Oxfordshire, OX15 5RN

October 2019

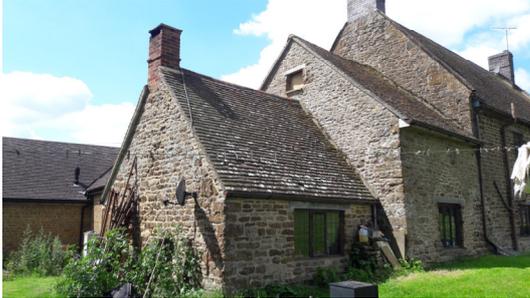
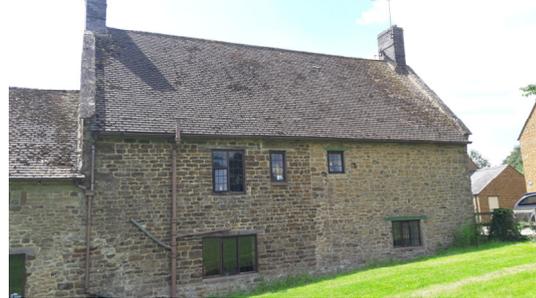
The main, taller element is three-storey (including the rooms in the roof space) and has clear evident vertical joint approximately at its mid-point as seen in the right hand photograph above. This 'straight' joint in the stonework is, somewhat unusually offset at the first floor level (as noted on SK/05) from one side of the internal cross-wall to the other. On the north elevation, shown in the two photographs above the construction varies across the joint. Coursed, reasonably well-dressed stone is to the left whereas the stone to the right is poorly dressed and only semi coursed. The joint occurs in the matching position on the front face, as shown below, but the stone is all reasonably well dressed and coursed.

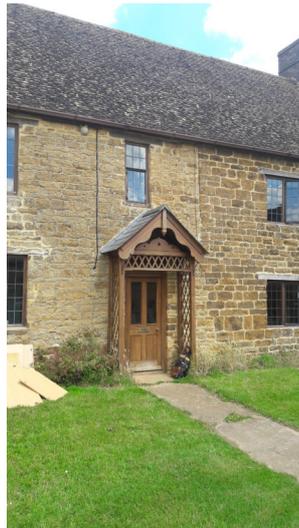
There is also a slight step in the face of this joint where some degree of lateral movement has occurred in to the right hand side of the joint. The thickness of the internal cross-wall suggests that it was originally intended to be an external wall and the variation in style of stonework indicates that construction of the walls was not all contemporaneous. However, the offset in the joint suggests that the addition of second sections of wall (suspected to be the eastern section) was already intended to be constructed as a second cottage during the construction of the first and that the origins of the two elements were separated by only a short period in the early to mid-part of the 18th Century.

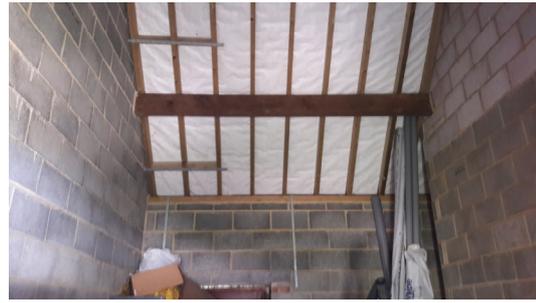
These garages are constructed with modern 'split and tumbled' ironstone facing, as shown above left and a concrete blockwork inner leaf as shown above right. The plain tile roof covering incorporates a modern breathable roof felt and is supported on a 'cut' timber roof of rafters and purlins.

The garage building has clearly been completed in recent years. It is assumed that it was subject to planning and building regulation approval. This should be verified. The building appears to be performing satisfactorily. However, it is noted that purlins are present midway in the rafter slopes but without a ridge purlin. In this structural arrangement it would be usual to provide timber collars between the purlins. This can easily be done and is recommended.

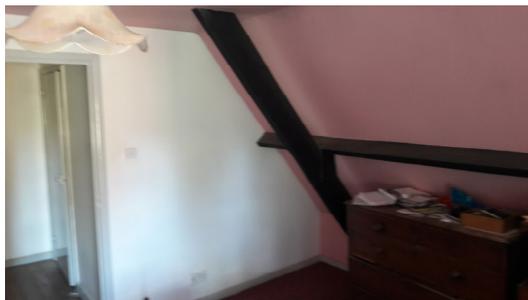
The purlin span is approximately 2.5 metres which is a little in excess of its capacity by modern design calculations but there is relatively little deflection. The rafter size could not be checked but again there is little indication of sagging. The principal rafter of the truss is not sagging significantly it is assumed that there is a horizontal tie within the floor but this should be verified.

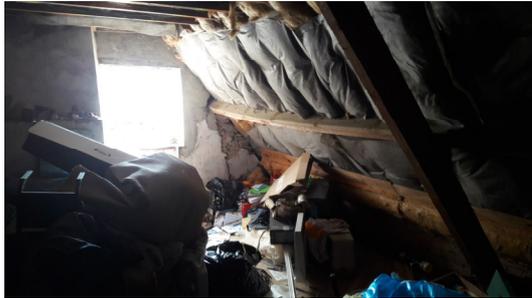
Mineral wool insulation has been used between the rafters to provide some degree of insulation. However, it is insufficient to satisfy modern building regulation and is quite possibly causing condensation somewhere in its depth with limited opportunity for ventilation. It is recommended that this arrangement is remedied by the use of a vapour control layer, ventilation and better insulation.

A purlin can be seen in the left hand photograph which is spanning to the far wall at the east end of the three-storey element and to a truss at the right hand wall. This purlin can be seen to be sagging significantly. This purlin spans further than the others and it is not clear whether it was doubled up as can be seen, or if a second purlin was added (noting that a single timber section was used elsewhere) to address the shortcoming when it was noticed. The other single purlins are also deflecting but slightly less seriously. Although the sagging purlins are not currently causing serious problems it is recommended that they are reinforced.

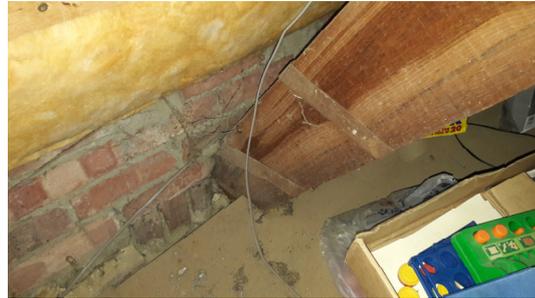
The photograph above right shows the principal rafter of the truss entering the external supporting wall. It is assumed that the feet of the truss principal rafters are tied by the substantial oak beam visible in the ceiling of the master bedroom below. This should be verified.

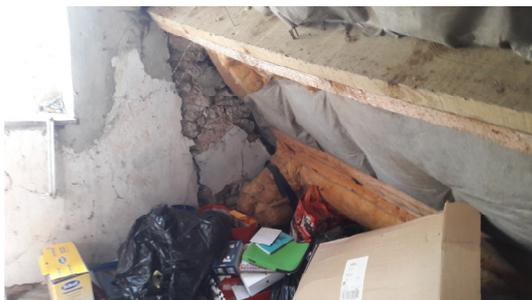
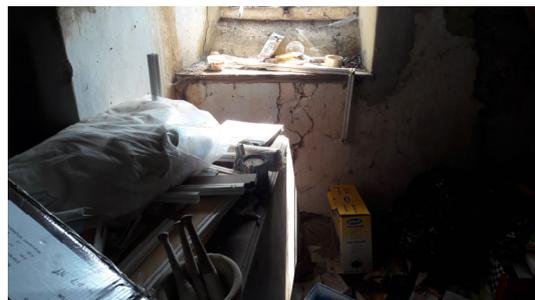
There is no current evidence of ongoing spread of the walls at eaves level. However, there is historic cracking in the west gable at its north end near to the support of the doubled up purlin and under the third floor window in the gable (see photograph below).

This is a result of the downslope thrust that occurs in the roof when a ridge purlin is not present and the horizontal force at the eaves is not resisted by floor joists. This cracking has continued in the wall below the second floor where it can be seen in the back of the master bedroom cupboard as shown below.

There is some indication that a former crack has been repointed but not reappeared. It is assumed that the horizontal spread has ceased, possibly as a result of the replacement roof structure 60 years ago or as a result of doubling up the purlins. In any case, it would be relatively simple and cost-effective to improve tying between rafter feet and ceiling. This could be easily implemented as part of a refurbishment project as a preventative measure.

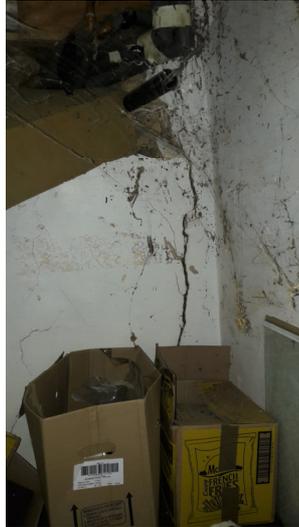
There is no evidence of current cracking between the ceiling and wall of the master bedroom and no current cracking in the west gable external face. Furthermore the ridge of this section of roof remains relatively straight.

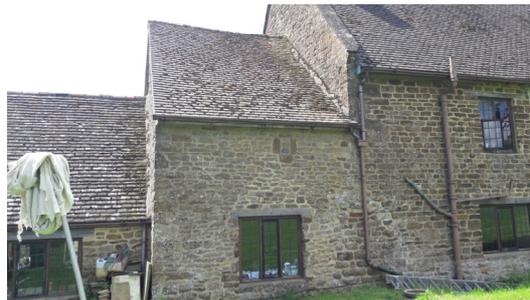
The intermediate level roof has also been replaced with modern softwood rafters and purlins. In this case the span between loadbearing walls is not sufficient to require a truss. Nevertheless, the purlins are somewhat undersized for the span and some degree of deflection has occurred. In this case the problem is exacerbated by the absence of either a ridge purlin or ceiling joists. A slight amount of dishing of the roof slope can be seen together with a slight dip in the ridge line as shown below.

Deflection of the purlins will frequently cause spread at the walls at eaves level if it is not restrained by ceiling joists (which are not present here). This can take the form of bowing in the eaves line or cracking in gable walls as noted in 3.1.1 above. There is again historic evidence of some cracking of this sort of the walls together with slight bowing of the north/south walls. However, there is no current cracking in the external walls and it is assumed, therefore, to have ceased. It would however, be prudent and cost-effective to implement prevention measures as part of a refurbishment measures. This could be carried out by any of the following

1. Strengthen existing purlins
2. Installing ceiling collars at purlin level
3. Install a ridge purlin

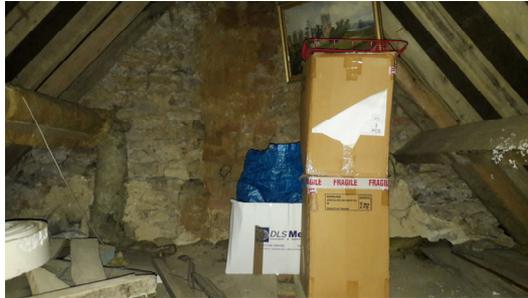
The replacement roof over this section is slightly more substantial using 200x75mm purlins and 100x50mm rafters

It is suspected that this roof structure may have been replaced more recently than the others. Although the purlins are still slightly undersized by current standards, there is little sign of deflection and the eaves are well tied by the ceiling joists. No action is necessary.

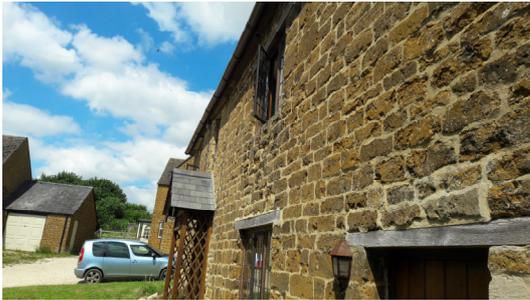
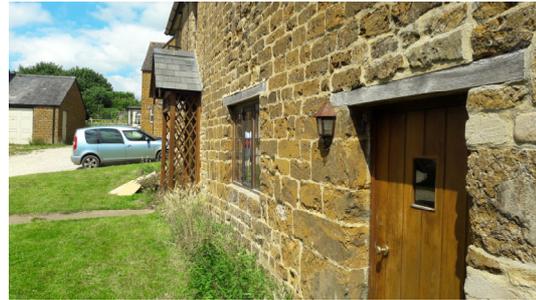
There is a small amount of bowing on the front wall as can be seen in the photographs below and marked on drawing SK/04 in Appendix B

The problem has also occurred, to a slightly smaller degree, in the rear elevation. Cracking has not reoccurred since the walls were repointed externally and replastered internally. However, it would be worthwhile to provide additional tying measures at floor level, as noted previously, as a preventative measure as part of refurbishment works. There is no requirement for this work to impact the historic structure.

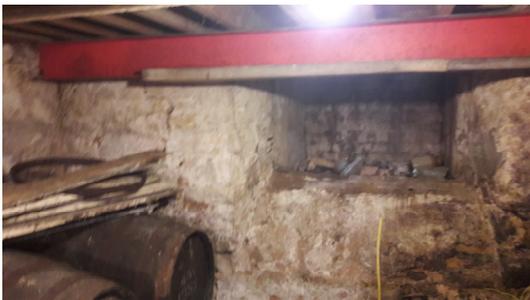
The floor over the basement has been completely renewed using a combination of softwood joists and steel beams as shown below left

This floor is clearly a relatively modern intervention and is performing well. However, a timber prop has been used to support the end of the steel beam from the bottom step as shown above right. Although not currently causing a problem, it is suggested that this situation is formalised.
