## PARSONS BARN FARM, SIBFORD GOWER

### STRUCTURAL SURVEY ON TRACTOR SHED / WORKSHOP

June 2020

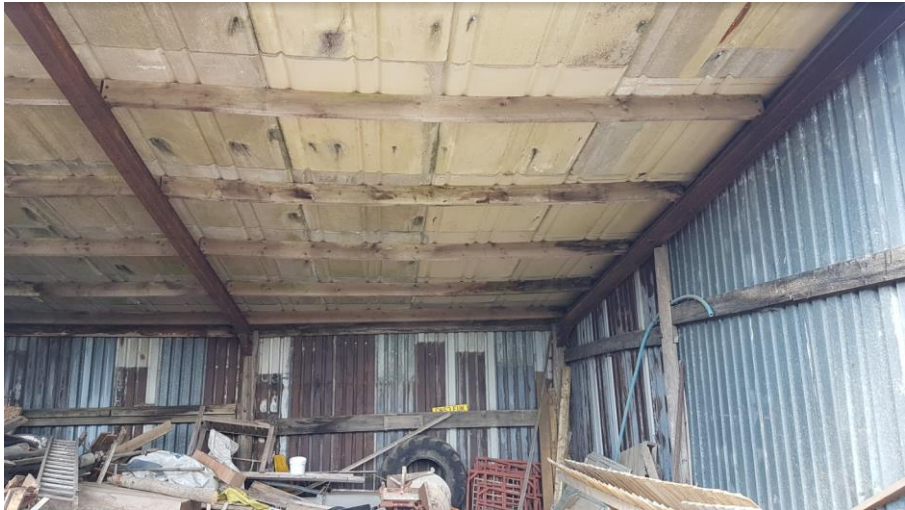
The purlins are in poor condition with signs of wet rot and damp on much of the timber. It would also appear that the purlins are undersized leading to midspan sagging.

Roof purlins showing sag at midspan

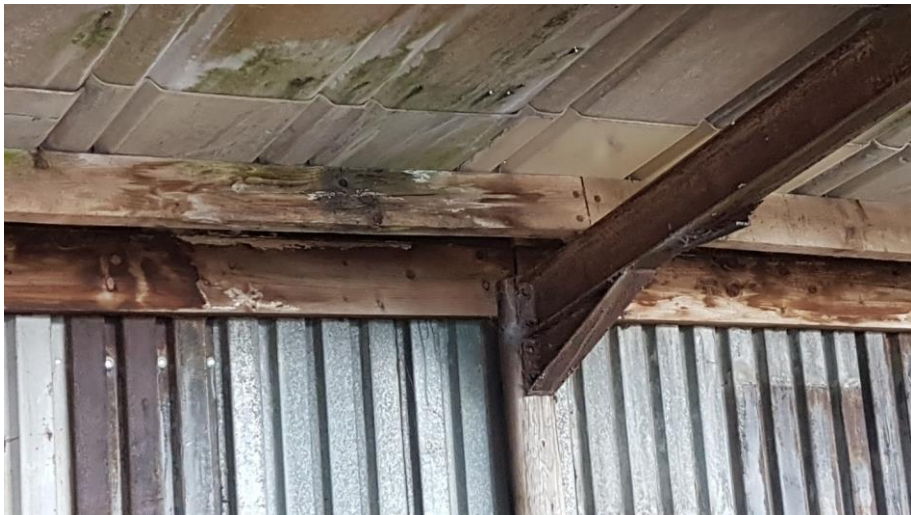
The overall condition of the structure is generally poor with no paint protection to the steel. There are signs of water ingress throughout the structure leading to some concern about the integrity of the steel to telegraph pole connections; particularly at the low end of the roof.

Connection between steel rafter and timber column

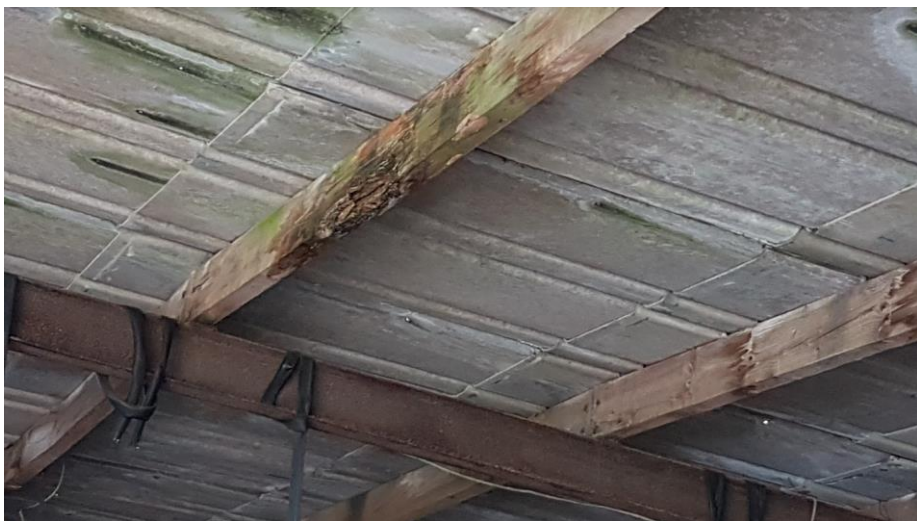
The wall cladding is starting to corrode badly in places and has holes from its former life that let in water. The roof has obvious signs of leakage contributing to the failure of the purlins.

Water damage to purlins
