**REPORT ON CONDITION OF A
 TRADITIONAL AGRICULTURAL BUILDING
 AT
 CROCKWELL FARM, GT BOURTON**

Survey by	Mark Allen BEng(Hons) CEng MStructE	4 th May 2020
Author	Mark Allen BEng(Hons) CEng MStructE Principal Engineer	June 2020
Reference	AB3522-BLDG 1	Issued 14 TH JULY 2020

AB Design Solutions Ltd were asked to inspect and comment on the condition of structural elements and the suitability of a traditional agricultural building to form part of an application of change of use to residential dwelling.

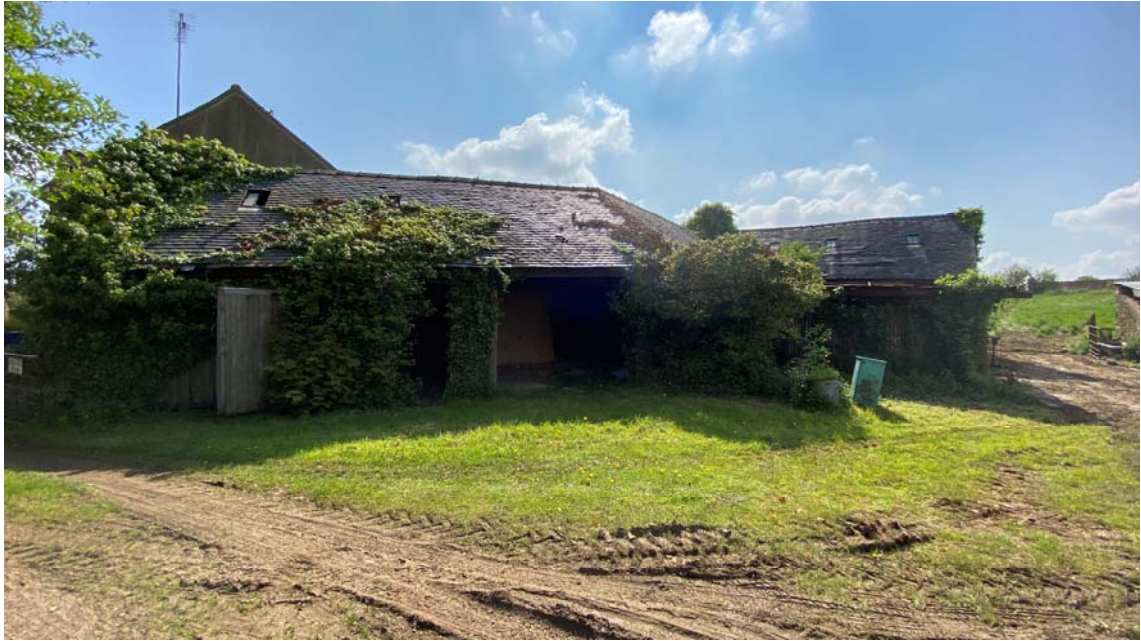
Open hovel, lean to and Northern section to right

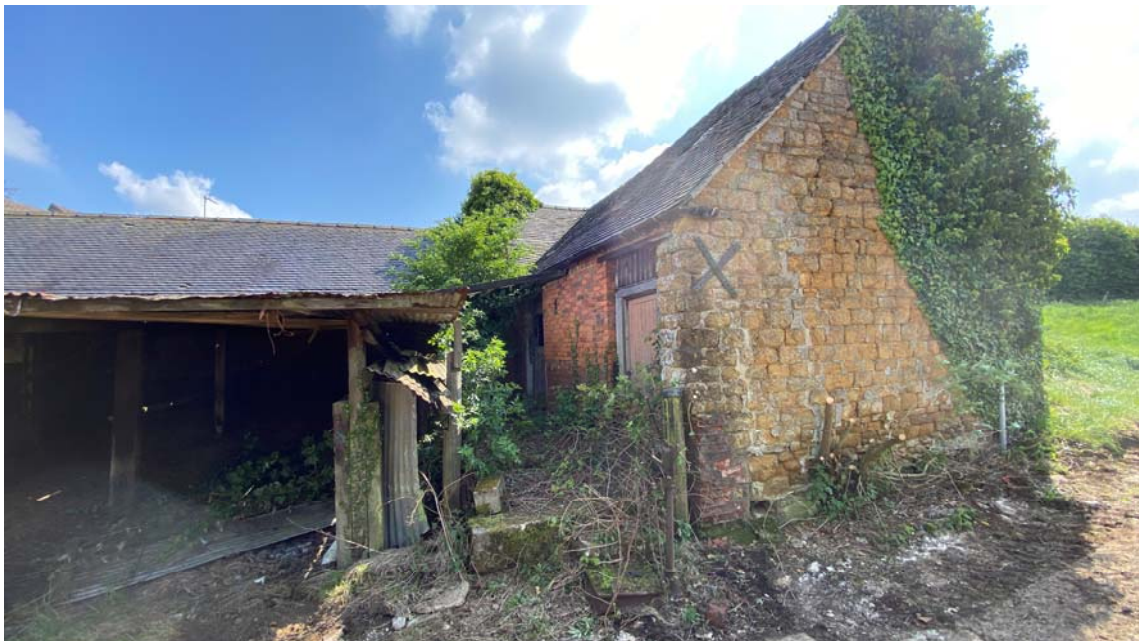
2 Storey Northern section

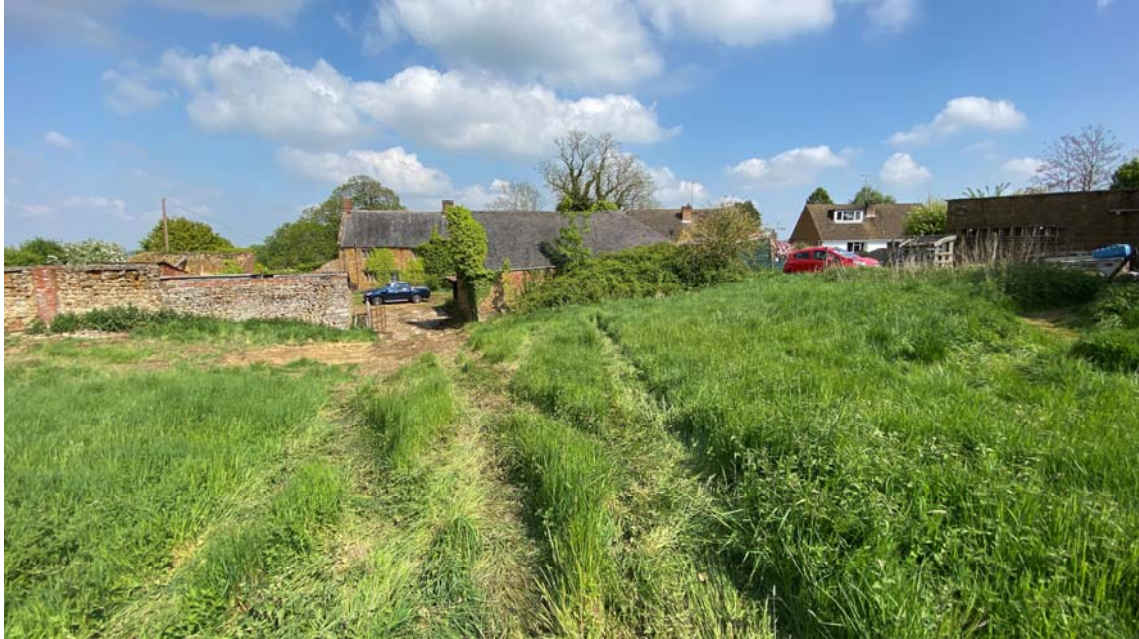
Northern Elevation showing neighbouring driveway and retaining nature of rear wall

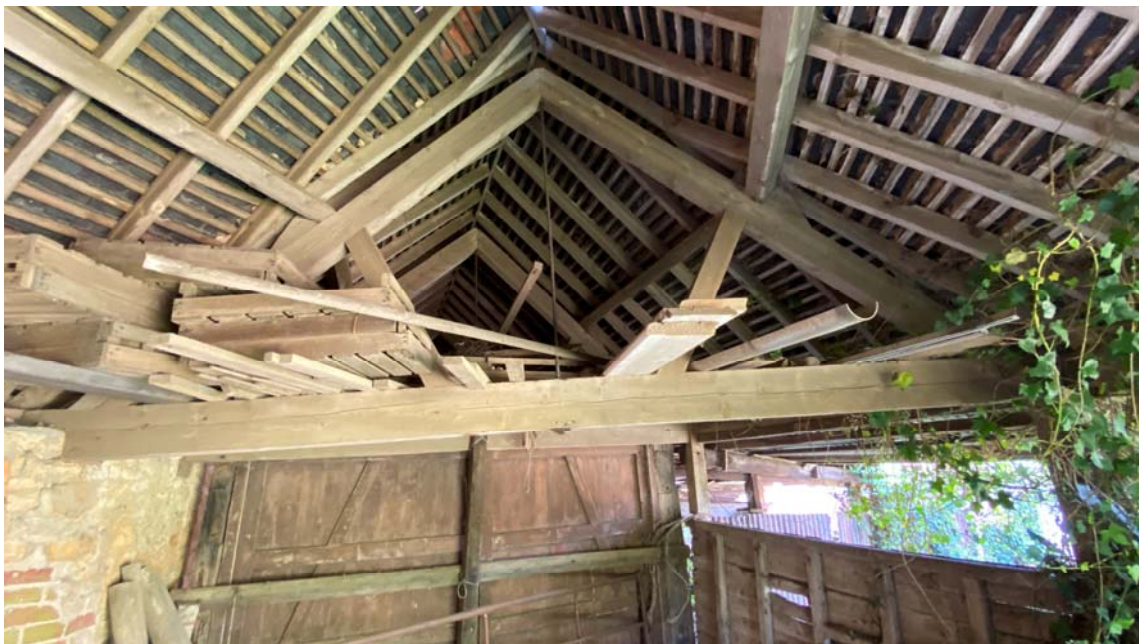
The wall plate was largely obscured to the rear wall, so this could not be inspected. However, the rest of the roof timbers appeared to be in good condition, with few signs of decay, including common rafter, purlins and principle trusses, and eaves beams.

Typical Principle truss and purlin arrangement in hovel

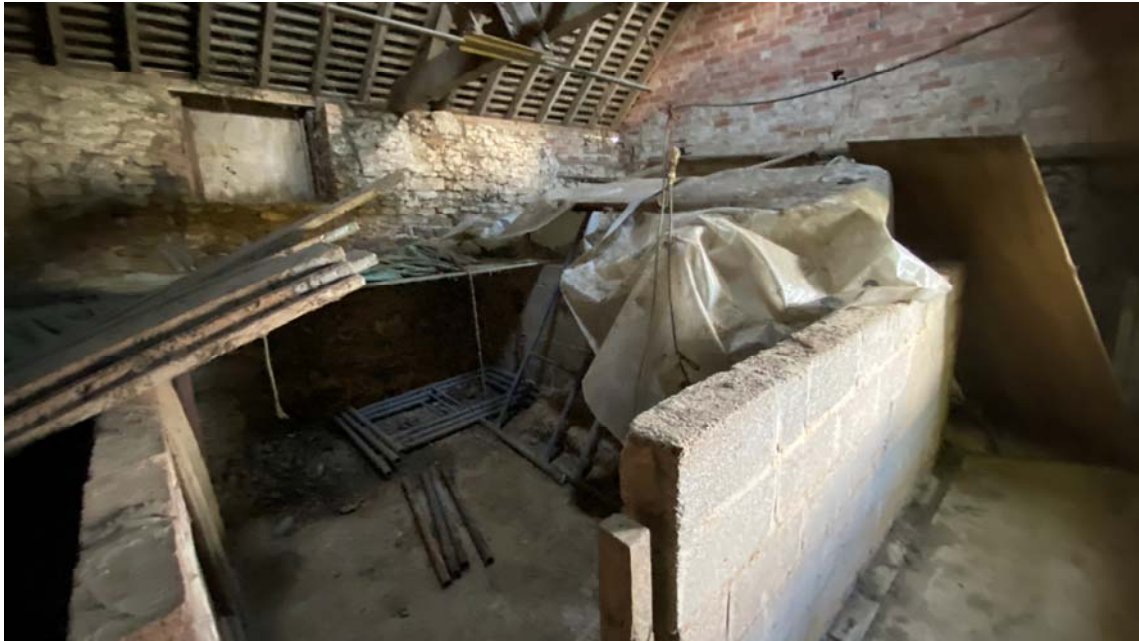
There was some modern concrete blockwork walls constructed up to above waist height off of the floor. These were for either retaining bulk materials feed, or forming livestock pens.

Northern section of the buiding with block walls to waist height.

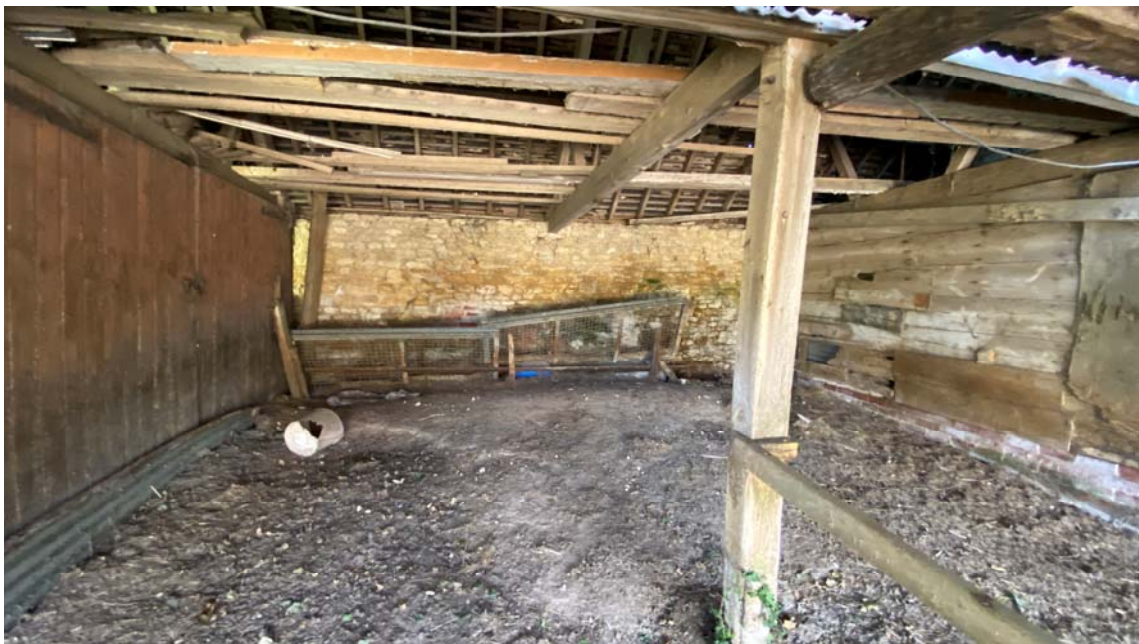
There were also areas at low level of the wall that showed signs of dampness and spalling of the face of stonework. This was most likely due to being damp with the combination with frost. There were no obvious large bulges to the wall, and it appeared within servieable limits.

The rear wall of the hovel section is retaining and is largely damp. This is suffering a little, and if left would deteriorate further. This wall could be assisted by some buttressing walls, or piers. It would also require strategy to relieve water pressure at the back of the wall, and some waterproofing if this building were to be converted to any other use than agriculture. If this is carried out, and there are various techniques including the drainage at the rear of the wall access permitting, or other techniques if not. Strength of the wall could be improved using stitching techniques tying both leaves of the retaining wall together. The wall can also be waterproofed internally, with suitable materials, and suitable internal linings, with a clear void between stonework and linings. One repair that would make the biggest improvement of the dampness of the wall would be to ensure the rainwater goods are effective as run off off the rear slope of the roof can provide a concentrated source of water to the ground behind the retaining wall.

Rear wall of hovel, Some dampness visible from floor to approx mid height

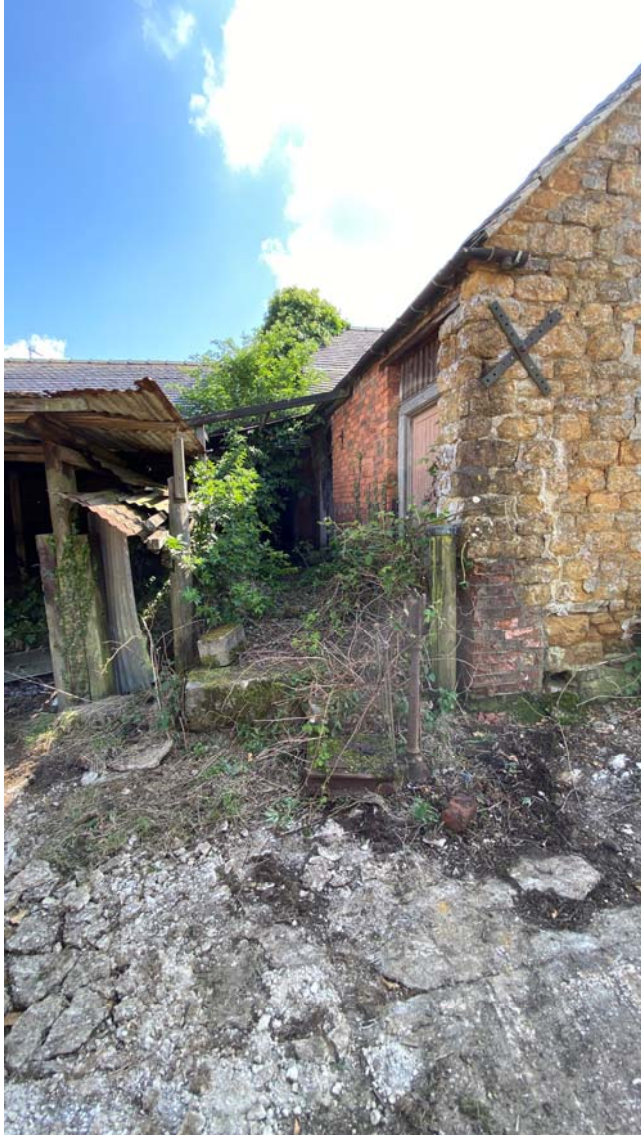
The gable end has a tie rod running to the southern eaves, with a patress on the gable end. Adjacent to the patress, especially below, there is some bulging to the wall. The upper section of the gable, whilst ironstone faced to the exterior has had some brickwork repairs. This section has other brickwork patch repairs to the stonework. There was some large areas obscured by ivy. This can also be a catalyst for damage to masonry, with aggressive roots anchoring into mortar joints and holding moisture against the masonry. We would recommend careful removal of climbing plants.

Northern section with mixture of brickwork and stonework. Tie rod and patress visible at eaves

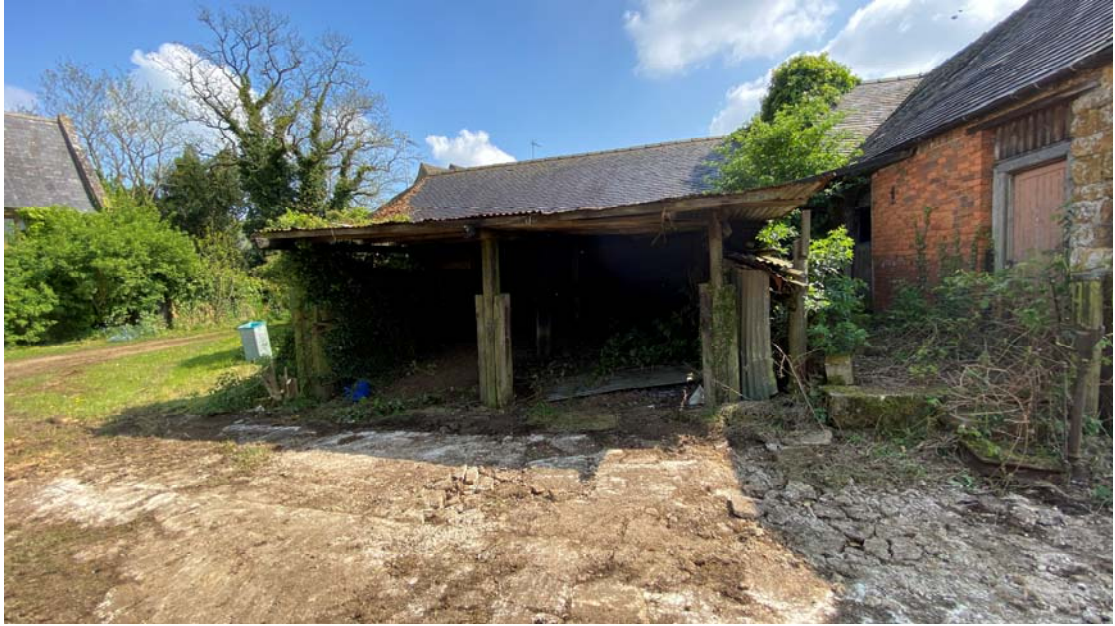
Open lean to recommended to be demolished

It would be the recommendation of AB Design that this lean to structure is replaced, It is of low historical structural value. Whilst it tells the story of the requirement for fast, cheap animal shelter, it has little architectural value, but does form part of the building cluster. Hence, replacement of this section of building would be the most feasible practically and economically.

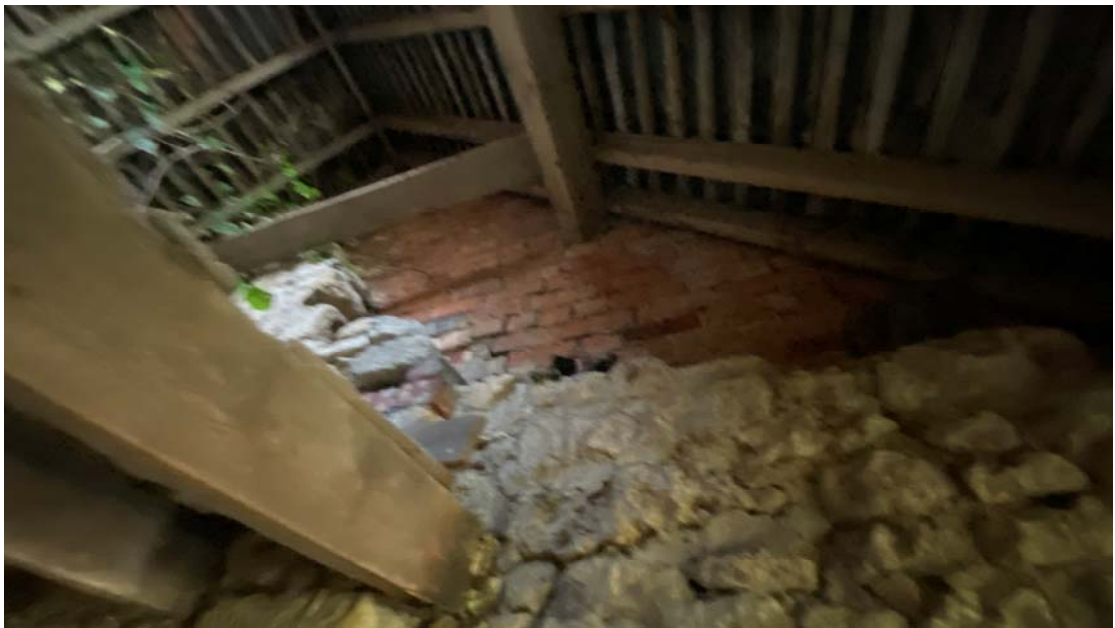
The walls are suffering in some local areas. The gable wall to the Northern most section requires some local patch repairs where bulging. This is a result of some moisture ingress into the centre of the wall, where moisture has ingressed from above.

Mixture of stone and brick gable to Northern section
