**REPORT ON CONDITION OF  
 AGRICULTURAL BUILDING  
 AT  
 CROCKWELL FARM, GT BOURTON**

Survey by	Mark Allen BEng(Hons) CEng MStructE	4 <sup>th</sup> May 2020
Author	Mark Allen BEng(Hons) CEng MStructE Principal Engineer	June 2020
Reference	AB3522 – BLDG 2	Issued 12 <sup>TH</sup> July 2020

### 3.0 Building 2

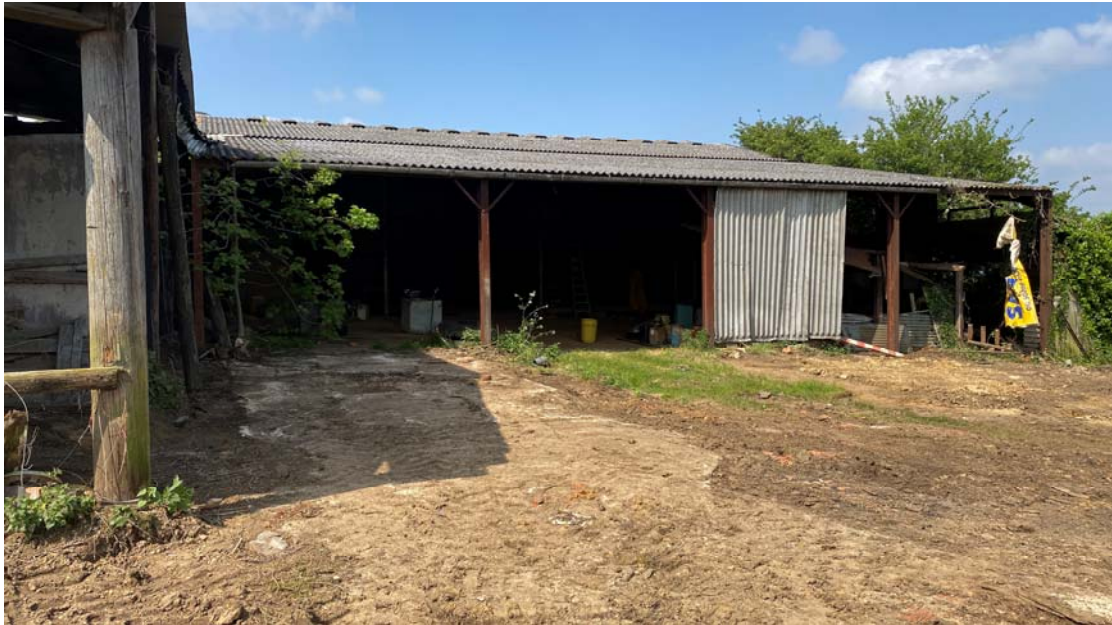
ELEVATION FACING FARMYARD – Pole barn to left.

Building 2 is steel framed building which is located in the “Rickyard” of Crockwell farm house, and has been used for the storage of forage, and livestock. There is a timber structure which adjoins the building constructed from telegraph poles and corrugated steel sheeting. ABDS have recommended that this building is demolished as part of this proposal.

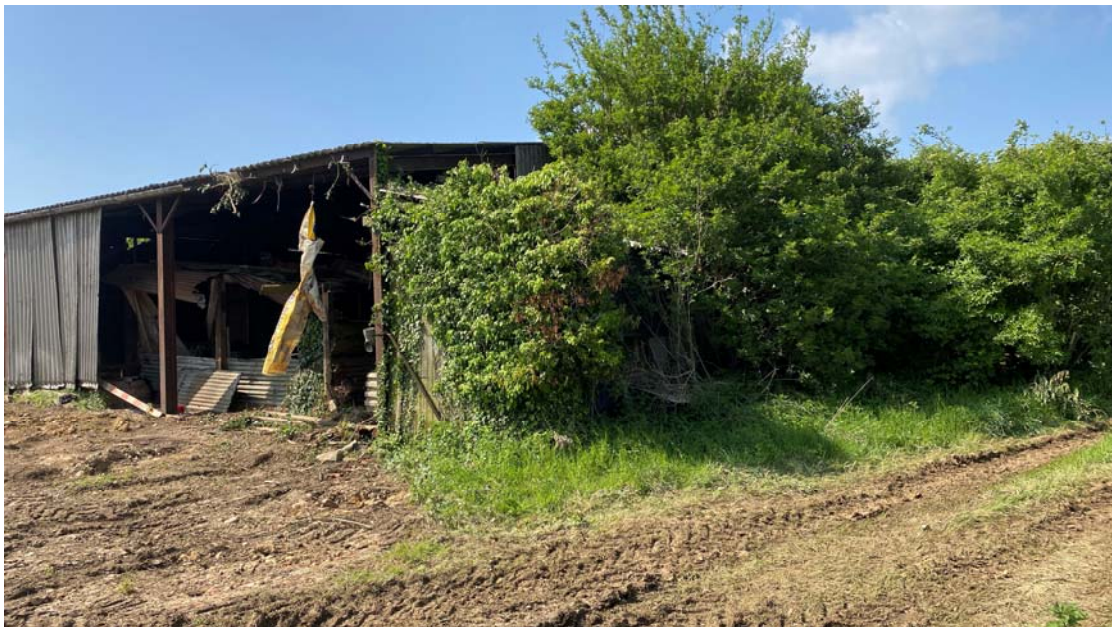
There were some saplings and shrubs growing close to both gable ends of the building. We would recommend the removal of these and replacing them with appropriate planting, perhaps not as tall.

Southern Gable Obscured by trees and shrubs

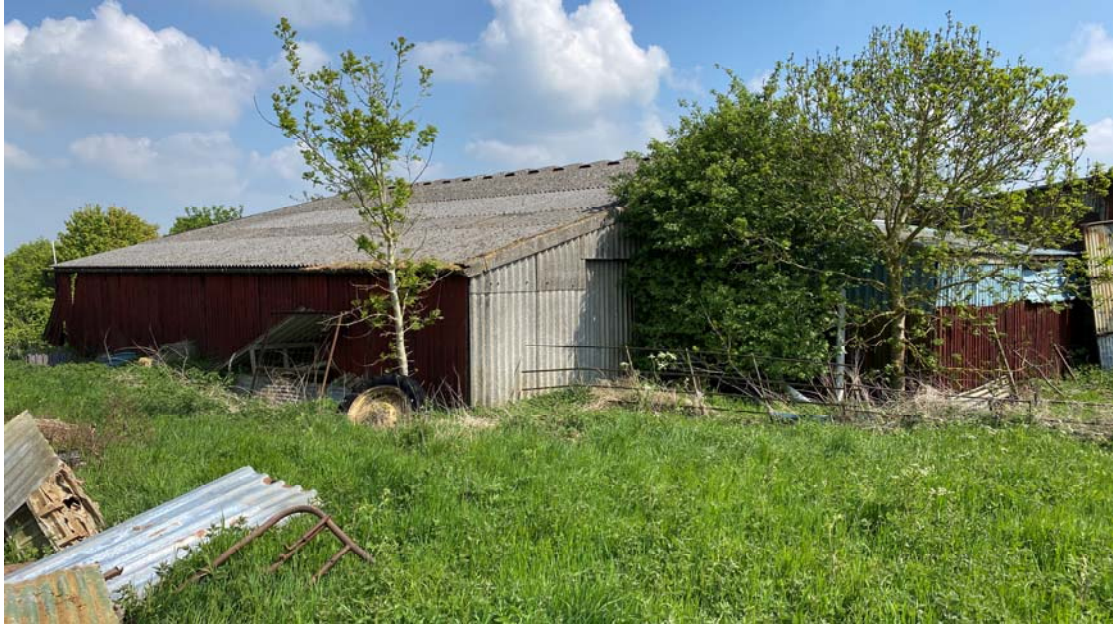
There were some loose corrugated sheet near to the Eastern end of the Northern elevation of the building.

All sides had cladding, there were some panels missing to the Eastern end of the Southern Elevation.

North and Eastern Elevations

The building was found to be in a serviceable condition with only some minor repairs required. Including refixing of some local areas of sheeting.

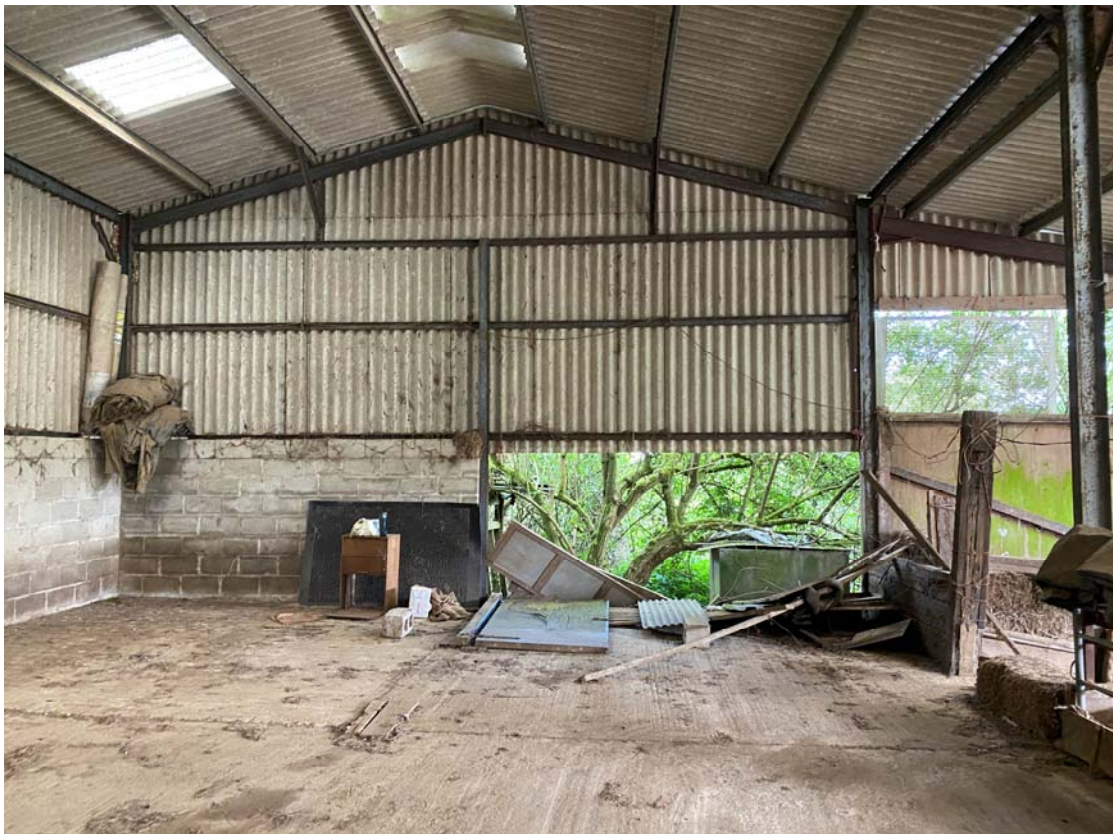
Southern Gable internally

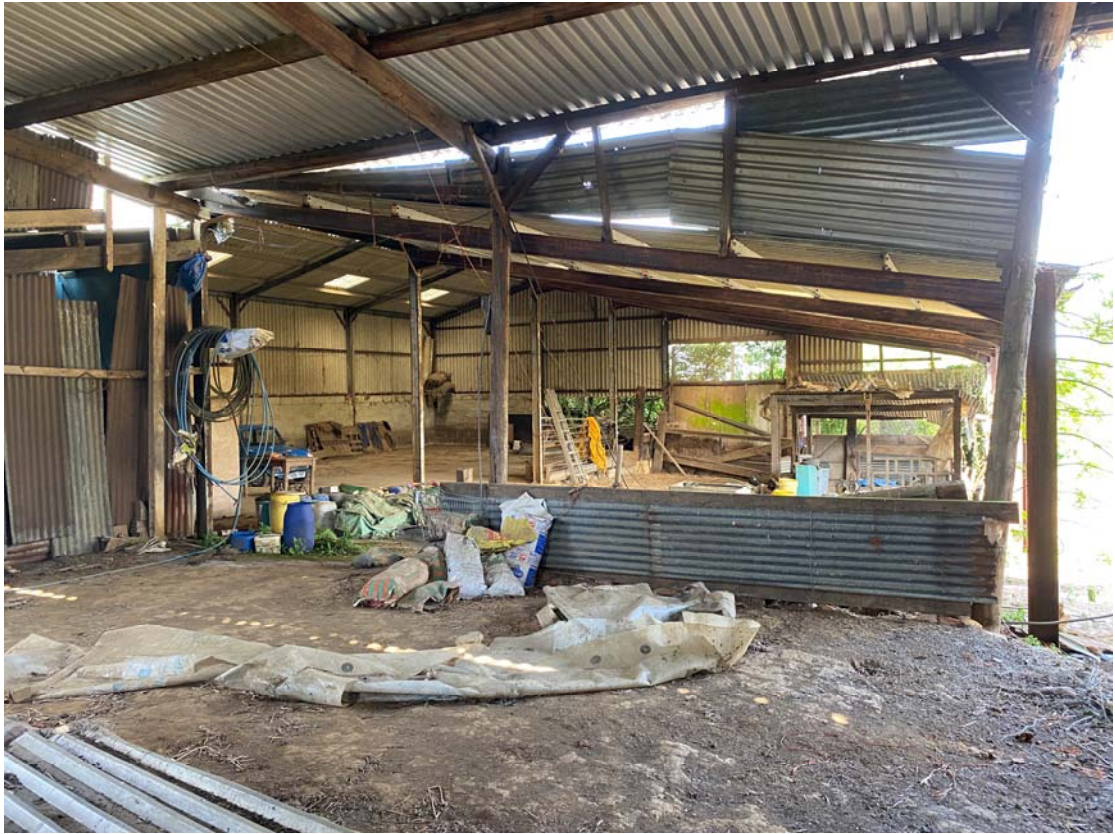
View from Pole barn

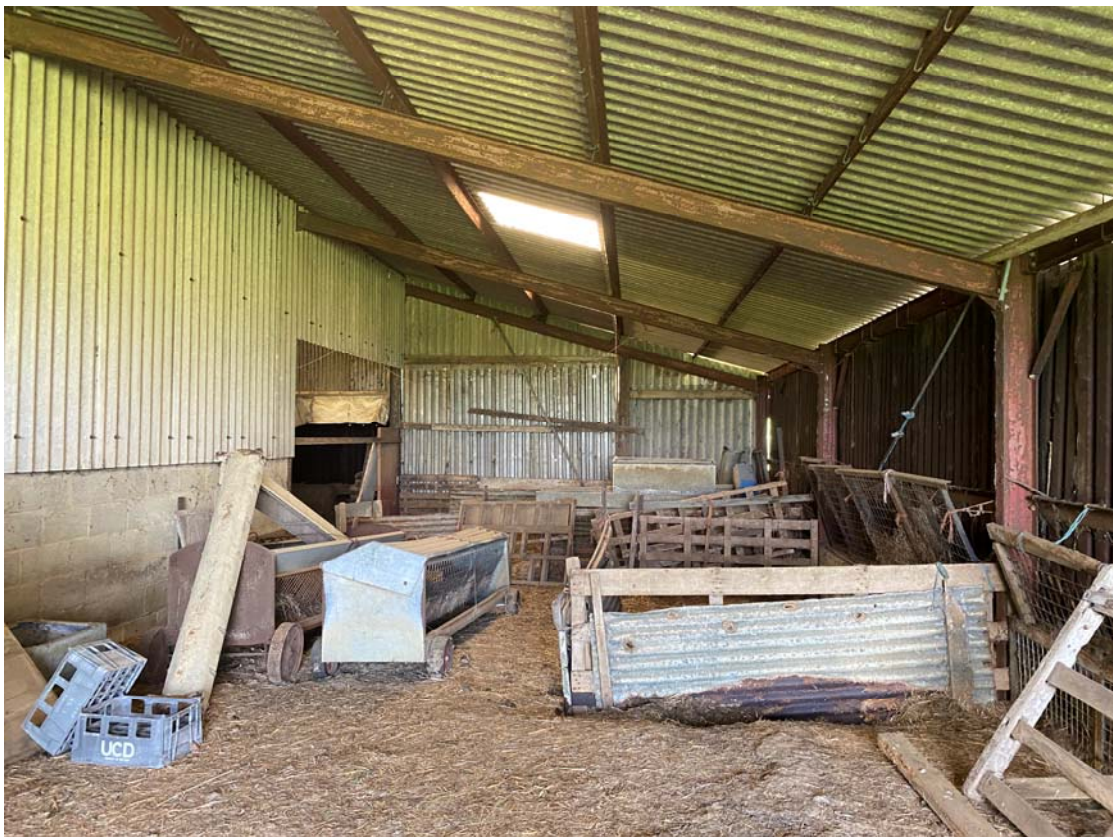
Eastern lean to.

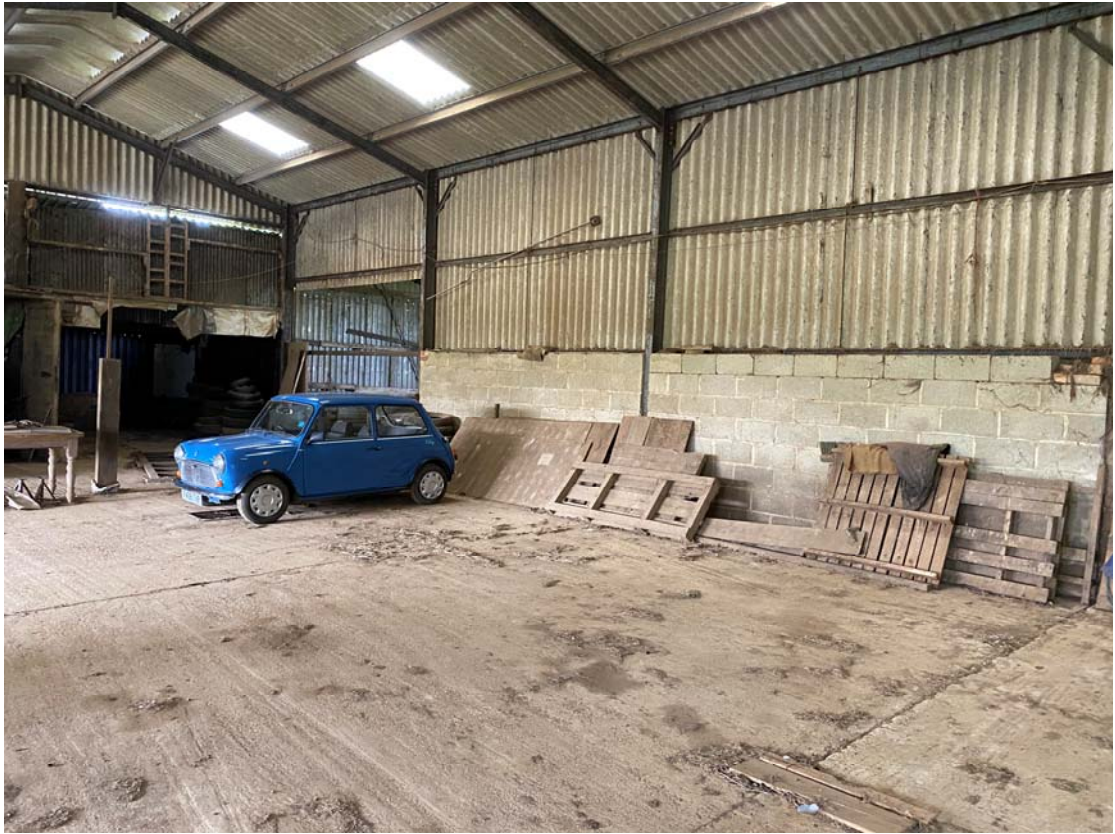
The steel frame appeared to be in good condition with light corrosion only. This took the form of some surface rust and most of the original paint was intact.

Main portal looing North to pole barn and Eastern lean to

We recommend that the steel framework is redecorated to prevent any further corrosion. At present the corrosion is minor and slight, with no structral repairs required. We recommend that the exisitng rust is removed by abrasive means, and the steelwork is decorated with appropriate paint system.
