Our ref: R9675/rs

Date: 30 September 2019

**Buildings for conversion – Mawles Farm, Sibford Gower.**

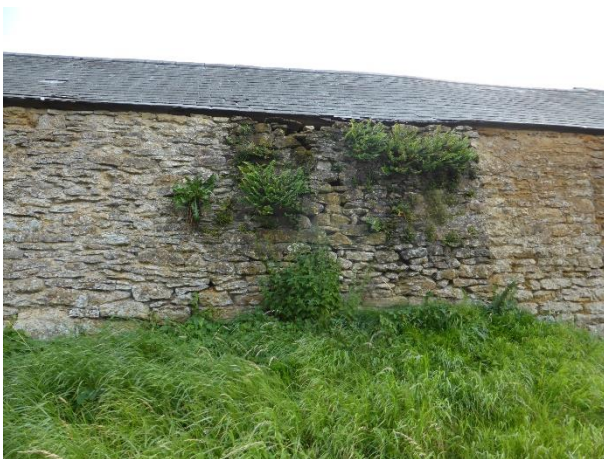
Vegetation

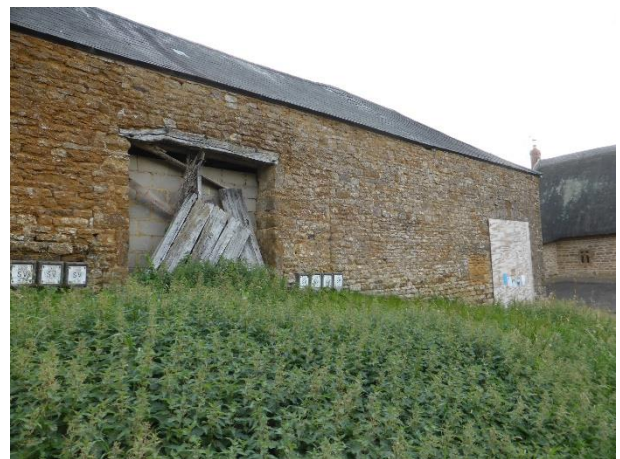
Blocked up opening
