HIGHWAY CONDITION SURVEY, CAMP ROAD

20/02730//DISC-Heyford Park

Heyford Park, Camp Road, Upper Heyford, Bicester

Dorchester Living Limited

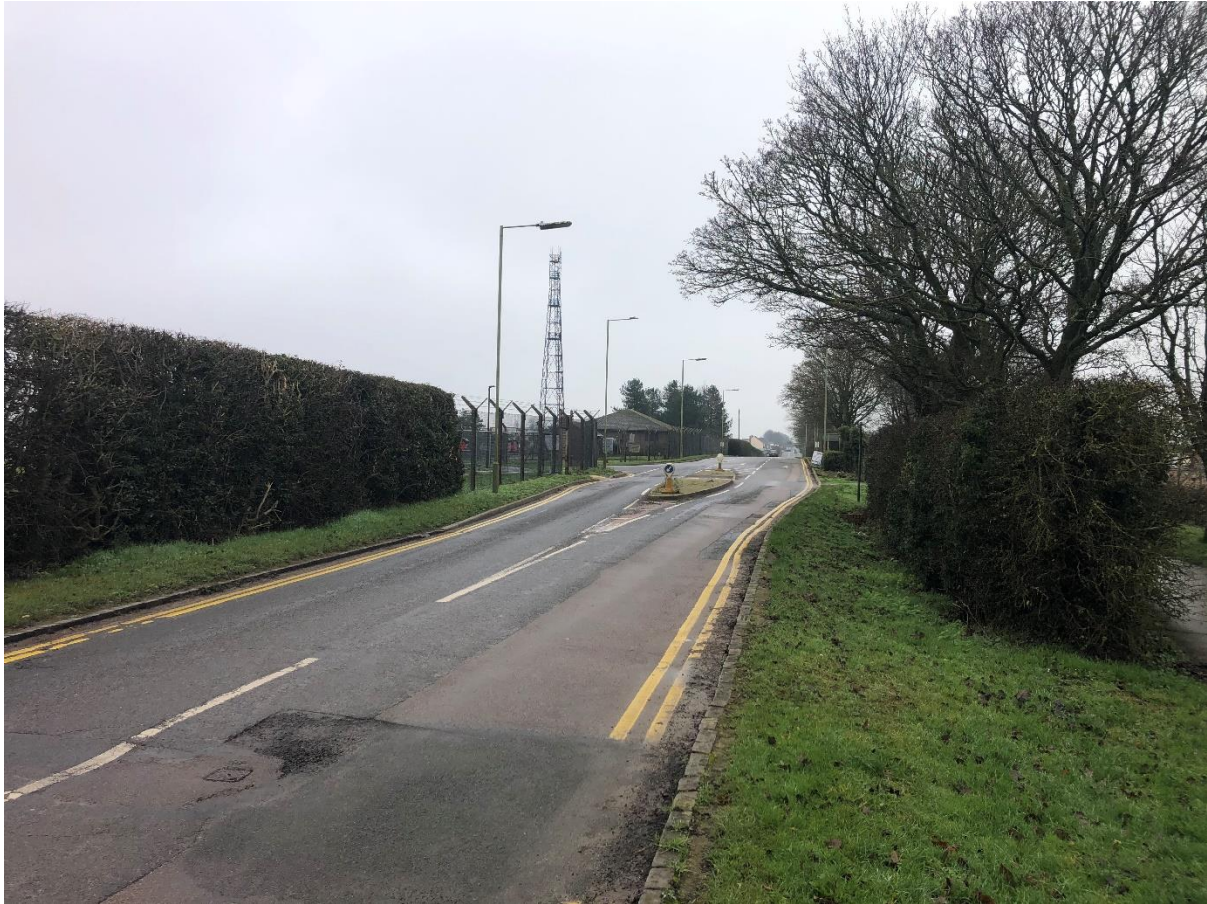
Photo 1

- Cobble kerbs are not straight and are starting to become dislodged
- Recent patching has been completed over existing double yellow lines
- Channels filled with silt and debris which indicates poor surface water drainage
- Clear cracking/delamination of existing surface course in places
- Clear settlement of road indicated where the road dips around the small valve chamber
- Whitelining is starting to fade
- Obvious signs of patching

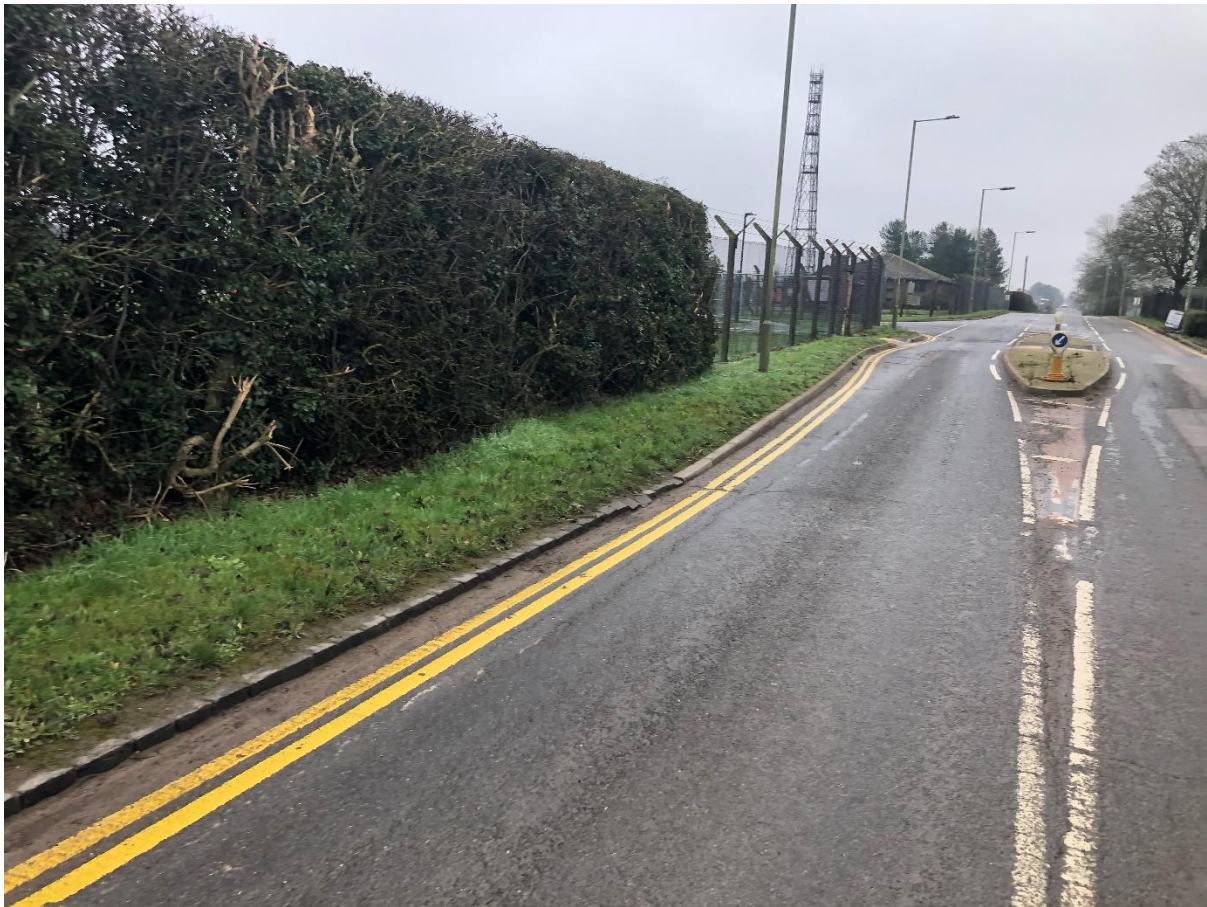
Photo 2

- Whitelining starting to fade
- Clear signs of cracking to existing surface course

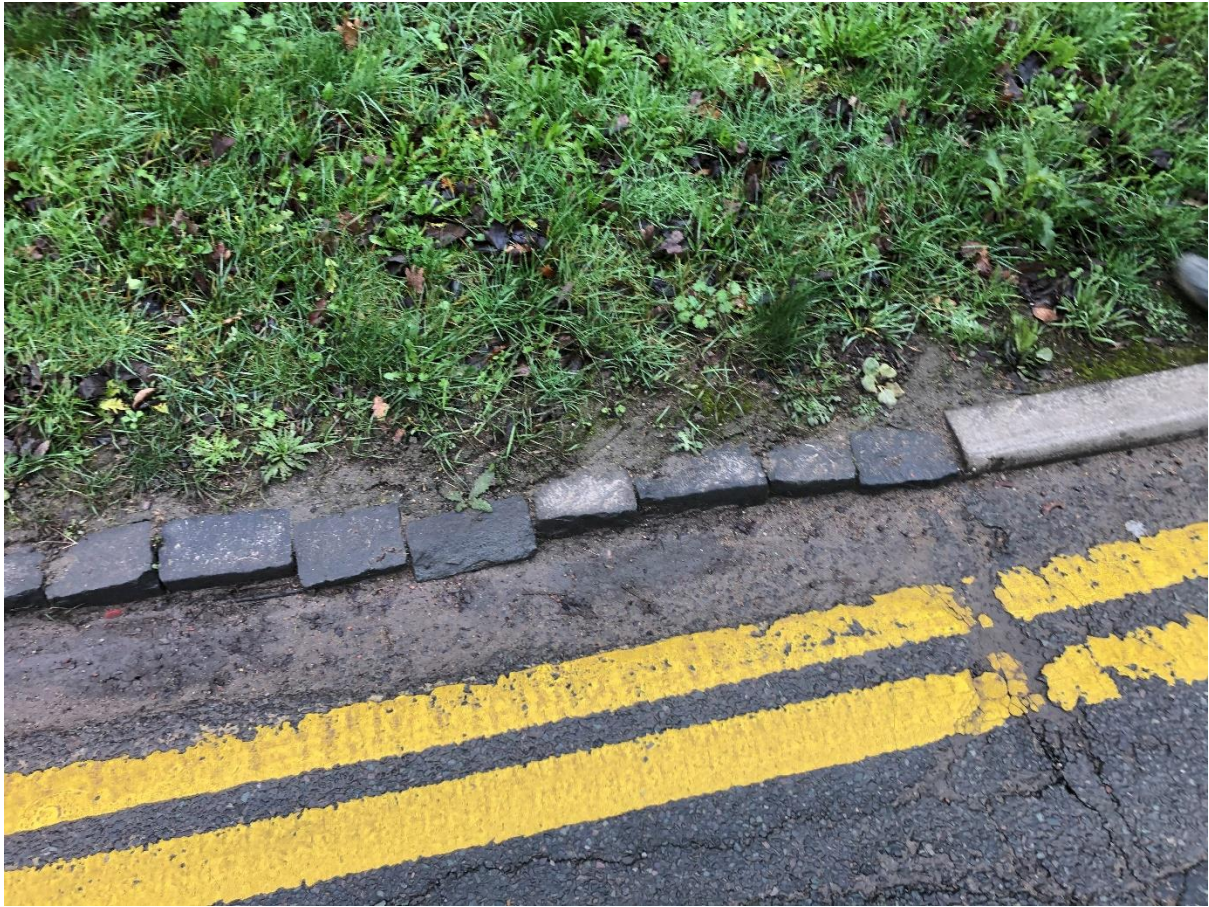
Photo 2a

- Cobbled kerb sets have sunk and are failing
- Surface course cracked

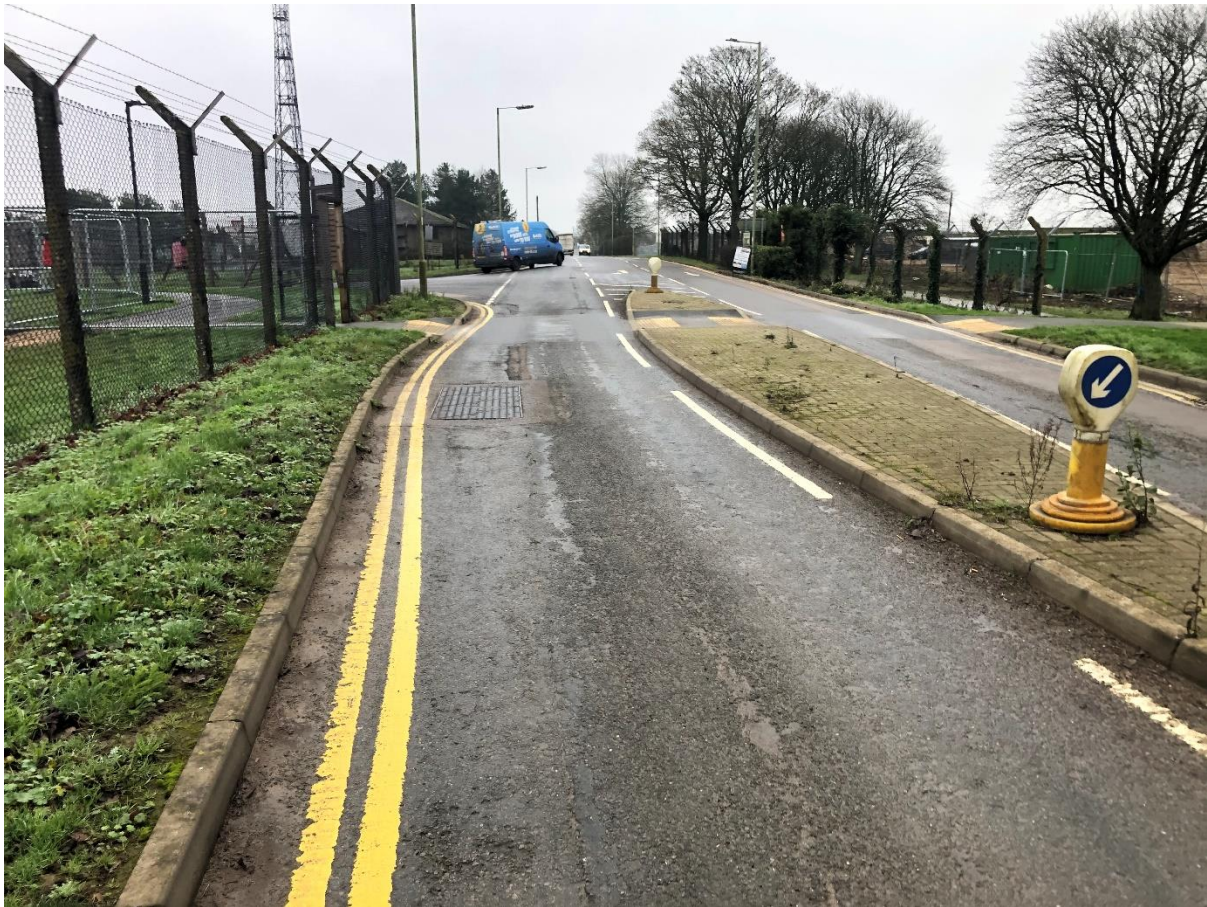
Photo 3

- Surface course is cracking and starting to delaminate in places
- Obvious signs of wear and defects
- Sediment build up in channels

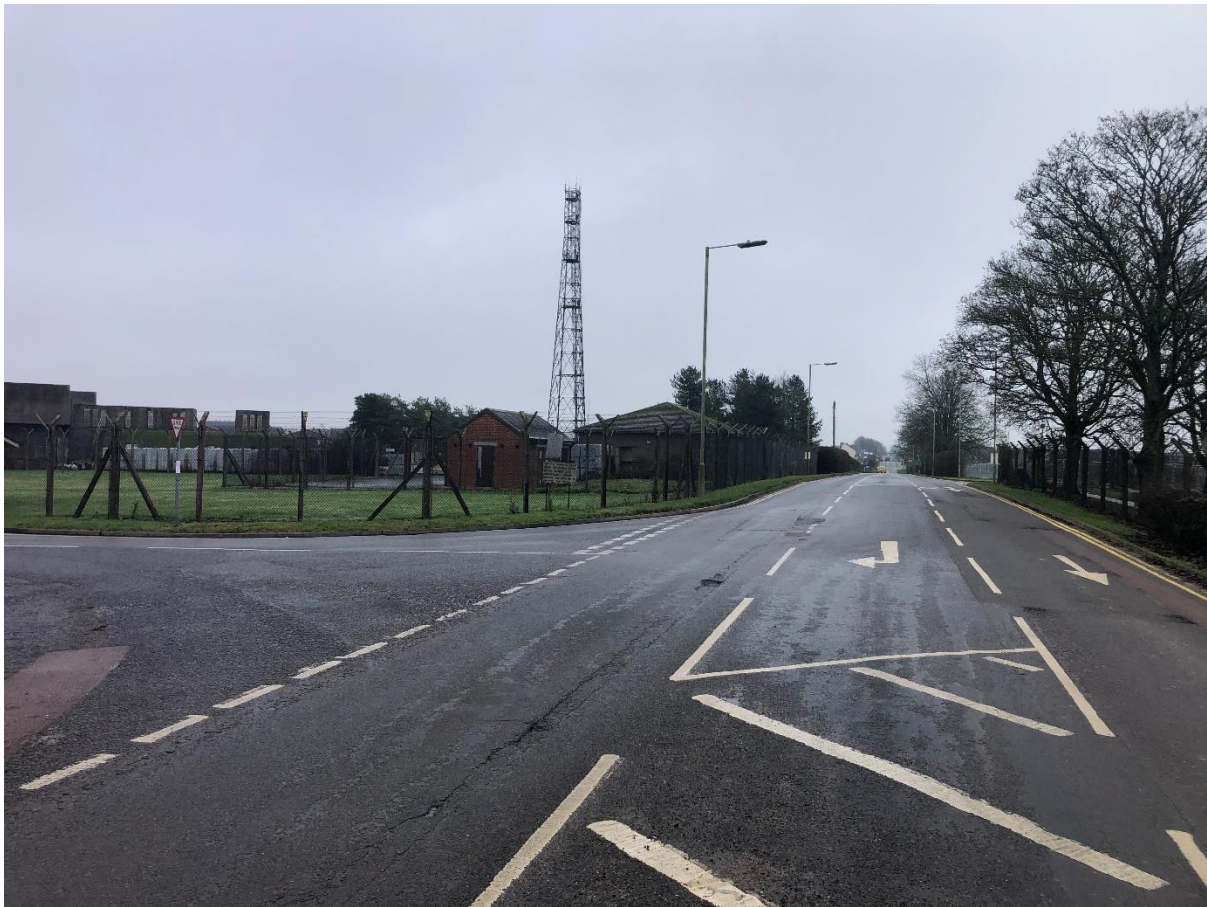
Photo 4

- Surface course is cracking and starting to delaminate in places
- Potholes across the highway - water could enter the binder course and cause further damage
- Obvious signs of wear and defects
- Surface course in poor condition

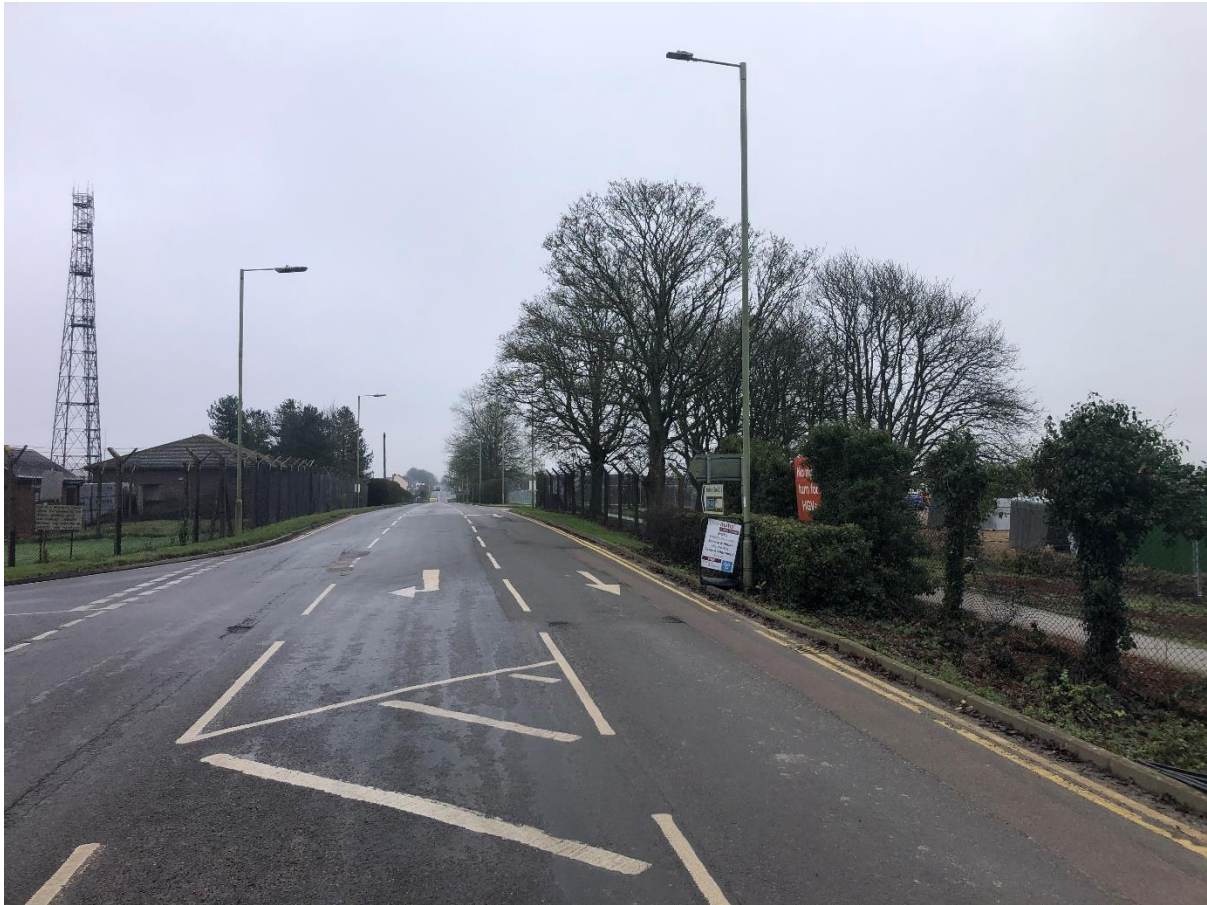
Photo 5

- Surface course is cracking and starting to delaminate in places
- Potholes across the highway - water could enter the binder course and cause further damage
- Surface course in poor condition
- Signs of patching

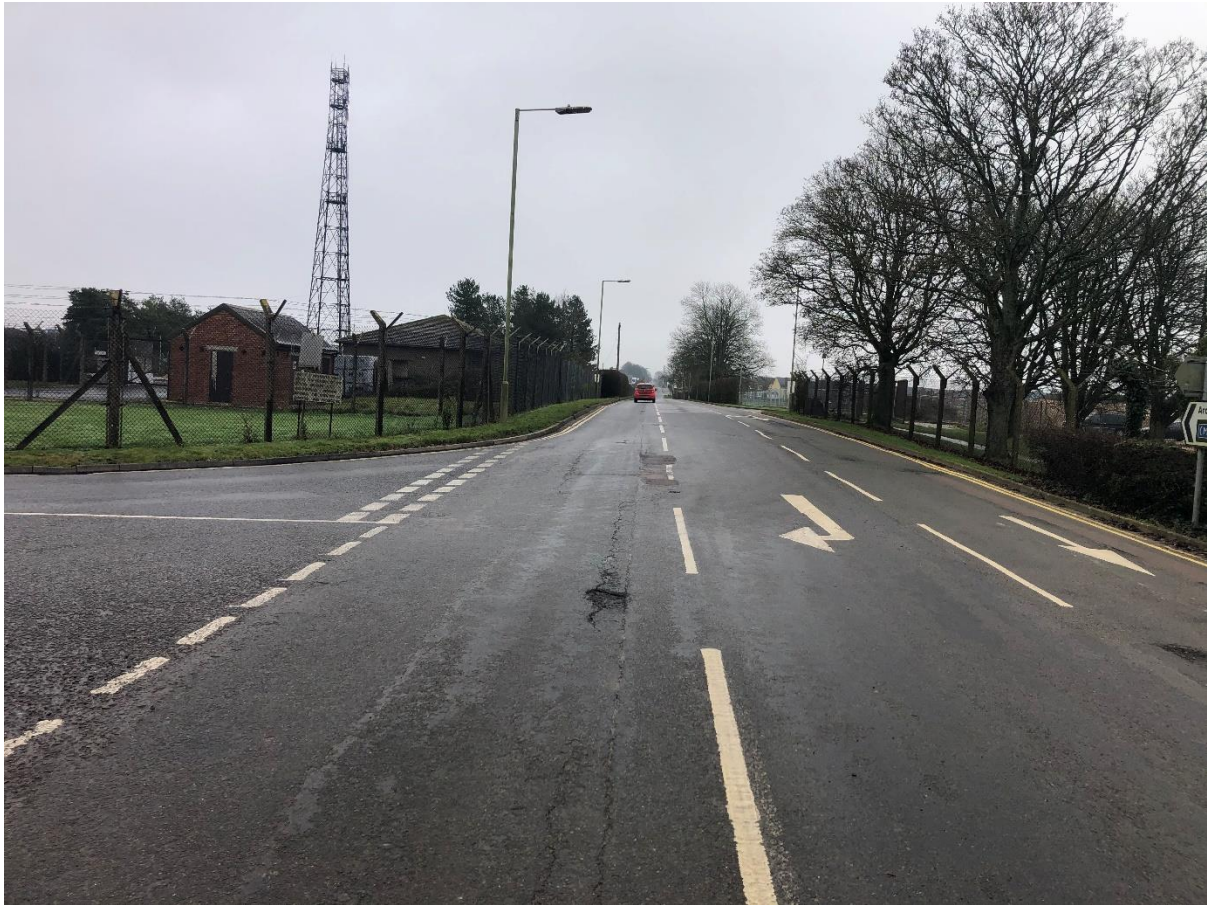
Photo 6

- Surface course is cracking and starting to delaminate in places
- Potholes across the highway - water could enter the binder course and cause further damage
- Obvious signs of wear and defects
- Surface course in poor condition

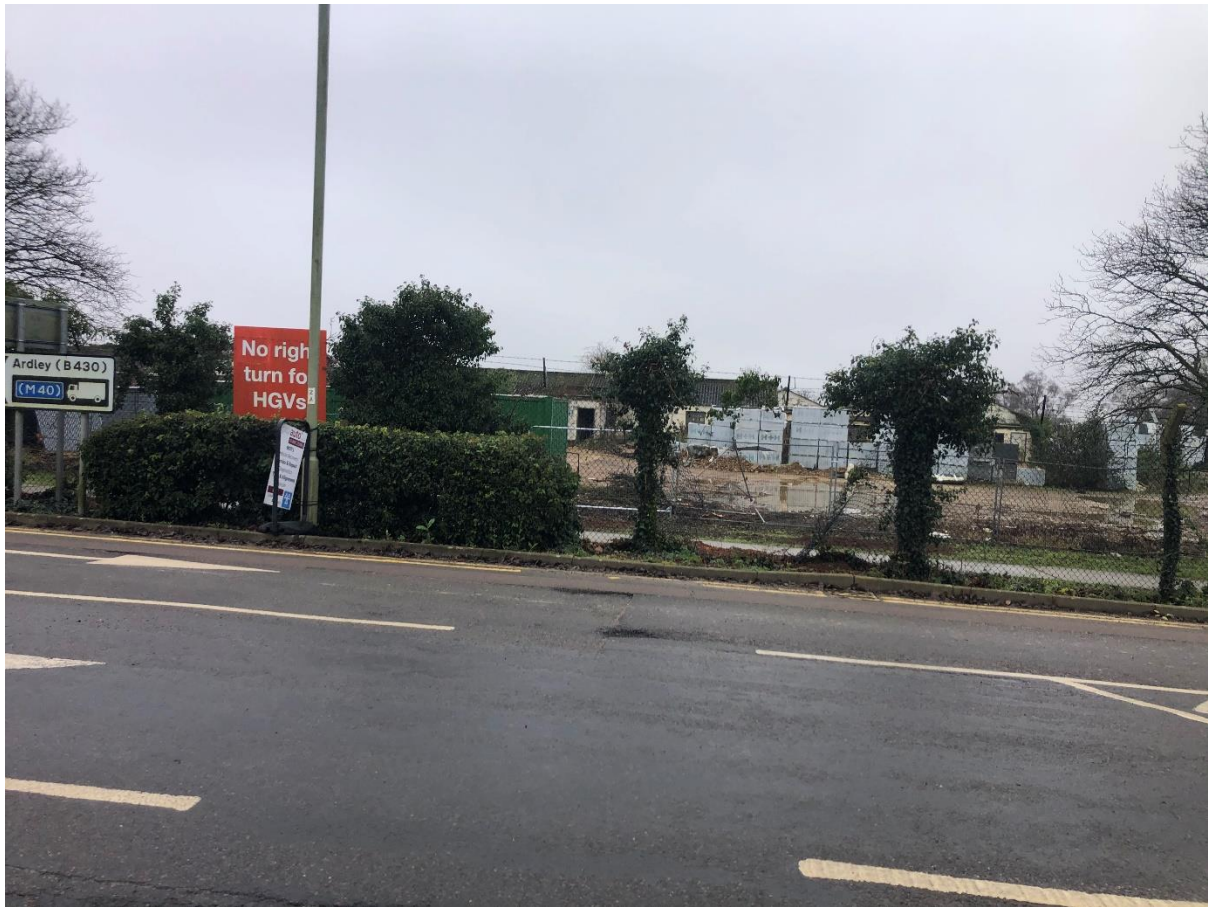
Photo 7

- Potholes across the highway - water could enter the binder course and cause further damage
- Obvious signs of wear and defects
- Surface course in poor condition

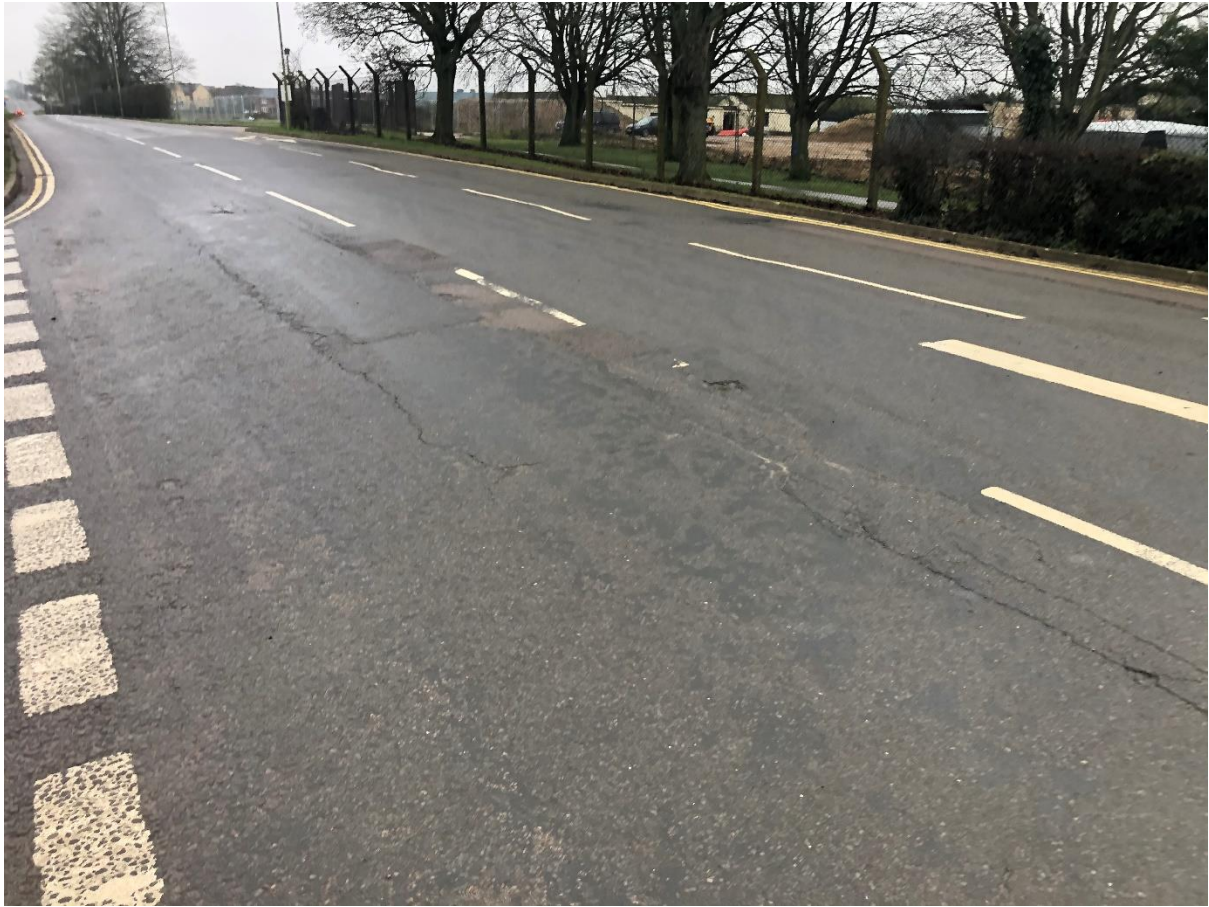
Photo 8

- Surface course is cracking and starting to delaminate in places
- Obvious signs of wear and defects
- Surface course in poor condition
- Signs of settlement

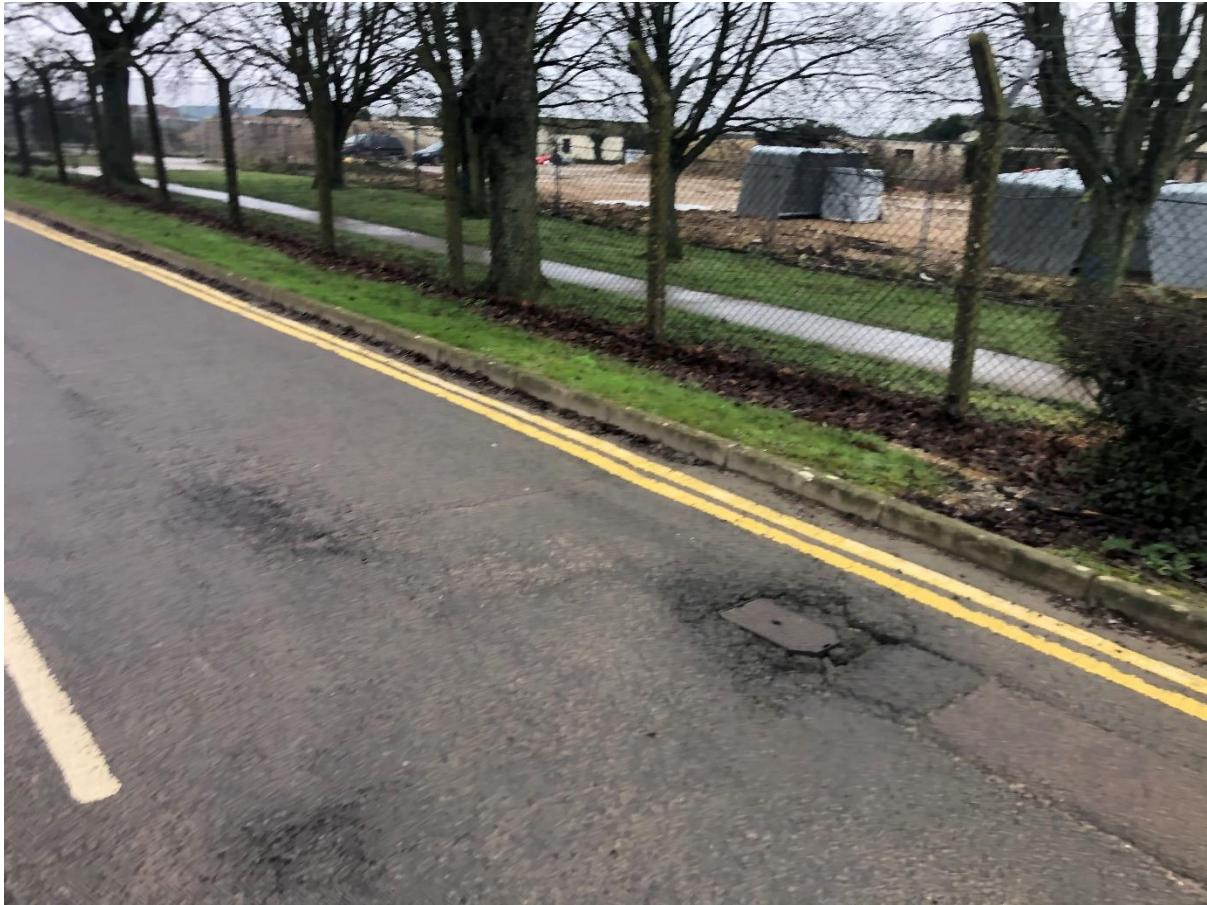
Photo 9

- Surface course is cracking and starting to delaminate in places
- Large defect/pothole around valve chamber
- Obvious signs of wear and defects
- Surface course in poor condition

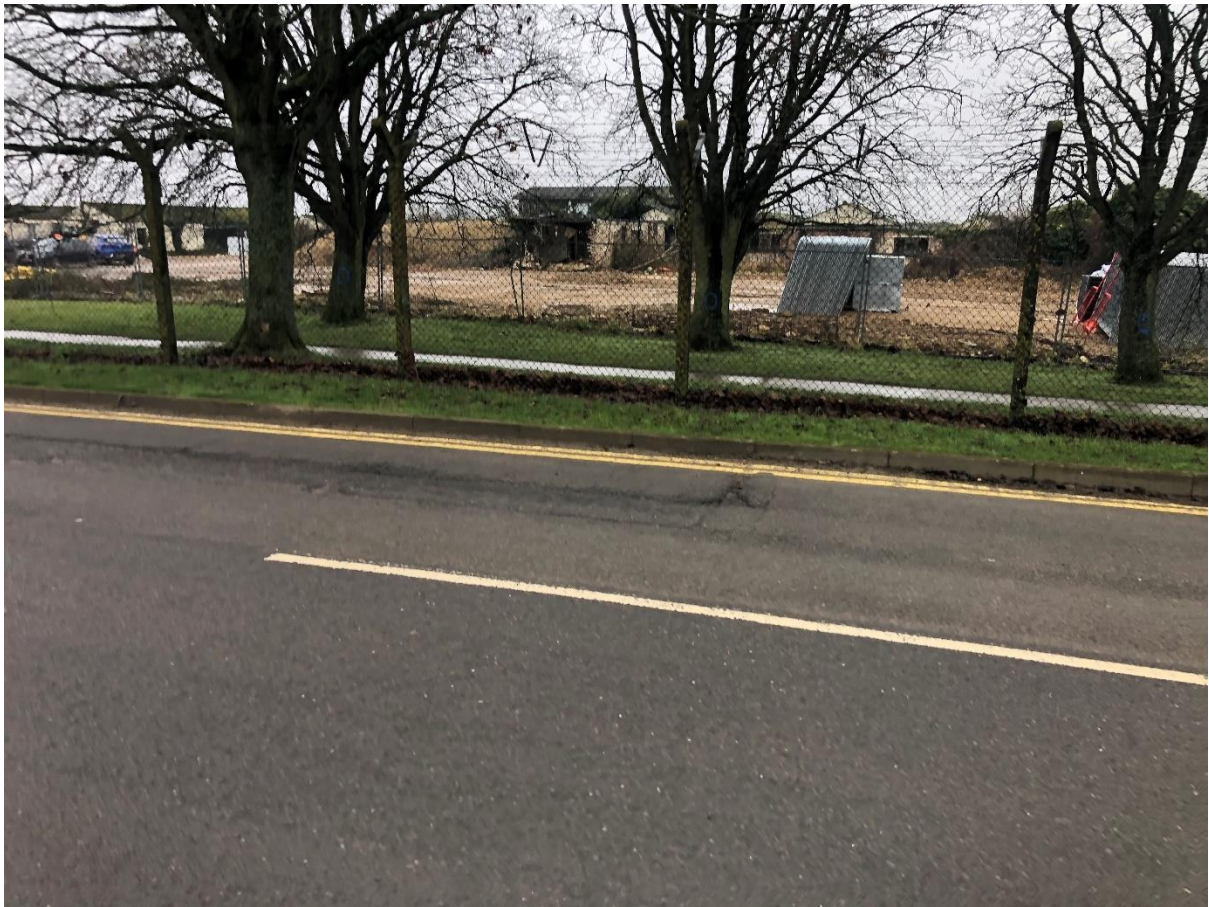
Photo 10

- Surface course is cracking/showing signs of settlement

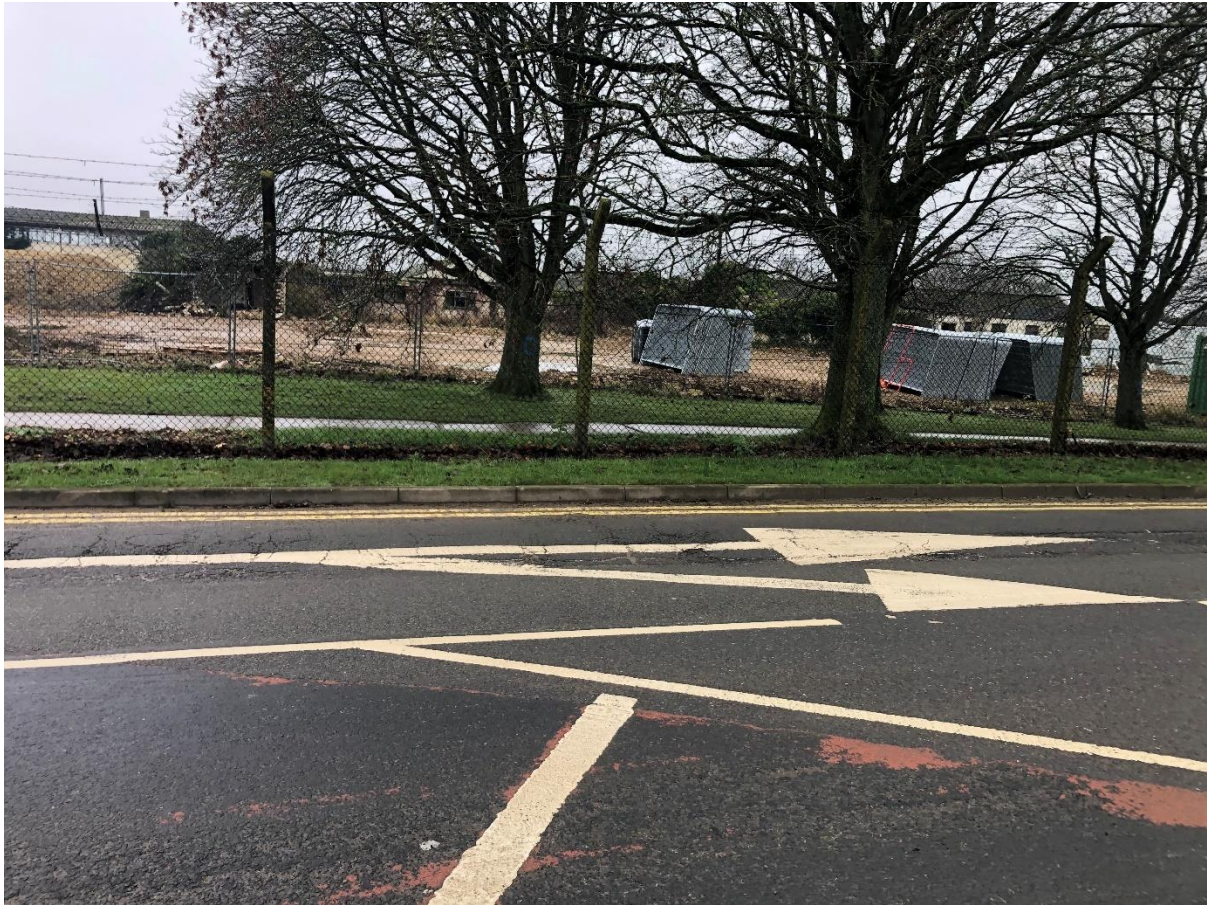
Photo 11

- Surface course is cracking/showing signs of settlement
- Surface course is heavily worn in large patches

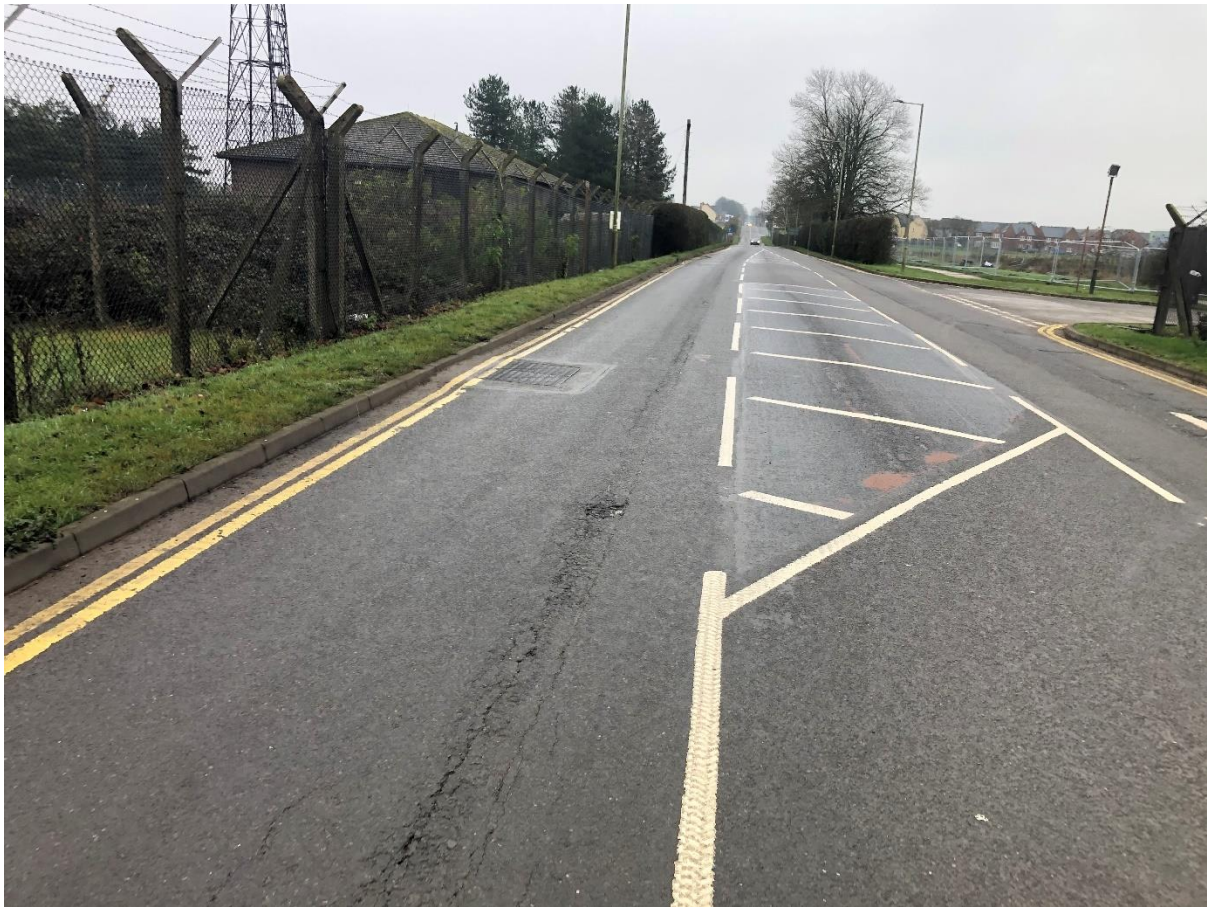
Photo 12

- Obvious signs of cracking
- Surface course in poor condition
- Patching around manhole
- Surface course is heavily worn

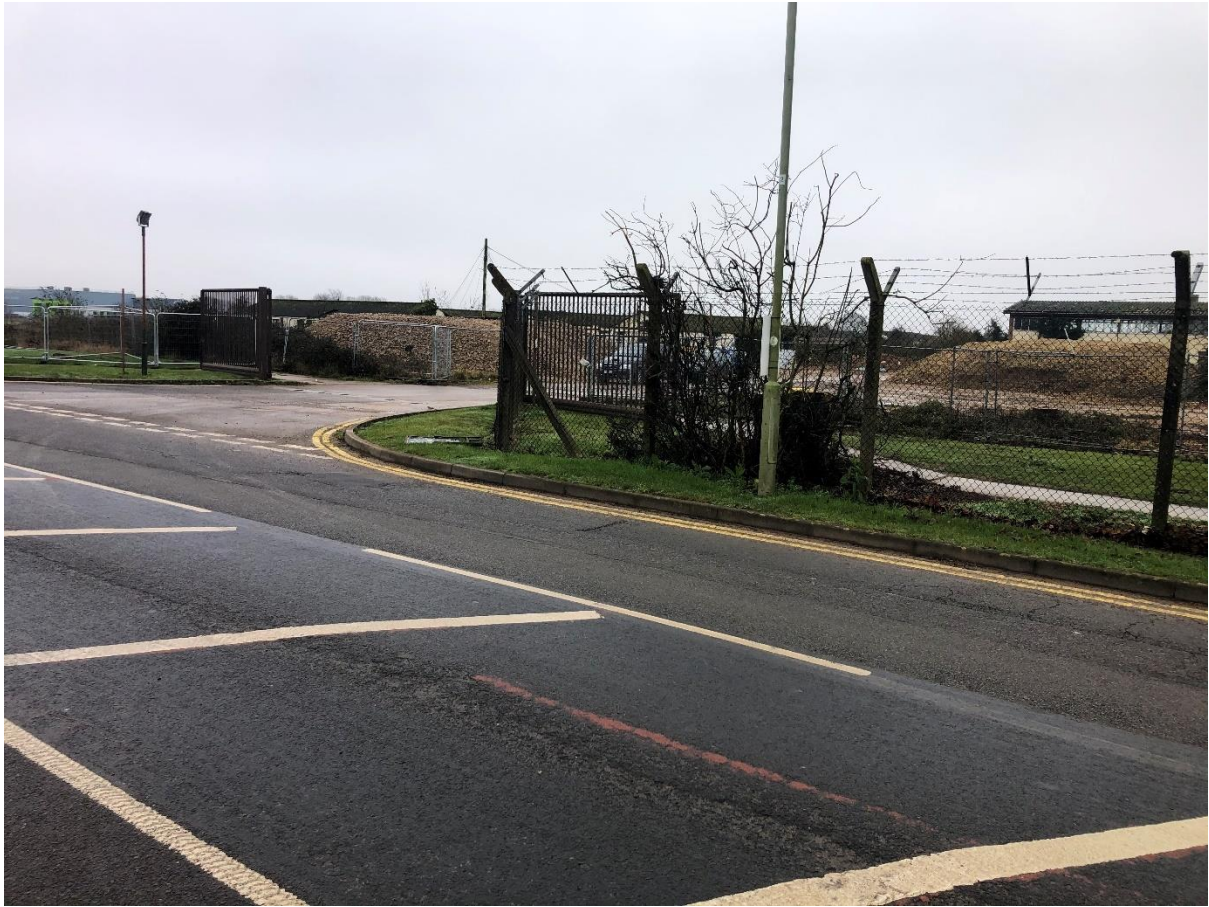
Photo 13

- Obvious signs of cracking
- Surface course in poor condition

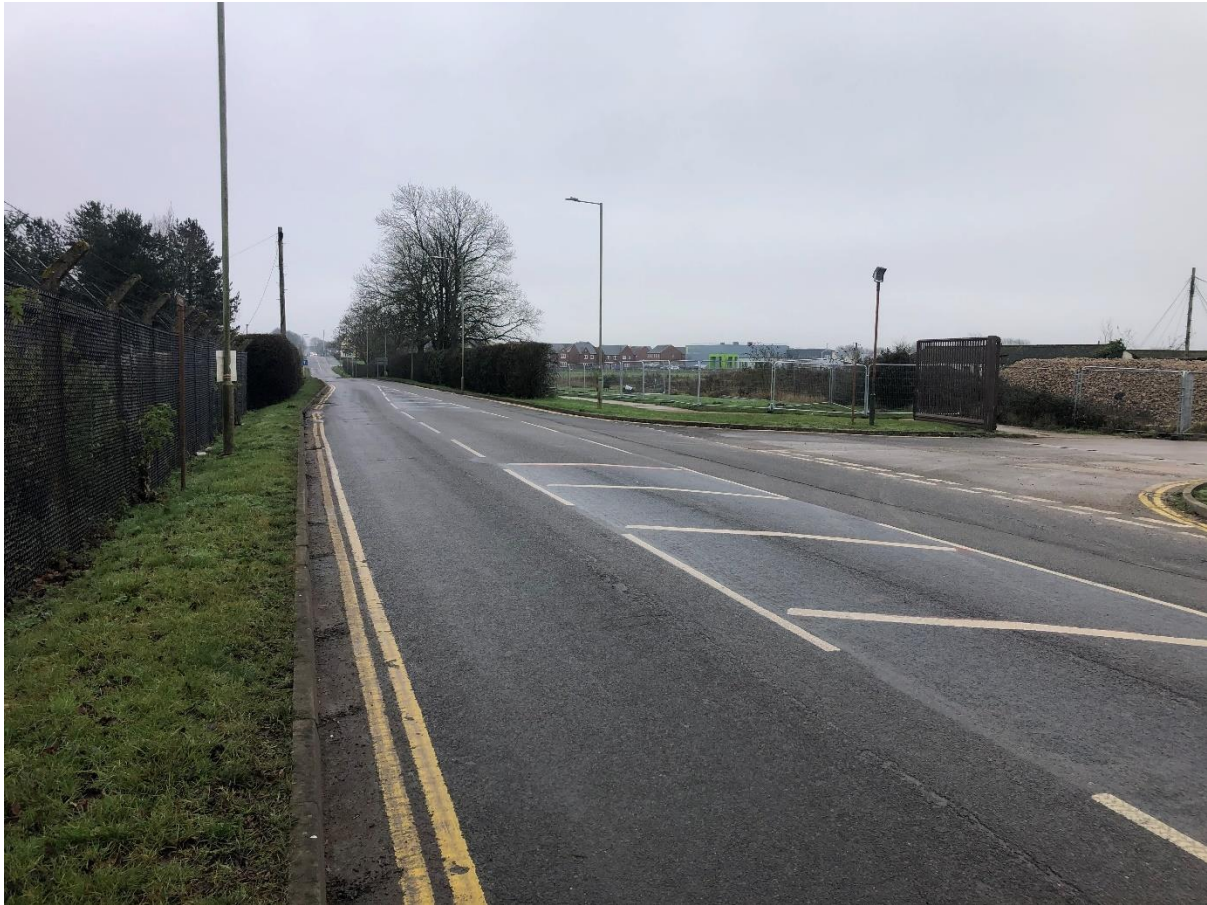
Photo 14

- Obvious signs of wear and defects
- Surface course in poor condition
- Signs of settlement
- The central road joint is worn

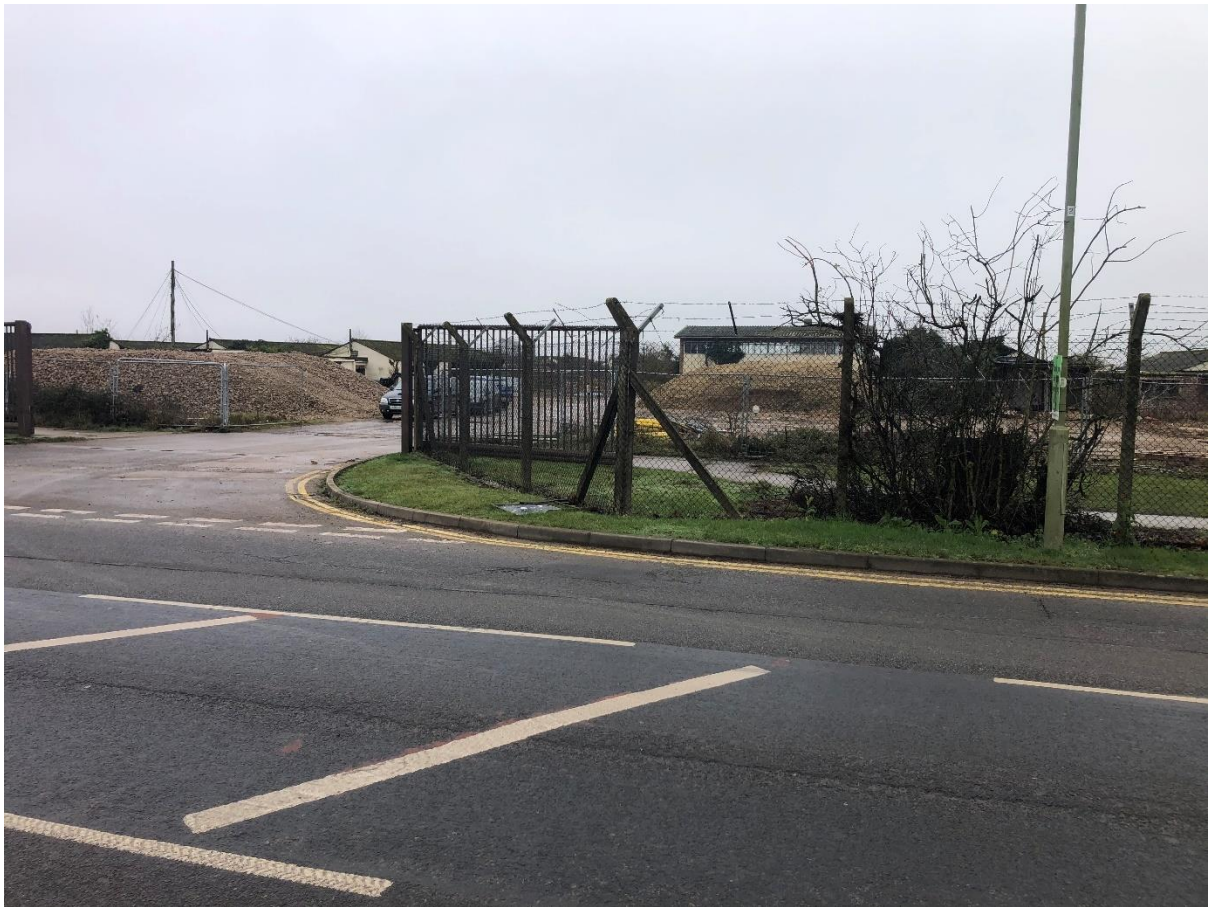
Photo 15

- Surface course is cracking/showing signs of settlement

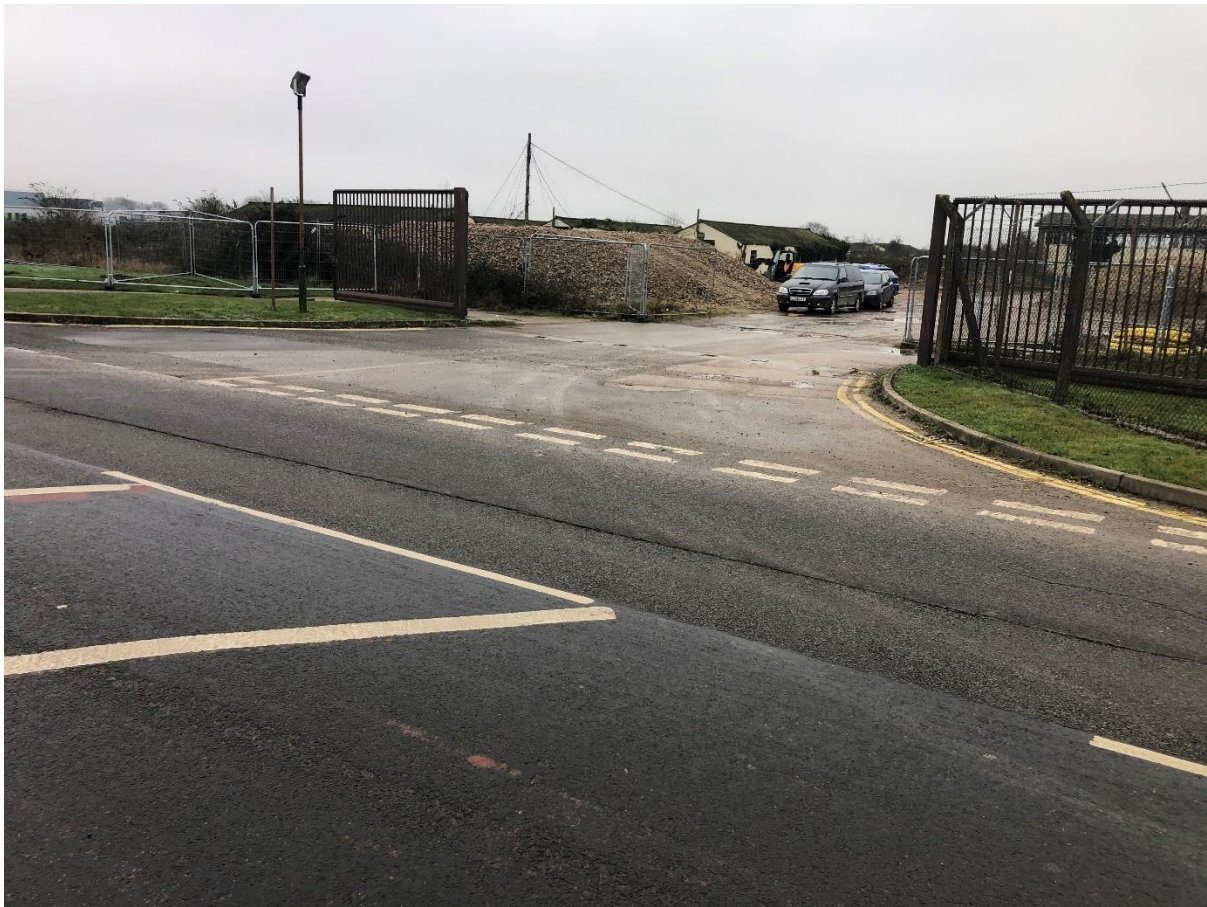
Photo 16

- Surface course is cracking/showing signs of settlement
- Signs of an existing joint/patch starting to fail

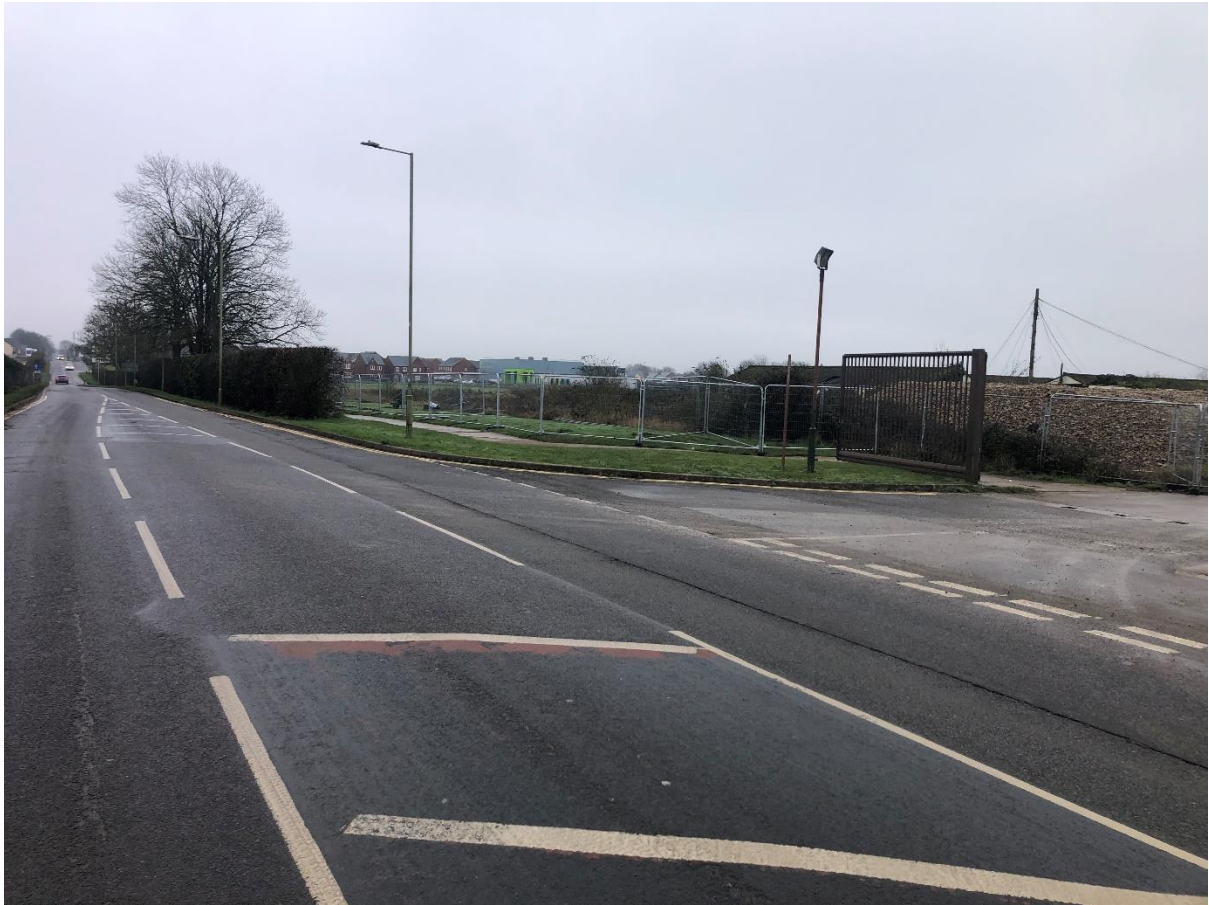
Photo 17

- Surface course is cracking/showing signs of settlement
- Signs of an existing joint starting to fail

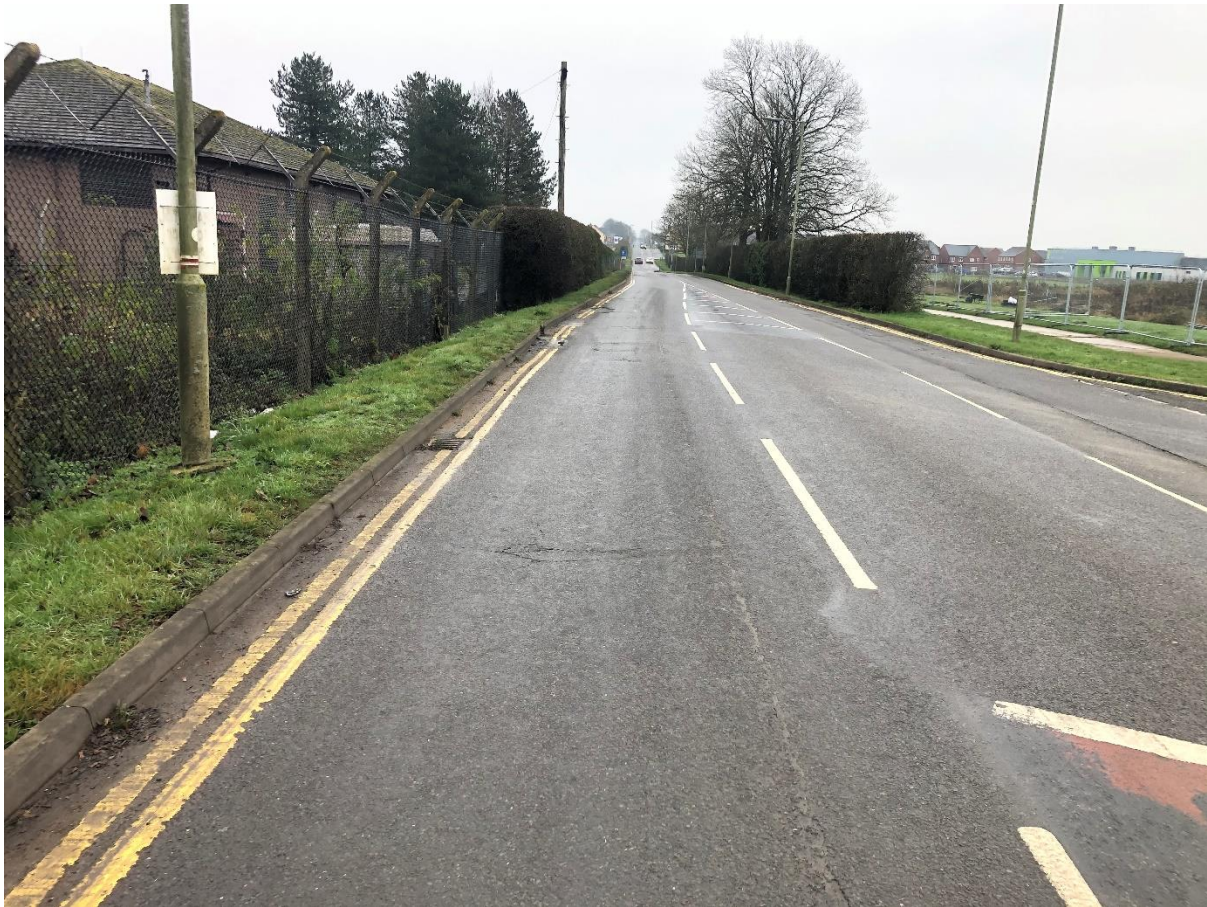
Photo 18

- Surface course is cracking/showing signs of settlement
- Signs of an existing joint starting to fail

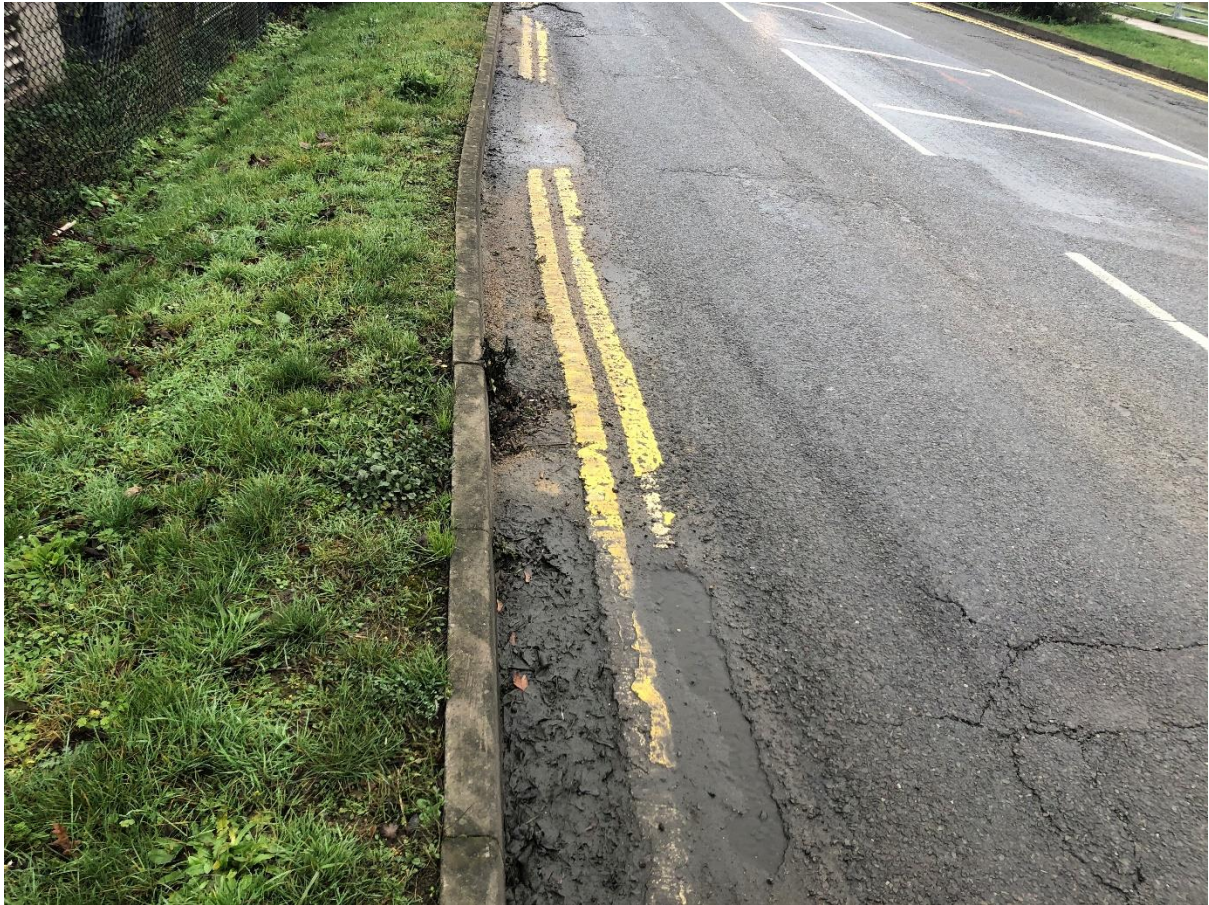
Photo 18a

- Surface course starting to delaminate and hold water
- Large build-up of silt/sediment
- Whitelining starting to fade
- Visible cracking
