HIGHWAY CONDITION SURVEY, CAMP ROAD

20/02730//DISC-Heyford Park

Heyford Park, Camp Road, Upper Heyford, Bicester

Dorchester Living Limited

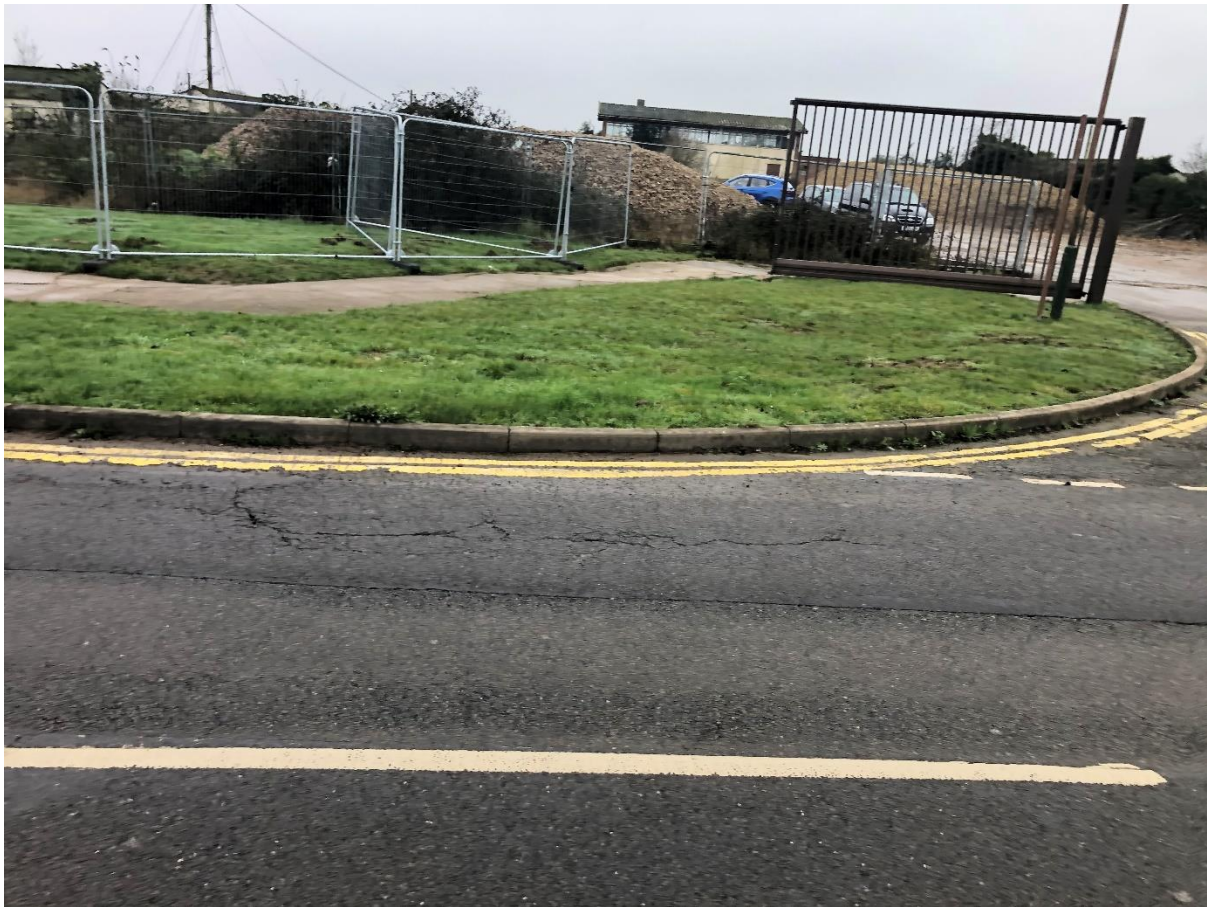
Photo 19

- Surface course is cracking/showing signs of settlement
- Signs of an existing joint starting to fail

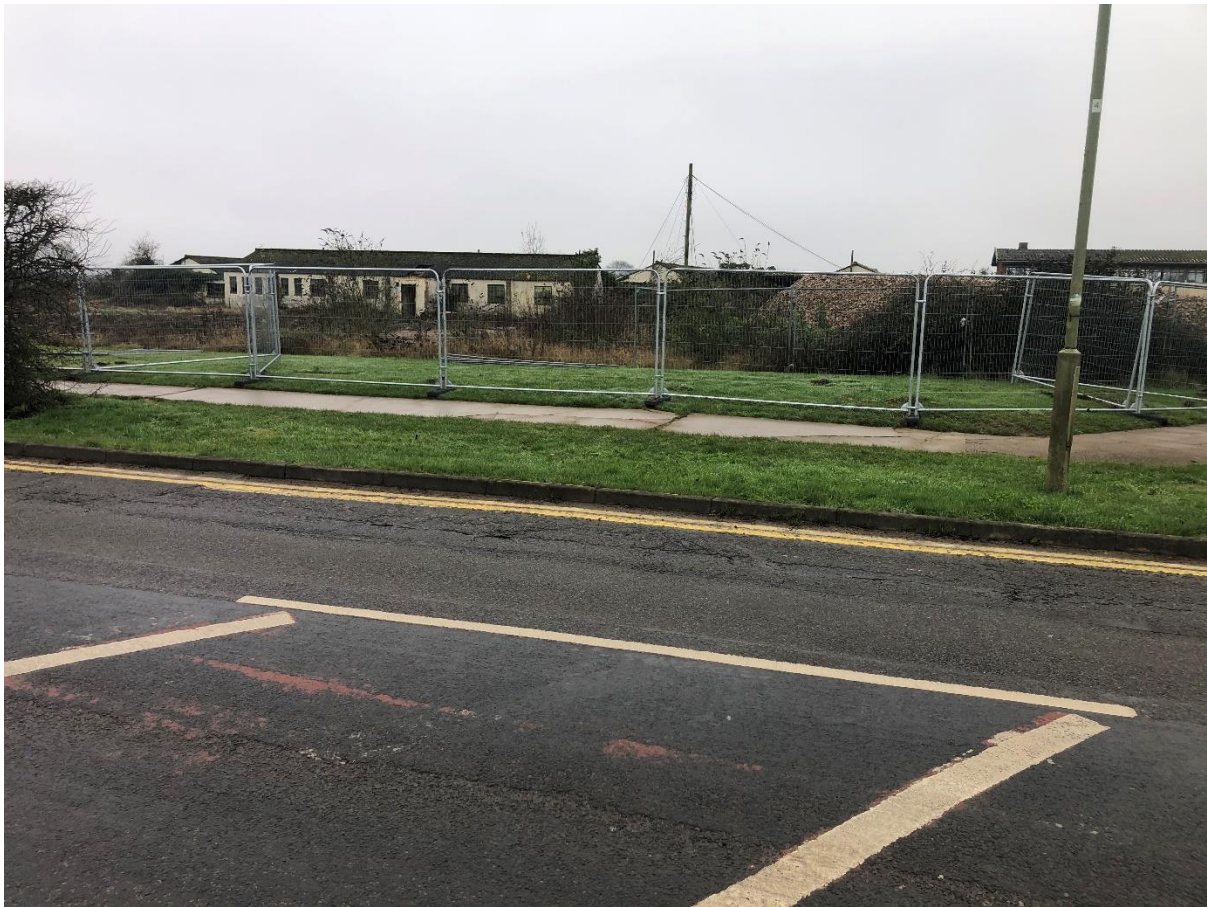
Photo 20

- Surface course is cracking/showing signs of settlement
- Signs of an existing joint starting to fail
- Surface course is heavily worn

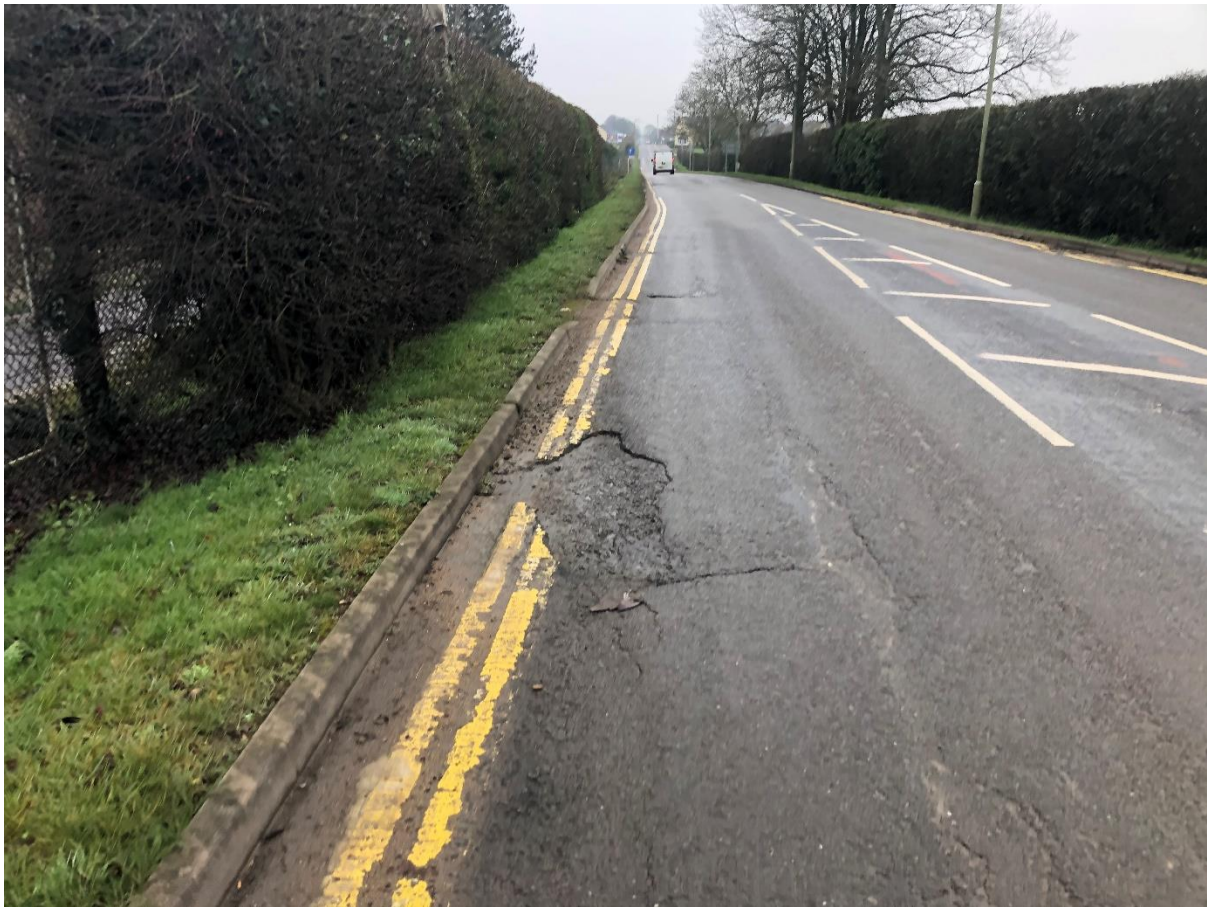
Photo 21

- Surface course starting to delaminate and hold water
- Whitelining starting to fade
- Visible cracking

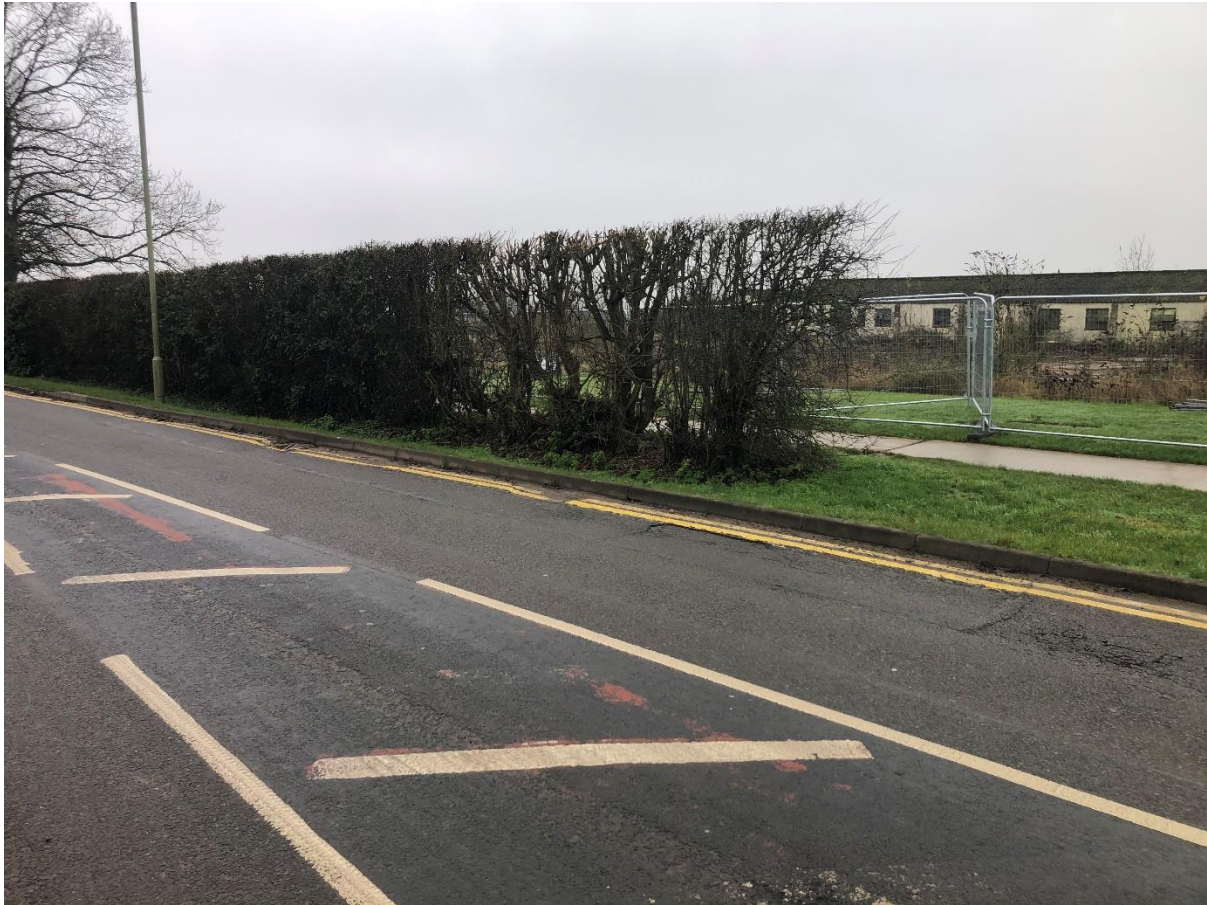
Photo 22

- Surface course starting to delaminate
- Visible cracking and settlement to highway

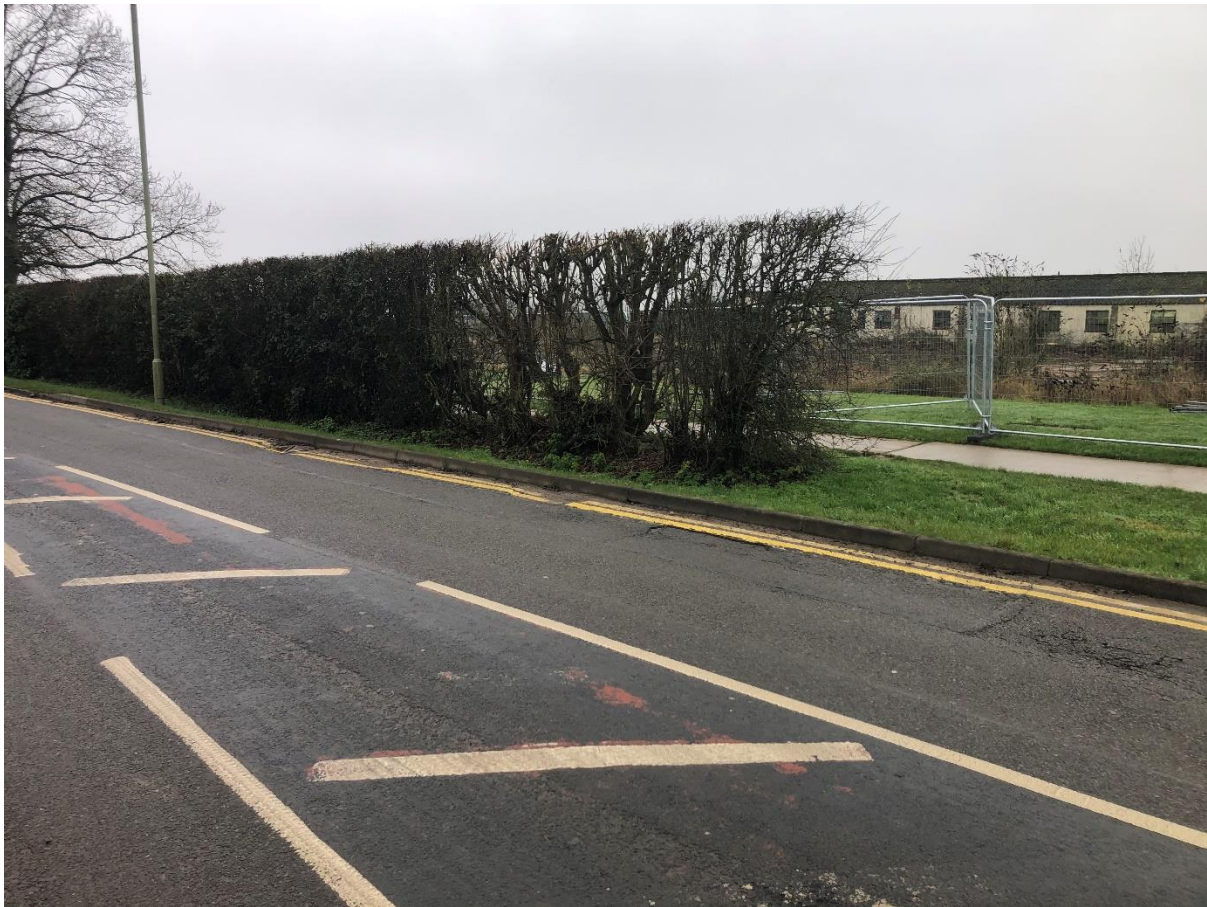
Photo 23

- Surface course starting to delaminate
- Visible cracking and settlement to highway

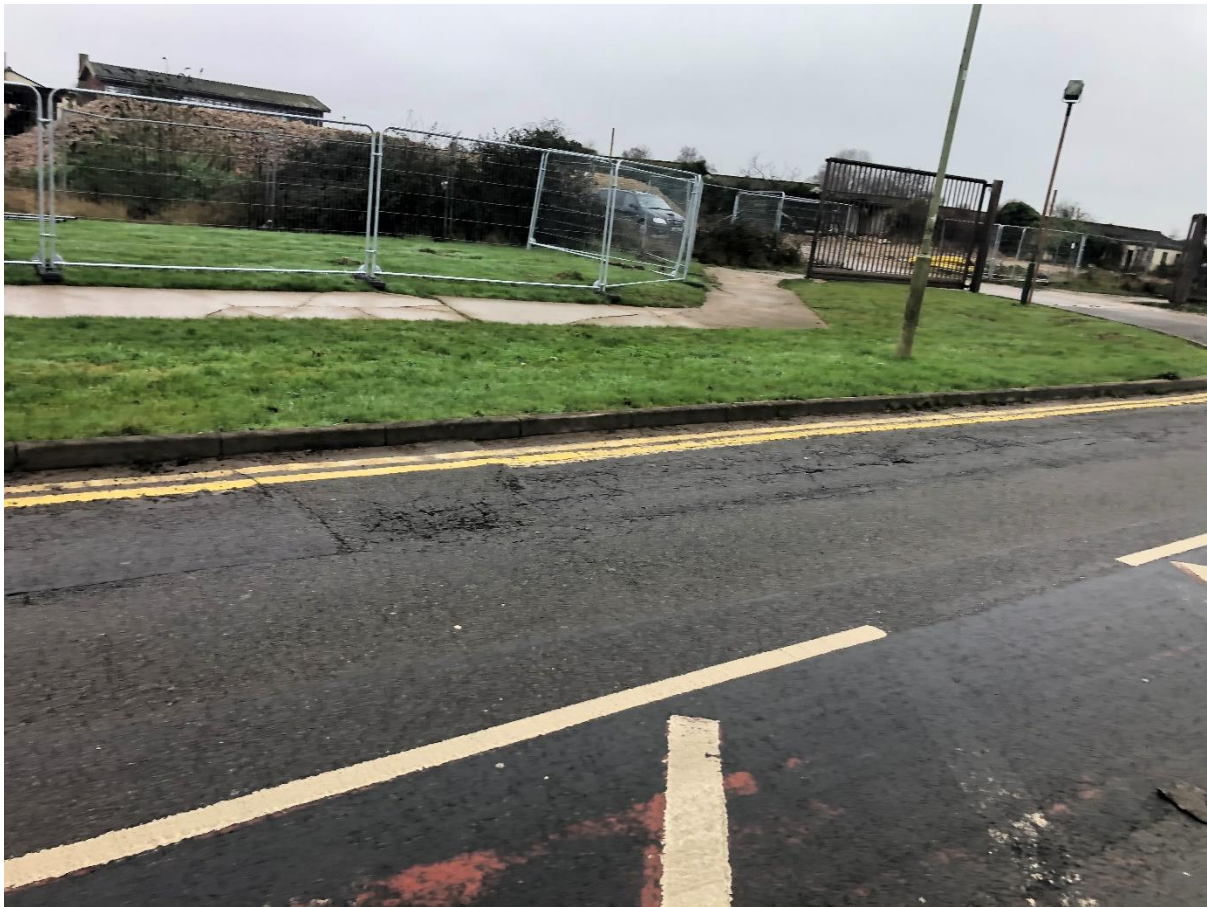
Photo 24

- Surface course starting to delaminate
- Visible cracking and settlement to highway
- Surface course is heavily worn

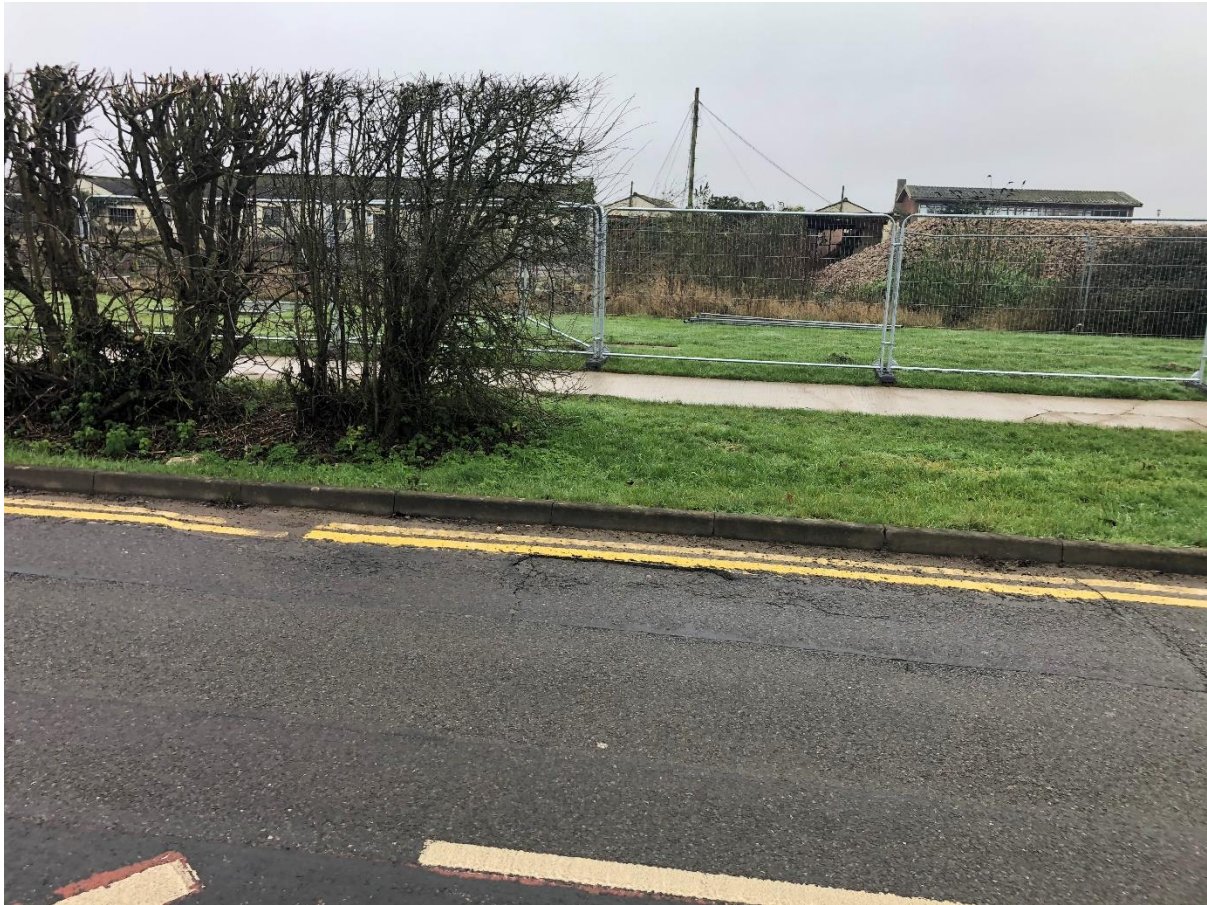
Photo 25

- Surface course starting to delaminate
- Visible cracking and settlement to highway
- Surface course is heavily worn

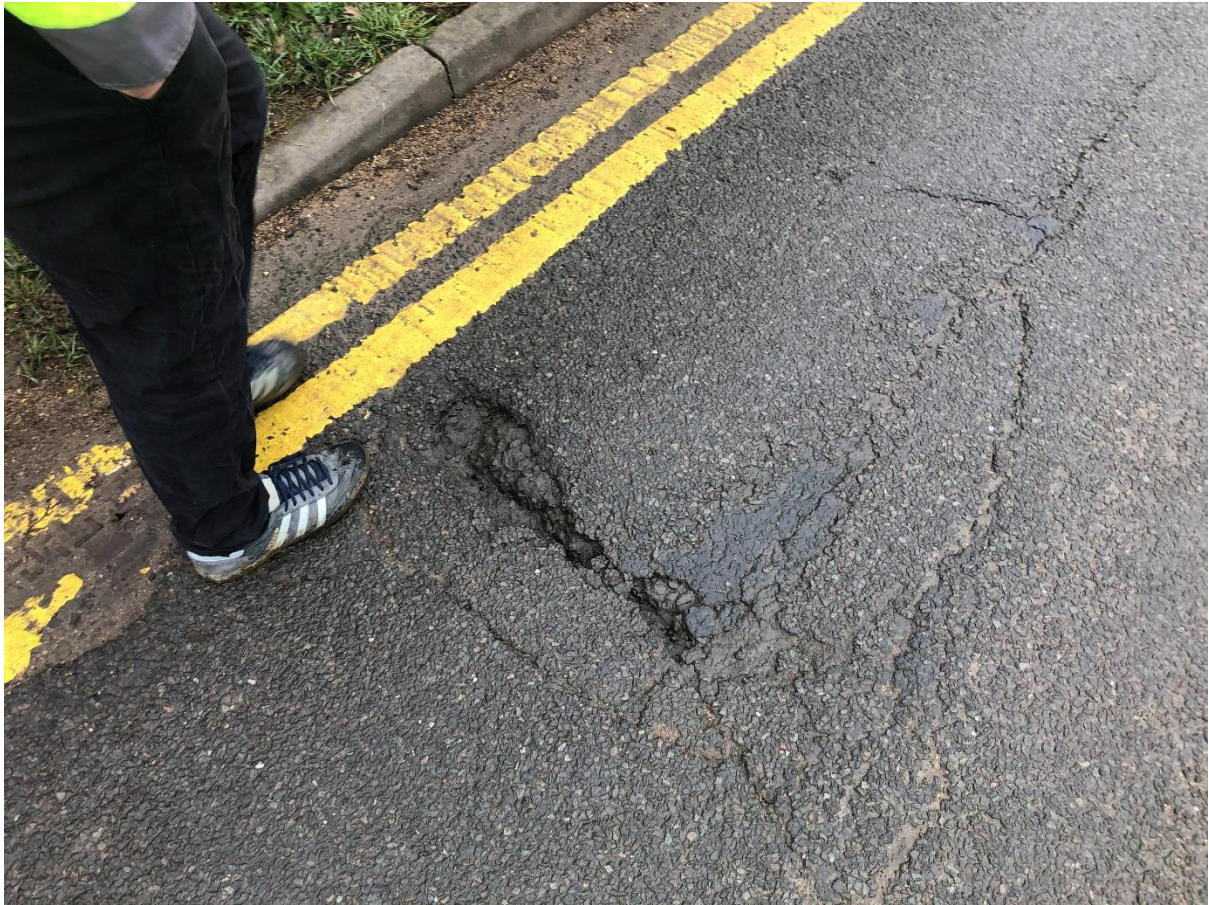
Photo 26

- Deep crack in surface course where water could seep into and cause further damage

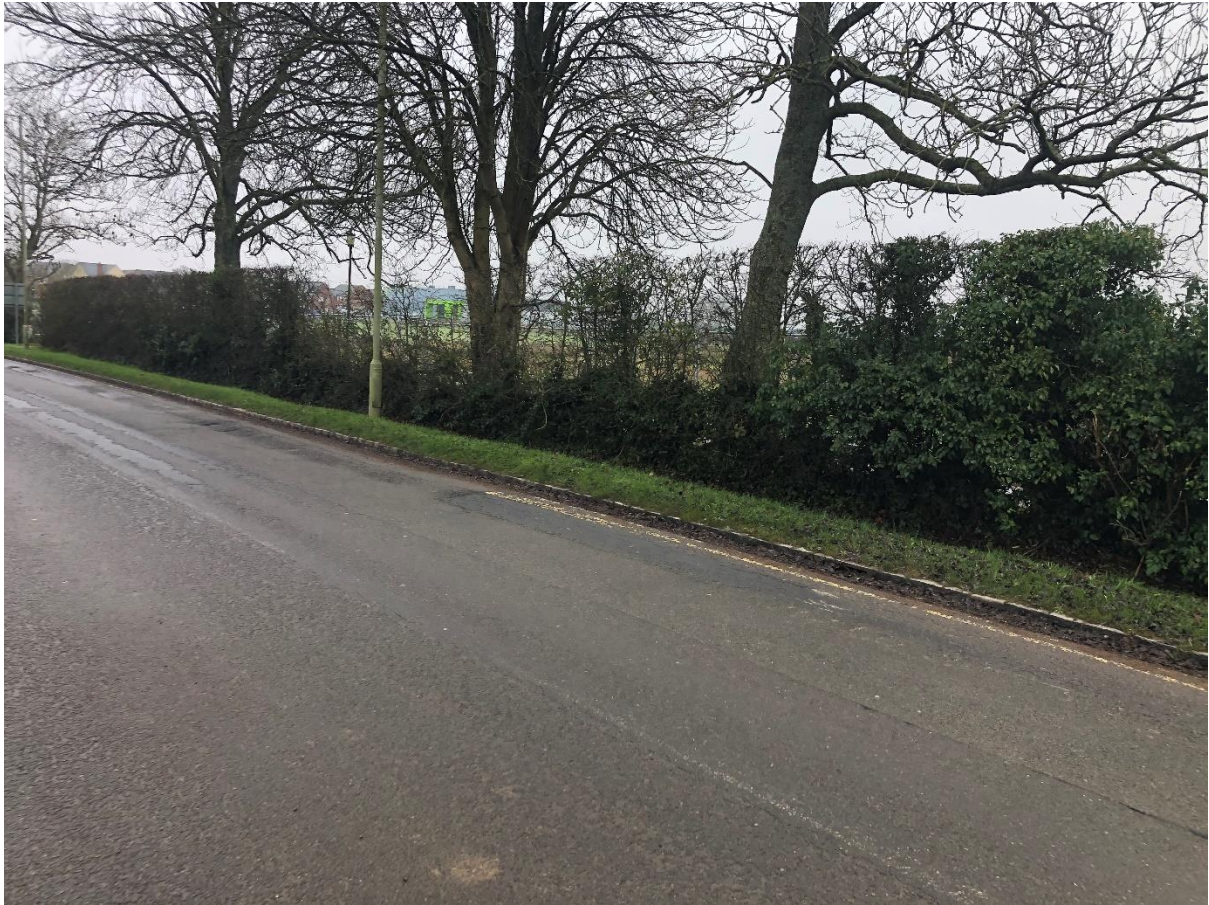
Photo 28

- Signs of patching/road joint failure
- Large amounts of sediment in channels
- Surface course in poor condition

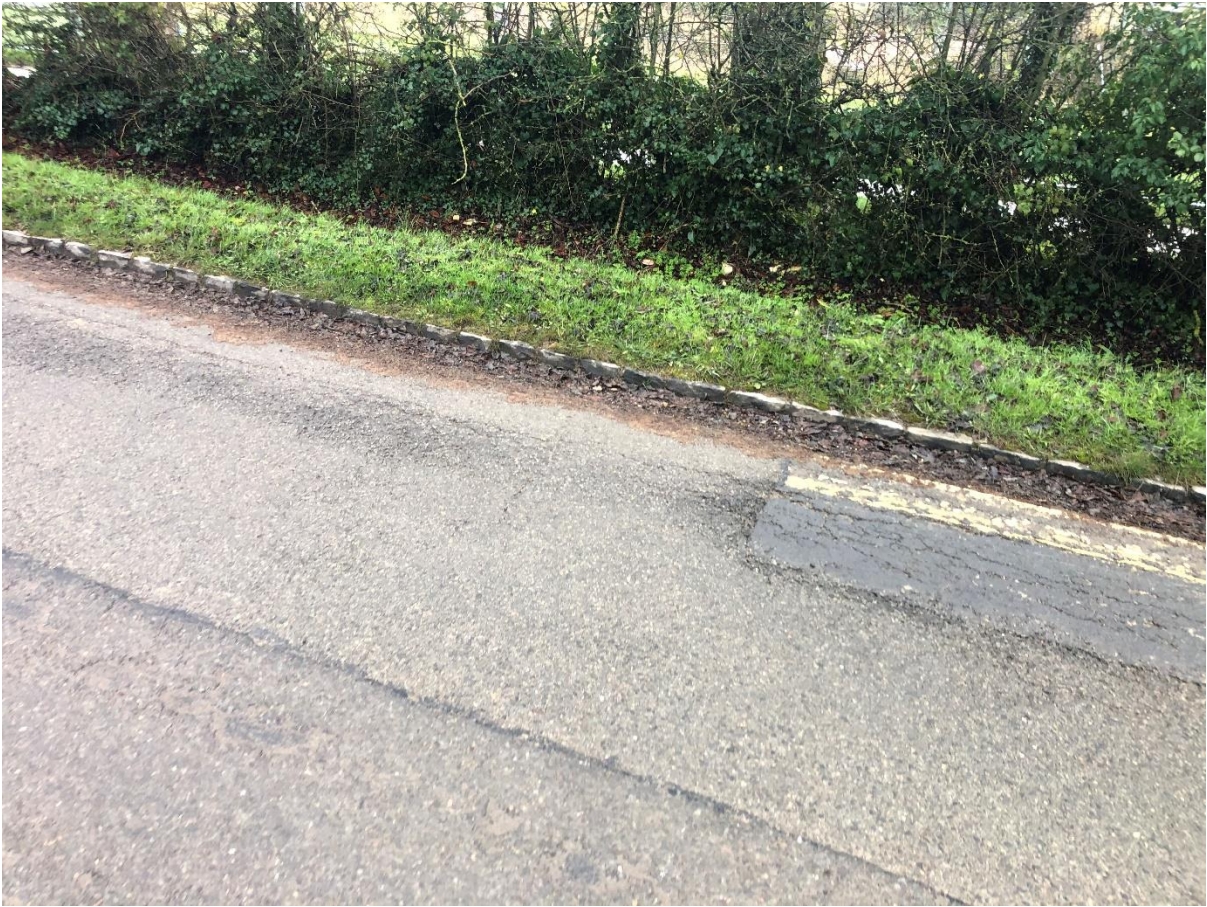
Photo 29

- Surface course starting to delaminate
- Visible cracking and settlement to highway
- Surface course is heavily worn

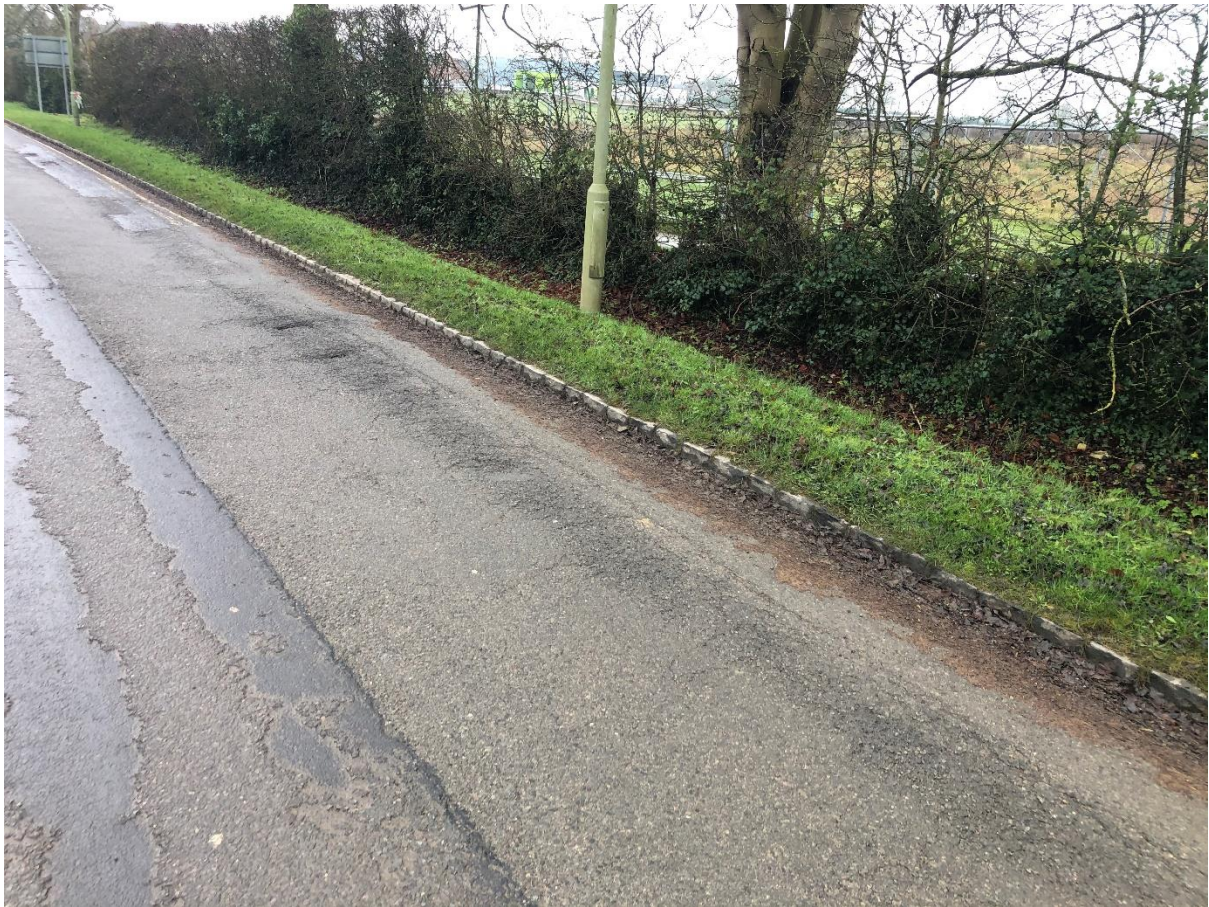
Photo 30

- Visible cracking and settlement to highway
- Surface course is heavily worn and delaminated
- Silt and sediment in channel indicating poor drainage
- Section of road looks raised

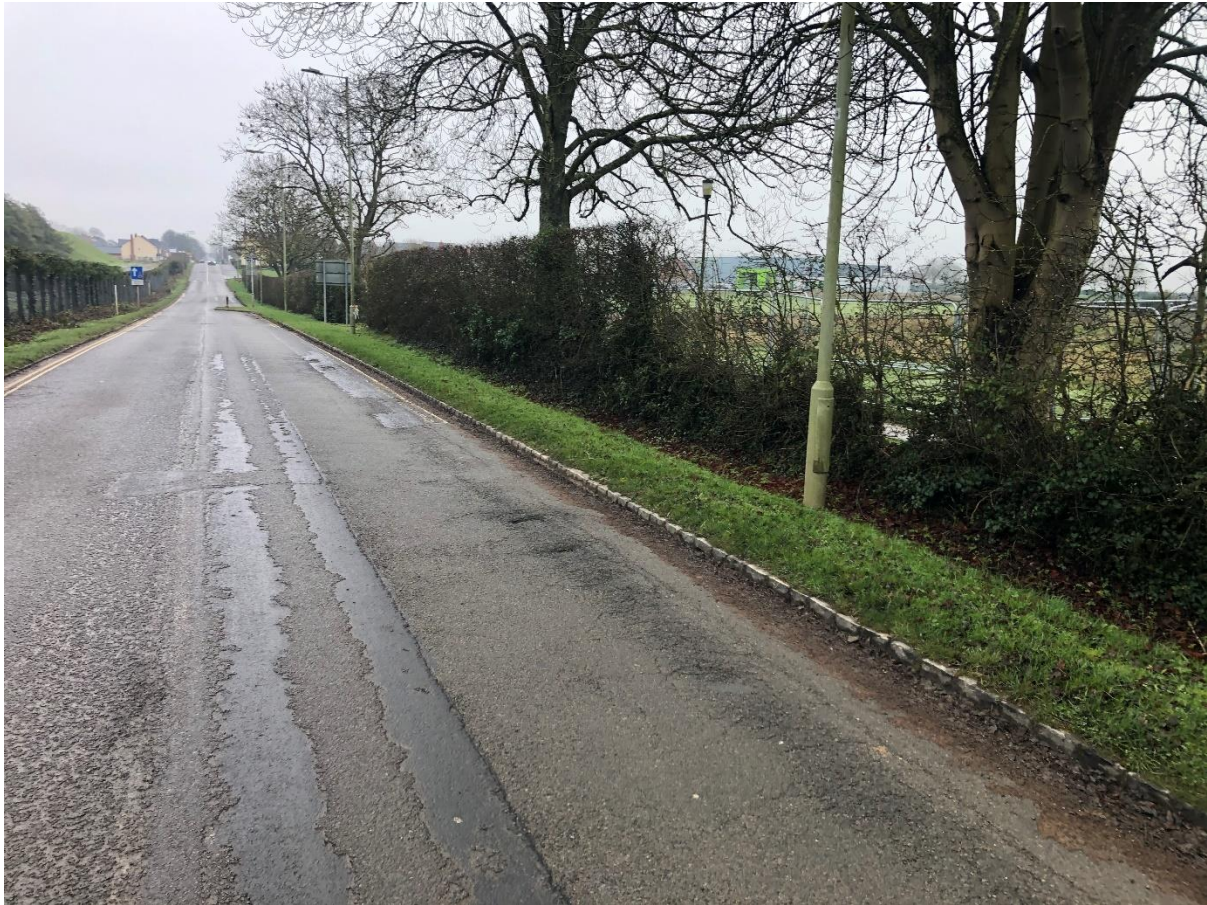
Photo 31

- Visible cracking and settlement to highway
- Surface course is heavily worn and delaminated
- Silt and sediment in channel indicating poor drainage
- Section of road looks raised

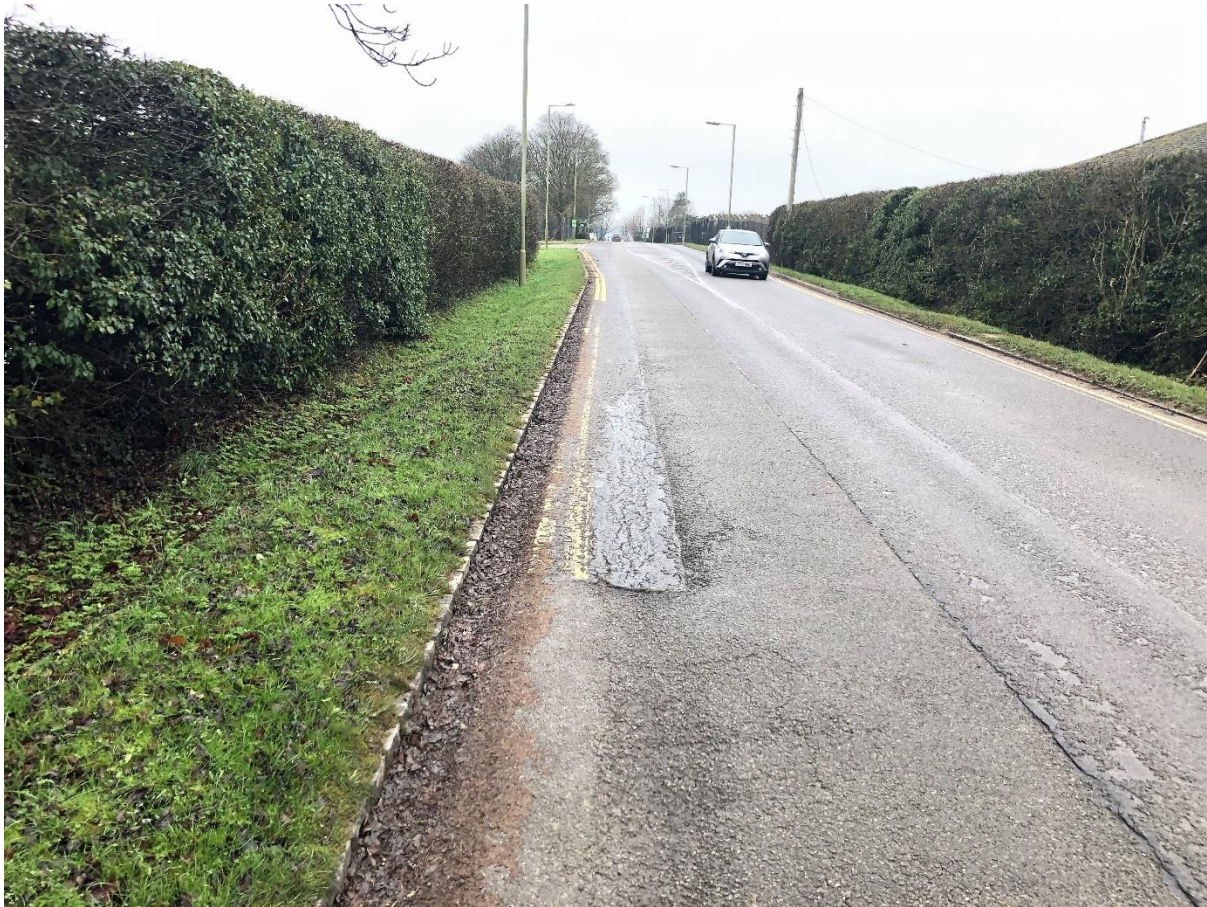
Photo 32

- Visible cracking and settlement to highway
- Surface course is heavily worn and delaminated
- Silt and sediment in channel indicating poor drainage
- Whitelining faded

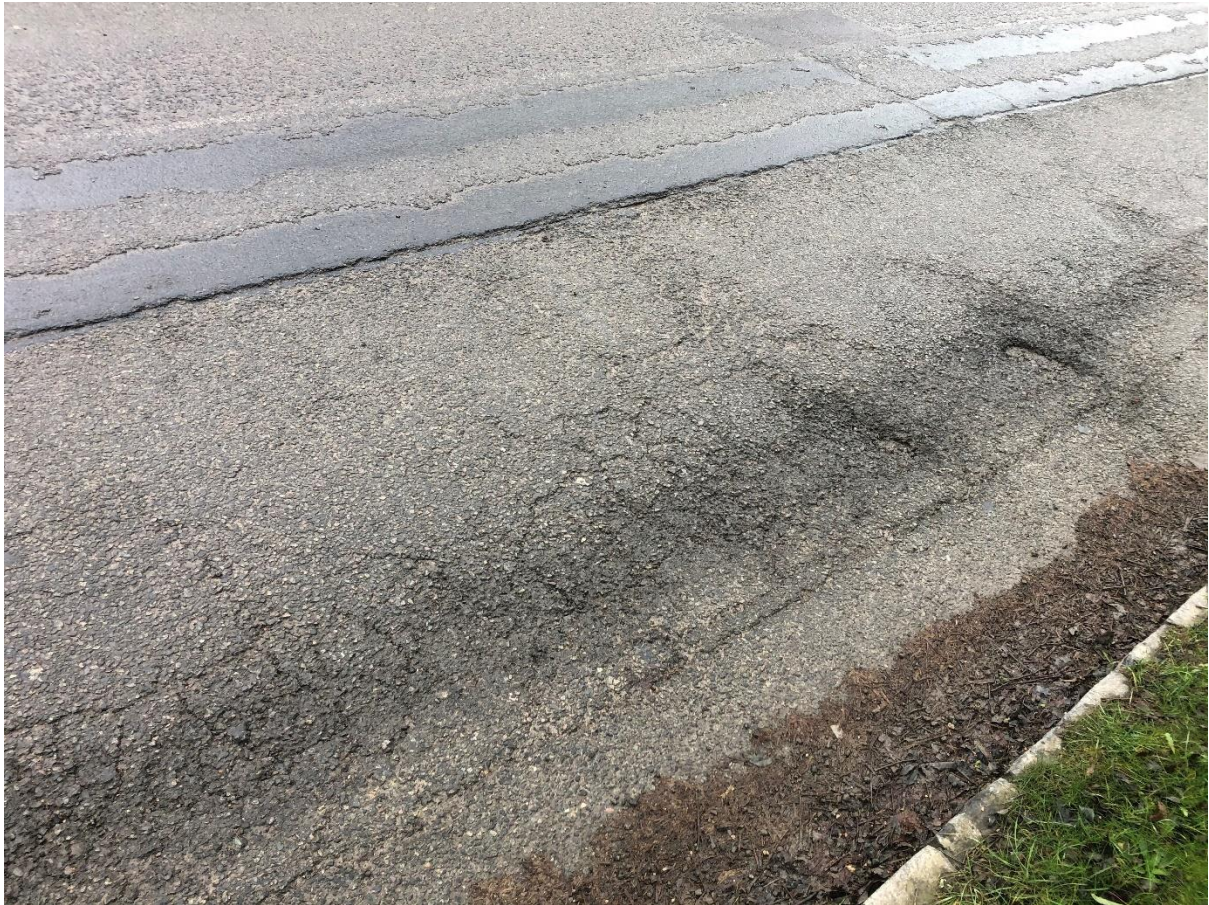
Photo 32

- Heavily worn surface course which is starting to delaminate
- Large amounts of silt/sediment in channel

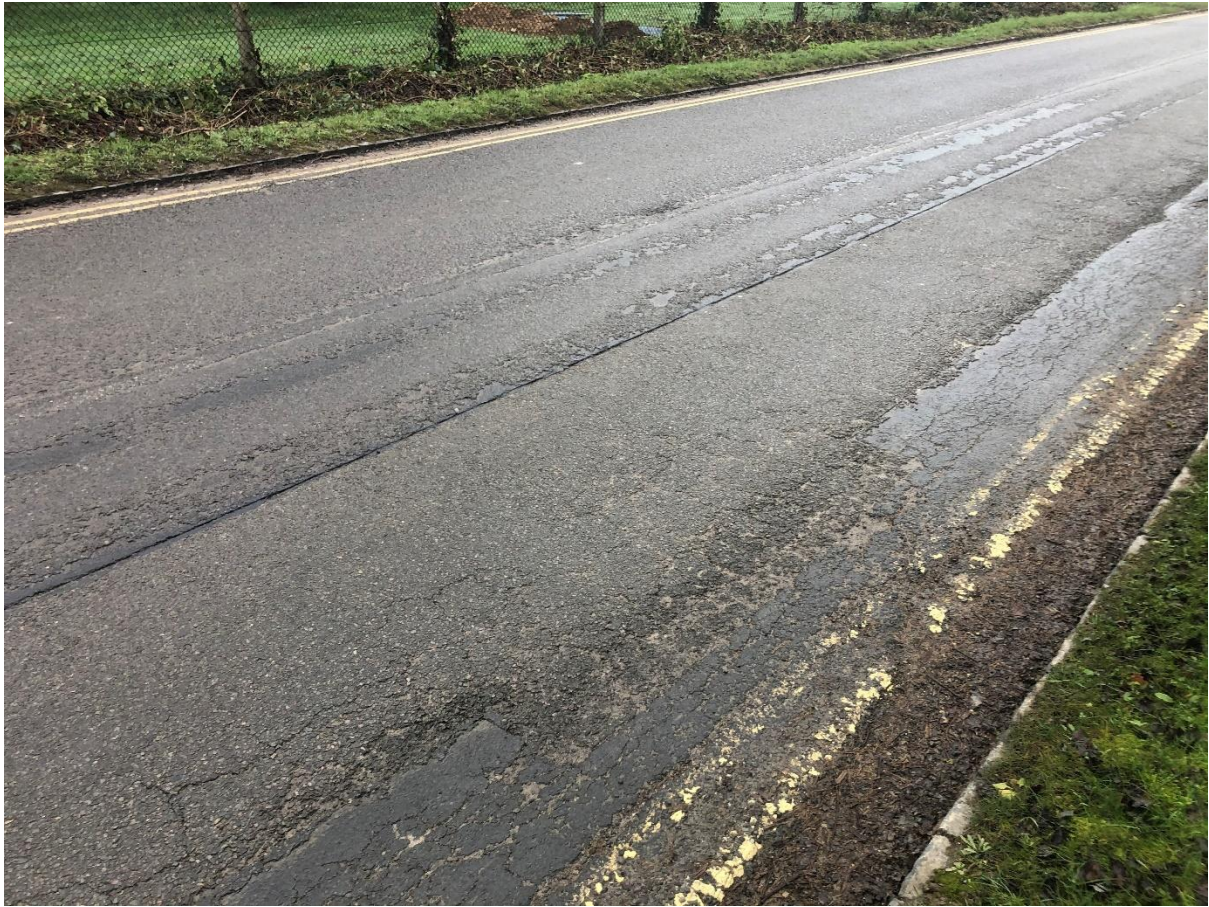
Photo 34

- Surface course is heavily worn
- Large amount of sediment in channels

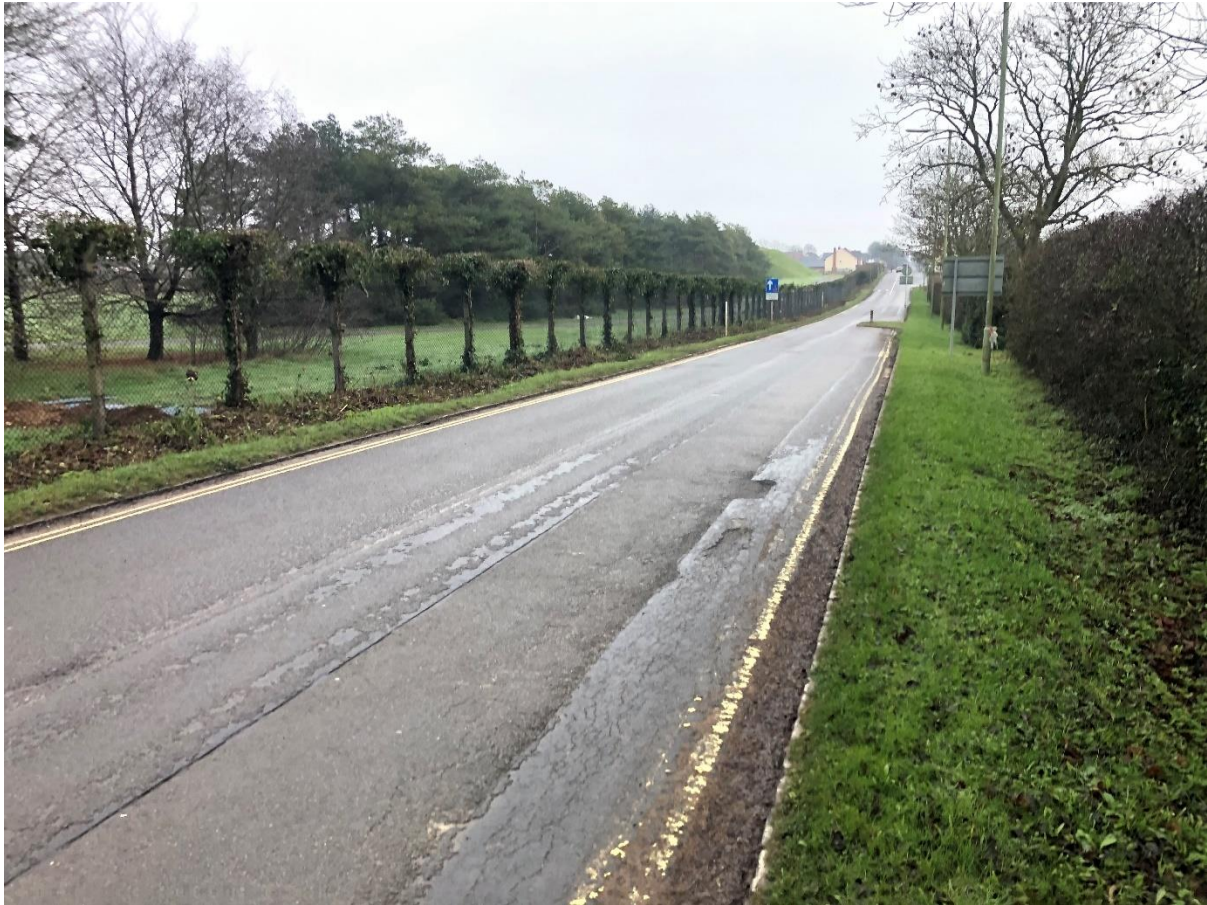
Photo 35

- Signs of patching
- Road joint starting to wear
- Large amounts of sediment in channels
- Surface course delaminating

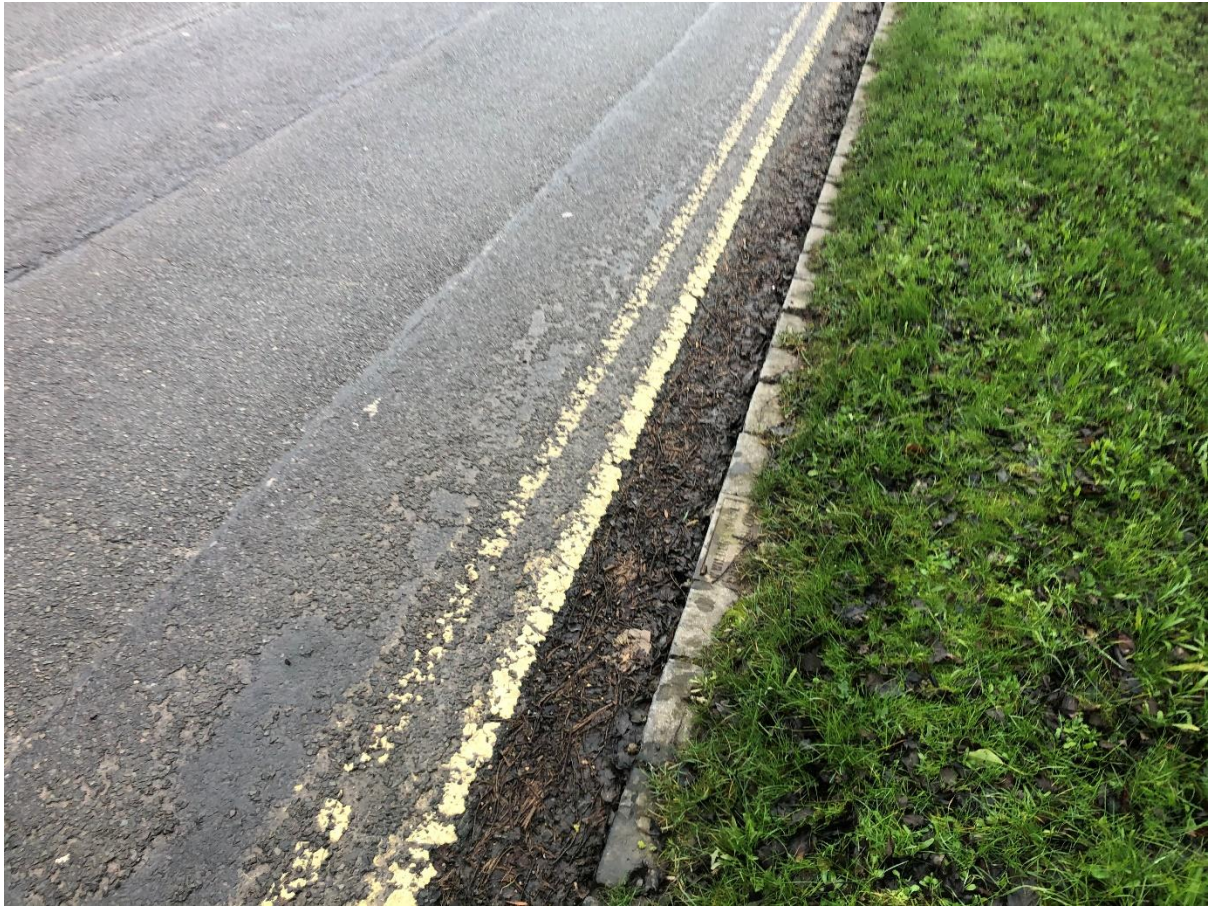
Photo 36

- Excessive amount of sediment

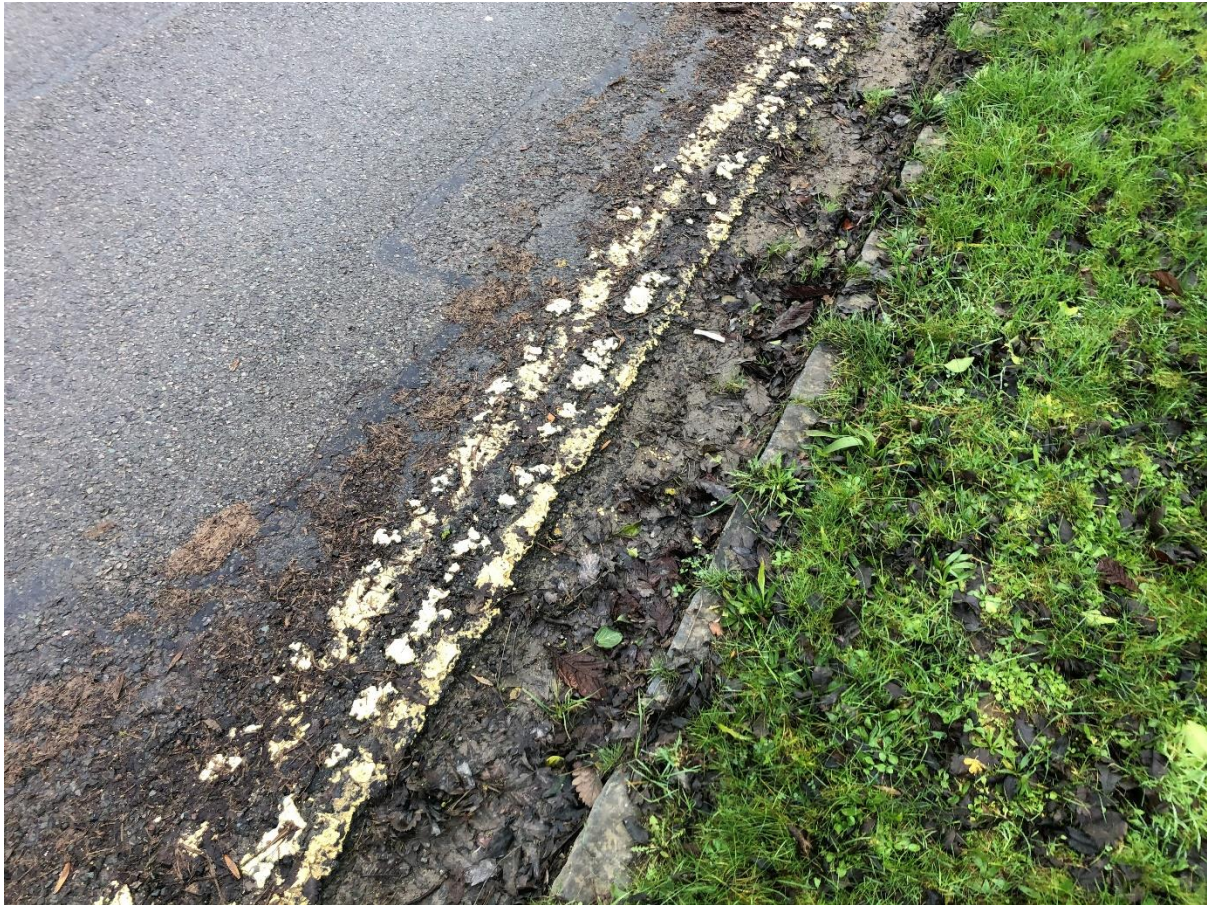
Photo 37

- Whitelining not clearly visible due to sediment and mud

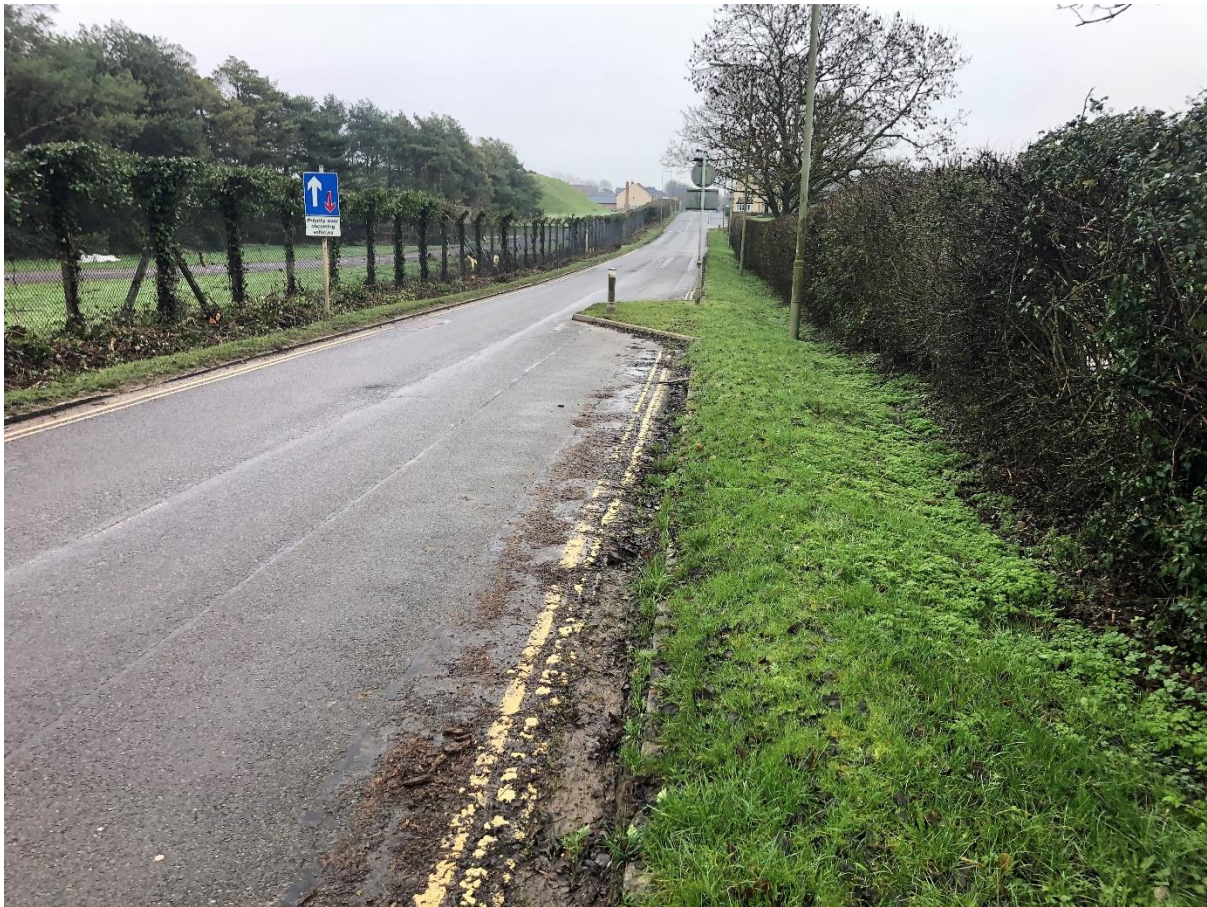
Photo 38

- Excessive amount of silt and mud on carriageway

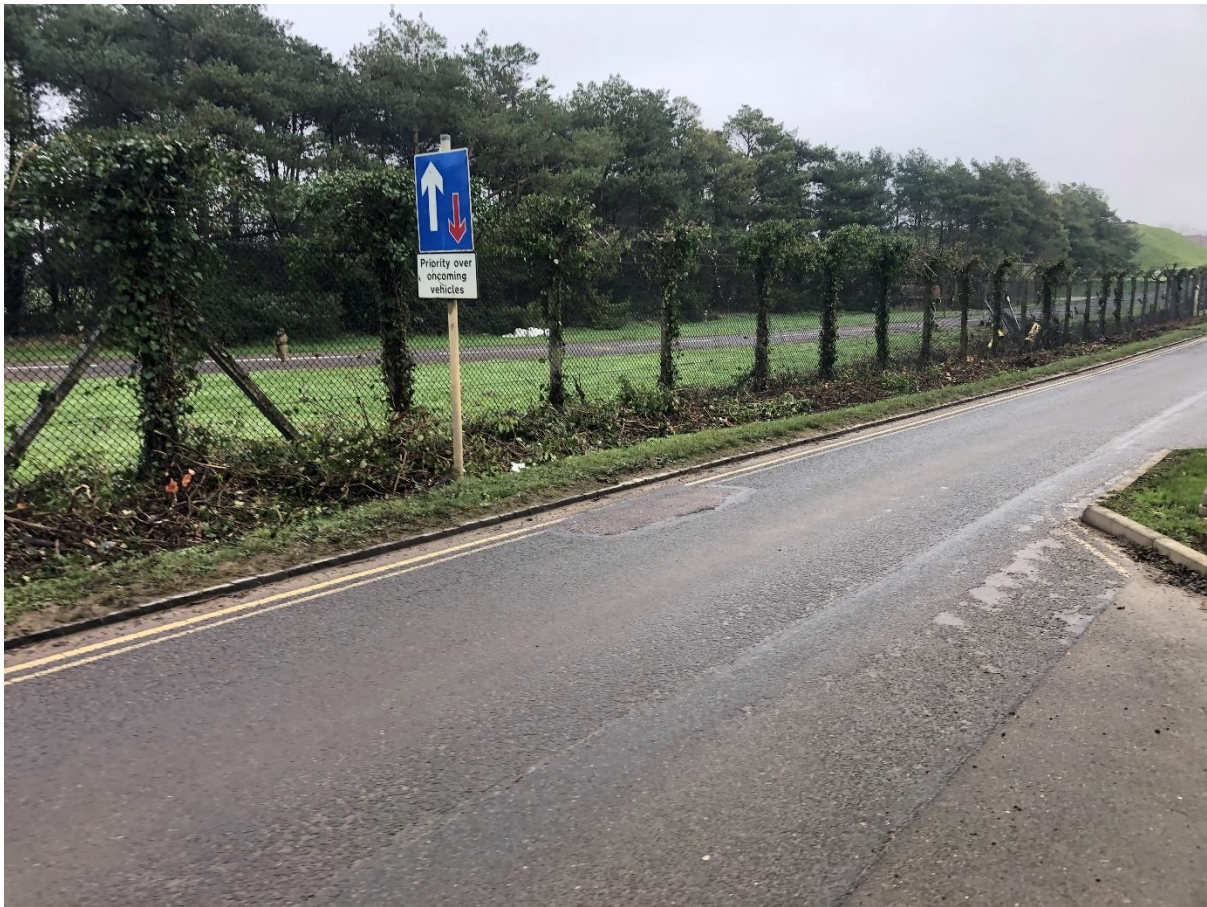
Photo 39

- A patch has been undertaken in the highway
- Surface course shows signs of wear
- Whitelining looks faded
