HIGHWAY CONDITION SURVEY, CAMP ROAD

20/02730//DISC-Heyford Park

Heyford Park, Camp Road, Upper Heyford, Bicester

Dorchester Living Limited

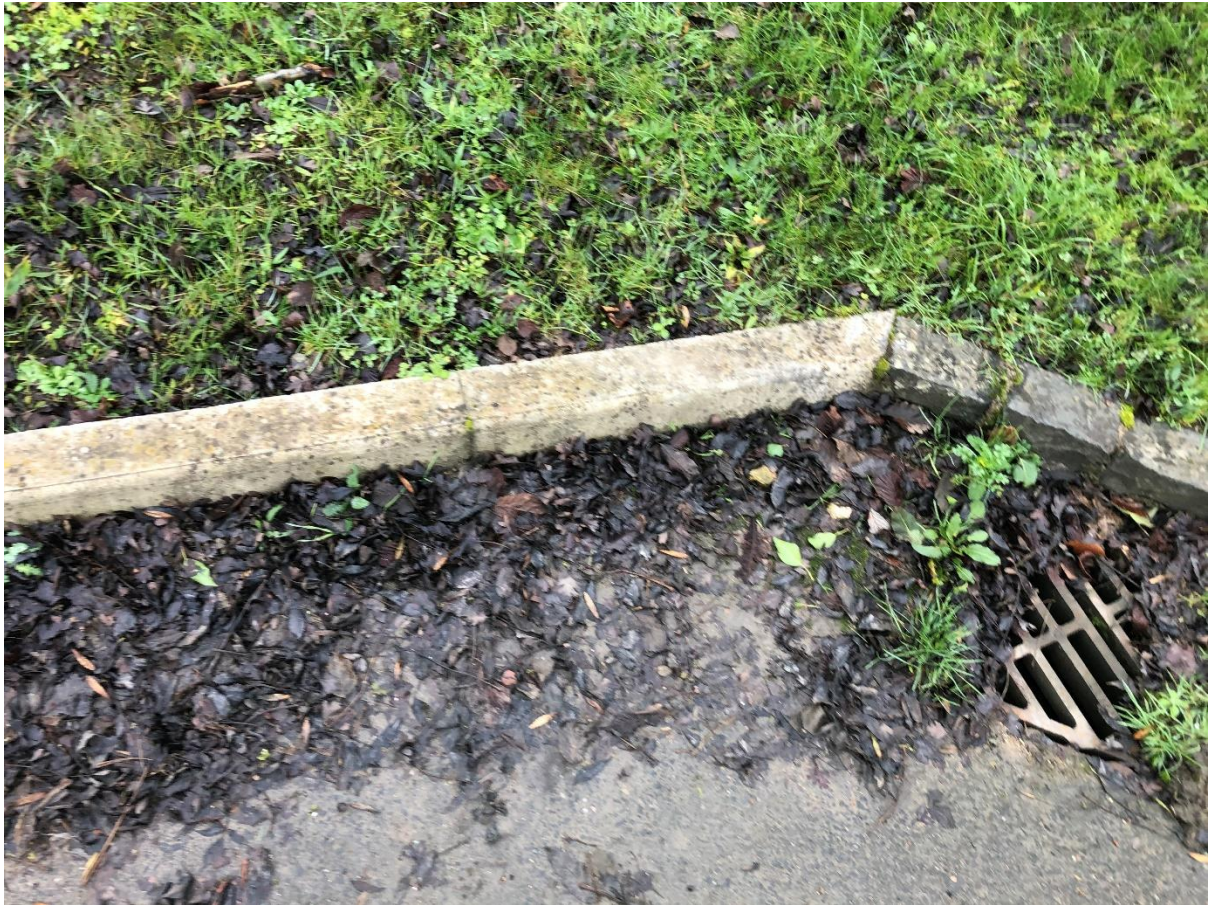
Photo 40

- Excessive sediment in road and weeds growing around gulley grate

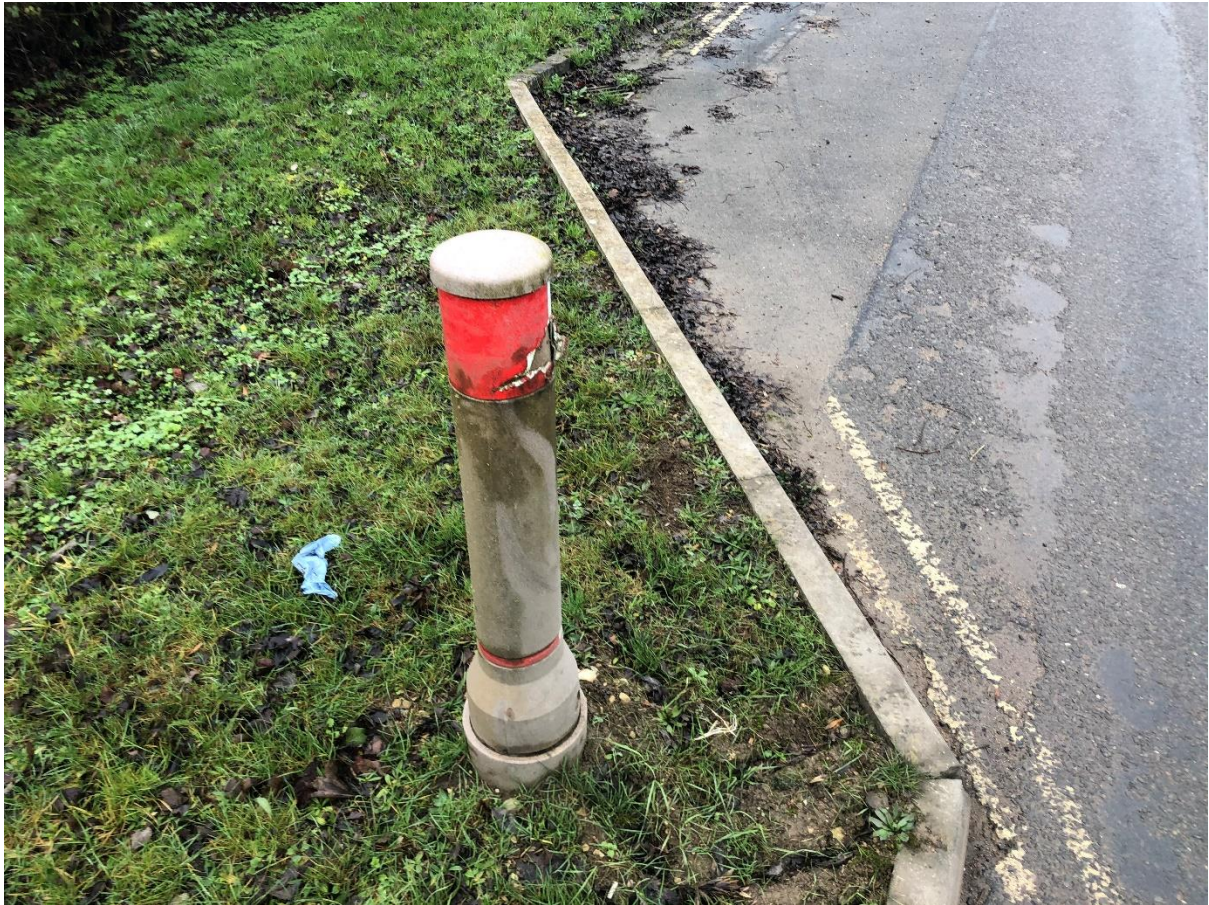
Photo 41

- Bollard in poor condition

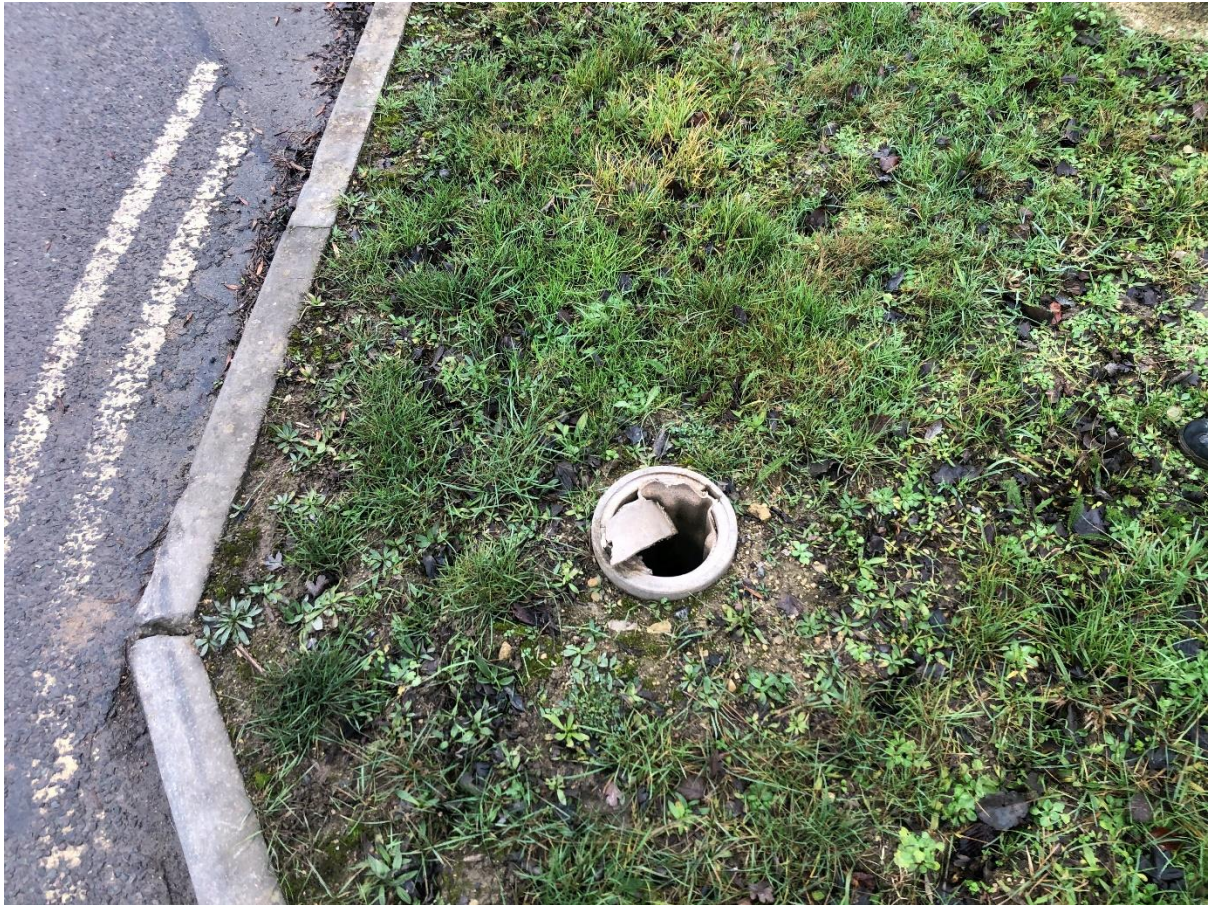
Photo 42

- Bollard damaged

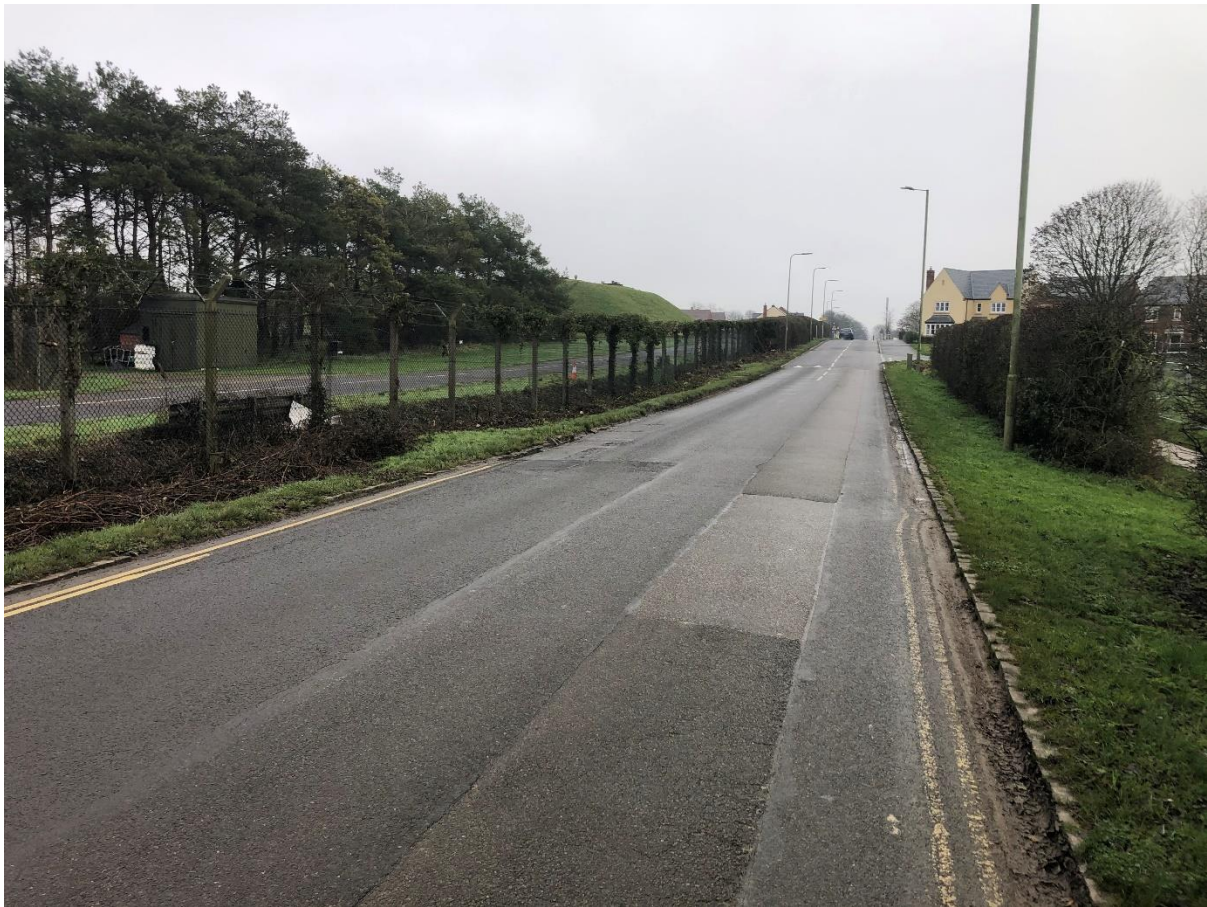
Photo 48

- Signs of patching, scars in road

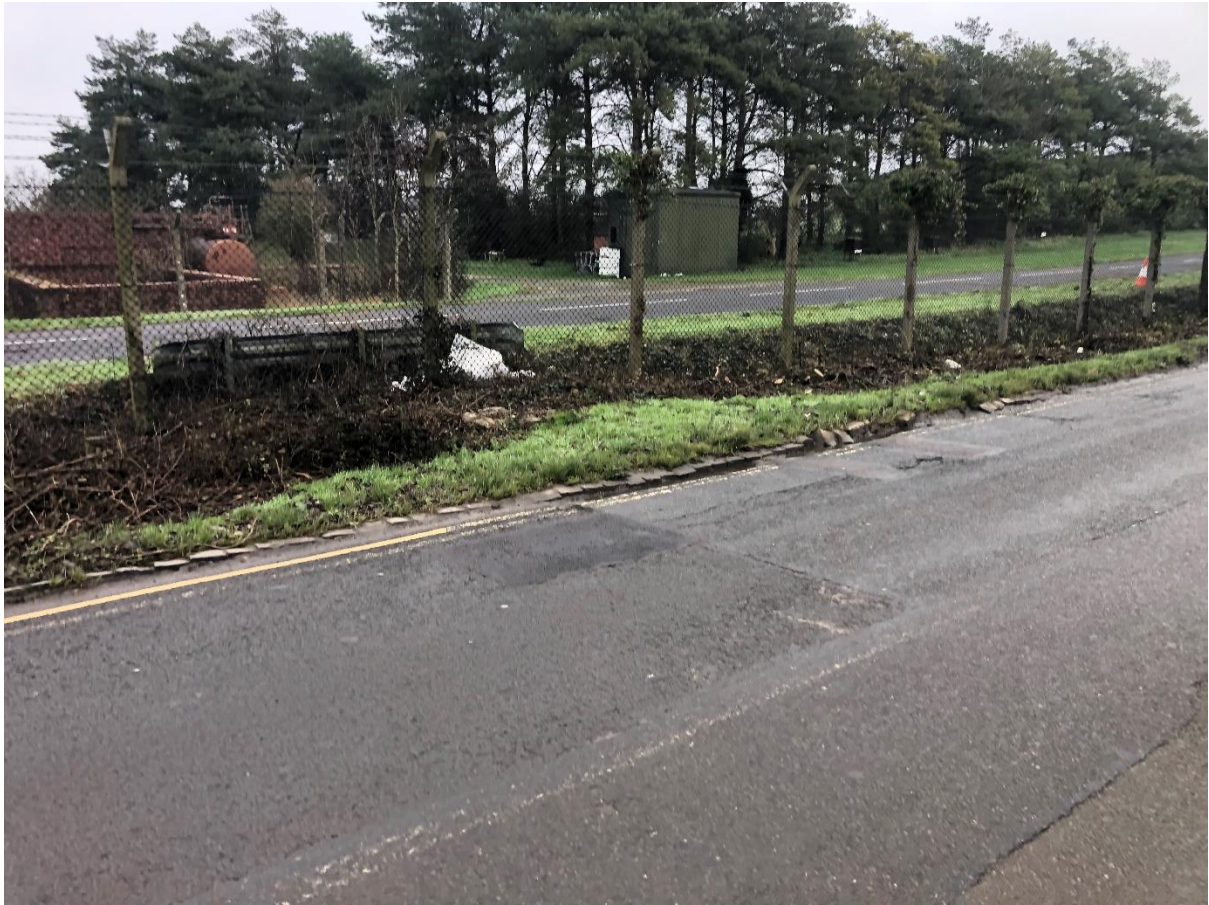
Photo 49

- Cobbled kerb sets have completely failed

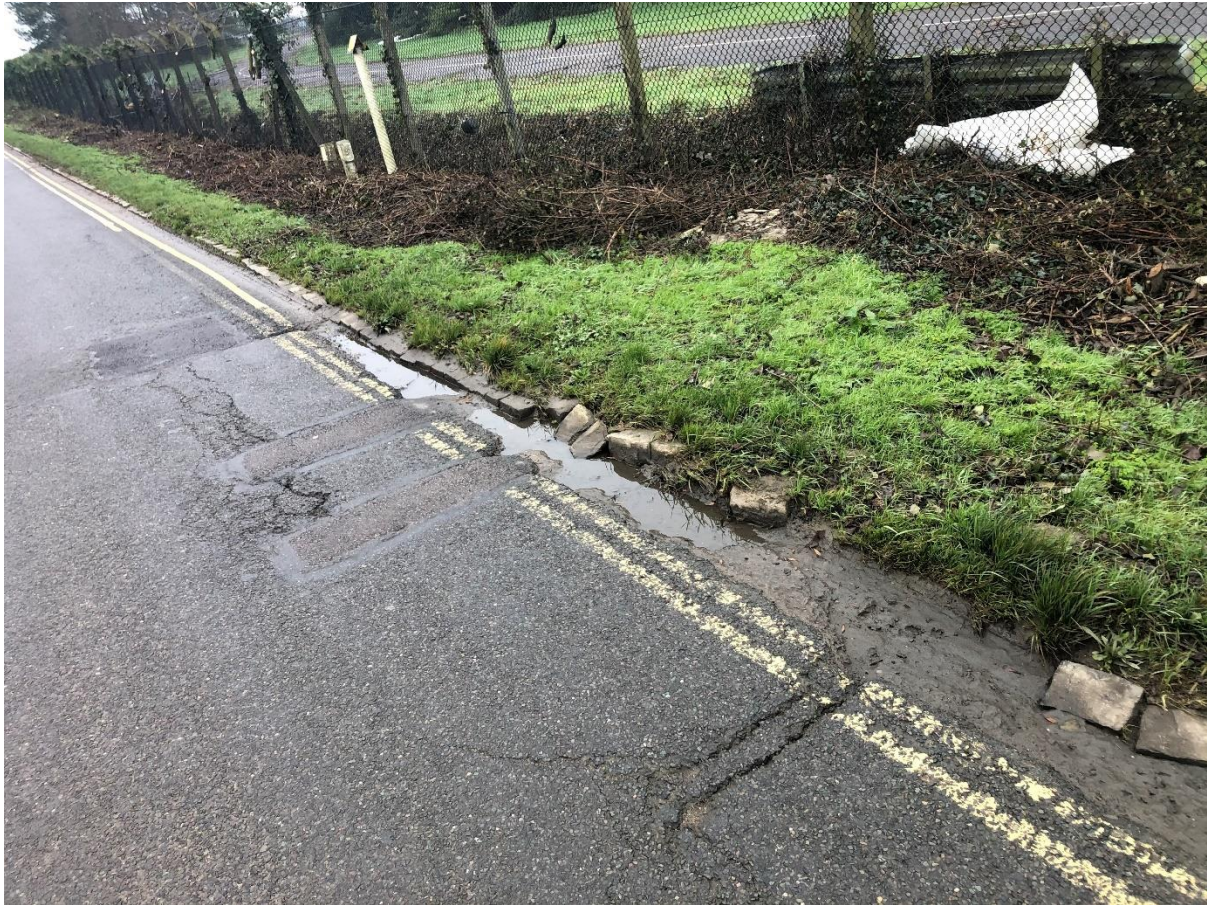
Photo 52

- Cobbled kerb sets and edge of surface course has completely failed causing standing water
- Road shows signs of settlement
- Clear cracking to surface course
