**WYKHAM PARK FARM,
A361 BLOXHAM ROAD, BANBURY**

**PROPOSED RESIDENTIAL DEVELOPMENT
SECTION 38 WORKS**

Stage 1 Road Safety Audit

DL-EB-21-3344-RSA1

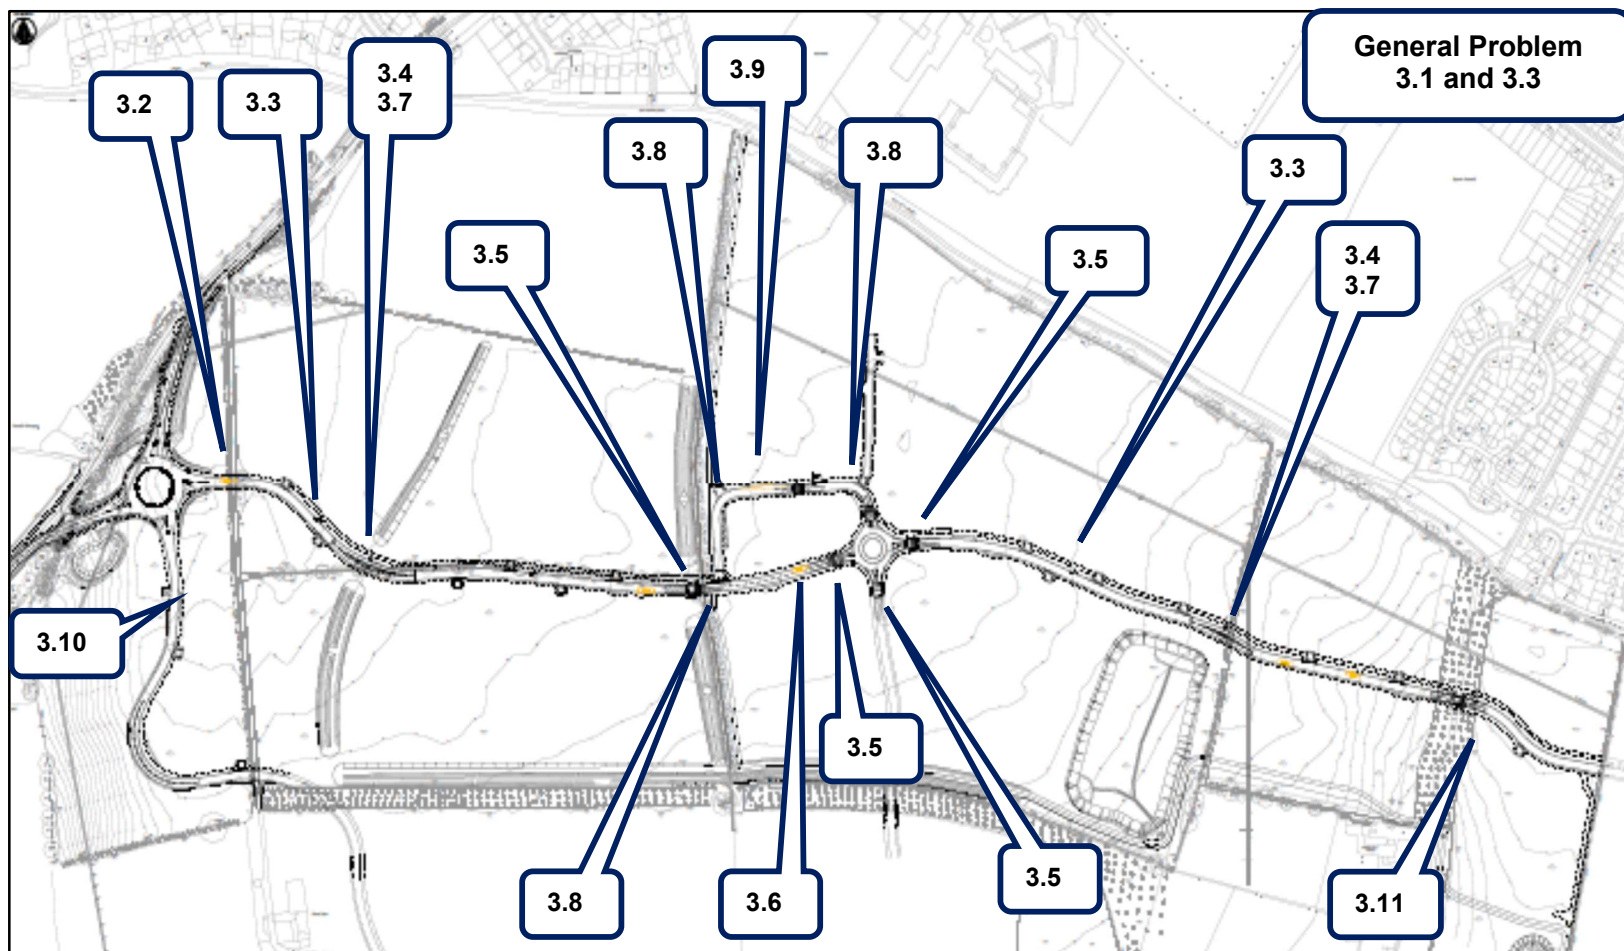
APPENDIX A: LOCATION PLAN

- 1.12 All problems identified in this Road Safety Audit Report are indicated on a location plan in Appendix A
