## **Health Hub, Bicester**

### **Review of Walking & Cycling Routes in Bicester**

February 2021

**Client Name:** Apollo  
**Document Reference:** WIE16470-R-1-1-1-Walking & Cycling Routes  
**Project Number:** WIE16470

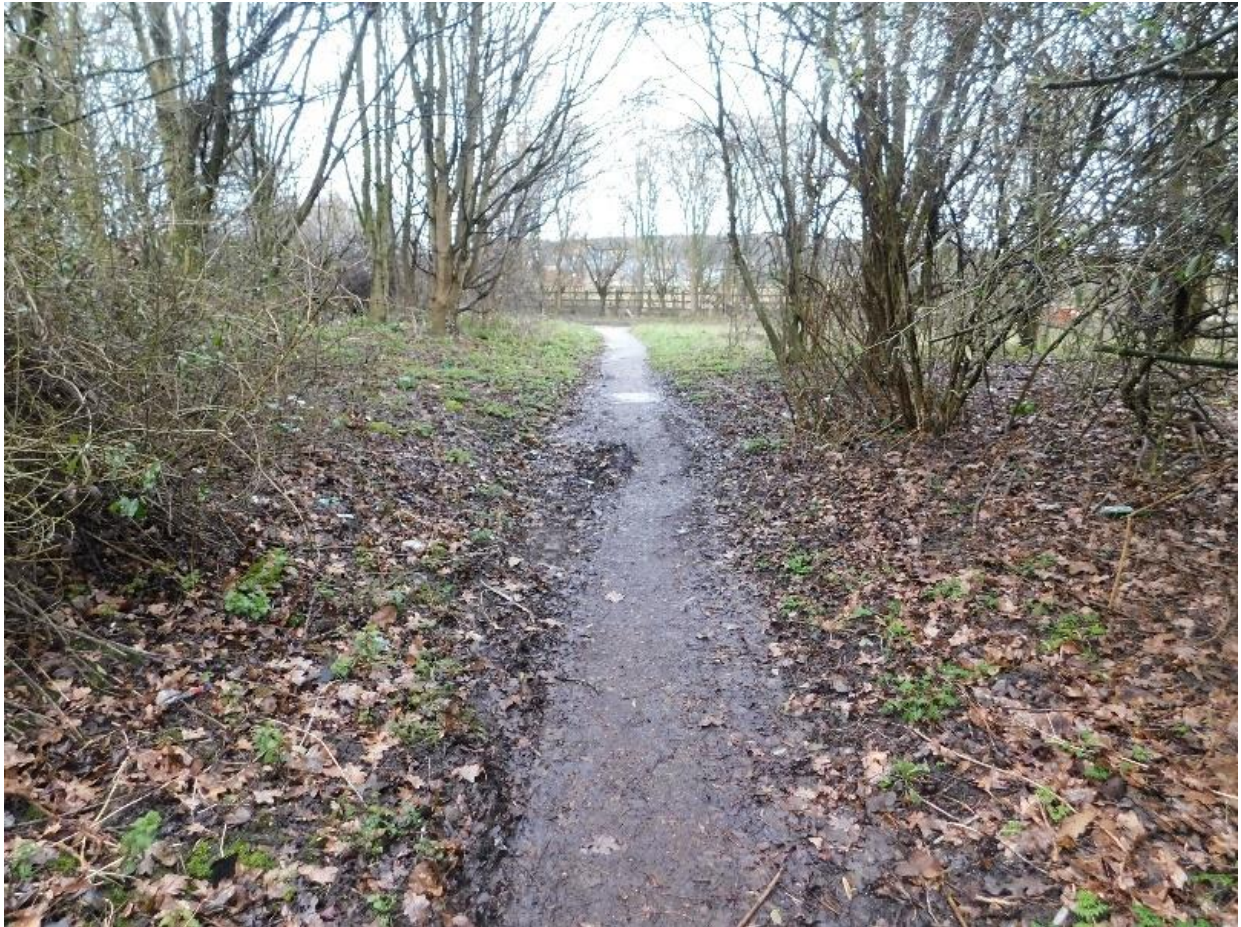
Figure 3: Route 1 - Unpaved Footpath

This unpaved footpath, as shown in **Figure 3** below, was accessible however the path is unpaved with a raised surface due to a manhole cover and in general the path was slightly uneven. Accessible users would find this path difficult to use as unpaved.

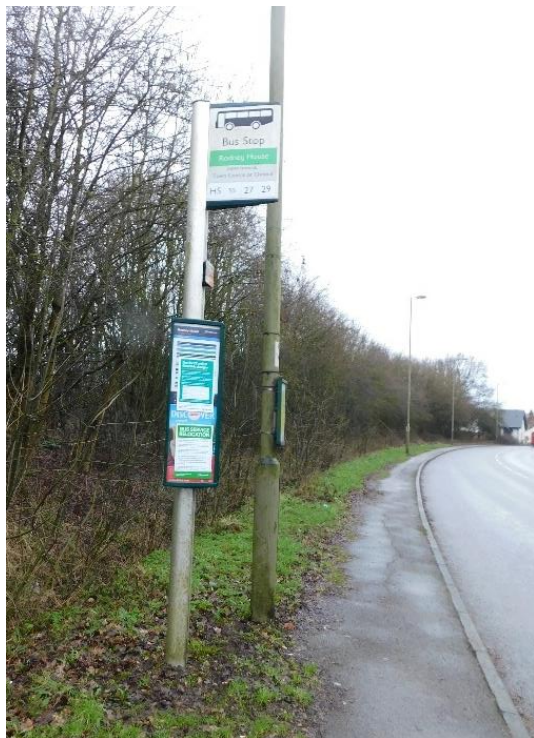
Figure 4: Route 1 - London Road Bus Stop

The bus stops provides services from numbers; H5, S5, 27 and 29. The information on the stop itself states that from 7<sup>th</sup> February 2021, the number 27 will no longer be in operation and there will be changes to number 29. **Figure 4** below shows this bus stop along London Road.

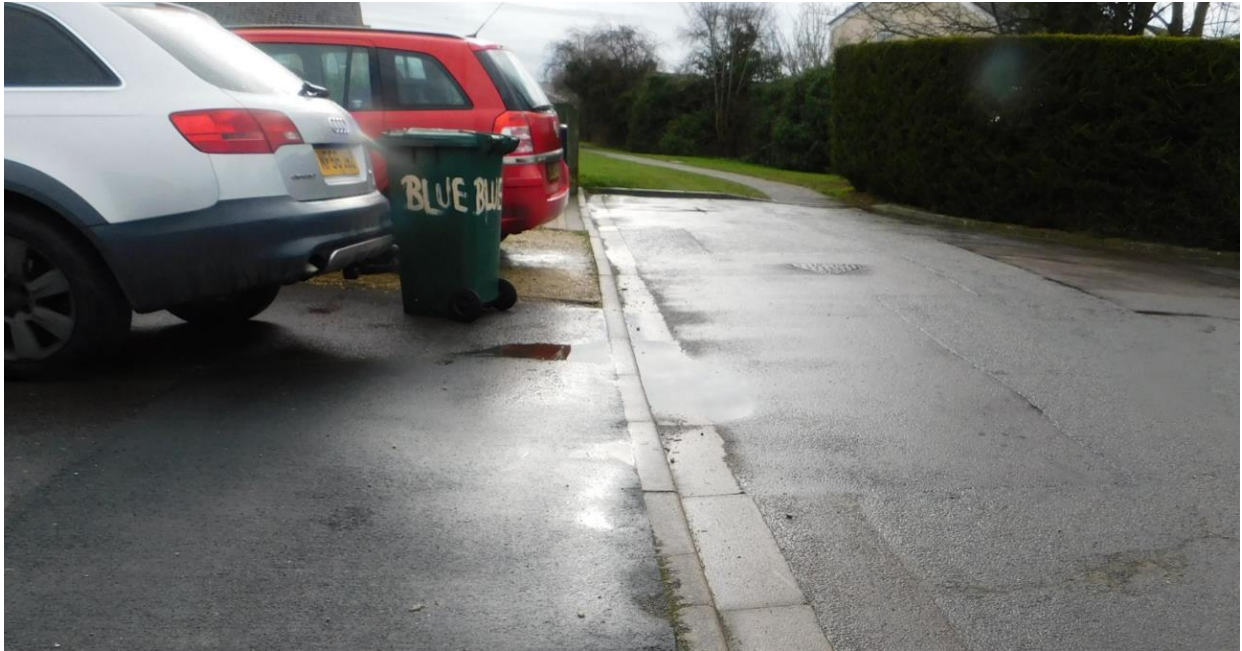
Figure 7: Route 2 - Meredith Close

Meredith Close footways have a few minor concerns including cracking and uneven surface but these issues would not prevent the use of the footways. However, at the end of the footways on Meredith Close you have to use the end of the carriageway to access the footpath which leads onto Orchard Way, this is not ideal but the carriageway allows access to a small number of residential dwellings and is therefore has low traffic. This is shown in **Figure 7** below.

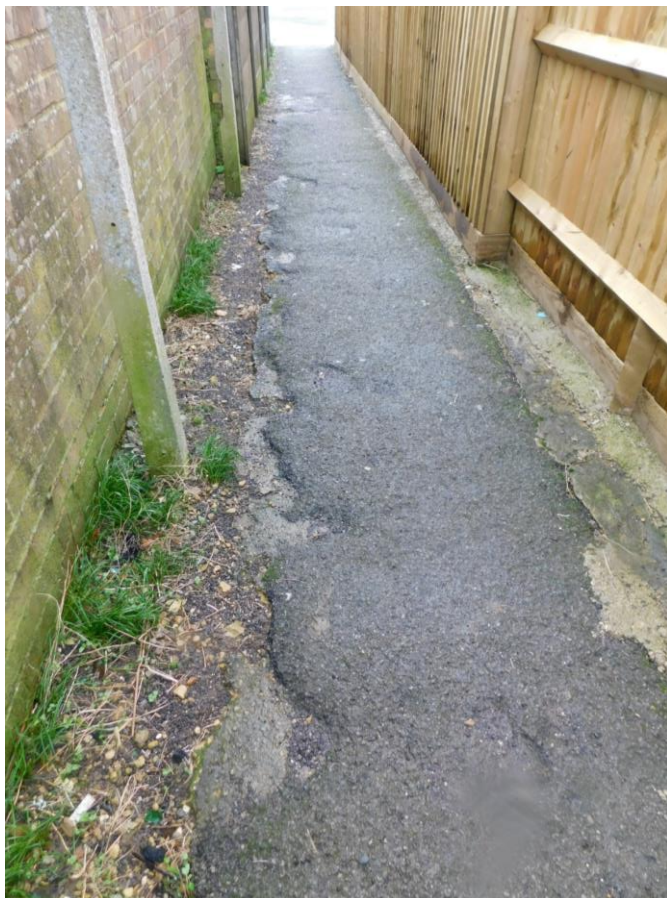
Figure 8: Route 2 - Footpath

The footpath between Meredith Close and Orchard Way is of good condition to start but is narrow, making it difficult for people to pass comfortably on the paved path, users would have to use the vegetation at the side of the path. As you continue down the path the conditions become worse as shown in **Figure 8** below.

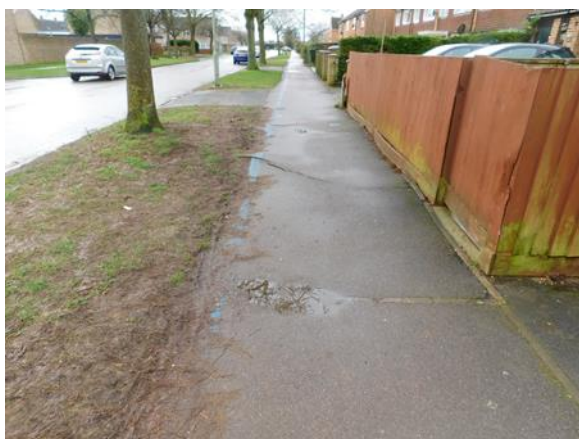
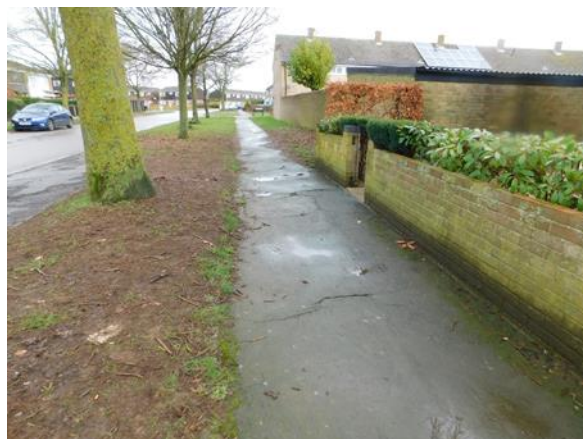
From Blenheim Drive the route continues south onto Leach Road. Leach Road also has a few minor issues including uneven surface and cracking due to tree roots. However, the footpath becomes less attractive to the north of the bus stop on the eastern kerb, as shown in figures below.

Figure 9: Route 2 - Leach Road (1)

Figure 10: Route 2 - Leach Road (2)

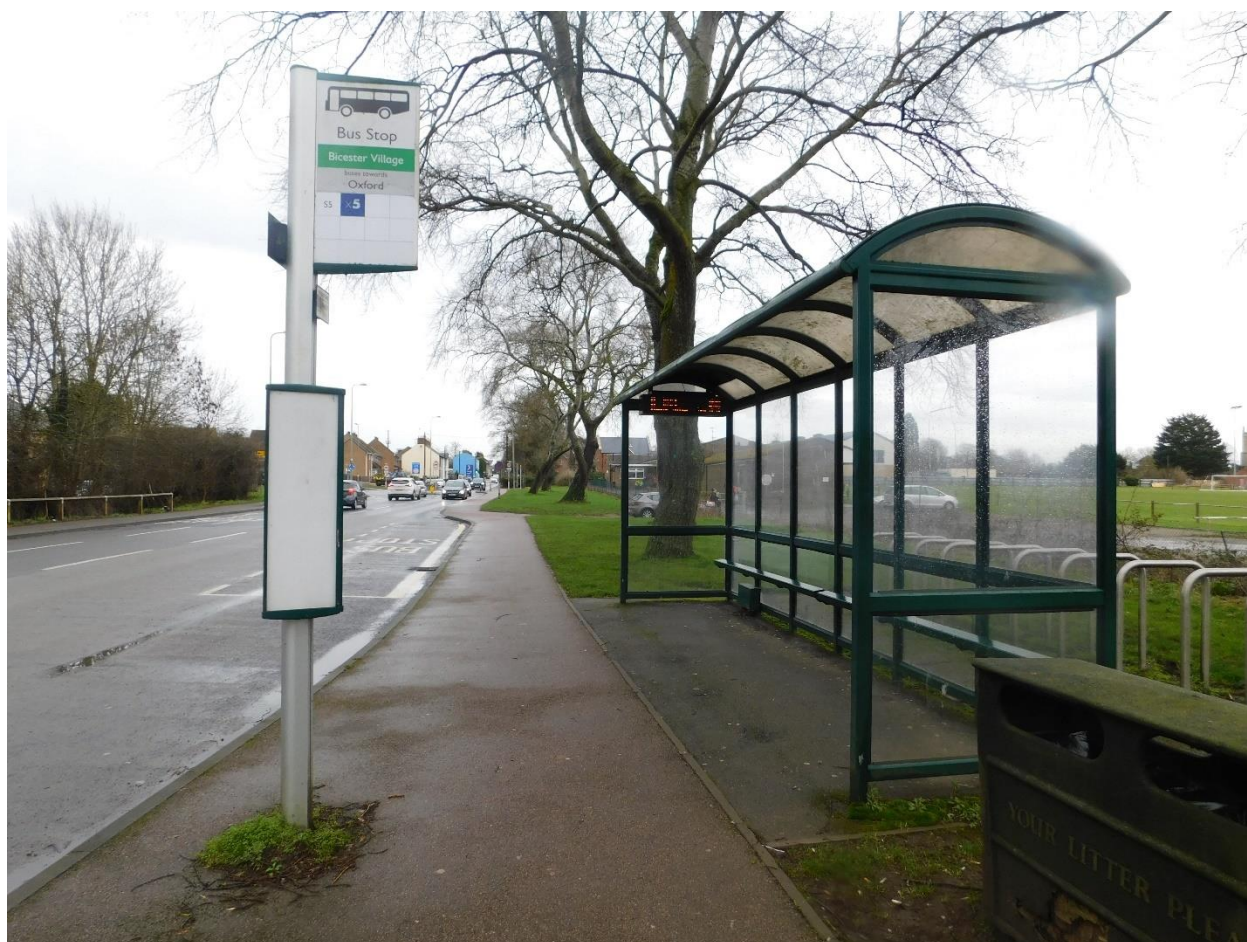
Figure 11: Route 2 - Bicester Village Bus Stop

Oxford Road offers two bus stops which are in very good condition with excellent crossing facilities. The stop on the eastern kerb line has live information, 10 cycle parking bays and a number of seats. This could be due to the proximity to Bicester Village, a large retail outlet. The eastern bus stop is shown in **Figure 11** below.

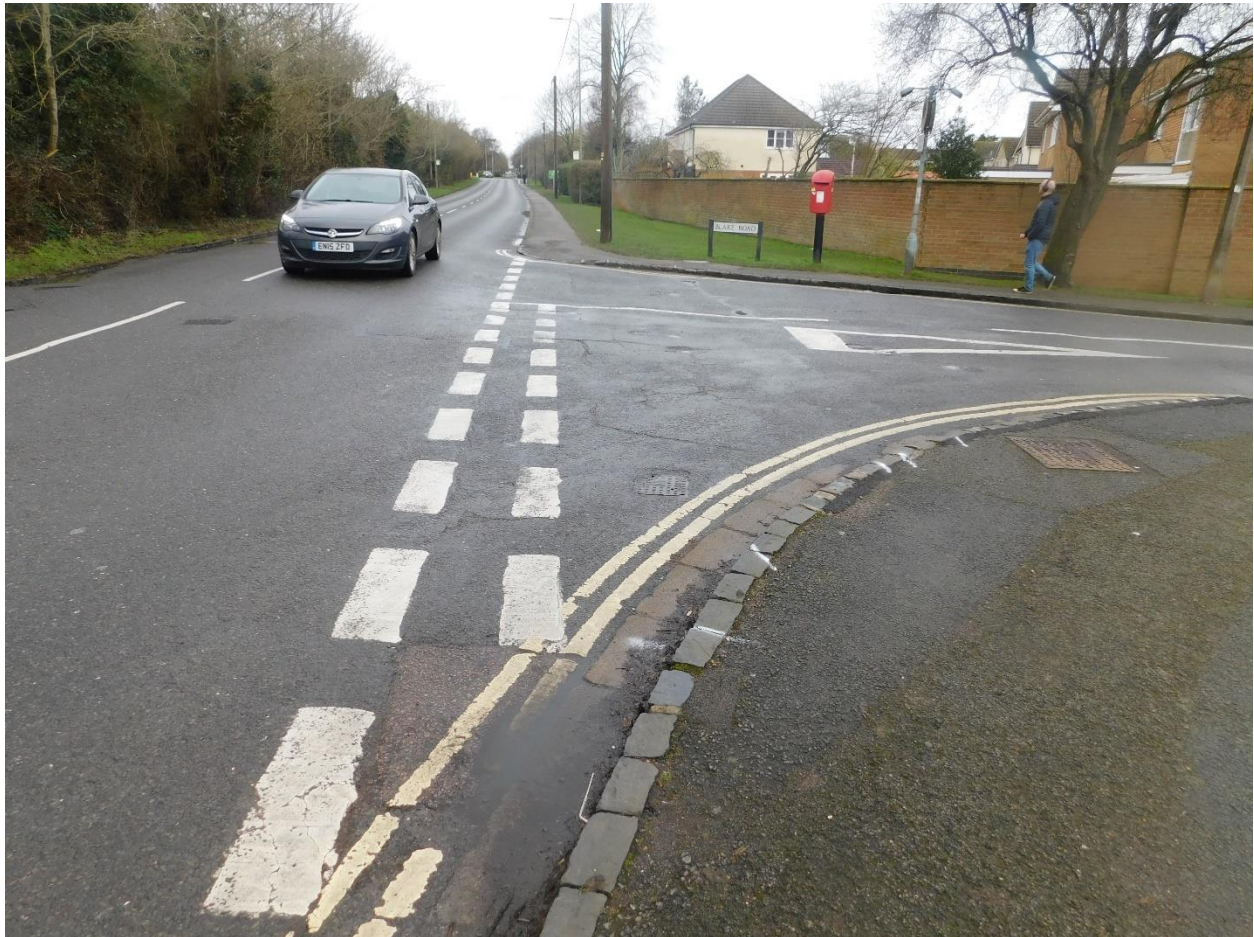
Figure 14: Route 3 - Banbury Road / Blake Road Junction

Users can cross Buckingham Road safely to follow the route onto Banbury Road as there is dropped kerbs and tactile paving's. However, users would be unable to cross over the B400 to access Banbury Road as there is no dropped kerbs to cross safely. The dropped kerbs along Banbury road are slightly raised therefore not dropped enough to meet the carriageway level if users wanted to cross, however this is not a major concern.

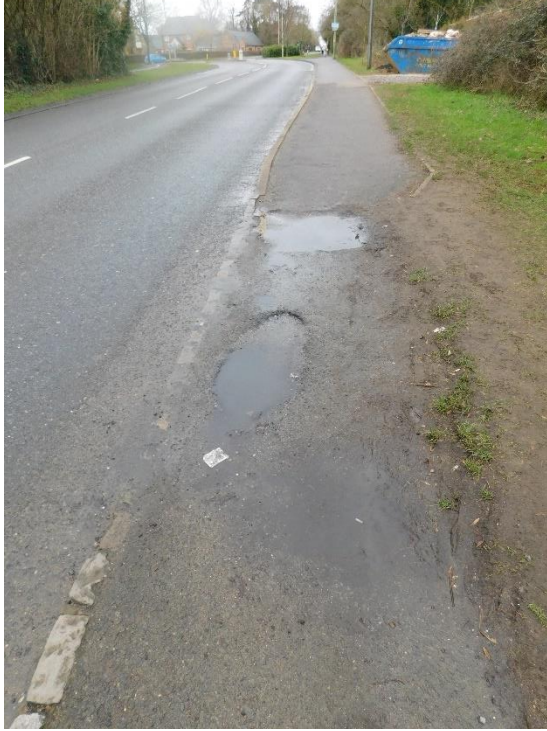
Figure 15: Route 3 - Conditions on Banbury Road (North)

As users approach the roundabout with Lucerne Avenue the footway becomes slightly uneven but not to cause concern, however further north before another bus stop there is some surface uplift which could create issues such as trips and falls, shown in figure below. The bus stop was another flag and pole but the service information wasn't clear enough to read.

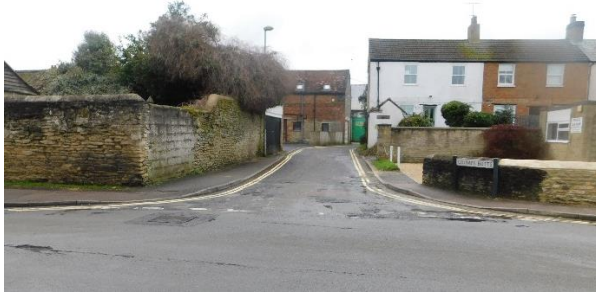
Figure 17: Route 4 - Crumps Butts Junction

At the beginning of the route, Bell Lane and Sheep Street, north kerb line is slightly narrow and at junction with Crumps Butts, there is no tactile paving at this junction and due to frequent vehicle use the carriageway is uneven and would be difficult to cross for vulnerable users. However, the southern kerb is more attractive as the footway is wider but there has been some damage to the tactile paving's. Crumps Butts junction and the damaged paving is shown in the figures below.

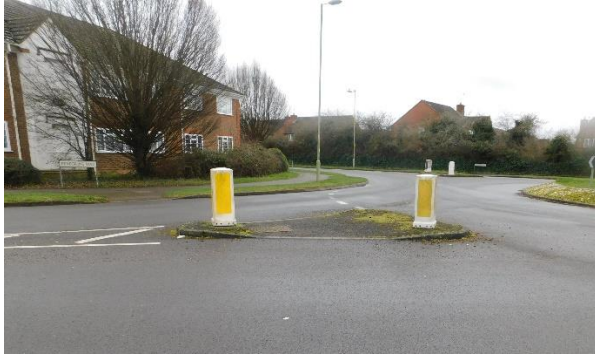
Figure 21: Route 5 - lack of Tactile Pavings at junctions

At Hawksmead junction with Peregrine Way there are no tactile paving's but a dropped kerbs are present; this is the same for its junction with Turnstone Green and Kingfisher Way further along. There are a few minor issues including cracking and raised ironworks but overall conditions are good.

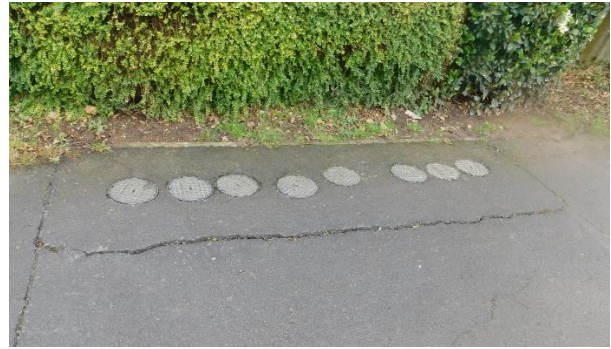
Figure 22: Route 5 - Cracking Issues

At the mini roundabout there continues to be no tactile paving's and as the route follows Peregrine Way past the roundabout there are further issues including surface uplift, cracking and the footpath has become smaller due to vegetation growing on the footpath. There is some concerns near the southwest kerb bus stop as there is more significant cracking.

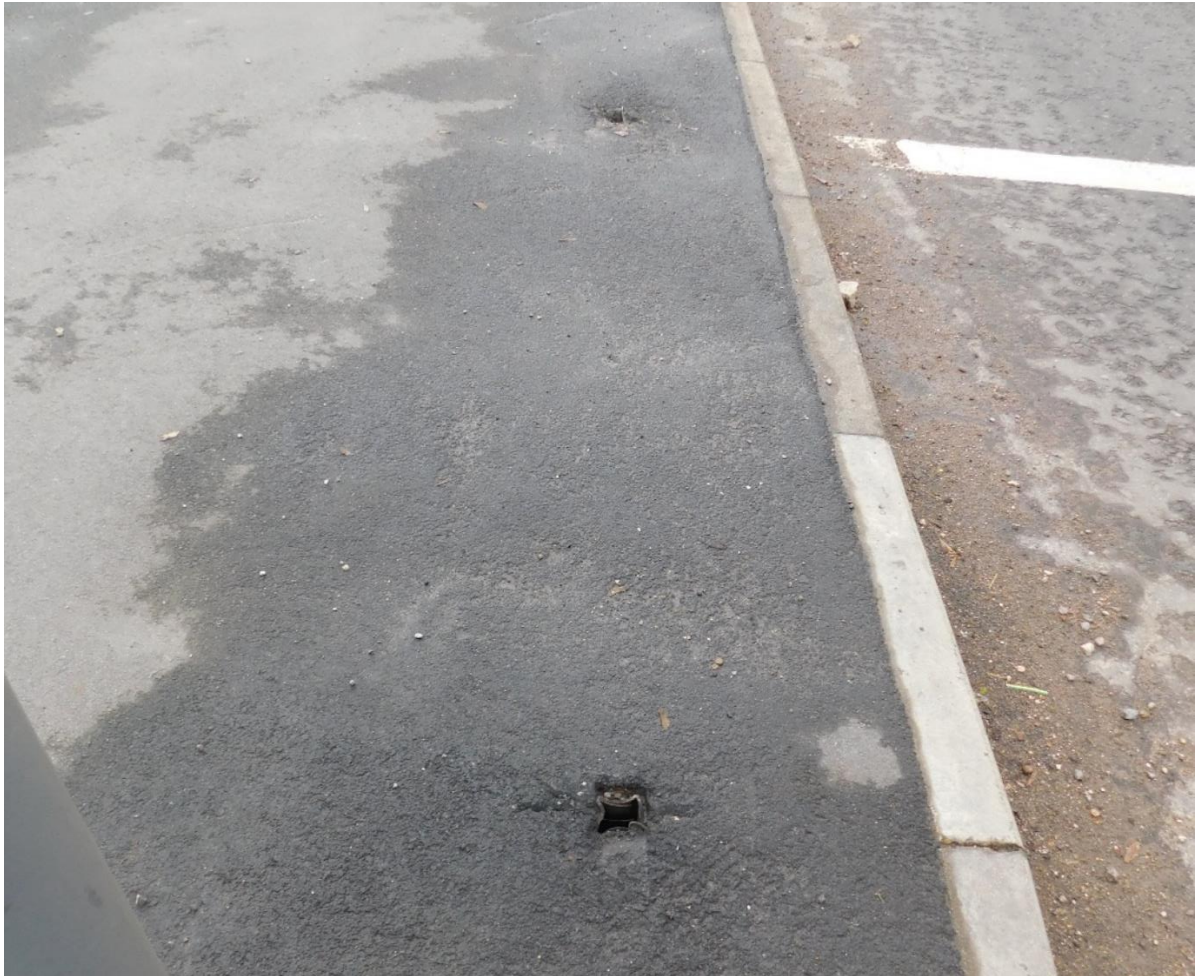
Figure 26: Route 6 - Metal holes

The route was started at the roundabout junction crossing along the A4421, at this pedestrian crossing there is a number of holes with sharp metal protruding, where metal poles were previously present.

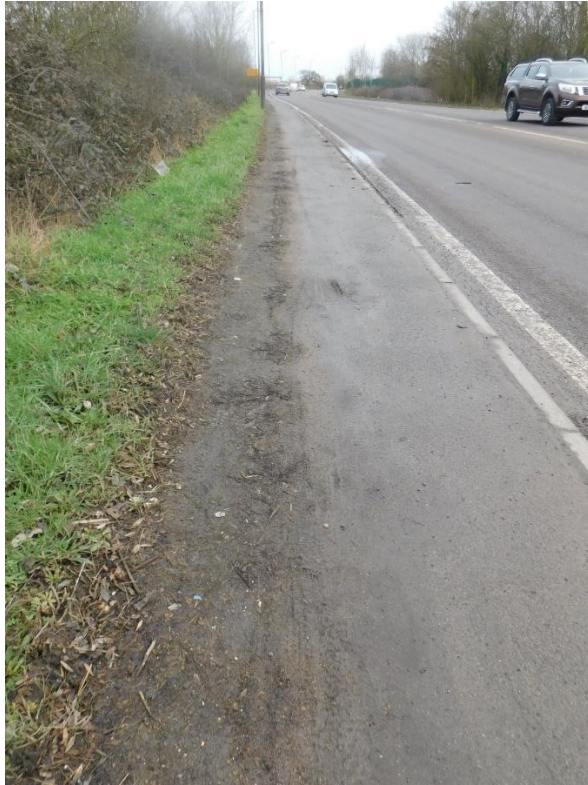
Figure 27: Route 6 - Typical Conditions of Footway

The northern footway along the A41 is not the most ideal route for pedestrians as there are a number of issues. The surface of the footway is old and therefore the surface is uneven with cracking, and the footway slopes into the vegetation. There is also no street lighting or protection barriers from the busy A41. The figures below highlight the footpath and its most concerning aspects.

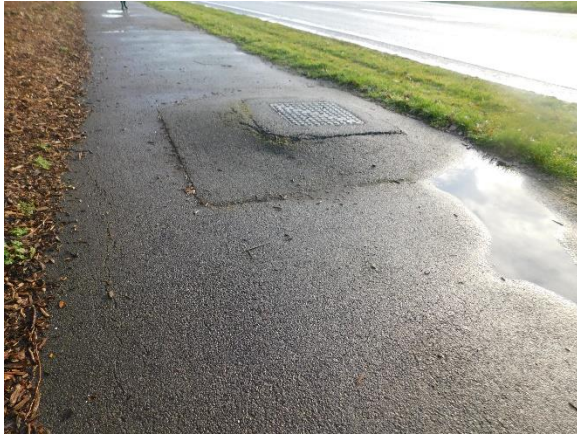
Figure 31: Route 1 - Raised Ironworks

As mentioned, the footpath surface was not ideal for cycling. There was a number of raised surfaces at iron works, surface uplift, severe cracking, dipped channels and vegetation growth. These issues are shown in the figures below.

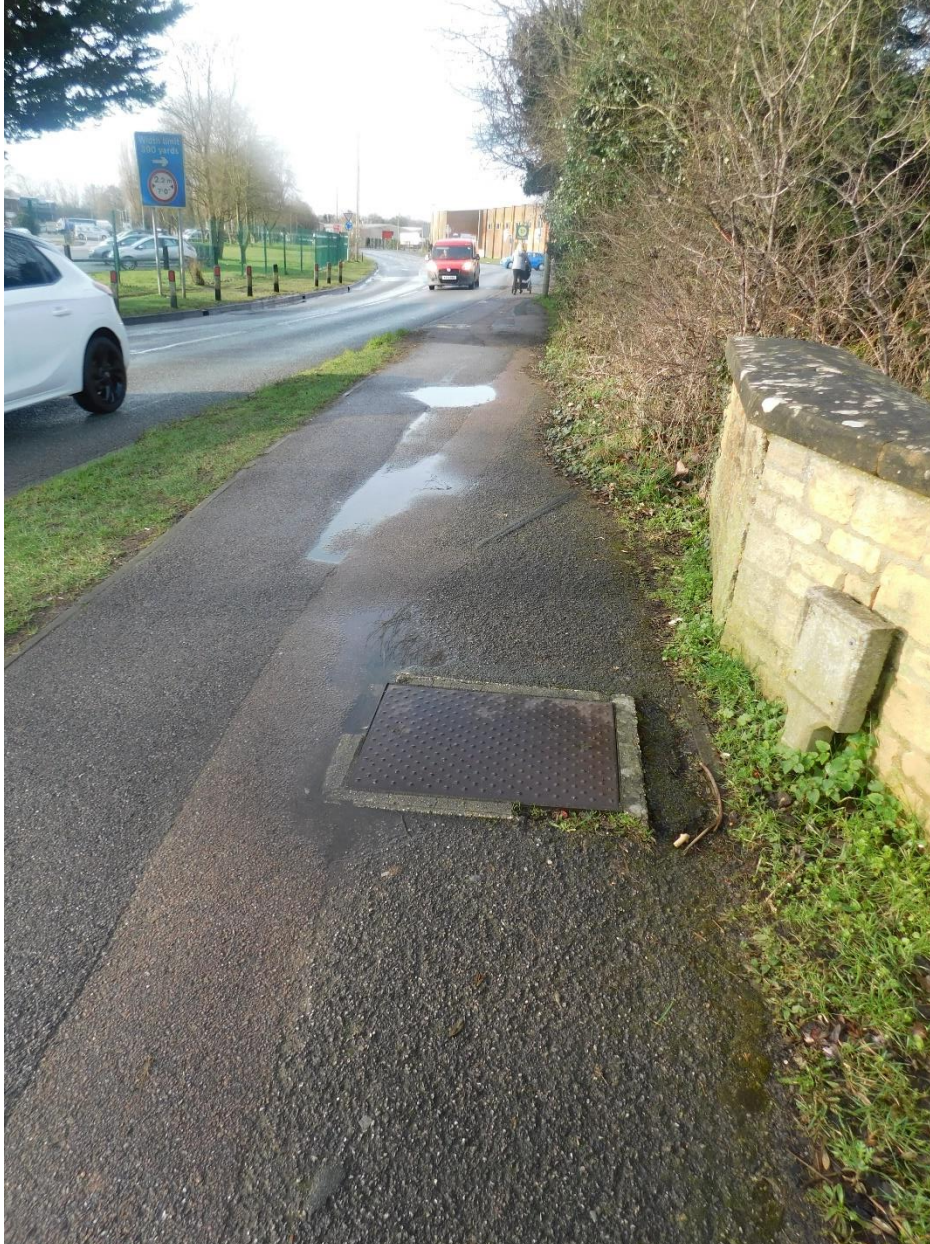
Figure 35: Route 2 - Lauton Road

These cycle paths are of good condition, with separation lines for cyclists and pedestrians and was well sign posted. This separation between pedestrians and cyclists ends at the junction with Boston Road where the route continues on Lorton Road where path becomes narrow and would be difficult for pedestrians and cyclists to share the path. There is some minor issues including uneven surface and

surface uplift but would not cause concerns for cyclists.

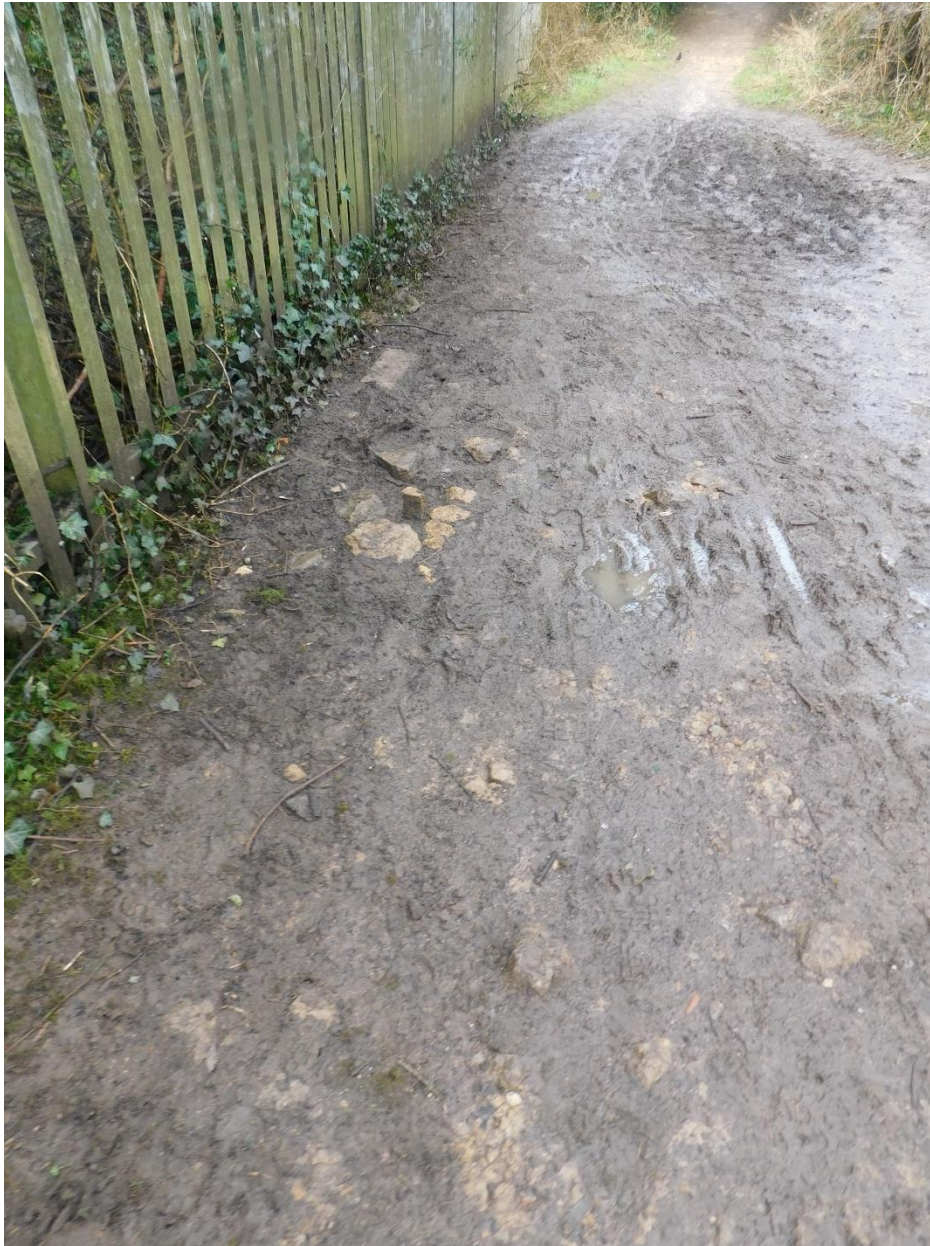
Figure 38: Route 3 - Cycle way Issues

As you follow the footpath west it is unpaved and therefore not in good condition for cycling as whilst on site it was very muddy and wet with no lighting. There was stones sticking out the mud which could damage cycle tyres. There was also fallen vegetation on the path and it was very uneven and narrow.

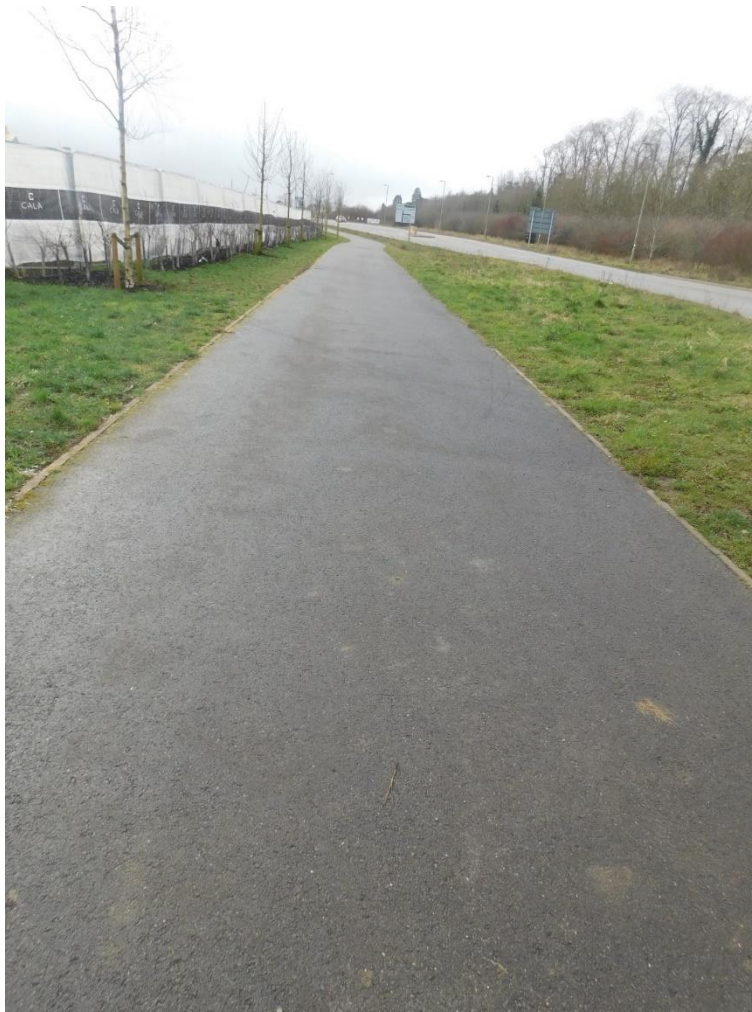
Figure 39: Route 3 - Vendee Drive

Vendee Drive is in excellent condition for cycling, with wide footways, street lighting and is separated from the carriageway by a green verge. Towards the south of Vendee drive there is no cracking and surface uplift at the edge which could cause some issues if left.
