LAND AT NORTH WEST BICESTER

STAGE 1 RSA DESIGNER'S RESPONSE (A4095)

PROJECT NO. 4600/1100 DOC NO. D017

Stage 1 Road Safety Audit
Howes Lane junction with Bucknell Road, Bicester
Proposed Mini Roundabout

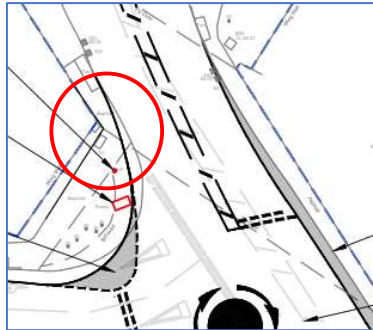
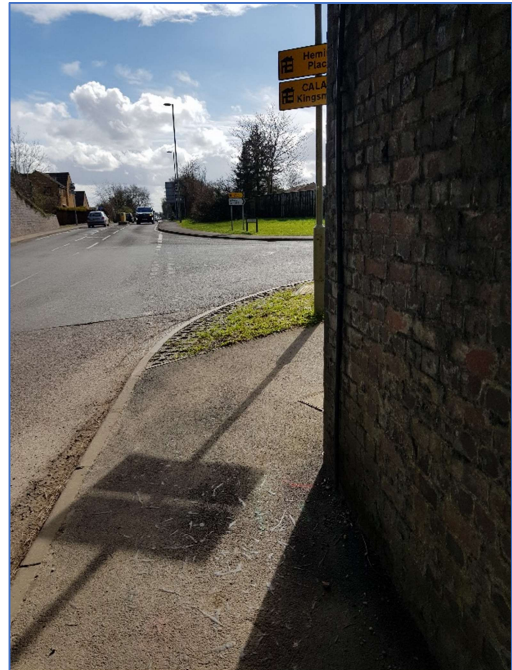
Item	Problem	Auditor's Recommendation	Designer's Response	OCC Response
4.1	<p>Location: On Bucknell Road – northern arm of the junction</p> <p>Summary: Reduced footway width may lead to pedestrian to vehicle collisions</p> <p>The realigned kerb of the northern exit arm of Bucknell Road, produces a reduced footway width on the western side of the road. The design sketch appears to show a footway width of approximately 1m. The reduced footway width may lead to pedestrians walking in the carriageway to pass others on the footway. This may lead to pedestrian to vehicle collisions. This may be exacerbated by the restricted inter-visibility between opposing pedestrians at this location, due to the railway bridge wing wall.</p> <p>The reduced footway width may bring pedestrians closer to the carriageway edge, and the wing mirrors of large vehicles may overhang the footway resulting in wing mirror strikes to pedestrians.</p>	<p>It is recommended that measures are introduced to provide a footway width that enables opposing users to pass without entering carriageway areas; measures may include the realignment of kerb lines.</p>	<p>The RSA comment on the footway amendment is noted but not accepted.</p> <p>The proposed kerbs have been aligned in order to allow for heavy goods vehicles (HGVs) and other vehicles to turn left from the A4095 Howes Lane onto Bucknell Road without incursion into the southbound lane of Bucknell Road.</p> <p>Whilst this change has reduced the effective footway width, it is noted that there is very little (if any) pedestrian demand in this location, with no pedestrians observed using this route within the traffic surveys undertaken 02/02/2022. On that basis, the likelihood of any conflict between pedestrians is minimal.</p> <p>It is also noted that the footway is reduced to a minimum of 1m for a very limited stretch, which still accords with the minimum requirements set out within Department for Transport (DfT) Inclusive Mobility Guidance (2002).</p> <p>In addition, the proposals improve the pedestrian footway provision along the eastern kerb of Bucknell</p>

Location: On Bucknell Road – northern arm of the junction

Summary: Reduced footway width may lead to pedestrian to vehicle collisions

The realigned kerb of the northern exit arm of Bucknell Road, produces a reduced footway width on the western side of the road. The design sketch appears to show a footway width of approximately 1m. The reduced footway width may lead to pedestrians walking in the carriageway to pass others on the footway. This may lead to pedestrian to vehicle collisions. This may be exacerbated by the restricted inter-visibility between opposing pedestrians at this location, due to the railway bridge wing wall.

The reduced footway width may bring pedestrians closer to the carriageway edge, and the wing mirrors of large vehicles may overhang the footway resulting in wing mirror strikes to pedestrians.

<p>Road, where the greatest pedestrian demand was observed.</p> <p>On that basis, no changes are proposed to the design and if any were, it might be to remove the provision of the pedestrian footway on the western side of the Bucknell Road and the northern side of Howes Lane completely, thus preventing the opportunity for any pedestrians to utilise the crossing or the existing footway provision when there is considered to be no demand for this.</p>

It is recommended that measures are introduced to provide a footway width that enables opposing users to pass without entering carriageway areas; measures may include the realignment of kerb lines.

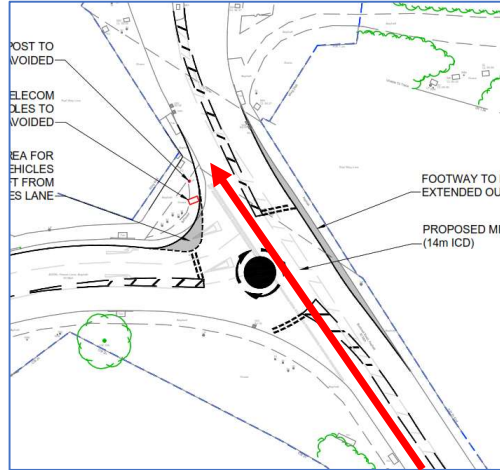
4.2	<p>Location: At the mini roundabout, northbound travel through the junction</p> <p>Summary: Excessive entry path through the junction may lead to vehicle to vehicle collisions</p> <p>The offset central island location produces an excessive vehicle path through the junction for northbound users. This may lead to drivers failing to appropriately 'negotiate' the central island. Poor compliance with the circulatory requirements of the junction may lead to vehicle to vehicle collisions.</p>	<p>It is recommended that the size and location of the central island is amended to encourage appropriate circulatory movements for all turning manoeuvres. Measures may include a reduction in central island diameter, realignment of the eastern kerb realignment and a reduction of the circulatory carriageway width</p>	<p>The RSA comment on the alignment of the mini roundabout is noted but not accepted.</p> <p>The current location and arrangement of the central island is to allow for access through the mini roundabout for southbound HGVs turning right onto the A4095 Howes Lane. In addition, it is considered that with appropriate signage (details confirmed at the Detailed Design stage), drivers will be notified of the new junction layout.</p>

Location: At the mini roundabout, northbound travel through the junction

Summary: Excessive entry path through the junction may lead to vehicle to vehicle collisions

The offset central island location produces an excessive vehicle path through the junction for northbound users. This may lead to drivers failing to appropriately 'negotiate' the central island. Poor compliance with the circulatory requirements of the junction may lead to vehicle to vehicle collisions.

It is recommended that the size and location of the central island is amended to encourage appropriate circulatory movements for all turning manoeuvres. Measures may include a reduction in central island diameter, realignment of the eastern kerb realignment and a reduction of the circulatory carriageway width.

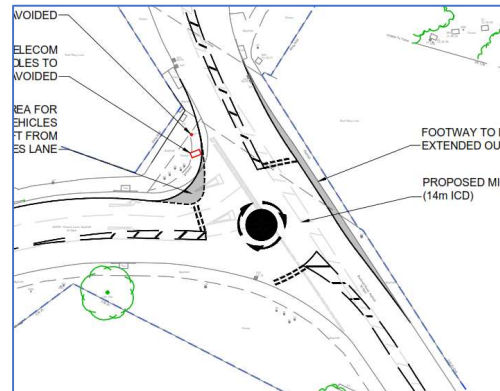
4.3	<p>Location: At the mini roundabout</p> <p>Summary: Construction joint issues may lead to loss of control type collisions</p> <p>The construction joint of the existing junction will fall within the circulatory carriageway area of the junction.</p>	<p>It is recommended that measures are introduced to ensure the integrity of the existing construction joint. Measures may include the resurfacing of the junction area to remove the construction joint</p>	<p>The RSA comment on the construction joint is noted and accepted.</p> <p>The details to ensure the integrity of the existing construction joint will be addressed at the Detailed Design</p>

<p>Large turning vehicles will increase stresses on the construction joint, which may lead to deterioration of the joint and pot holes within turning areas for vehicles. Poor carriageway surfaces within turning areas will increase the likelihood of loss of control type collisions, particularly for two-wheeled users.</p>	within likely stress areas	<p>stage.</p> <p>If it is considered necessary to resurface the junction area, this will be identified.</p>

Location: At the mini roundabout

Summary: Construction joint issues may lead to loss of control type collisions

The construction joint of the existing junction will fall within the circulatory carriageway area of the junction. Large turning vehicles will increase stresses on the construction joint, which may lead to deterioration of the joint and pot holes within turning areas for vehicles. Poor carriageway surfaces within turning areas will increase the likelihood of loss of control type collisions, particularly for two-wheeled users.

It is recommended that measures are introduced to ensure the integrity of the existing construction joint. Measures may include the resurfacing of the junction area to remove the construction joint within likely stress areas.

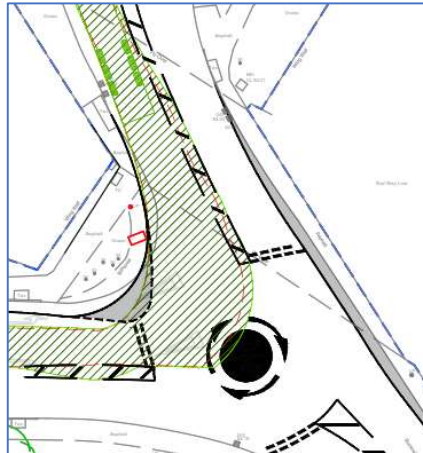
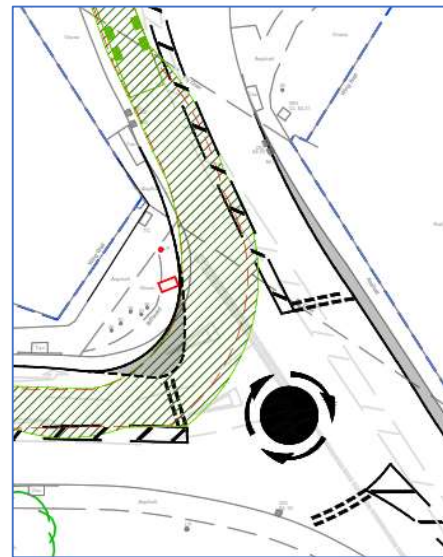
4.5	<p>Location: At the mini roundabout</p> <p>Summary: Swept path of large vehicles may lead to vehicle to vehicle collisions</p> <p>Whilst on site, the audit team noted that the drivers of large vehicles over-ran the central hatched area and opposing traffic lane when making a left turn manoeuvre from Howes Lane on to Bucknell Road. The swept path drawings provided indicate that drivers of large vehicles may have to carry out a precise left turn manoeuvre to avoid over-running the opposing traffic lane or striking nearside kerbs. This manoeuvre may lead to vehicle to vehicle collisions with the introduction of the mini roundabout and revised kerb line of the eastern side of Bucknell Road.</p>	<p>It is recommended that measures should be introduced to minimise the likelihood of large vehicle swept paths crossing the hatched areas and entering the opposing traffic lane; measures may include widening the hatched markings separating the two traffic streams, reducing the southbound traffic lane width, and amending the eastern kerb line</p>	<p>The RSA comment is noted but not accepted.</p> <p>The width of the existing southbound lane on Bucknell Road has been widened, with additional kerb alignment changes to the northbound lane in order to maximise the carriageway space available and prevent vehicles and HGVs travelling over the centreline.</p> <p>The proposals are considered to be the most appropriate within the constraints of the railway bridge to reduce conflict between vehicles</p> <p>The 'AutoTrack' vehicle tracking</p>

<p>software used contains safety allowances within the software, meaning in 'real life' situations a vehicle will be able to turn with greater ease and would be less onerous.</p> <p>No changes are therefore proposed to the current arrangement.</p>

Location: At the mini roundabout

Summary: Swept path of large vehicles may
lead to vehicle to vehicle
collisions

Whilst on site, the audit team noted that the drivers of large vehicles over-ran the central hatched area and opposing traffic lane when making a left turn manoeuvre from Howes Lane on to Bucknell Road. The swept path drawings provided indicate that drivers of large vehicles may have to carry out a precise left turn manoeuvre to avoid over-running the opposing traffic lane or striking nearside kerbs. This manoeuvre may lead to vehicle to vehicle collisions with the introduction of the mini roundabout and revised kerb line of the eastern side of Bucknell Road.

It is recommended that measures should be introduced to minimise the likelihood of large vehicle swept paths crossing the hatched areas and entering the opposing traffic lane; measures may include widening the hatched markings separating the two traffic streams, reducing the southbound traffic lane width, and amending the eastern kerb line.

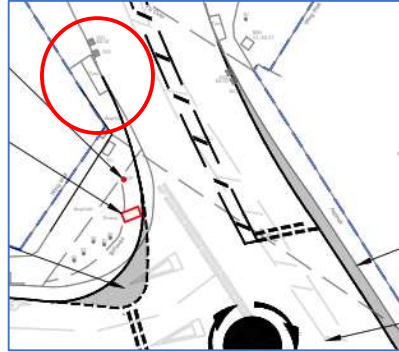
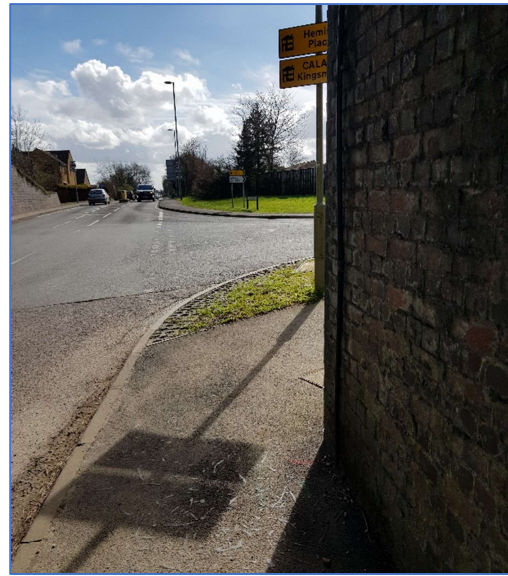
4.6	<p>Location: On Bucknell Road – northern arm of the junction western crossing point</p> <p>Summary: Restricted inter-visibility may lead to pedestrian to vehicle collisions</p> <p>The relocation of the give way line back into Howes Lane means that inter-visibility between a pedestrian waiting at the existing crossing point on the western side and a driver turning left from Howes Lane will be further restricted (existing inter-visibility between users is poor). This may lead to an increased likelihood of pedestrian to vehicle collisions.</p>	<p>It is recommended that the existing crossing point is relocated to a point where appropriate adequate inter-visibility can be achieved. It may be appropriate to extend the footway on the western side of Bucknell Road and provide a dropped kerb crossing point at the splitter island of the Lords Lane roundabout.</p>	<p>The RSA comment is acknowledged but not accepted.</p> <p>It is noted that the intervisibility for pedestrians is an existing constraint, with the collision data suggesting this has not led to any accidents occurring in the latest 5-year period.</p> <p>In addition, it is noted that no pedestrians were observed using this crossing in the observed traffic surveys undertaken, meaning the likelihood of any conflict is low given there is currently little (if any) demand.</p> <p>If required by OCC, the feasibility of a relocated crossing could be determined at the Detailed Design stage. Alternatively, the pedestrian facilities on the western side of Bucknell Road and the northern side of Howes Lane, could be removed completely.</p>

Location: On Bucknell Road – northern arm of the junction western crossing point

Summary: Restricted inter-visibility may lead to pedestrian to vehicle collisions

The relocation of the give way line back into Howes Lane means that inter-visibility between a pedestrian waiting at the existing crossing point on the western side and a driver turning left from Howes Lane will be further restricted (existing inter-visibility between users is poor). This may lead to an increased likelihood of pedestrian to vehicle collisions.

It is recommended that the existing crossing point is relocated to a point where appropriate adequate inter-visibility can be achieved. It may be appropriate to extend the footway on the western side of Bucknell Road and provide a dropped kerb crossing point at the splitter island of the Lords Lane roundabout.
