# **BS5837:2012 ARBORICULTURAL IMPACT ASSESSMENT & METHOD STATEMENT**

LAND AT TAPPERS FARM,  
OXFORD ROAD, BODICOTE, BANBURY,  
OXFORDSHIRE, OX15 4BN

**GREENSQUARE HOMES LTD**

### **BS5837:2012 Arboricultural Impact Assessment (AIA) & Method Statement**

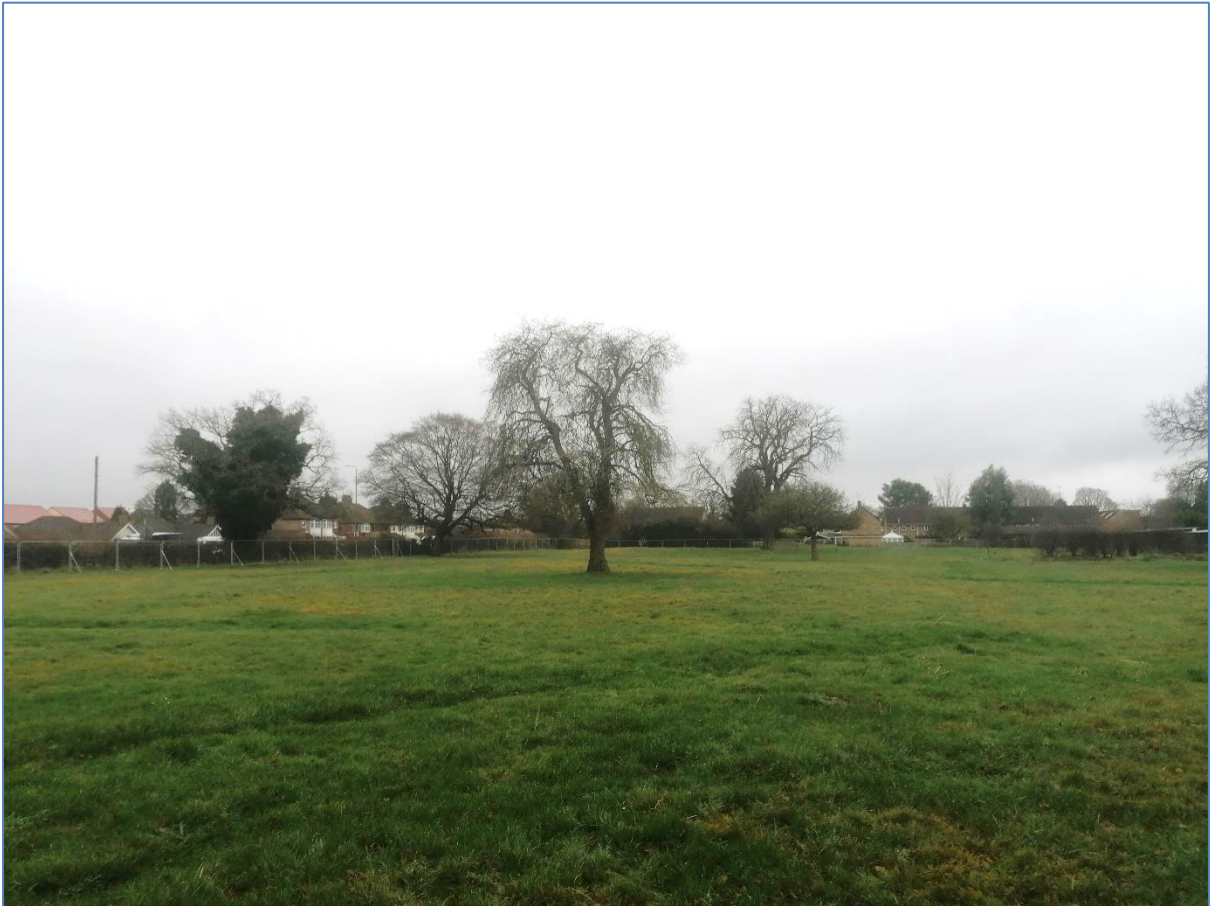
*Aesculus x carnea* is not a long-lived species and given the life stage of the tree and structural defects noted on the stem and within the crown, it is unlikely that the tree has more than 10 years useful life expectancy remaining. As such, extensive redesigning of the site to retain the tree within a public open space is likely to result in a dead or partially collapsed tree within a focal position of the site within 10 years.

**Plate 8:** central location and reduced form of T8.

Furthermore, the loss of the tree will not have a significant impact on the character and appearance of the wider area, and therefore the proposed development seeks to remove and replace the tree to improve the quality of the layout of the site and provide an improved replacement TPO tree for future generations.

The loss of the horse chestnut tree T8 has been specifically considered within the landscape proposals, with a clear stem *Liquidambar* tree (14 – 16cm girth, 4.5 – 5m height) planted as a specimen tree within public open space south of Plot 43 to provide internal visual amenity benefits. Given the proximity to the front garden of Plot 43 and concerns this may present future requests for crown management, the replacement TPO has been presented west of the site entrance, the walnut tree (*Juglans regia* 14 – 16cm, 4.5 – 5m) which has ample room from adjacent plots and is located within a prominent position framing the site entrance.

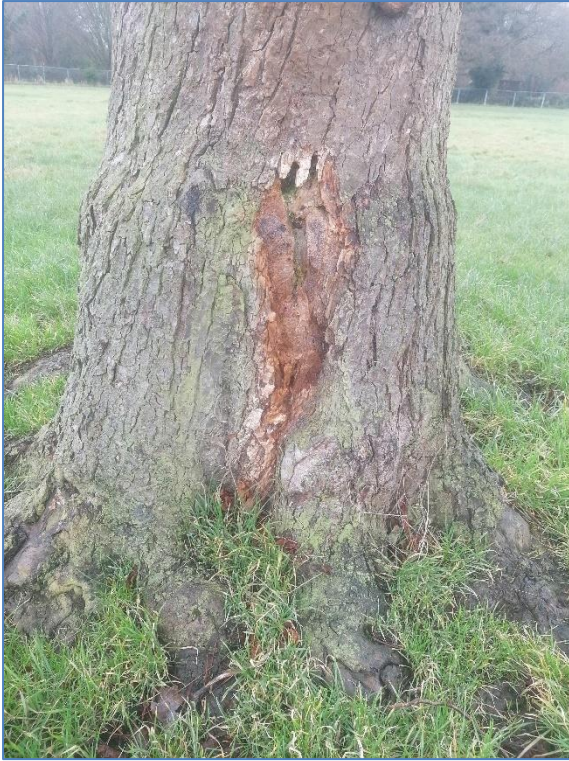
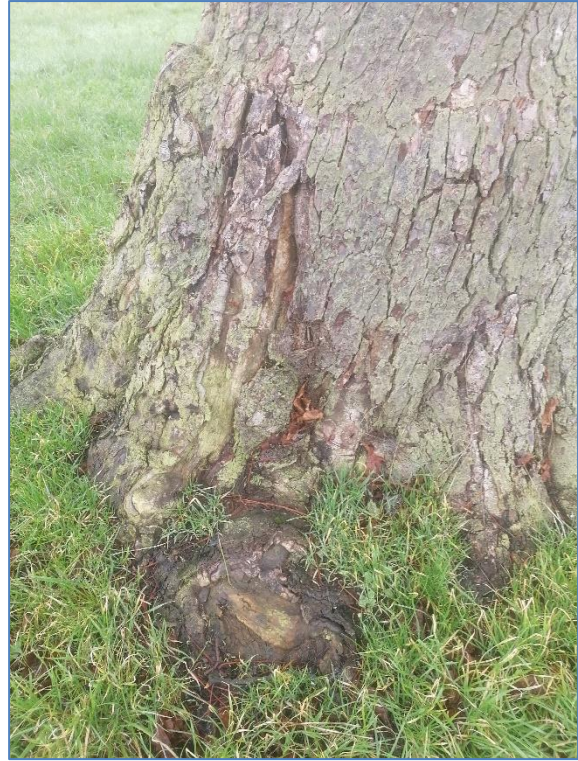
Close inspection of the tree found basal damage and decay from livestock impacts, bark necrosis and major stem canker formation on the main stem, seven large diameter target cankers on co-dominant stems and the scaffold limbs of the tree; two of which were at the base of major stem of scaffold limbs unions.

**Plate 9 & 10:** bark necrosis and major canker formation on the stem of T8 (left) root damage and basal decay (right).

T8 (TPO)	Red horse chestnut	<i>Aesculus x carnea</i>	Mature	15	760	6.5	6.5	6	5.5	2	Poor	Fair	10 to 20	Livestock damage to buttress roots. Bark necrosis and canker formation on stem. Epicormic growth on stem. Extensive target cankers, cavities and deadwood present throughout structure.	B	9.1	261

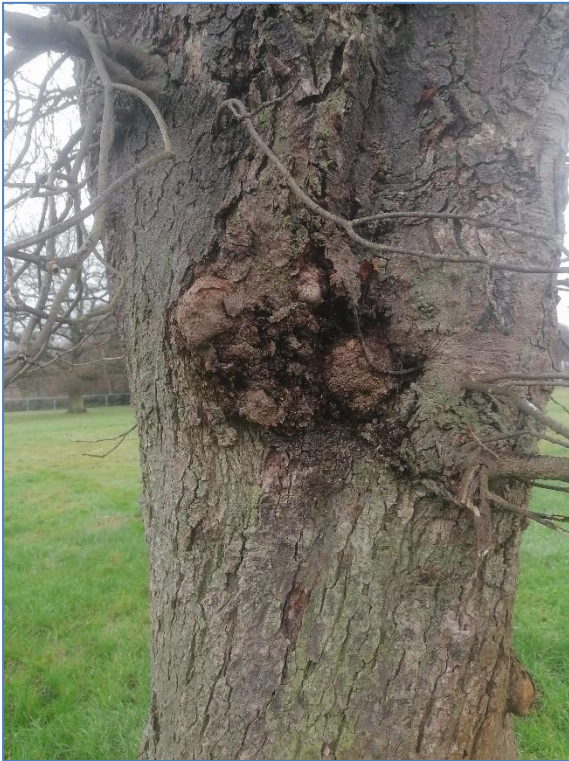
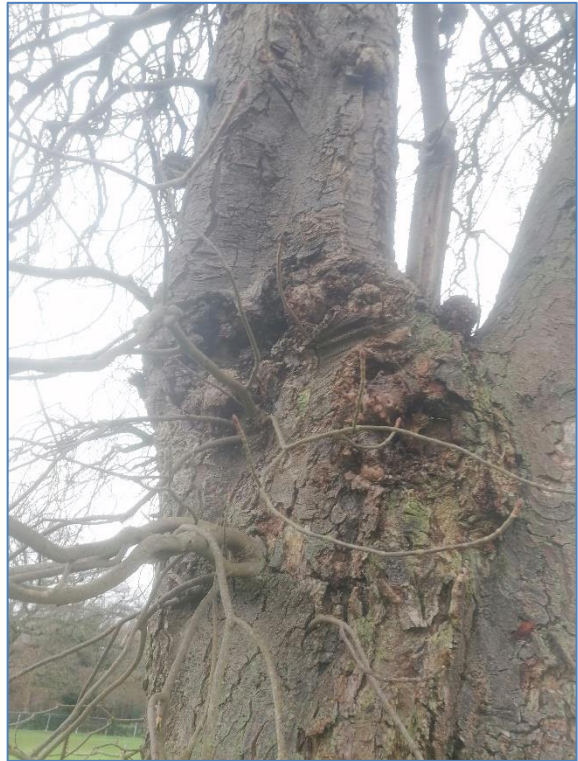
**Plates 11 & 12:** target cankers at the base of and within acute angle co-dominant stem attachments on T8.

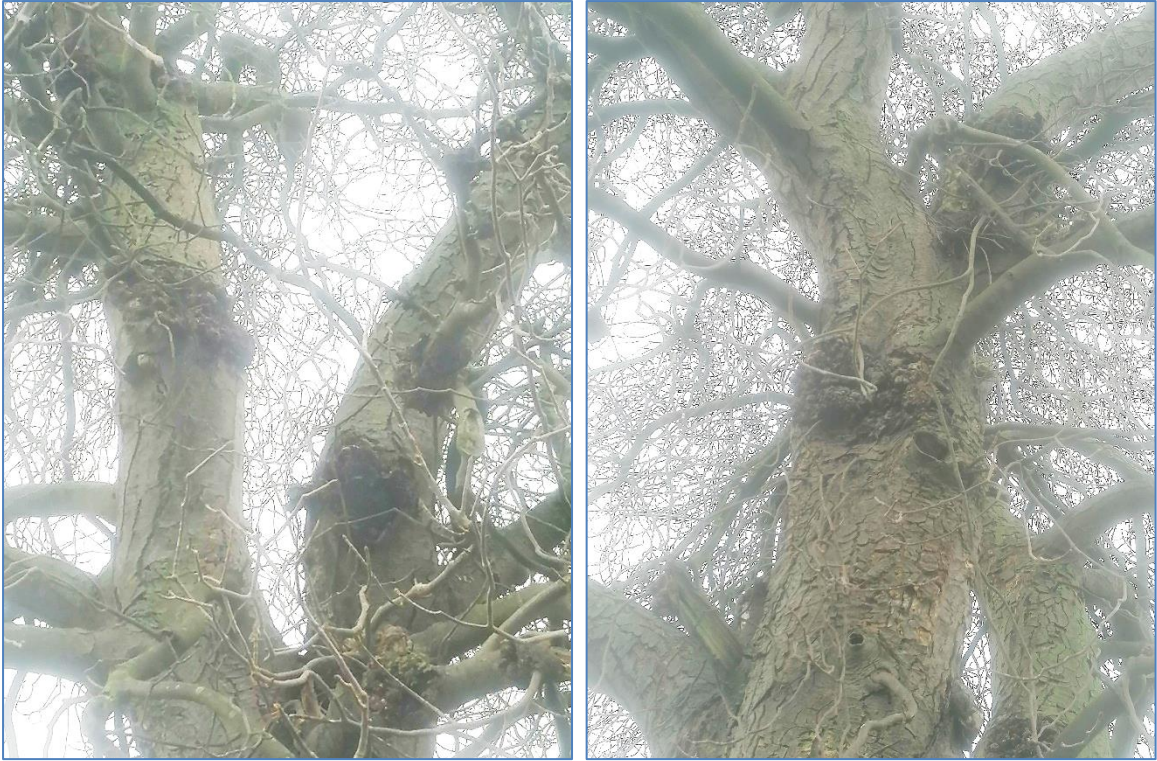
The species *Aesculus x carnea* (Red horse chestnut) is a grafted hybrid, not true to species, and is well known for developing extensive cankers into maturity which coupled with the inherent characteristics of brittle wood and acute angle branch attachments mean the species are liable to significant limb or whole crown failure in later life stages.

**Plates 13 & 14:** further cankers and structural defects noted within the crown of T8.

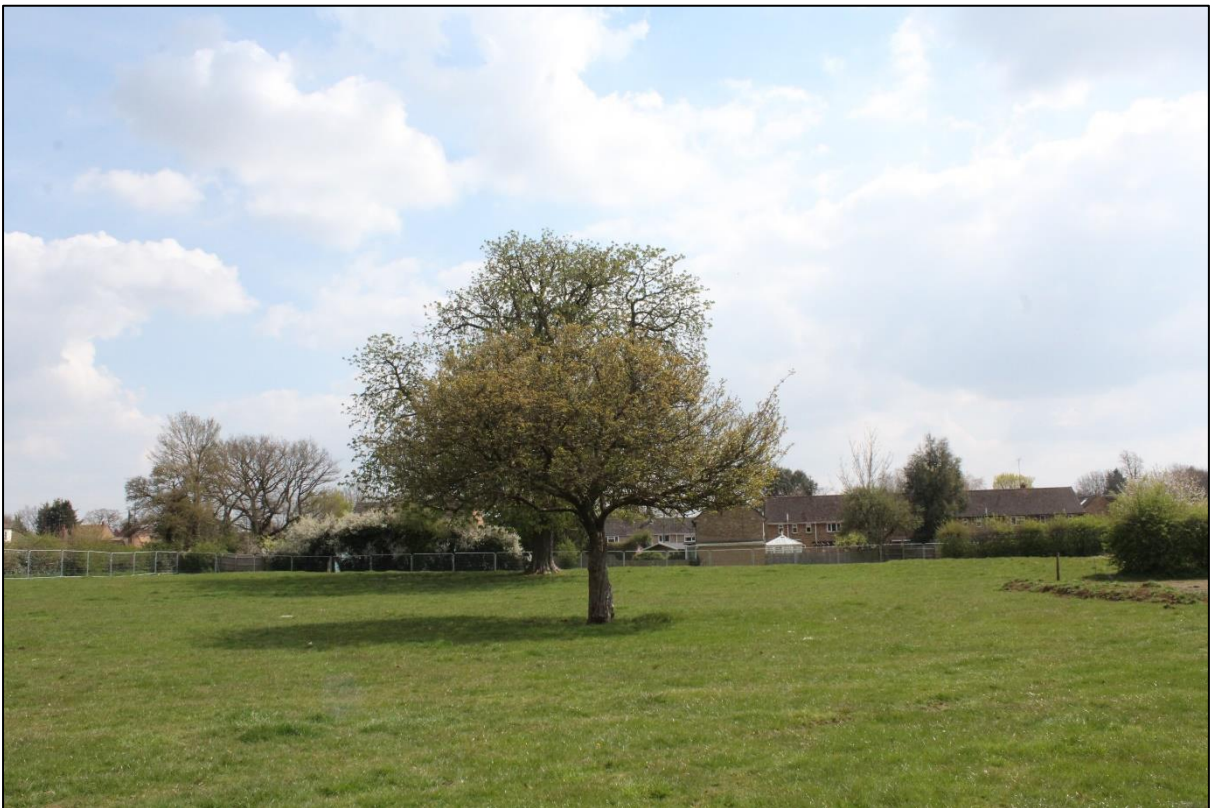
**Plate 15:** A Category 'C' hawthorn (T6) proposed for removal.

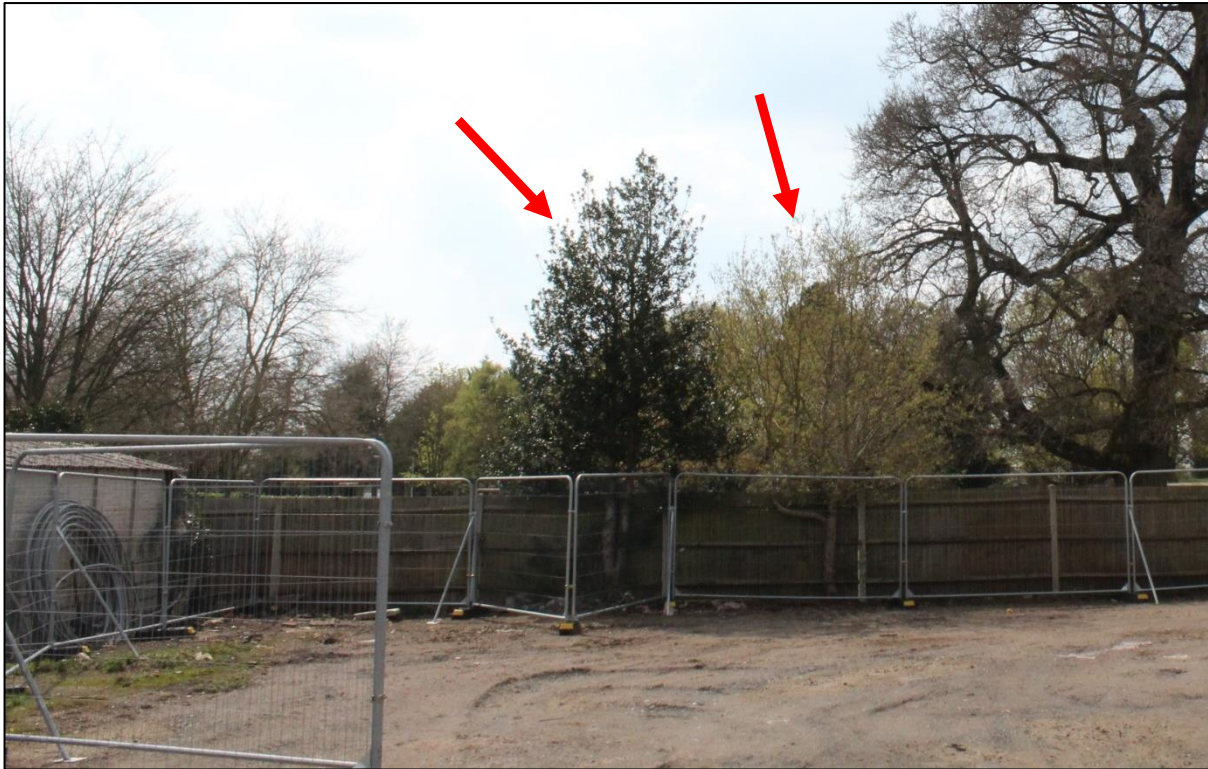
**Plate 16:** A Category 'C' holly (T14) and field maple (T15) proposed for removal.

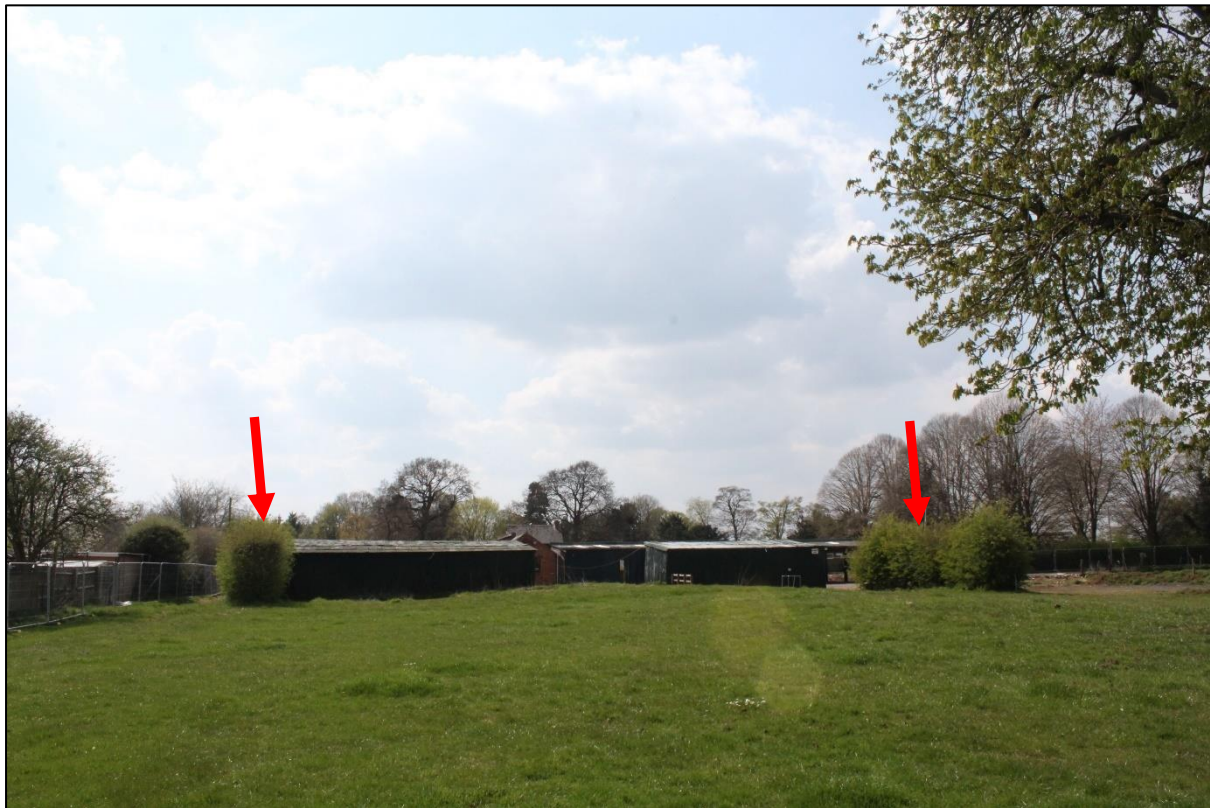
**Plate 17:** Two Category 'C' hawthorn hedgerows (H10 & H11) proposed for removal.

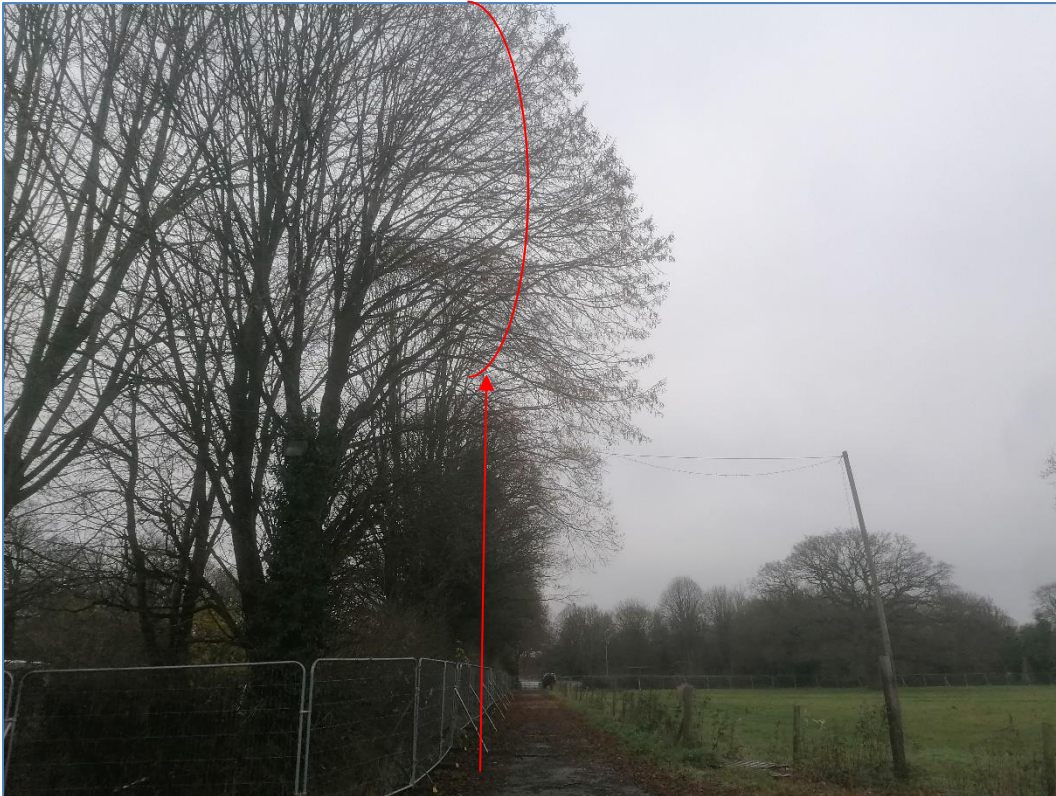
**Plate 20:** proposed 4m vertical clearance over site and 2m crown reductions to formalise boundary trees T18 – T35.

The offsite lime trees T18 – T35 will be crown lifted to 4m over the site (the majority have already been lifted to this height). Branch tips within the upper canopy will be reduced back to 3.5m from the tree stems (an average crown reduction of circa 2m) to formalise the boundary, reduce shading / overhang of private amenity spaces and allow future cyclical management. The pruning specification is in line with both British Standard 3998: 'Tree Work Recommendations', and common law rights.

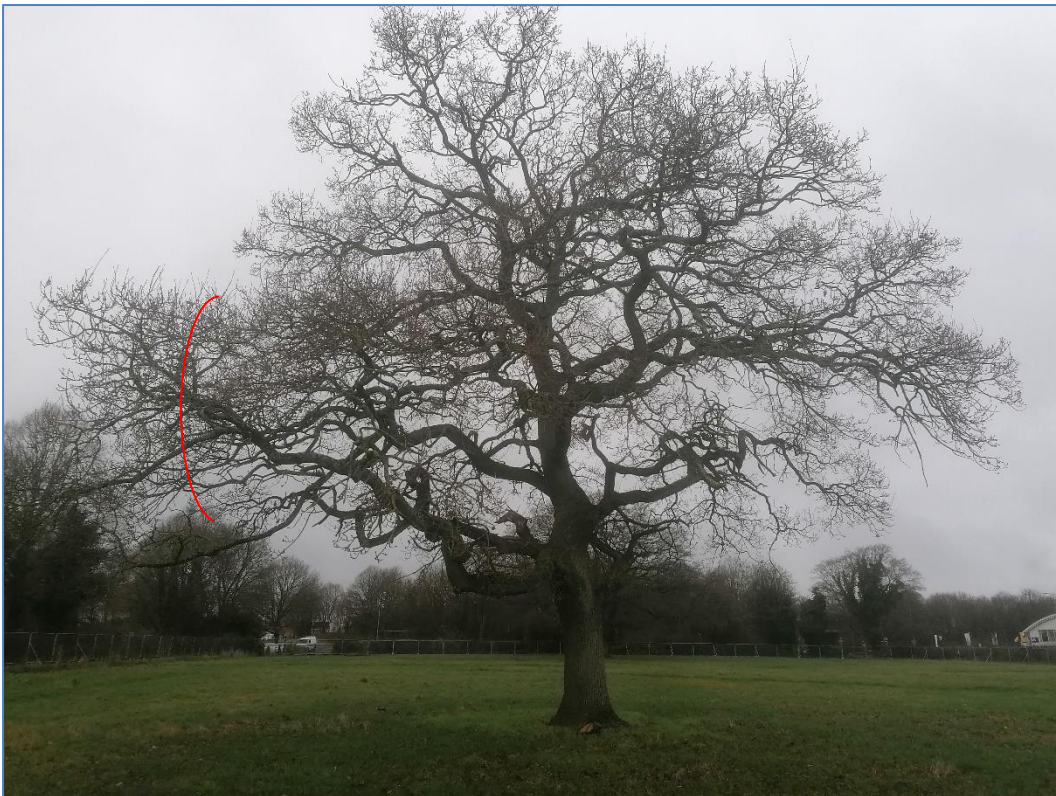
**Plate 21:** 2m crown reduction of extended lower lateral to balance form of T7.

The oak tree T7 will have the western aspect of the crown reduced by 1.5 – 2m, depending on the most suitable branch junction, by pruning the extended lowest lateral limb which extends beyond the crown extent and will be managed to balance and the form of the tree within the proposed amenity space.

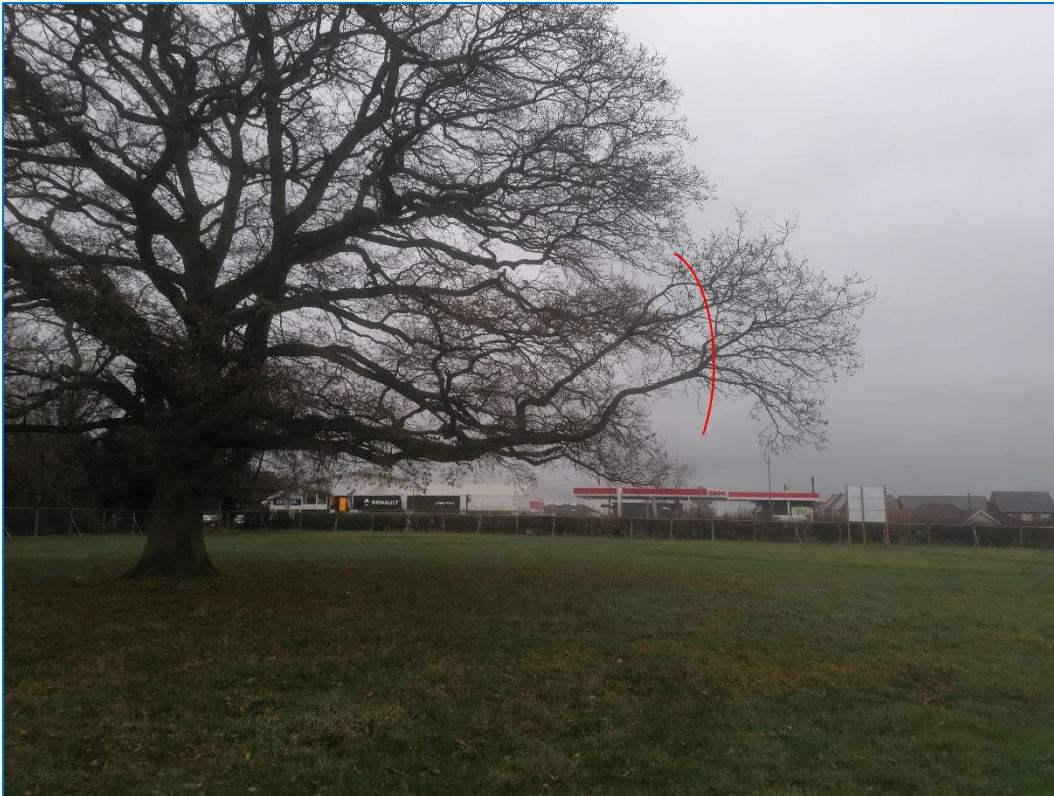
**Plate 22:** 2m crown reduction of extended lower lateral to balance form of T9.

The extended lower lateral limb of T9 will also be reduced by 2m on the southern aspect of the crown to balance the form of the tree and provide clearance from the proposed road.
