**Heyford Park
Dorchester Living: Phase 9
Remediation Earthworks Completion Report
For Urban Regen Ltd.
August 2021**

Report Ref: R1742-R23-v2

Report Title: Heyford Park, Dorchester Phase 9
Remediation Earthworks Completion Report

Client: Urban Regen Ltd

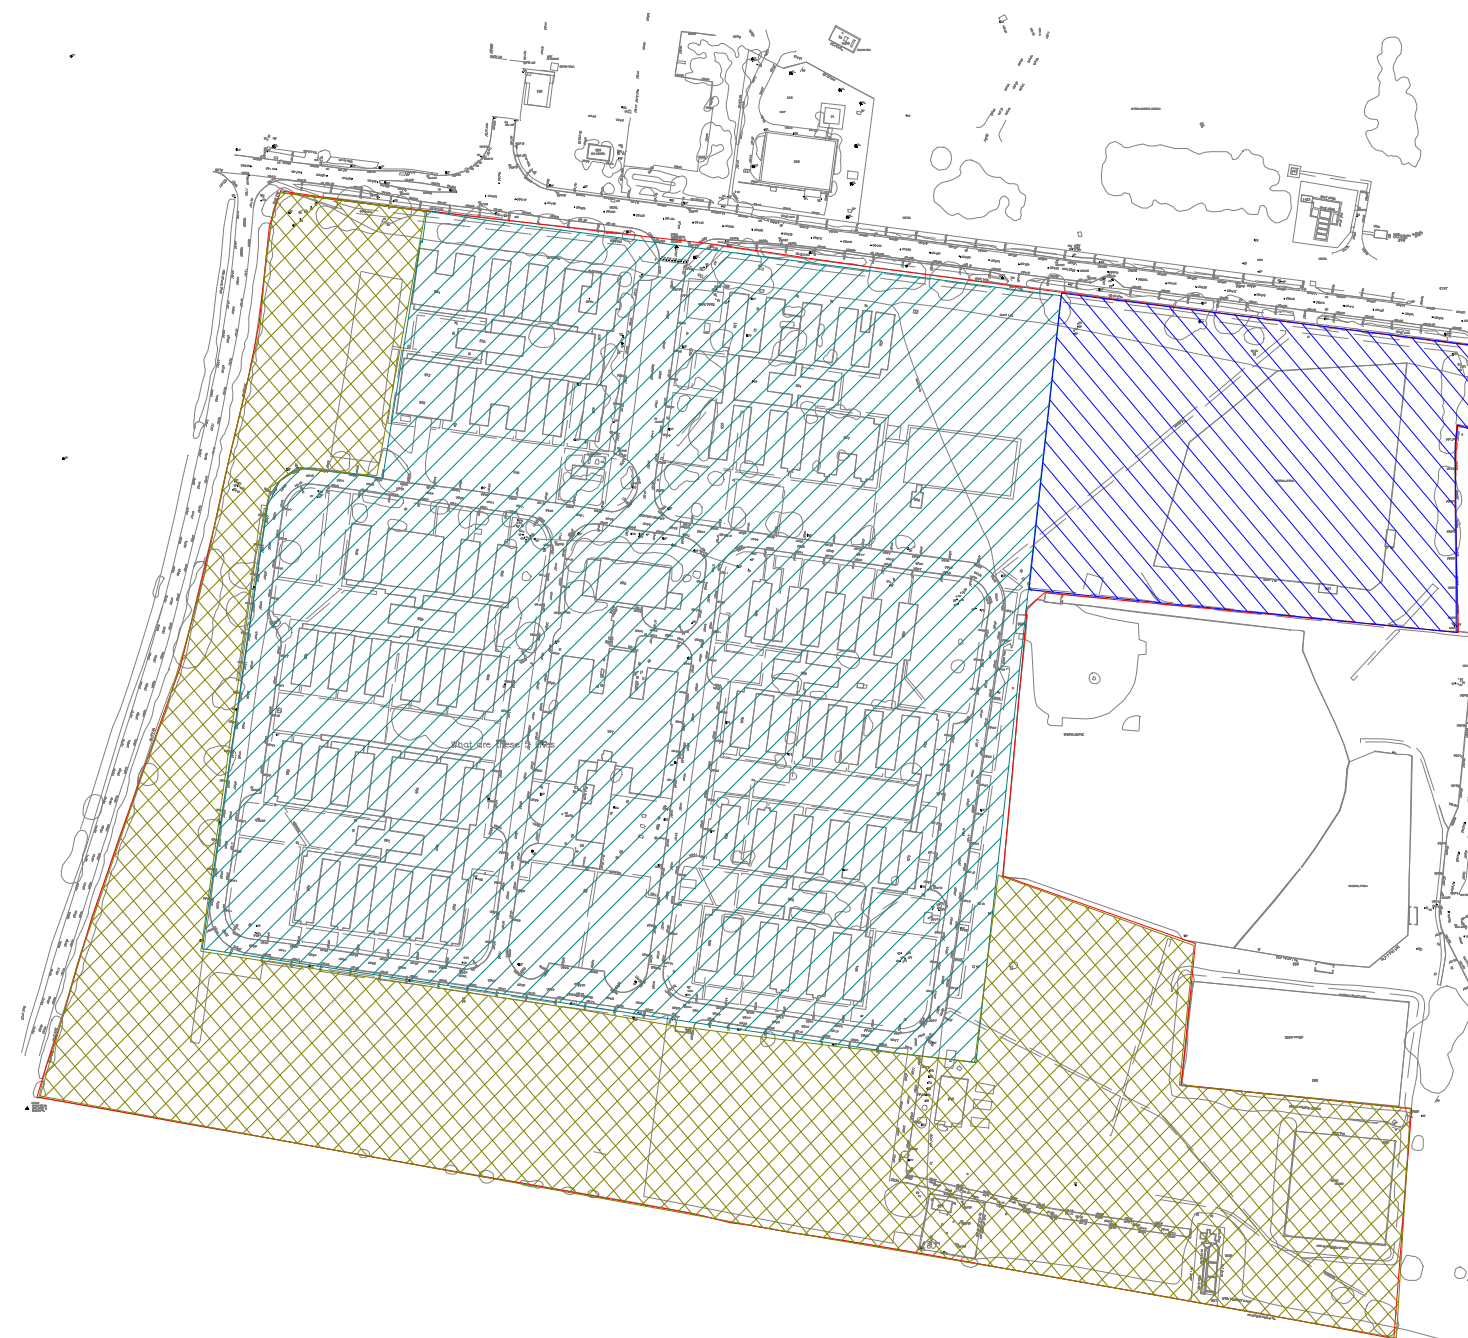
Job No: R1742b Drg No: R23-D01

Phase 9 Boundary
Extent of URL PH9 Remedial Works Reported within R1742-R23
PH9 Baseball Pitch Completed - Reported in R1742b-R22
Remedial Works Outstanding - To be completed at a later date

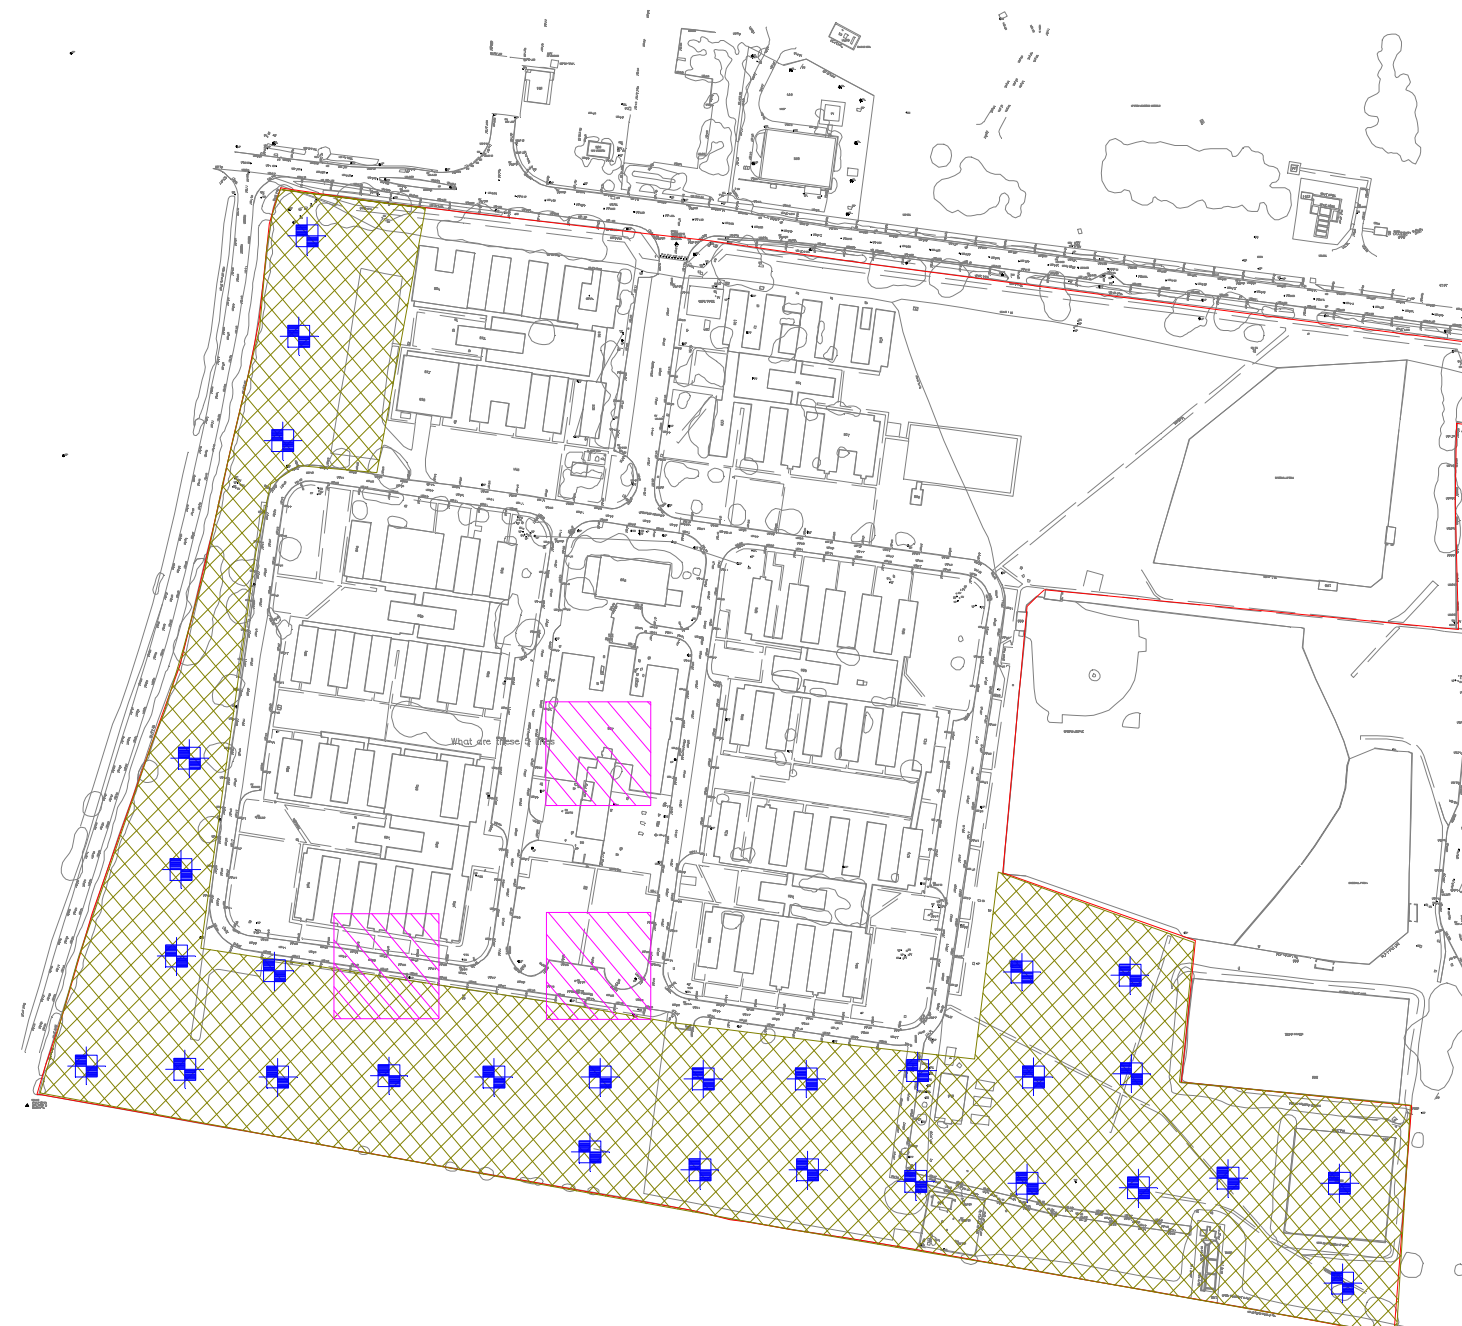
Job No: R1742b Drg No: R23-D04

- Phase 9 Boundary
- Remedial Works Outstanding - To be completed at a later date
- Outstanding Formation Validation - To be completed at a later date
- Precautionary surface strip from future gardens & additional PAH testing required

4.8.12 The overall risks to future residents from these minor isolated exceedances is considered low, however it is recommended due to the slight coal tar signature that a surface scrape is undertaken from future garden areas across these locations to allow removal of any remaining surface inclusions and supplemented by additional PAH testing following removal.

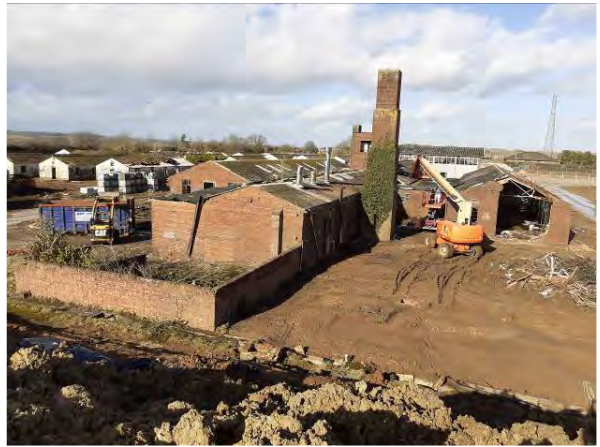
21.

16.02.21 – ACM strip from boiler house

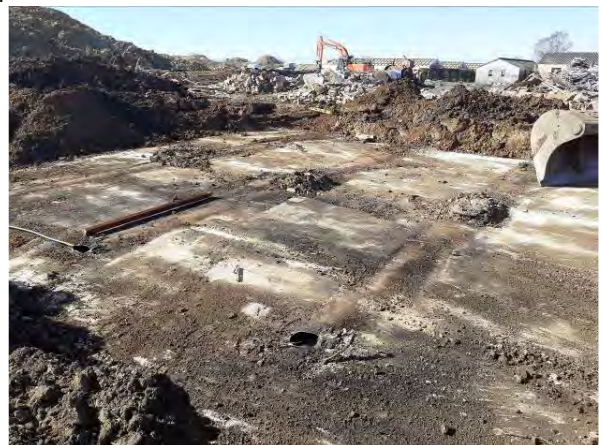
37.

4.5.5 Visual inspection of the base and sidewalls was undertaken with no staining or areas of free product observed. No odours were recorded from the excavation and screening of soils from the base and sidewall with a PID failed to exceed detection limits (<0.1ppm). A photographic record is provided in Appendix B.

09.03.21 – Exposure of USTs following demolition of boiler house

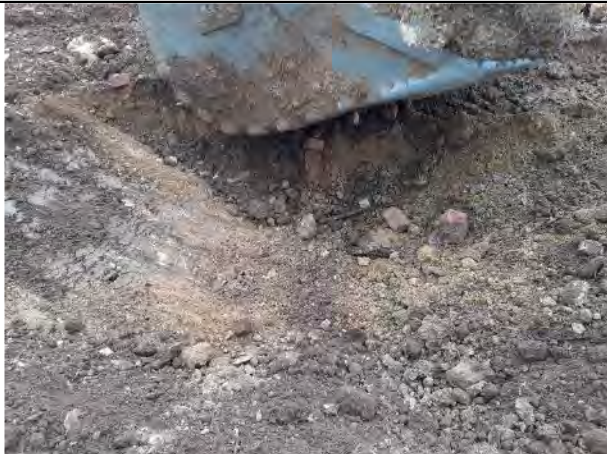
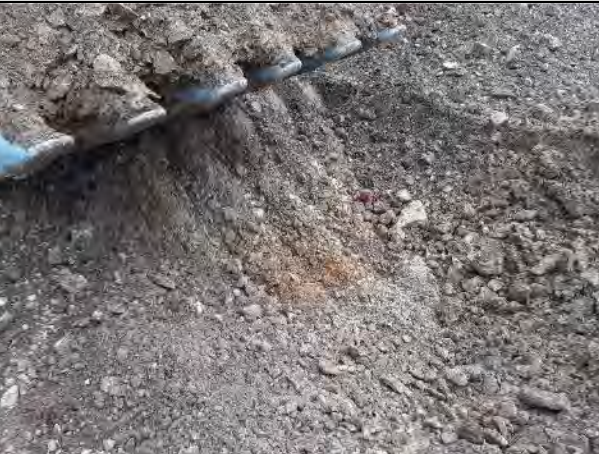
4.4.2 Following handpicking of visible ACM, SGP attended site and collected samples of the retained soils on a 1 per 5m² frequency for asbestos identification to assess whether any loose fibres remained within the soils.

4.4.3 During sampling the soils were inspected for any potential ACM, no such materials were observed with the soils consisting of re-worked sandy clay with coarse limestone gravel and

28.04.21 – Excavation to 0.6m bgl and collection of sample (S1) following completion of hand-picking. No visible ACM observed	28.04.21 - Excavation to 0.6m bgl and collection of sample (S2) following completion of hand-picking. No visible ACM observed	28.04.21 - Excavation to 0.6m bgl and collection of sample (S3) following completion of hand-picking. No visible ACM observed

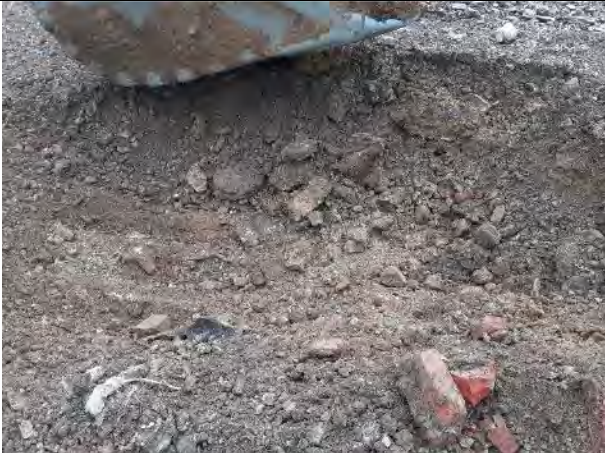
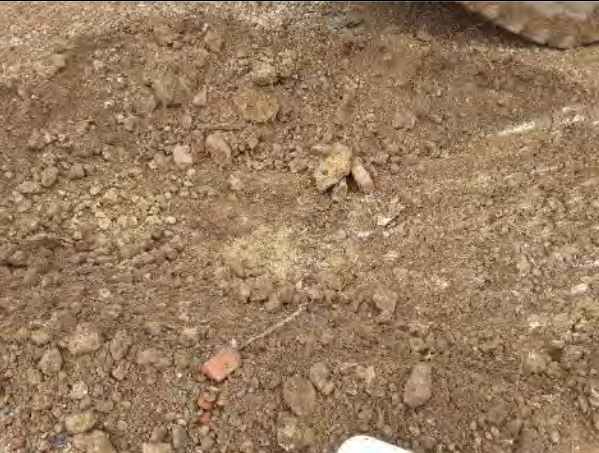
28.04.21 - Excavation to 0.6m bgl and collection of sample (S4) following completion of hand-picking. No visible ACM observed	28.04.21 - Excavation to 0.6m bgl and collection of sample (S5) following completion of hand-picking. No visible ACM observed	28.04.21 - Excavation to 0.6m bgl and collection of sample (S6) following completion of hand-picking. No visible ACM observed

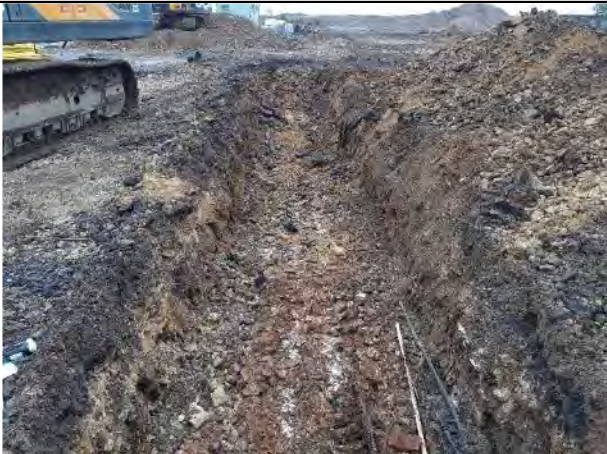
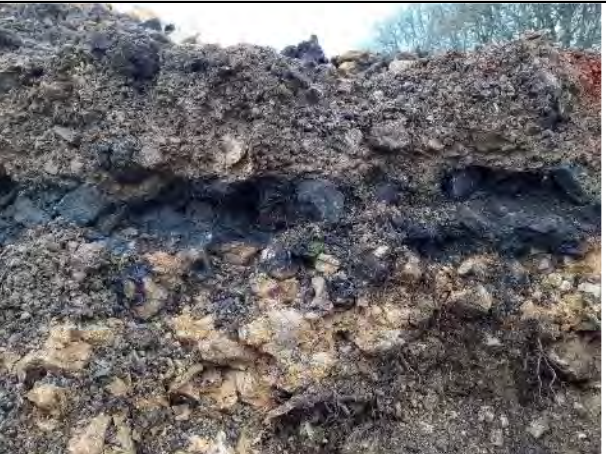
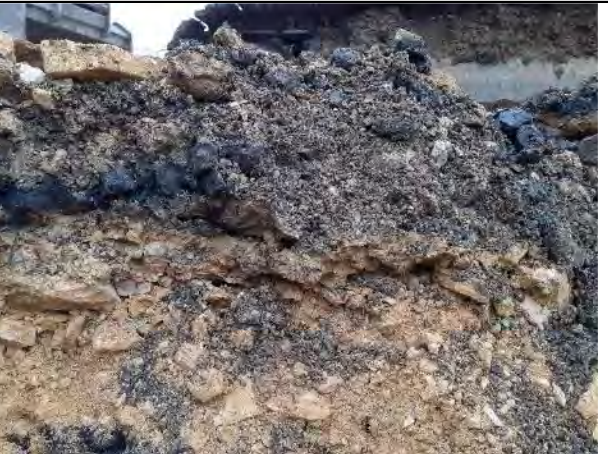
28.04.21 – Excavation of trench 1 within Hydrock hotspot area TP102.	28.04.21 – Black gravel present below surface cover of reworked natural (0-0.2m) and underlain by natural limestone gravel	28.04.21 – Black gravel within approximate area of former aerial mast, possible former base

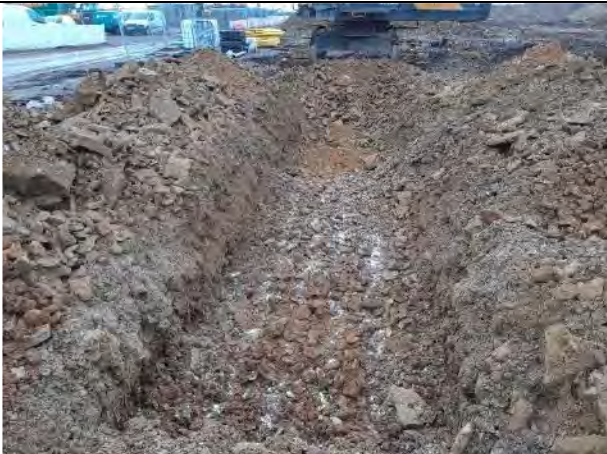
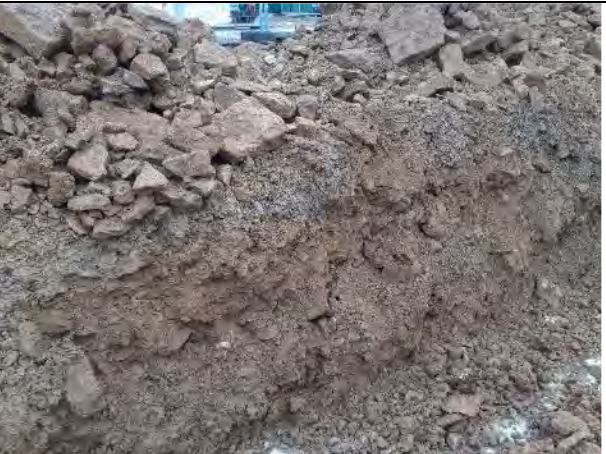
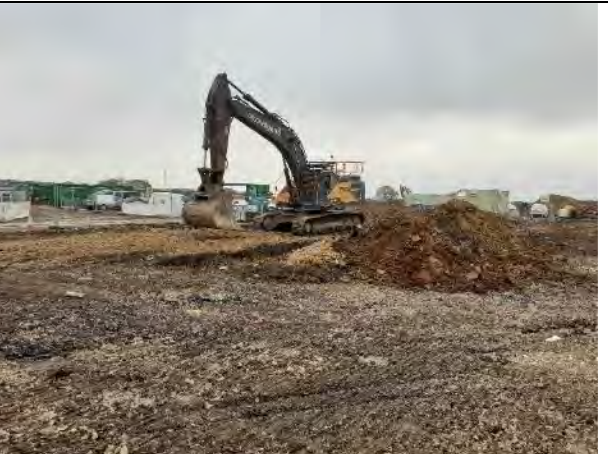
28.04.21 – Trench 2 excavated adjacent to access road into site, no black gravel encountered	28.04.21 – Natural strata of limestone gravel in clays soil (weathered bedrock) within trench confirming limited extend of area impacted by black gravel	28.04.21 – URL removal of black stained gravel
