Castle Street, Banbury

Flood Risk & Drainage Technical Note

Project No.	1260
Revision	B
Date	7 th December 2021
Client	Churchill Retirement Living
Prepared	L Blackmore
Checked	A Hanks
Authorised	C Yalden
File Ref.	P:\1260 Castle Street, Banbury\C Documents\Reports\1260 - Castle Street, Banbury - Flood Risk & Drainage Technical Note

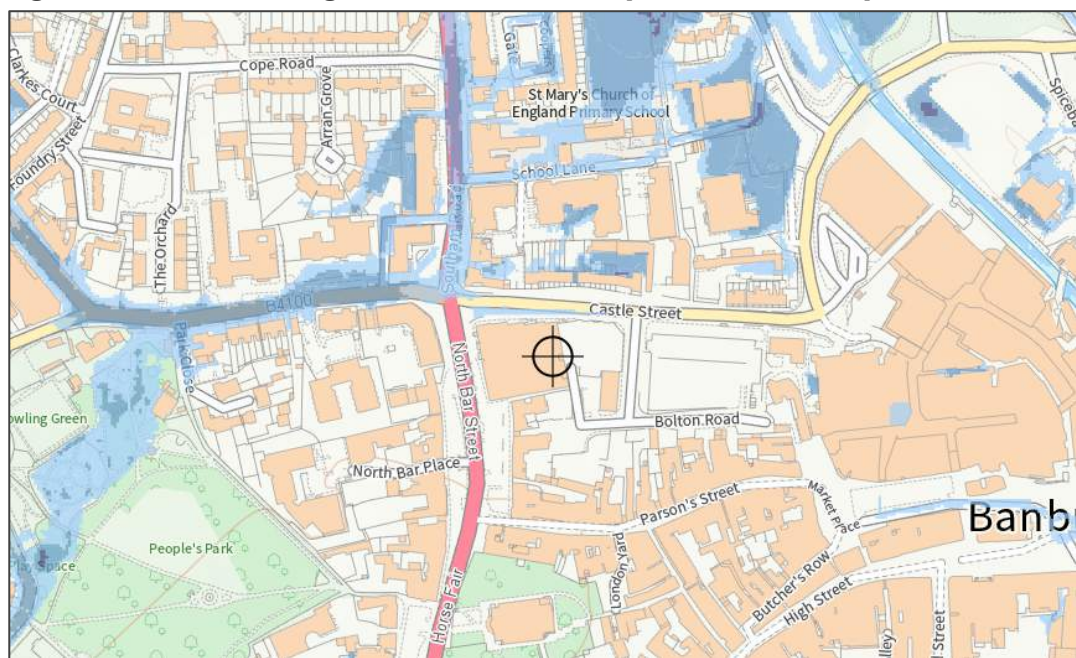
Figure 2.3 – EA Flooding from surface water (medium risk, 1%)

- 2.4 The mapping identifies that the northern boundary of the site may be susceptible to flooding below 300mm within the 100 year design life of the scheme (medium risk). The same area is indicated to be at risk of flooding greater than 300mm during the low risk event (beyond the 1 in 1,000 year event).
- 2.5 The developable extents of the site remain at a higher elevation above Castle Street and are therefore not at risk of flooding in either event.

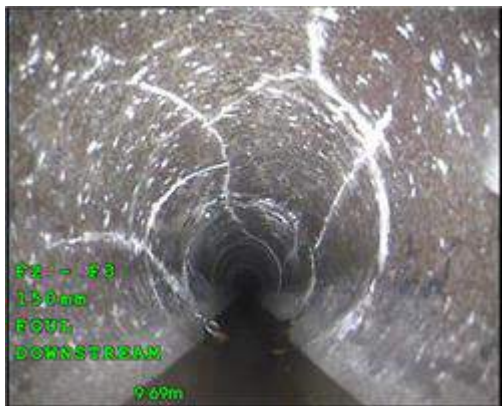
Section 2

Pos	Video Ref	Code	Description	Image
00.00m		MH	Start node type, manhole F2	
00.00m	0:00:00	WL	Water level: 5% Height/Diameter	
03.40m	0:00:32	CL	Crack, longitudinal at 12 o'clock - Severity 1	
06.95m	0:00:55	CL	Crack, longitudinal at 10 o'clock - Severity 1	
09.70m	0:01:17	S1 CM	Cracks, multiple 9.7m - 10.85m from 06 o'clock to 06 o'clock - Severity 2	Image Provided - Ref: 1_3

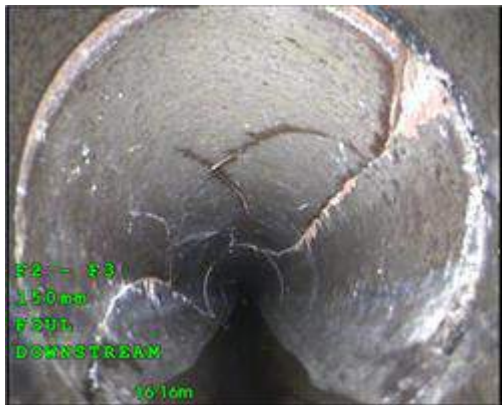
10.85m	0:01:17	F1 CM	Cracks, multiple Defect End from 06 o'clock to 06 o'clock - Severity 2	
12.16m	0:01:51	CL	Crack, longitudinal at 11 o'clock - Severity 1	
16.16m	0:02:24	CM	Cracks, multiple from 07 o'clock to 03 o'clock - Severity 2	Image Provided - Ref: 1_6

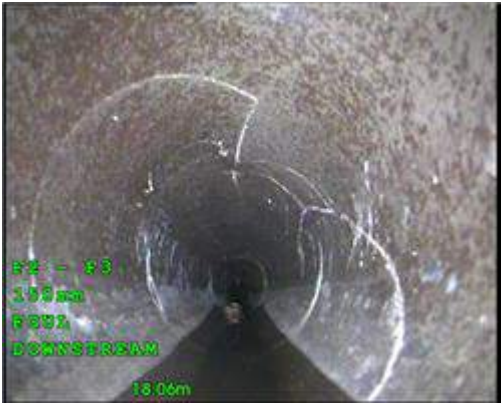
Pos	Video Ref	Code	Description	Image
18.06m	0:02:40	CM	Cracks, multiple from 07 o'clock to 05 o'clock - Severity 2	<p>Image Provided - Ref: 1_7</p>

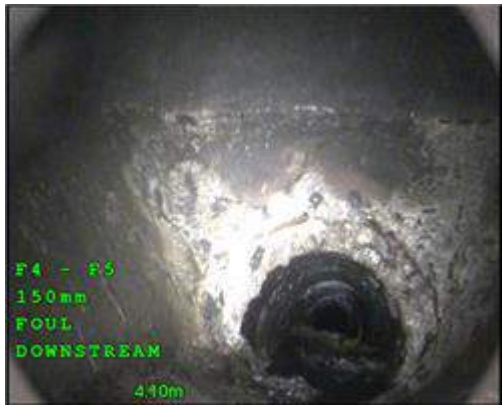
Section 4

Pos	Video Ref	Code	Description	Image
00.00m		MH	Start node type, manhole F4	
00.00m	0:00:00	WL	Water level: 5% Height/Diameter	
04.10m	0:00:33	REM	General remark ENTERS MANHOLE F5	<p>Image Provided - Ref: 3_2</p>

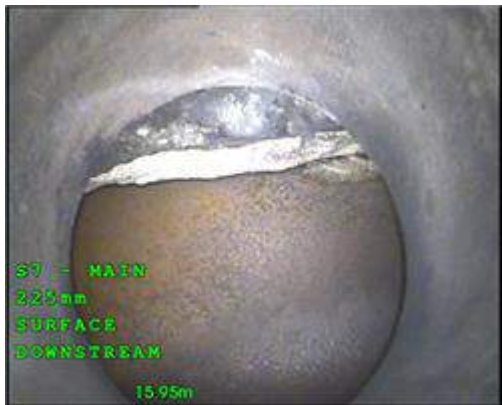
Section 13

- 2.13 A utility survey has been completed for the site which identifies existing foul and surface water drainage, with separate discharges to the adopted sewers within Castle Street.
- 2.14 The existing site drainage also receives separate private foul and storm connections from the adjacent commercial unit (Land Tyre Service). Whilst the existing site drainage can be abandoned, any live connections from other developments will need to be retained or otherwise diverted to accommodate the proposed development.
- 2.15 A CCTV condition survey has been conducted by Utilities Survey Ltd. (CCTV report ref. 071398, August, 2021). The 150mm diameter foul sewer connection to be retained (F4 to F5) is in good condition and is therefore considered adequate for re-use. The 225mm diameter surface water sewer connection from S7 to Mains are reported as DRB Grade: C, due to a large

joint displacement. Thus, there is a defect that requires remedial works before the existing surface water connection can be deemed serviceable.

Pos	Video Ref	Code	Description	Image
00.00m		MH	Start node type, manhole S7	
00.00m	0:00:00	WL	Water level: 5% Height/Diameter	
01.20m	0:00:14	FC	Fracture circumferential from 12 o'clock to 12 o'clock - Severity 3	
02.00m	0:00:20	CL	Crack, longitudinal at 12 o'clock - Severity 1	
05.30m	0:00:47	CC	Crack, circumferential from 07 o'clock to 05 o'clock - Severity 1	
07.20m	0:01:06	LDH	Line of drain/sewer deviates down [half]	
08.50m	0:01:16	LDH	Line of drain/sewer deviates down [half]	
10.00m	0:01:32	REM	General remark LINE LEVELS	
16.00m	0:02:48	JDL	Joint displaced large - Severity 4	<p>Image Provided - Ref: 12_9</p>

- 4.13 The proposed attenuation features will be linked by a balance pipe spanning beneath the groundfloor slab. Runoff from the tank, and enlarged diameter pipe, will pass through the new flow control chamber prior to discharging to the retained existing surface water chamber (S7) from which it will discharge to the TW surface water network via the existing lateral site connection. This will be subject to remedial works to correct a joint displacement, based on the CCTV condition report discussed in Section 2.
