## Castle Street, Banbury

### Flood Risk & Drainage Technical Note

<b>Project No.</b>	1260
<b>Revision</b>	C (Changes Highlighted)
<b>Date</b>	01 April 2022
<b>Client</b>	Churchill Retirement Living
<b>Prepared</b>	L Blackmore
<b>Checked</b>	C Yalden
<b>Authorised</b>	C Yalden
<b>File Ref.</b>	P:\1260 Castle Street, Banbury\C Documents\Reports\1260 - Castle Street, Banbury - Flood Risk & Drainage Technical Note - C

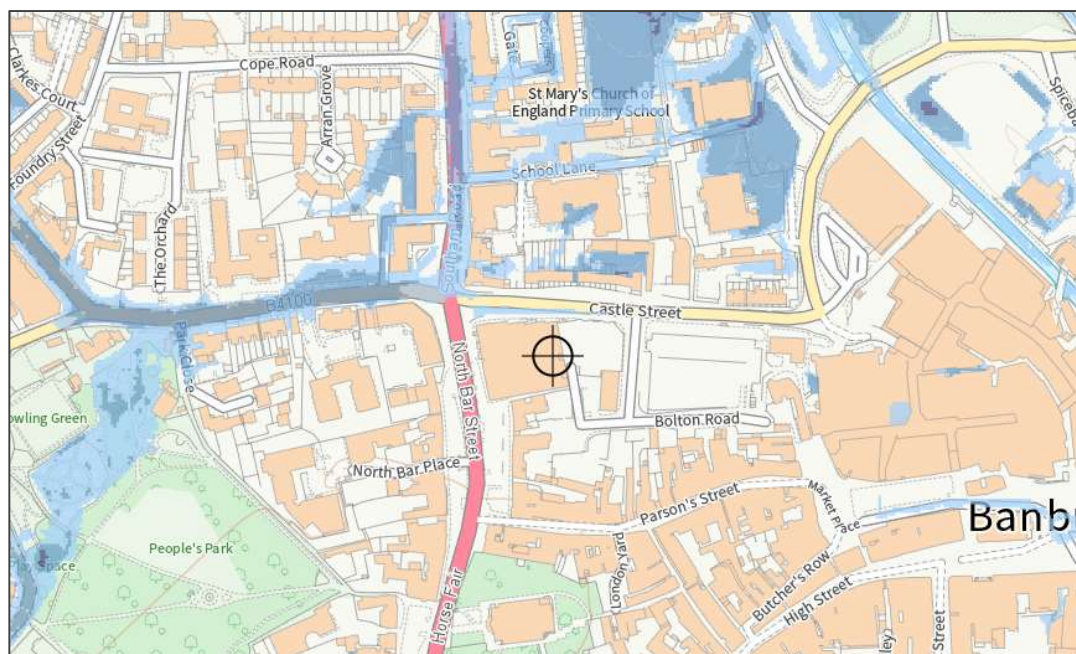
**Figure 2.3 – EA Flooding from surface water (medium risk, 1%)**

- 2.4 The mapping identifies that the northern boundary of the site may be susceptible to flooding below 300mm within the 100 year design life of the scheme (medium risk). The same area is indicated to be at risk of flooding

greater than 300mm during the low risk event (beyond the 1 in 1,000 year event).

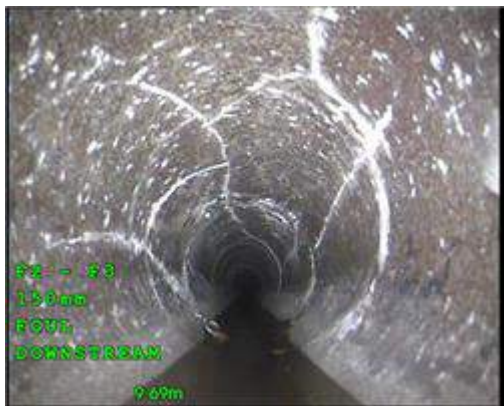
Pos	Video Ref	Code	Description	Image
00.00m		MH	Start node type, manhole F2	
00.00m	0:00:00	WL	Water level: 5% Height/Diameter	
03.40m	0:00:32	CL	Crack, longitudinal at 12 o'clock - Severity 1	
06.95m	0:00:55	CL	Crack, longitudinal at 10 o'clock - Severity 1	
09.70m	0:01:17	S1 CM	Cracks, multiple 9.7m - 10.85m from 06 o'clock to 06 o'clock - Severity 2	Image Provided - Ref: 1_3

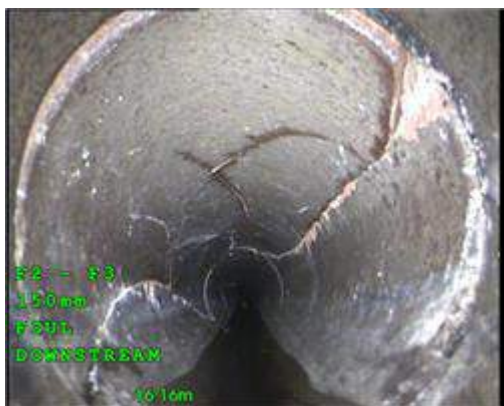
10.85m	0:01:17	F1 CM	Cracks, multiple Defect End from 06 o'clock to 06 o'clock - Severity 2	
12.16m	0:01:51	CL	Crack, longitudinal at 11 o'clock - Severity 1	
16.16m	0:02:24	CM	Cracks, multiple from 07 o'clock to 03 o'clock - Severity 2	Image Provided - Ref: 1_6

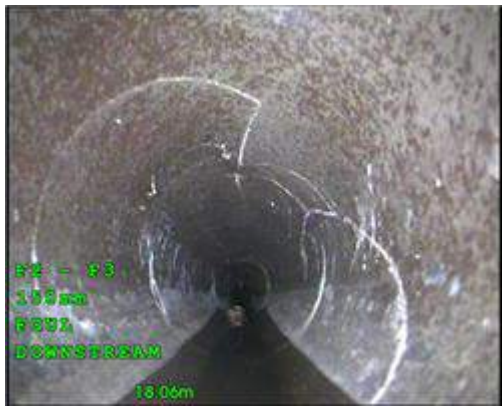
Pos	Video Ref	Code	Description	Image
18.06m	0:02:40	CM	Cracks, multiple from 07 o'clock to 05 o'clock - Severity 2	<p>Image Provided - Ref: 1_7</p>
