the **play inspection** company

Post Installation Report

Blossom Field

Inspection Ref: 1667769

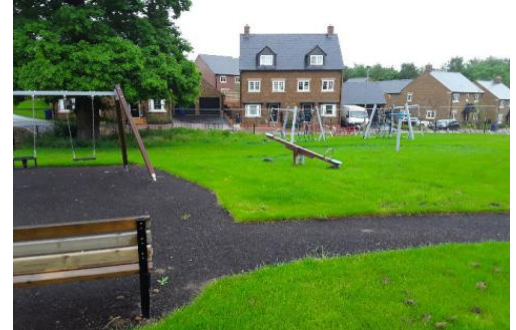
It is recommended that signage, with information including the site address, contact information for maintenance issues and emergency contact details are provided for the facility - Provide in accordance with the recommendations

There is weed / vegetation growth on, between, or around the edges of the surfacing - Remove weed / vegetation growth

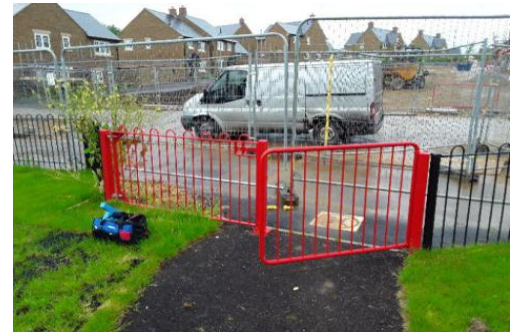
The gate is closing too quickly (less than 4 seconds) - Take corrective action to ensure that the gate closes in 4-8 seconds

There is no padlock on the maintenance gate - Provide a padlock to secure the gate

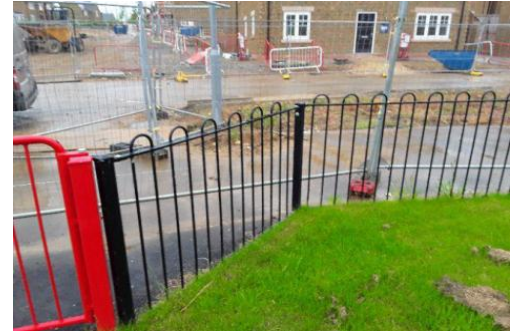
NOTE - a section of fence is incomplete - Complete the installation

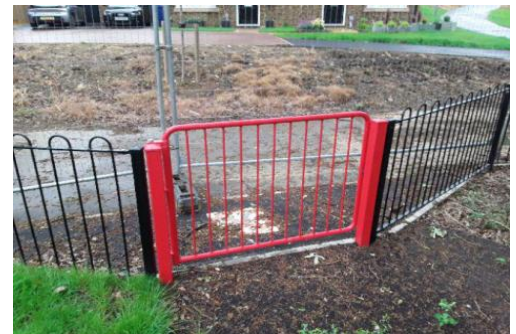
The gate is closing too quickly (less than 4 seconds) - Take corrective action to ensure that the gate closes in 4-8 seconds

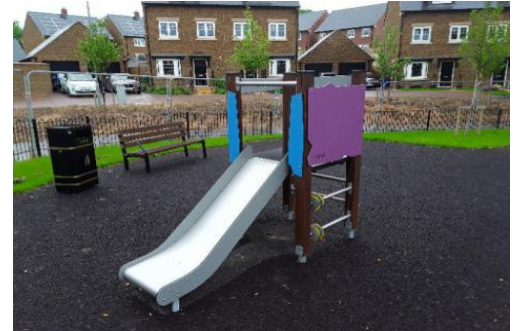
There is/are bolt cap covers missing or damaged on the item - Replace missing or damaged bolt cap covers

The item fails to meet the requirements of BS EN 1176 Part 1 4.2.7.2 for head and neck entrapment in the frame - Refer to the manufacturer / contractor

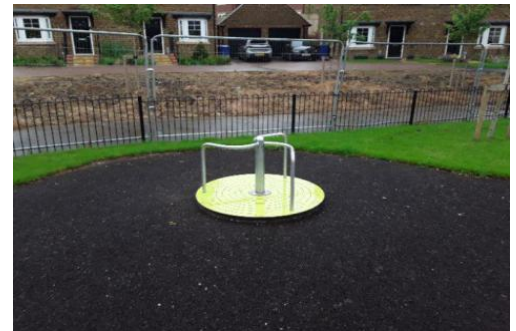
The distance between the underside of the roundabout platform and the playing surface is less than 60mm and contravenes the requirements of BS EN 1176 Part 5 which requires that the distance be maintained between 60mm-110mm for the entire circumference of the roundabout (measurement between the surface and the underside of the roundabout platform is 50mm) - Refer to the contractor

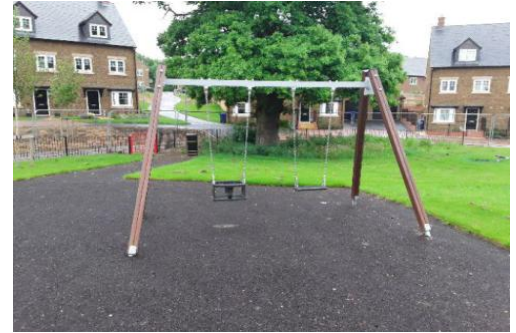
A number of shackle fixing(s) have worked loose - Secure all loose fixings

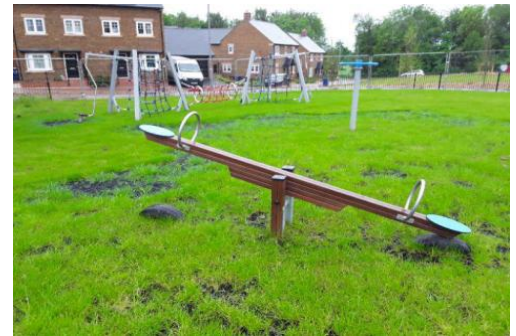
There is no identification label affixed to the equipment - Provide an identification label

The tyre dampener is damaged - Refer to the contractor

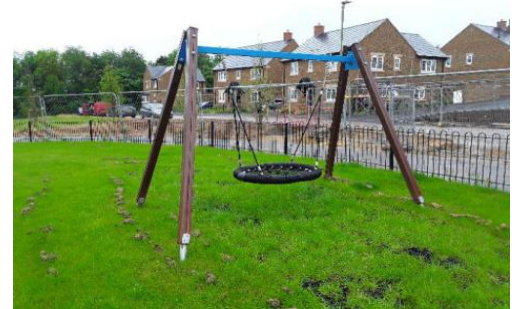
A number of shackle fixing(s) have worked loose - Secure all loose fixings

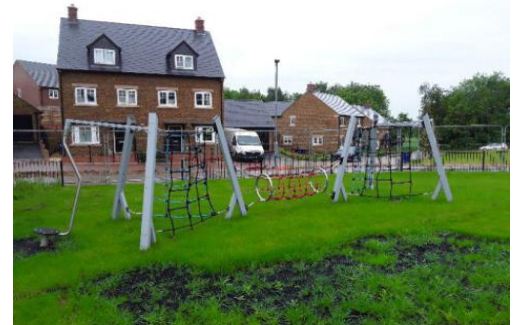
NOTE - There are fixings missing on a climbing net (currently secured by cable ties) - Complete the installation

There is/are finger entrapment/s in the frame due to missing inserts and the item fails to meet the requirements of BS EN 1176 Part 1 4.2.7.6 Entrapment of fingers - Replace the missing inserts to remove the entrapment

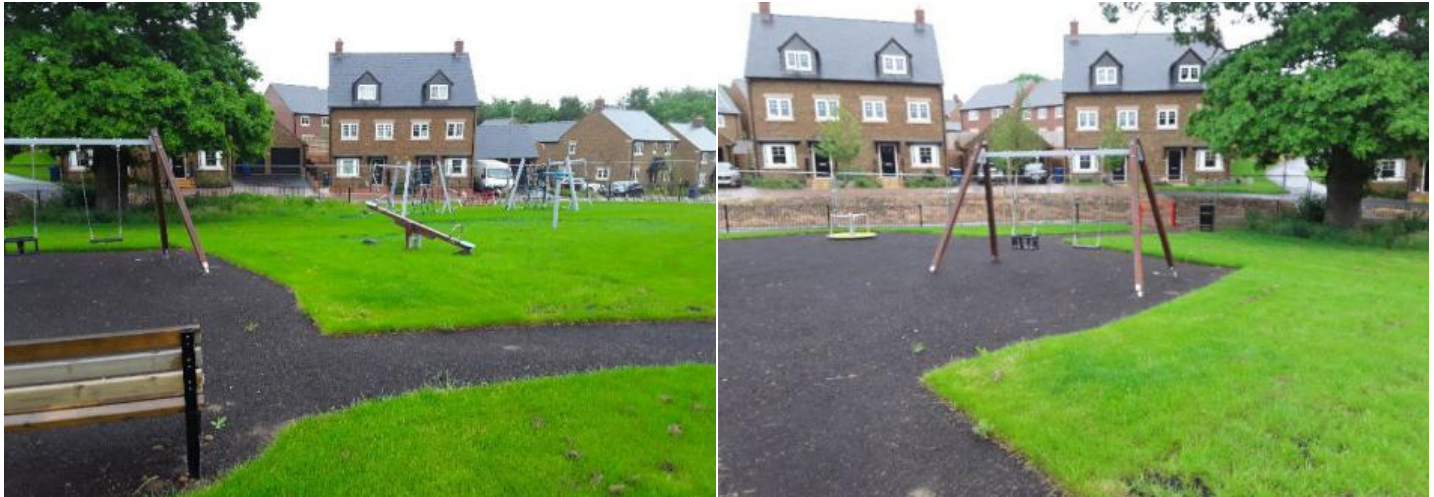
i 5 - Very Low Risk (Finding 1)

Finding: It is recommended that signage, with information including the site address, contact information for maintenance issues and emergency contact details are provided for the facility

Action: Provide in accordance with the recommendations

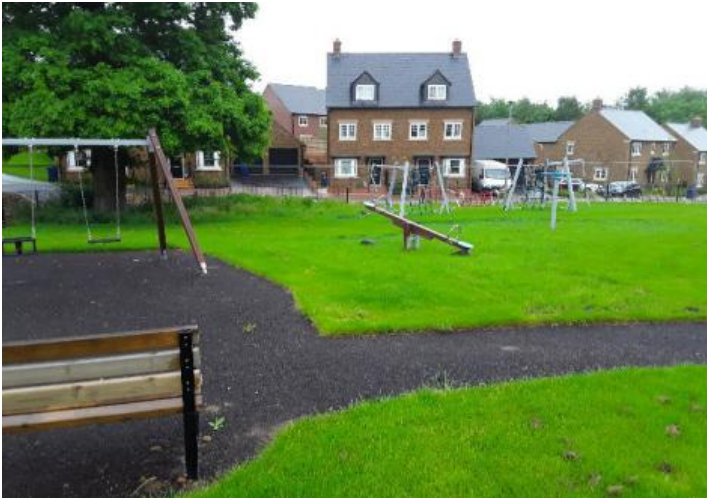
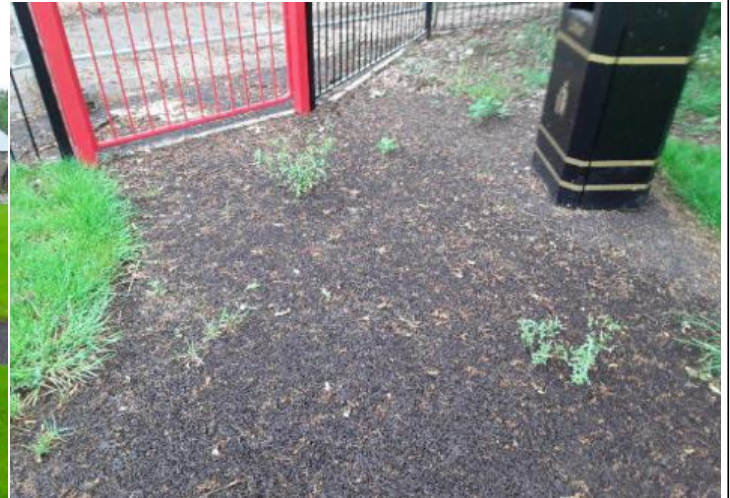
i 6 - Low Risk (Finding 2)

Finding: There is weed / vegetation growth on, between, or around the edges of the surfacing
Action: Remove weed / vegetation growth

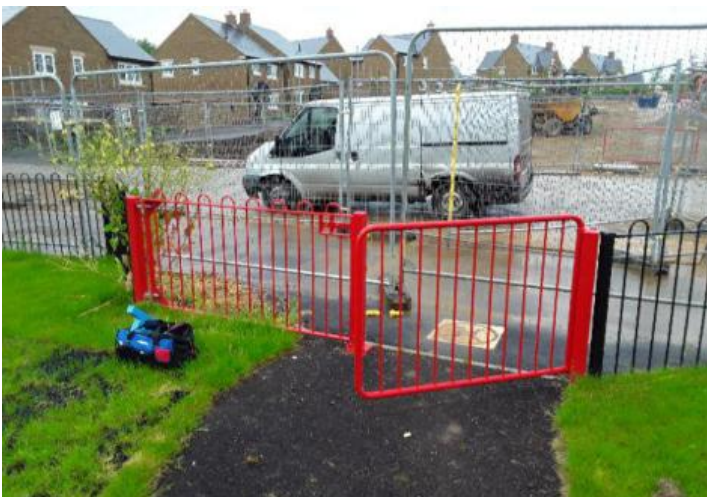
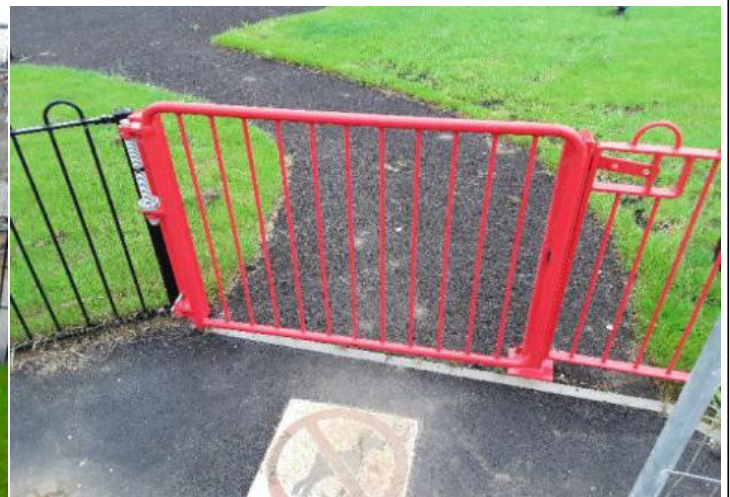
i 8 - Low Risk (Finding 1)

Finding: The gate is closing too quickly (less than 4 seconds)
Action: Take corrective action to ensure that the gate closes in 4-8 seconds

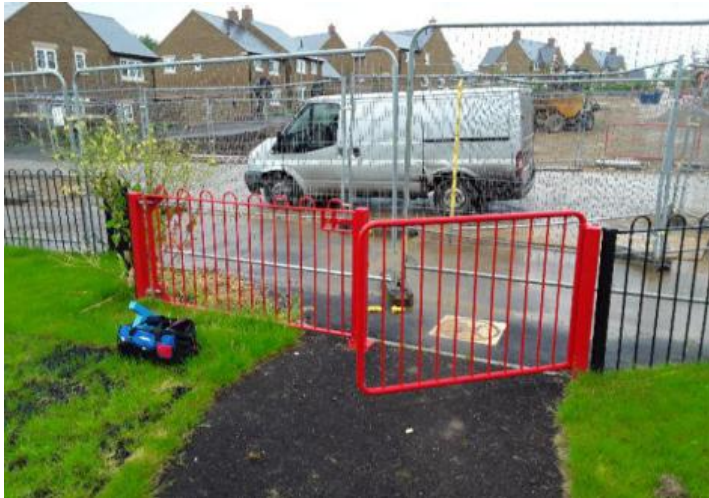
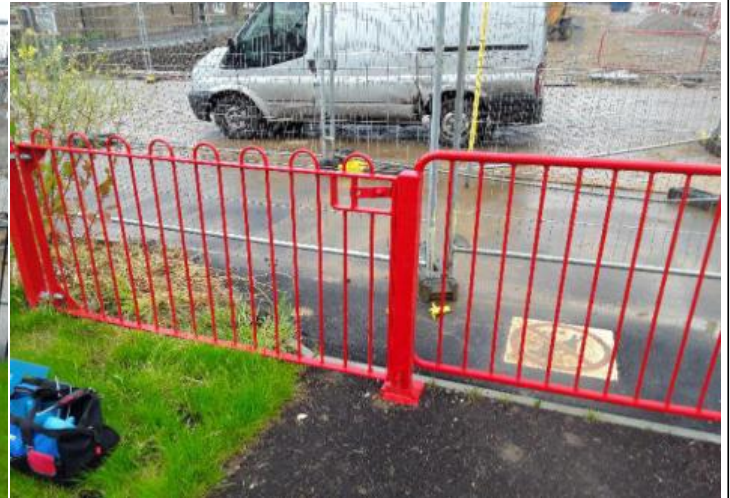
i 6 - Low Risk (Finding 2)

Finding: There is no padlock on the maintenance gate

Action: Provide a padlock to secure the gate

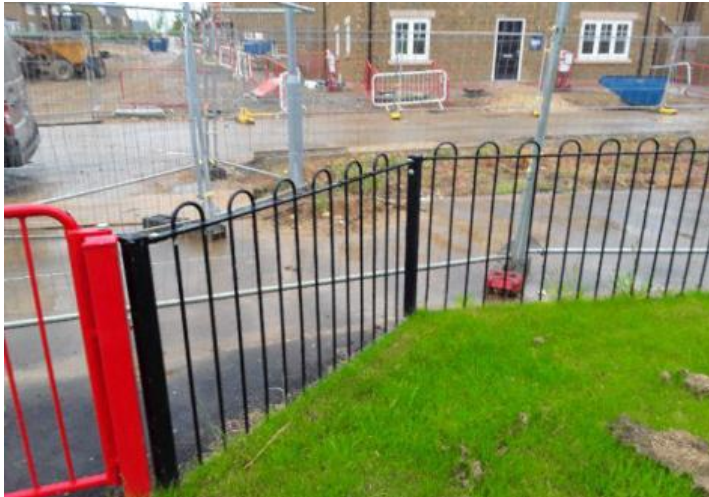
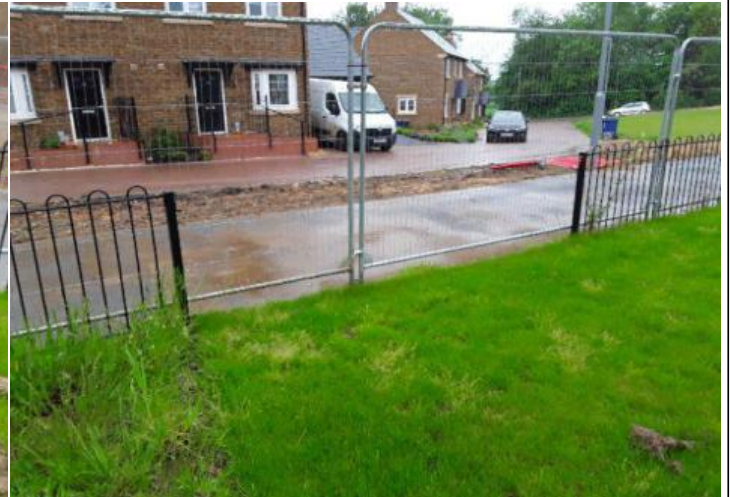
i 0 - Risk Assessment not Undertaken (Finding 1)

Finding: NOTE - a section of fence is incomplete

Action: Complete the installation

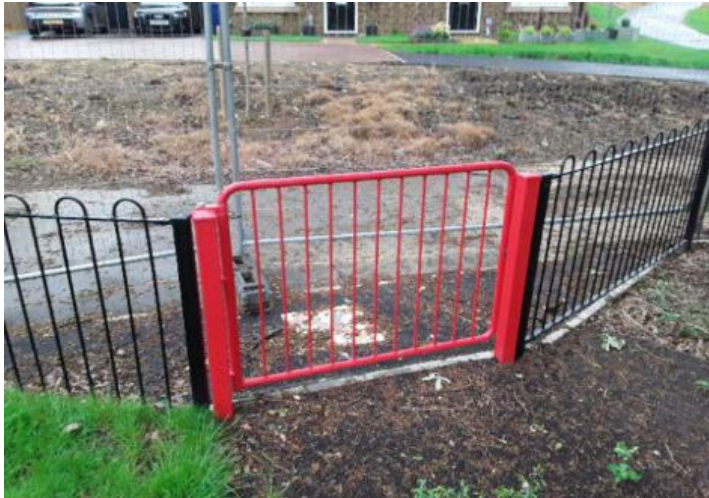
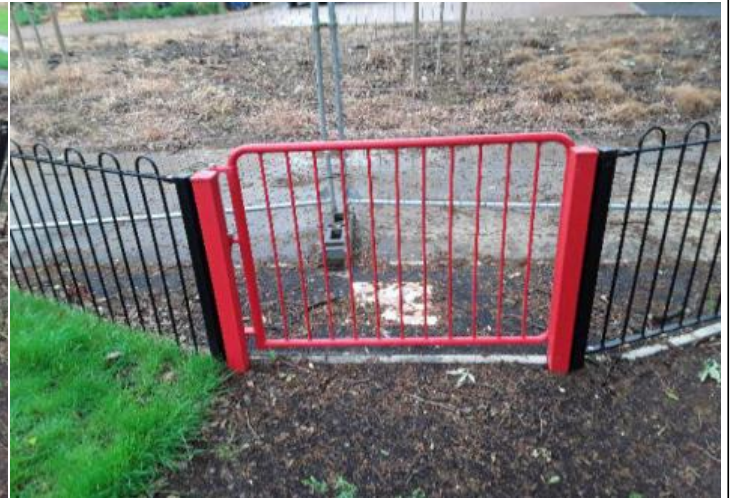
i 8 - Low Risk (Finding 1)

Finding: The gate is closing too quickly (less than 4 seconds)

Action: Take corrective action to ensure that the gate closes in 4-8 seconds

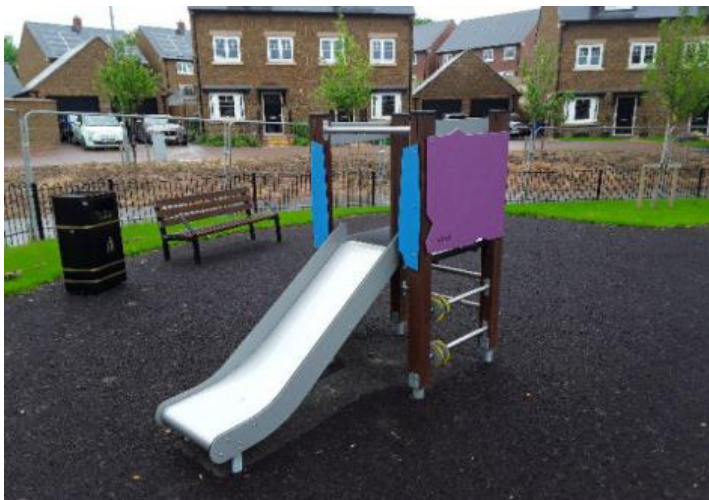
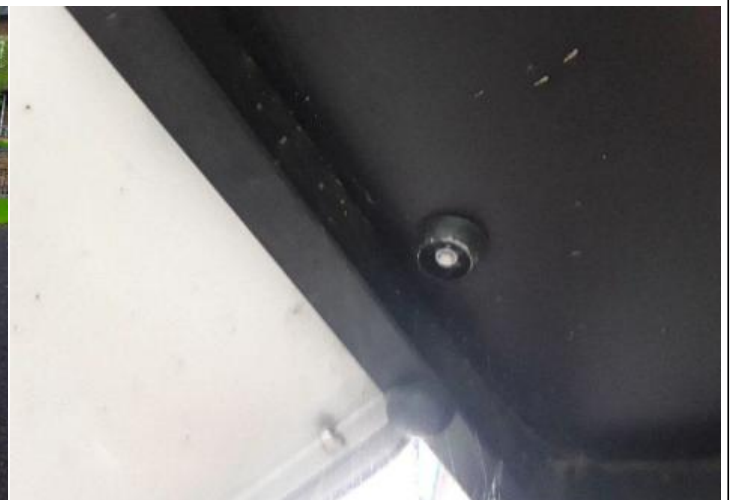
i 4 - Very Low Risk (Finding 1)

Finding: There is/are bolt cap covers missing or damaged on the item

Action: Replace missing or damaged bolt cap covers

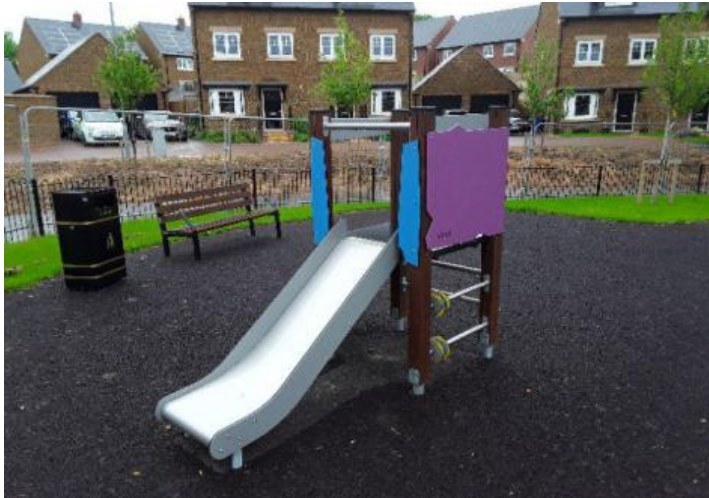
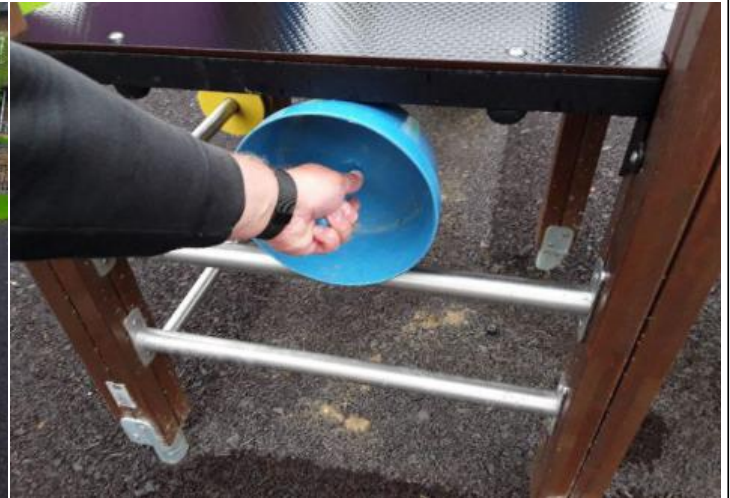
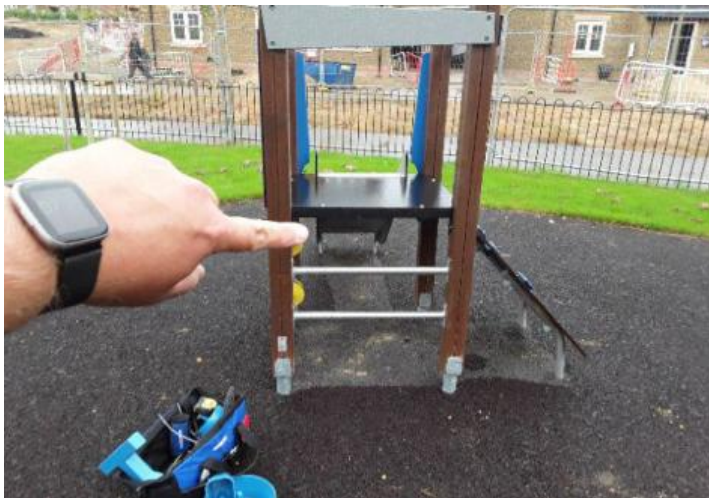
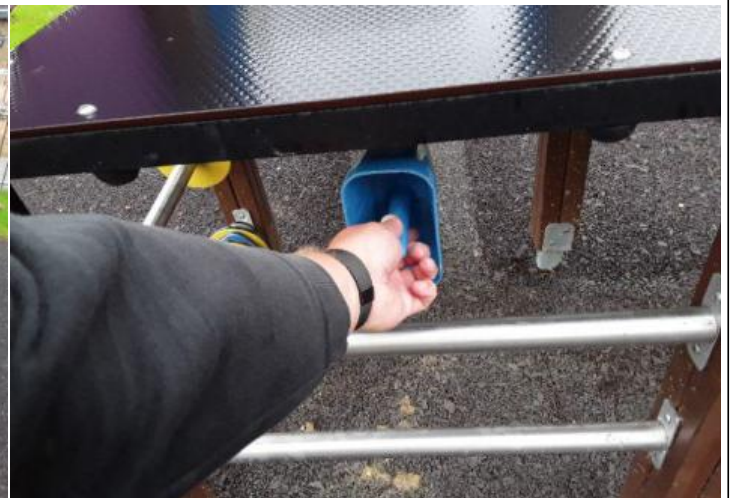
i 5 - Very Low Risk (Finding 2)

Finding: The item fails to meet the requirements of BS EN 1176 Part 1 4.2.7.2 for head and neck entrapment in the frame

Action: Refer to the manufacturer / contractor

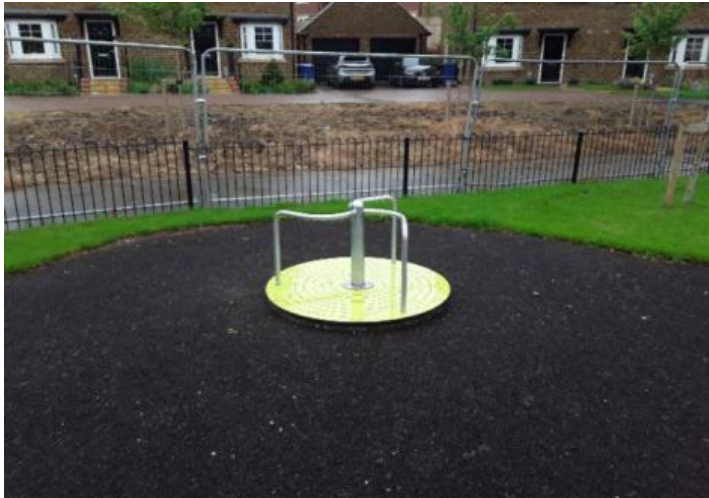
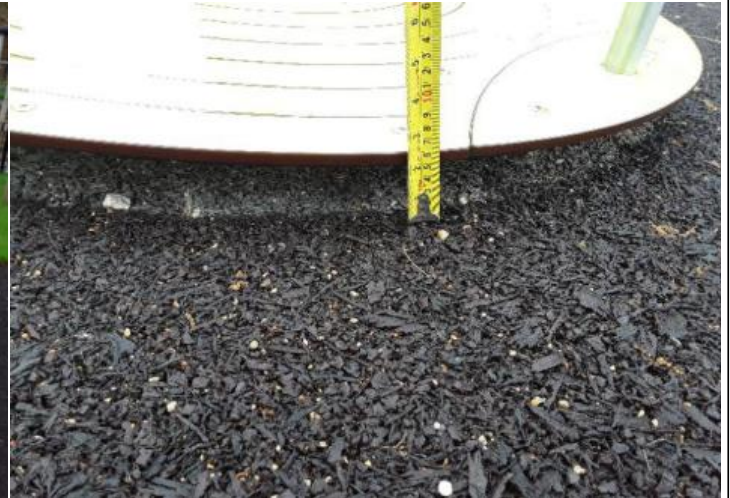
i 6 - Low Risk (Finding 1)

Finding: The distance between the underside of the roundabout platform and the playing surface is less than 60mm and contravenes the requirements of BS EN 1176 Part 5 which requires that the distance be maintained between 60mm-110mm for the entire circumference of the roundabout (measurement between the surface and the underside of the roundabout platform is 50mm)

Action: Refer to the contractor

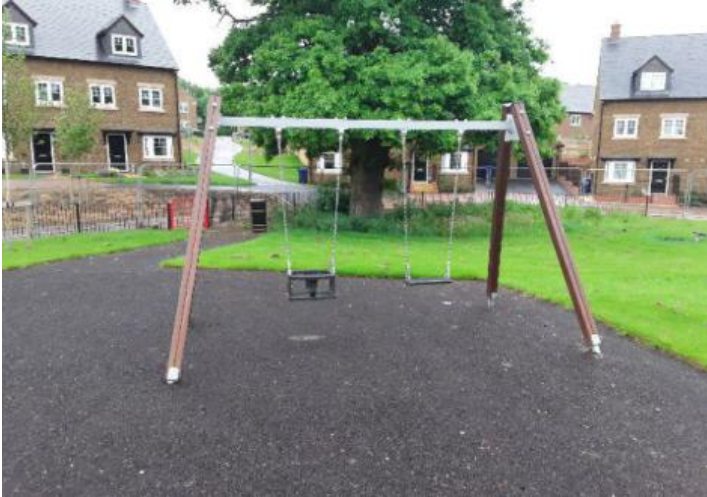
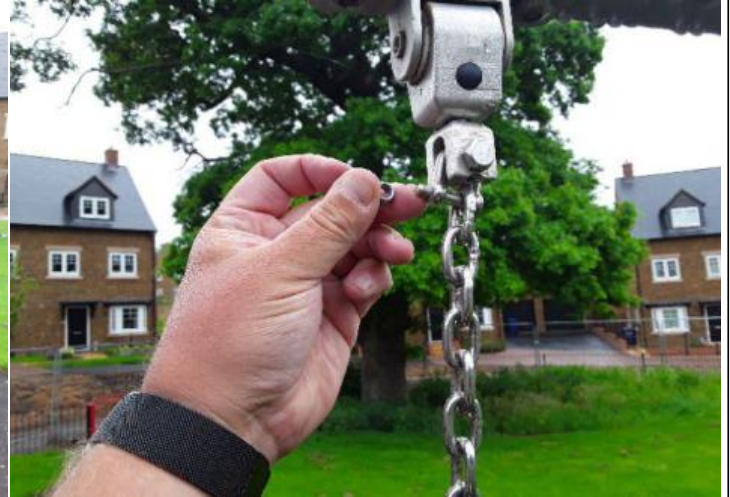
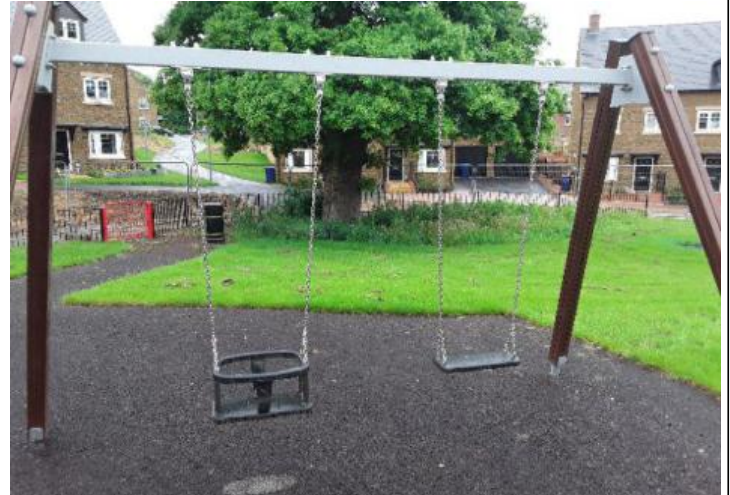
i 8 - Low Risk (Finding 1)

Finding: A number of shackle fixing(s) have worked loose

Action: Secure all loose fixings

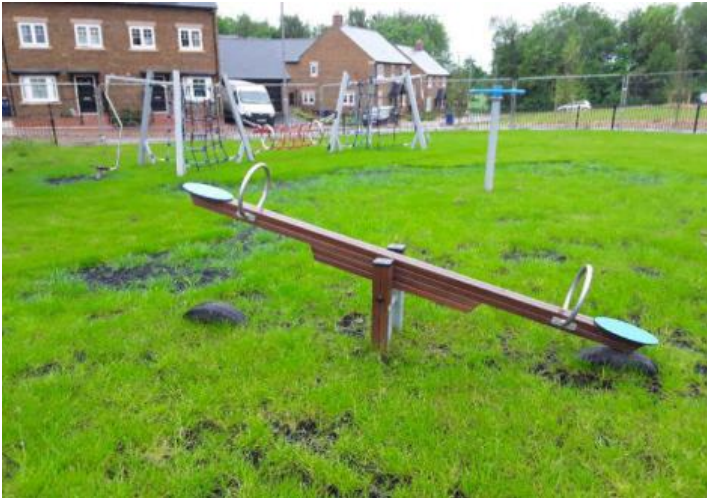
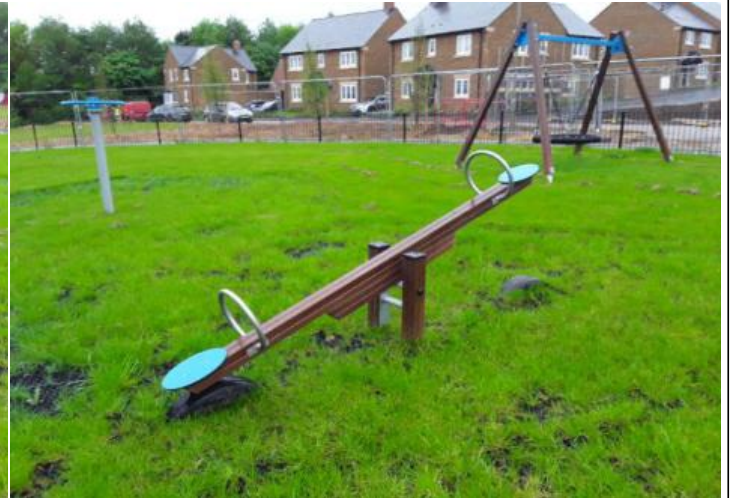
i 0 - Risk Assessment not Undertaken (Finding 1)

Finding: There is no identification label affixed to the equipment

Action: Provide an identification label

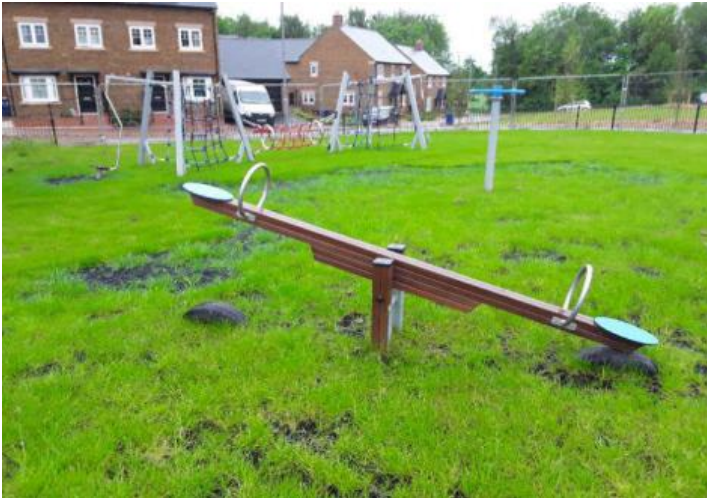
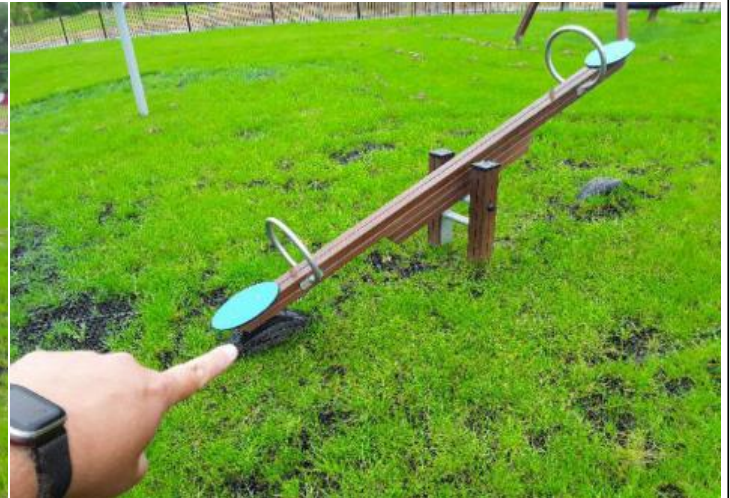
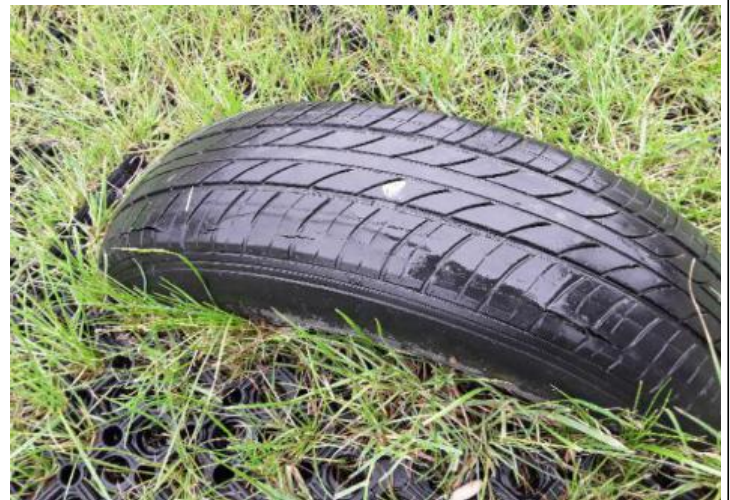
i 6 - Low Risk (Finding 2)

Finding: The tyre dampener is damaged

Action: Refer to the contractor

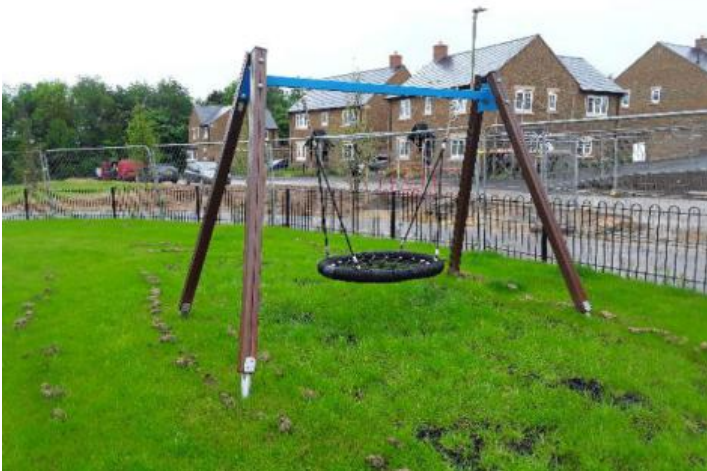
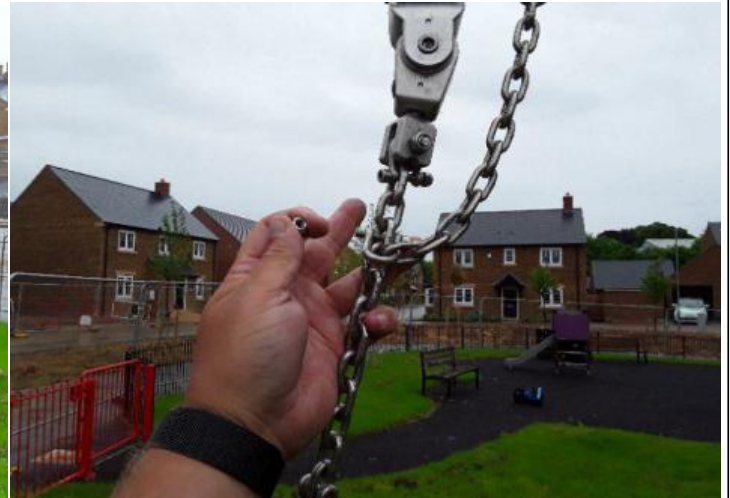
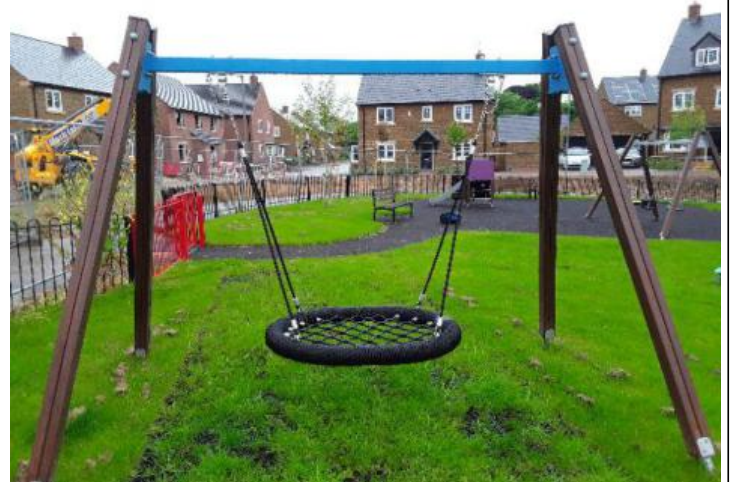
i 10 - Low Risk (Finding 1)

Finding: A number of shackle fixing(s) have worked loose

Action: Secure all loose fixings

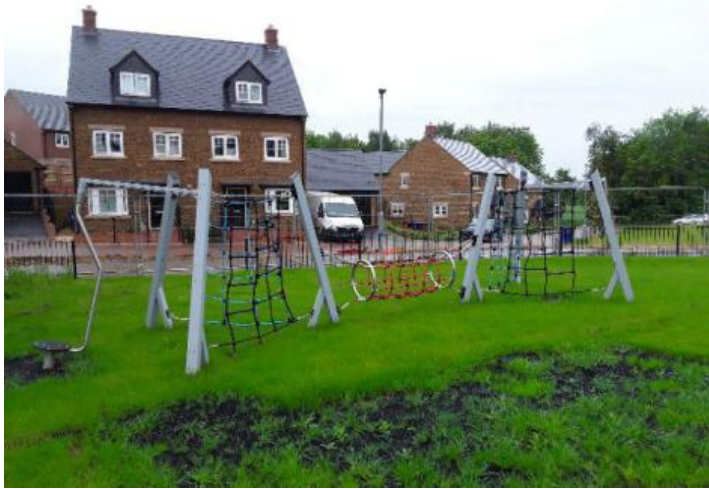
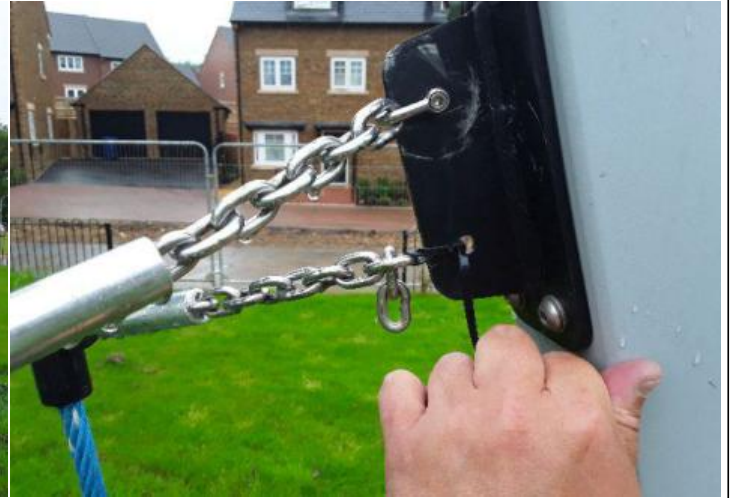
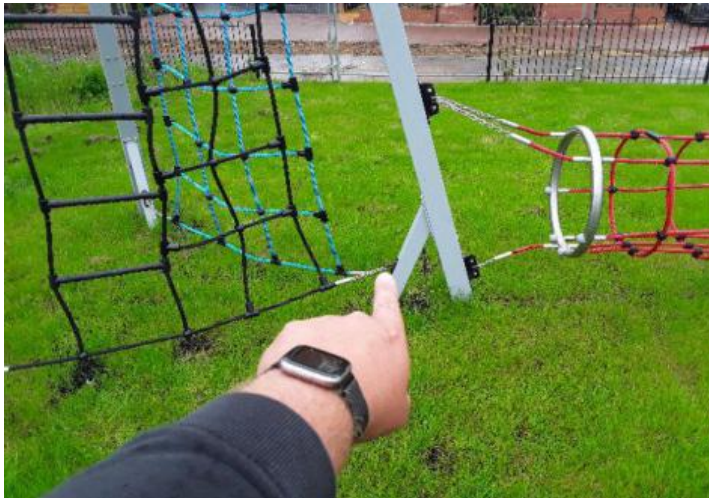
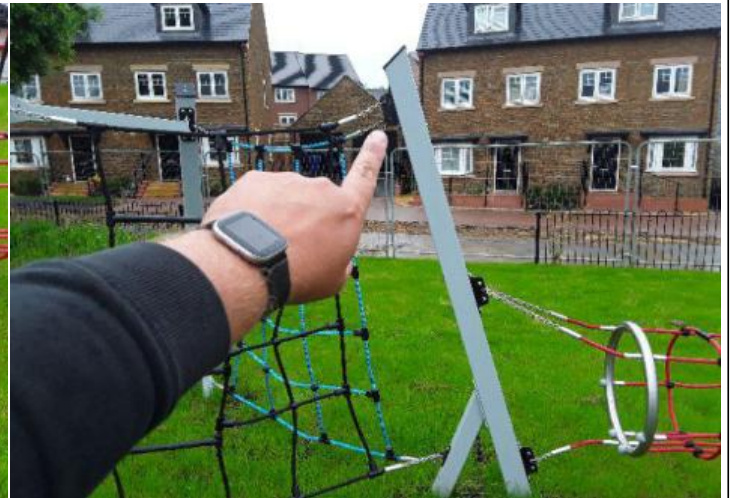
12 - Moderate Risk (Finding 1)

Finding: NOTE - There are fixings missing on a climbing net (currently secured by cable ties) **Action:** Complete the installation

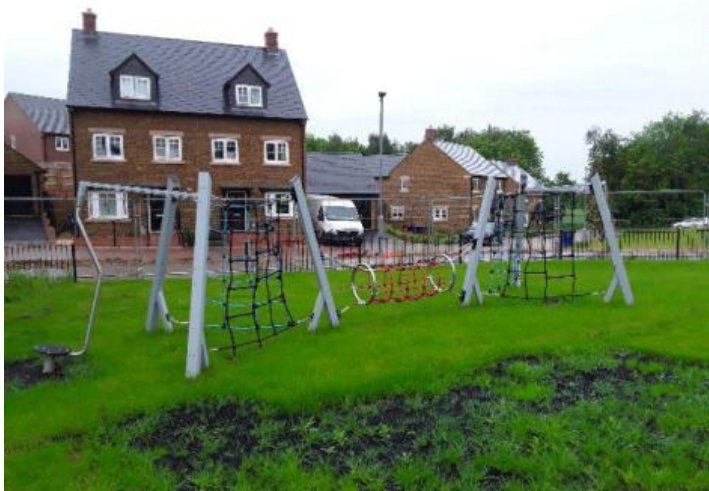
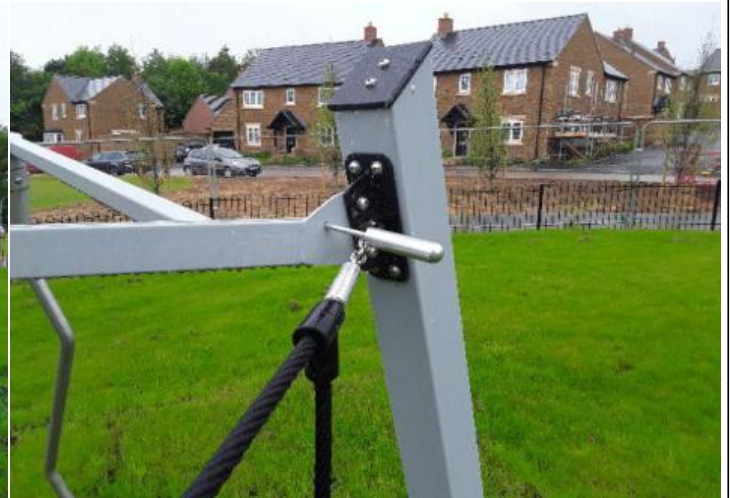
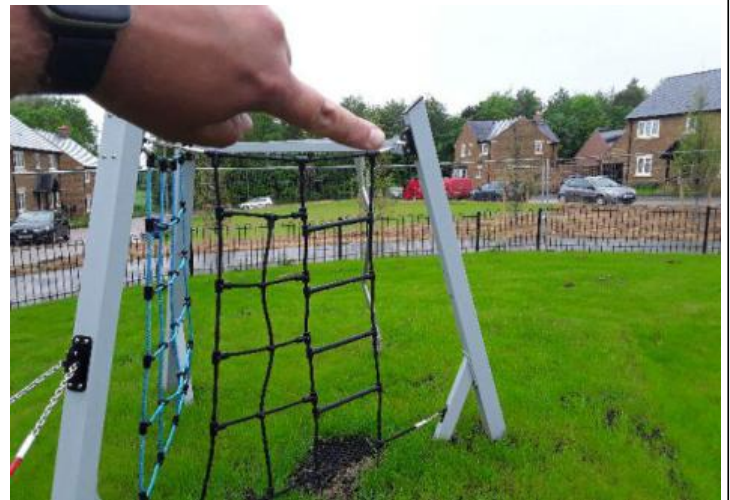
i 5 - Very Low Risk (Finding 2)

Finding: There is/are finger entrapment/s in the frame due to missing inserts and the item fails to meet the requirements of BS EN 1176 Part 1 4.2.7.6 Entrapment of fingers

Action: Replace the missing inserts to remove the entrapment
