**Manor Farm  
Noke  
Proposed Solar Farm**

**Pre-development Arboricultural Report  
and  
Method Statement  
Revision 3**

**04 February 2023**

**By  
Ian Kennedy  
Wharnccliffe Trees and Woodland Consultancy**

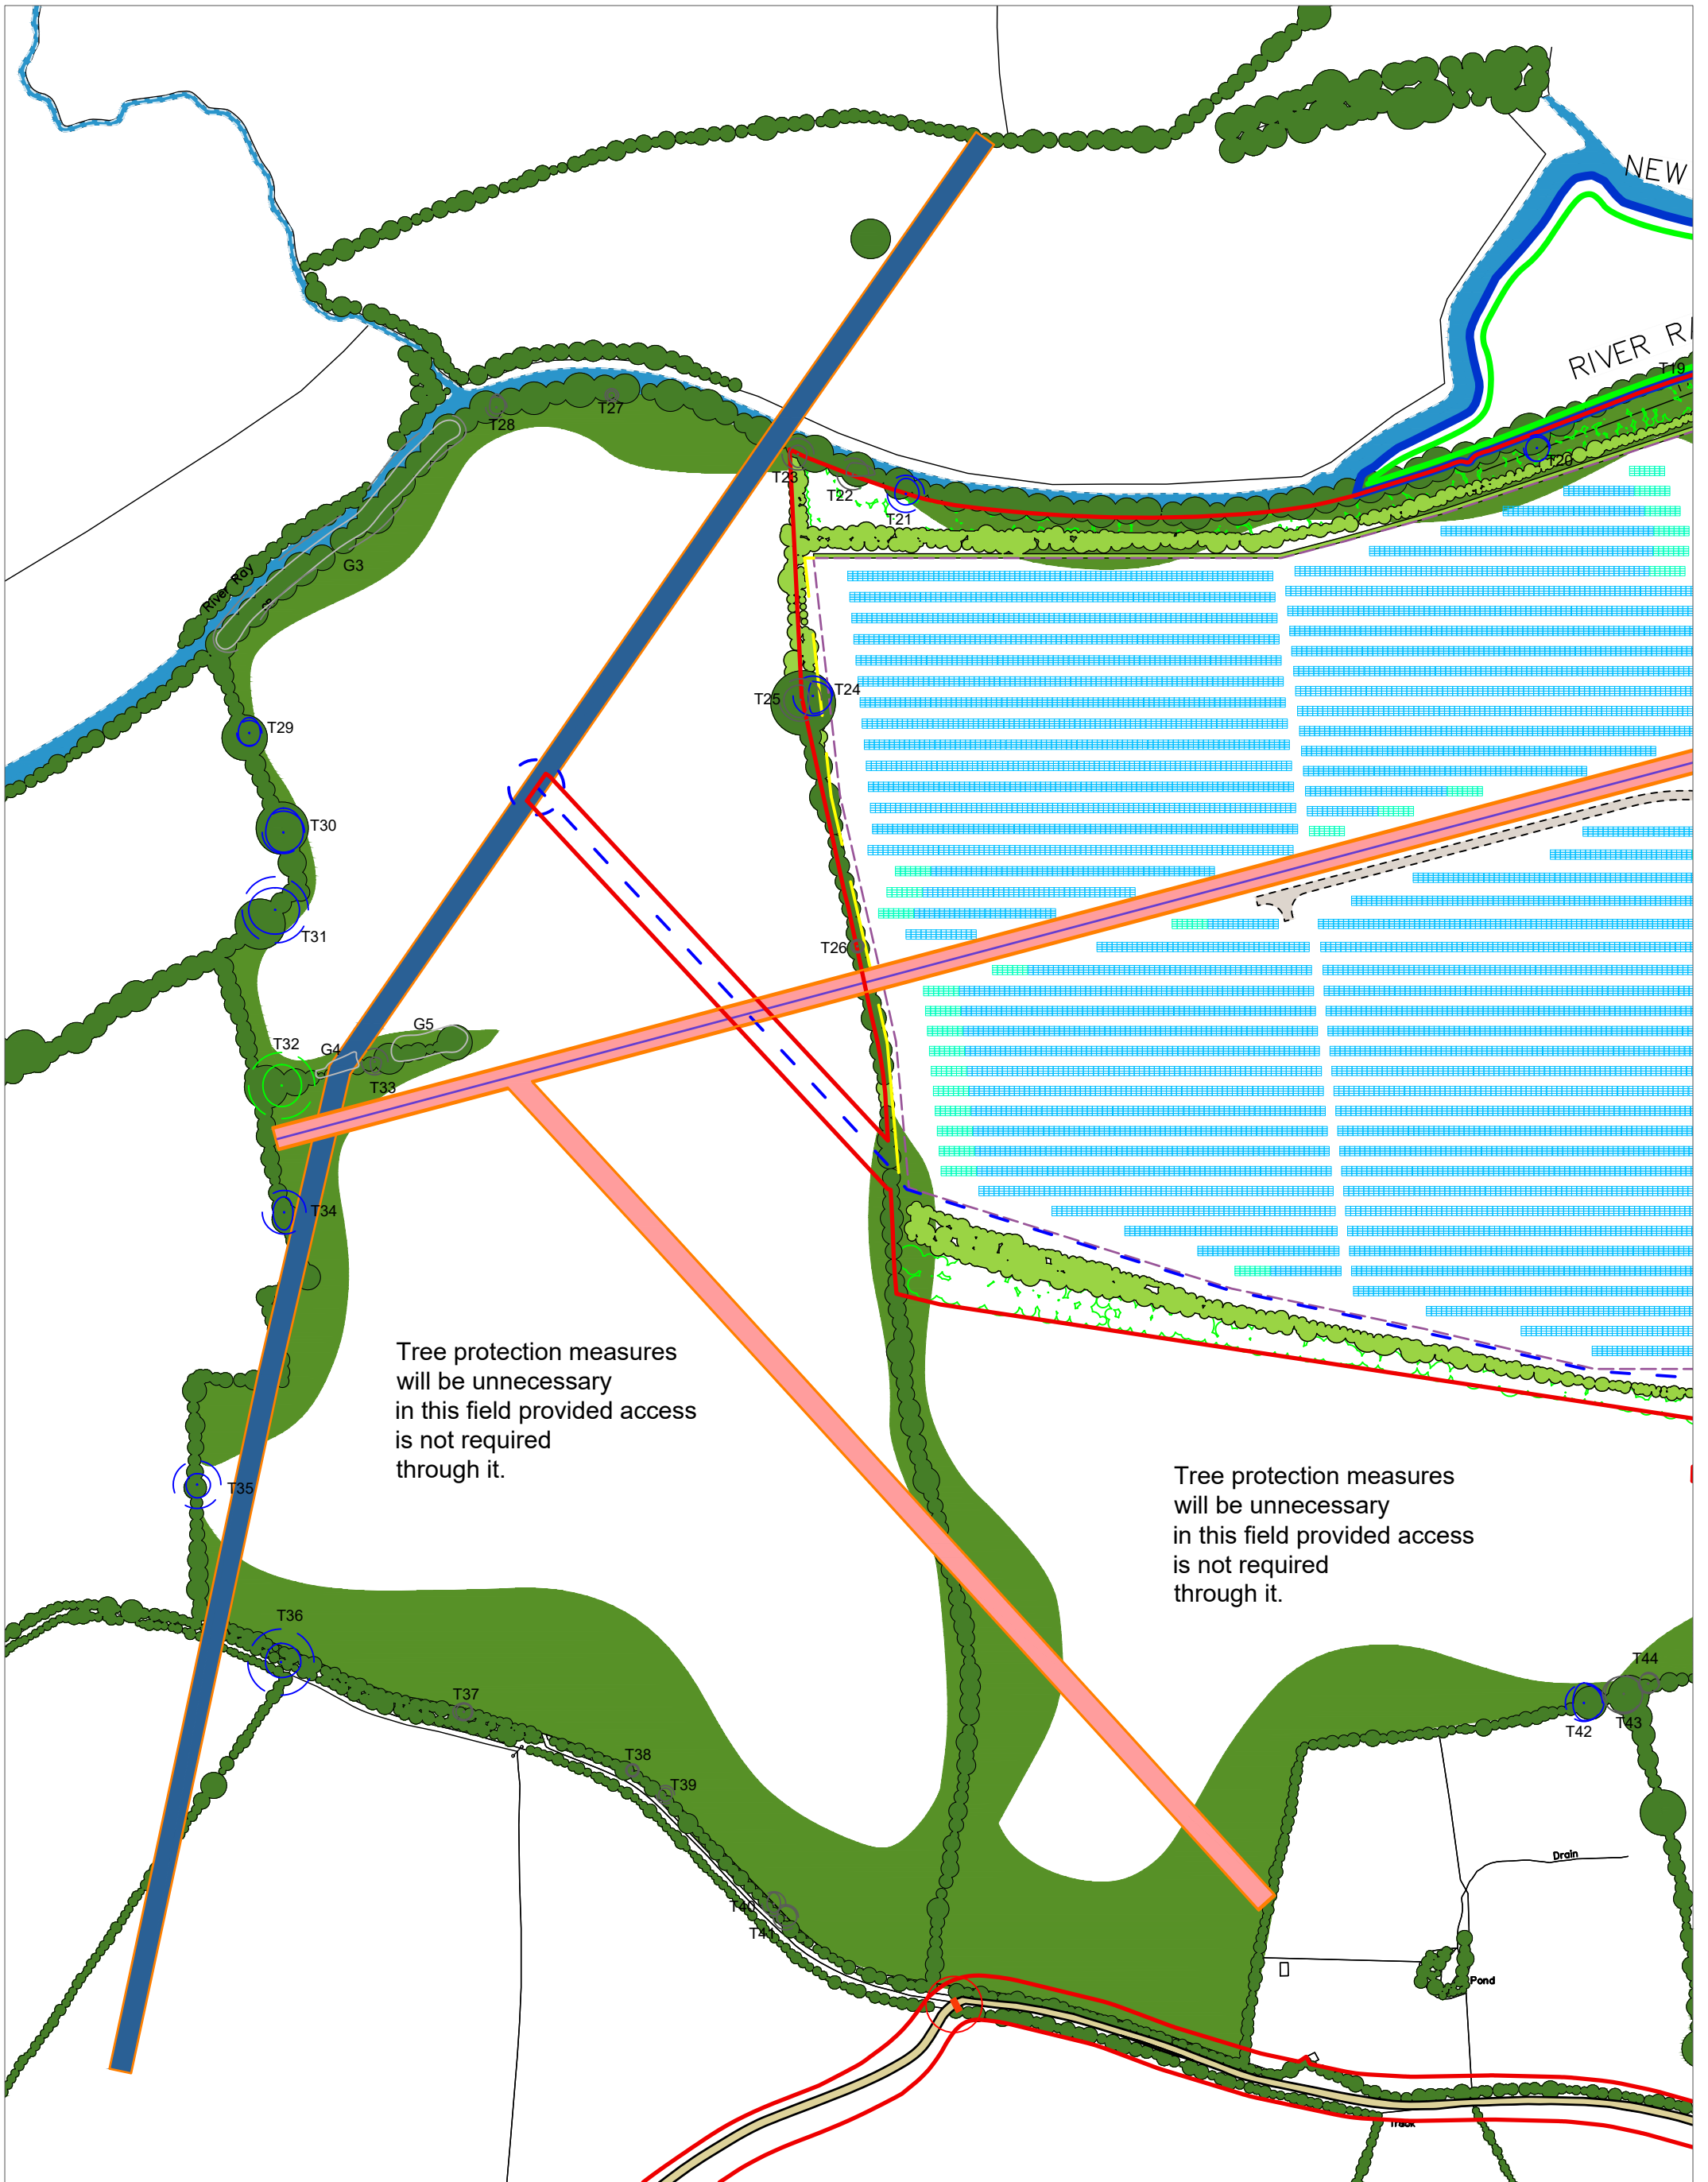
Plan 3a Tree Protection Plan showing the proposed layout; western third of the site.

Section of hedge to be removed
