JAMES MACKINTOSH ARCHITECTS

PROJECT Stratfield Farm
 OX5 1DL Kidlington

DRG TITLE Farmhouse Ground Floor
 Existing Plan

JOB/DRG No. 219/101

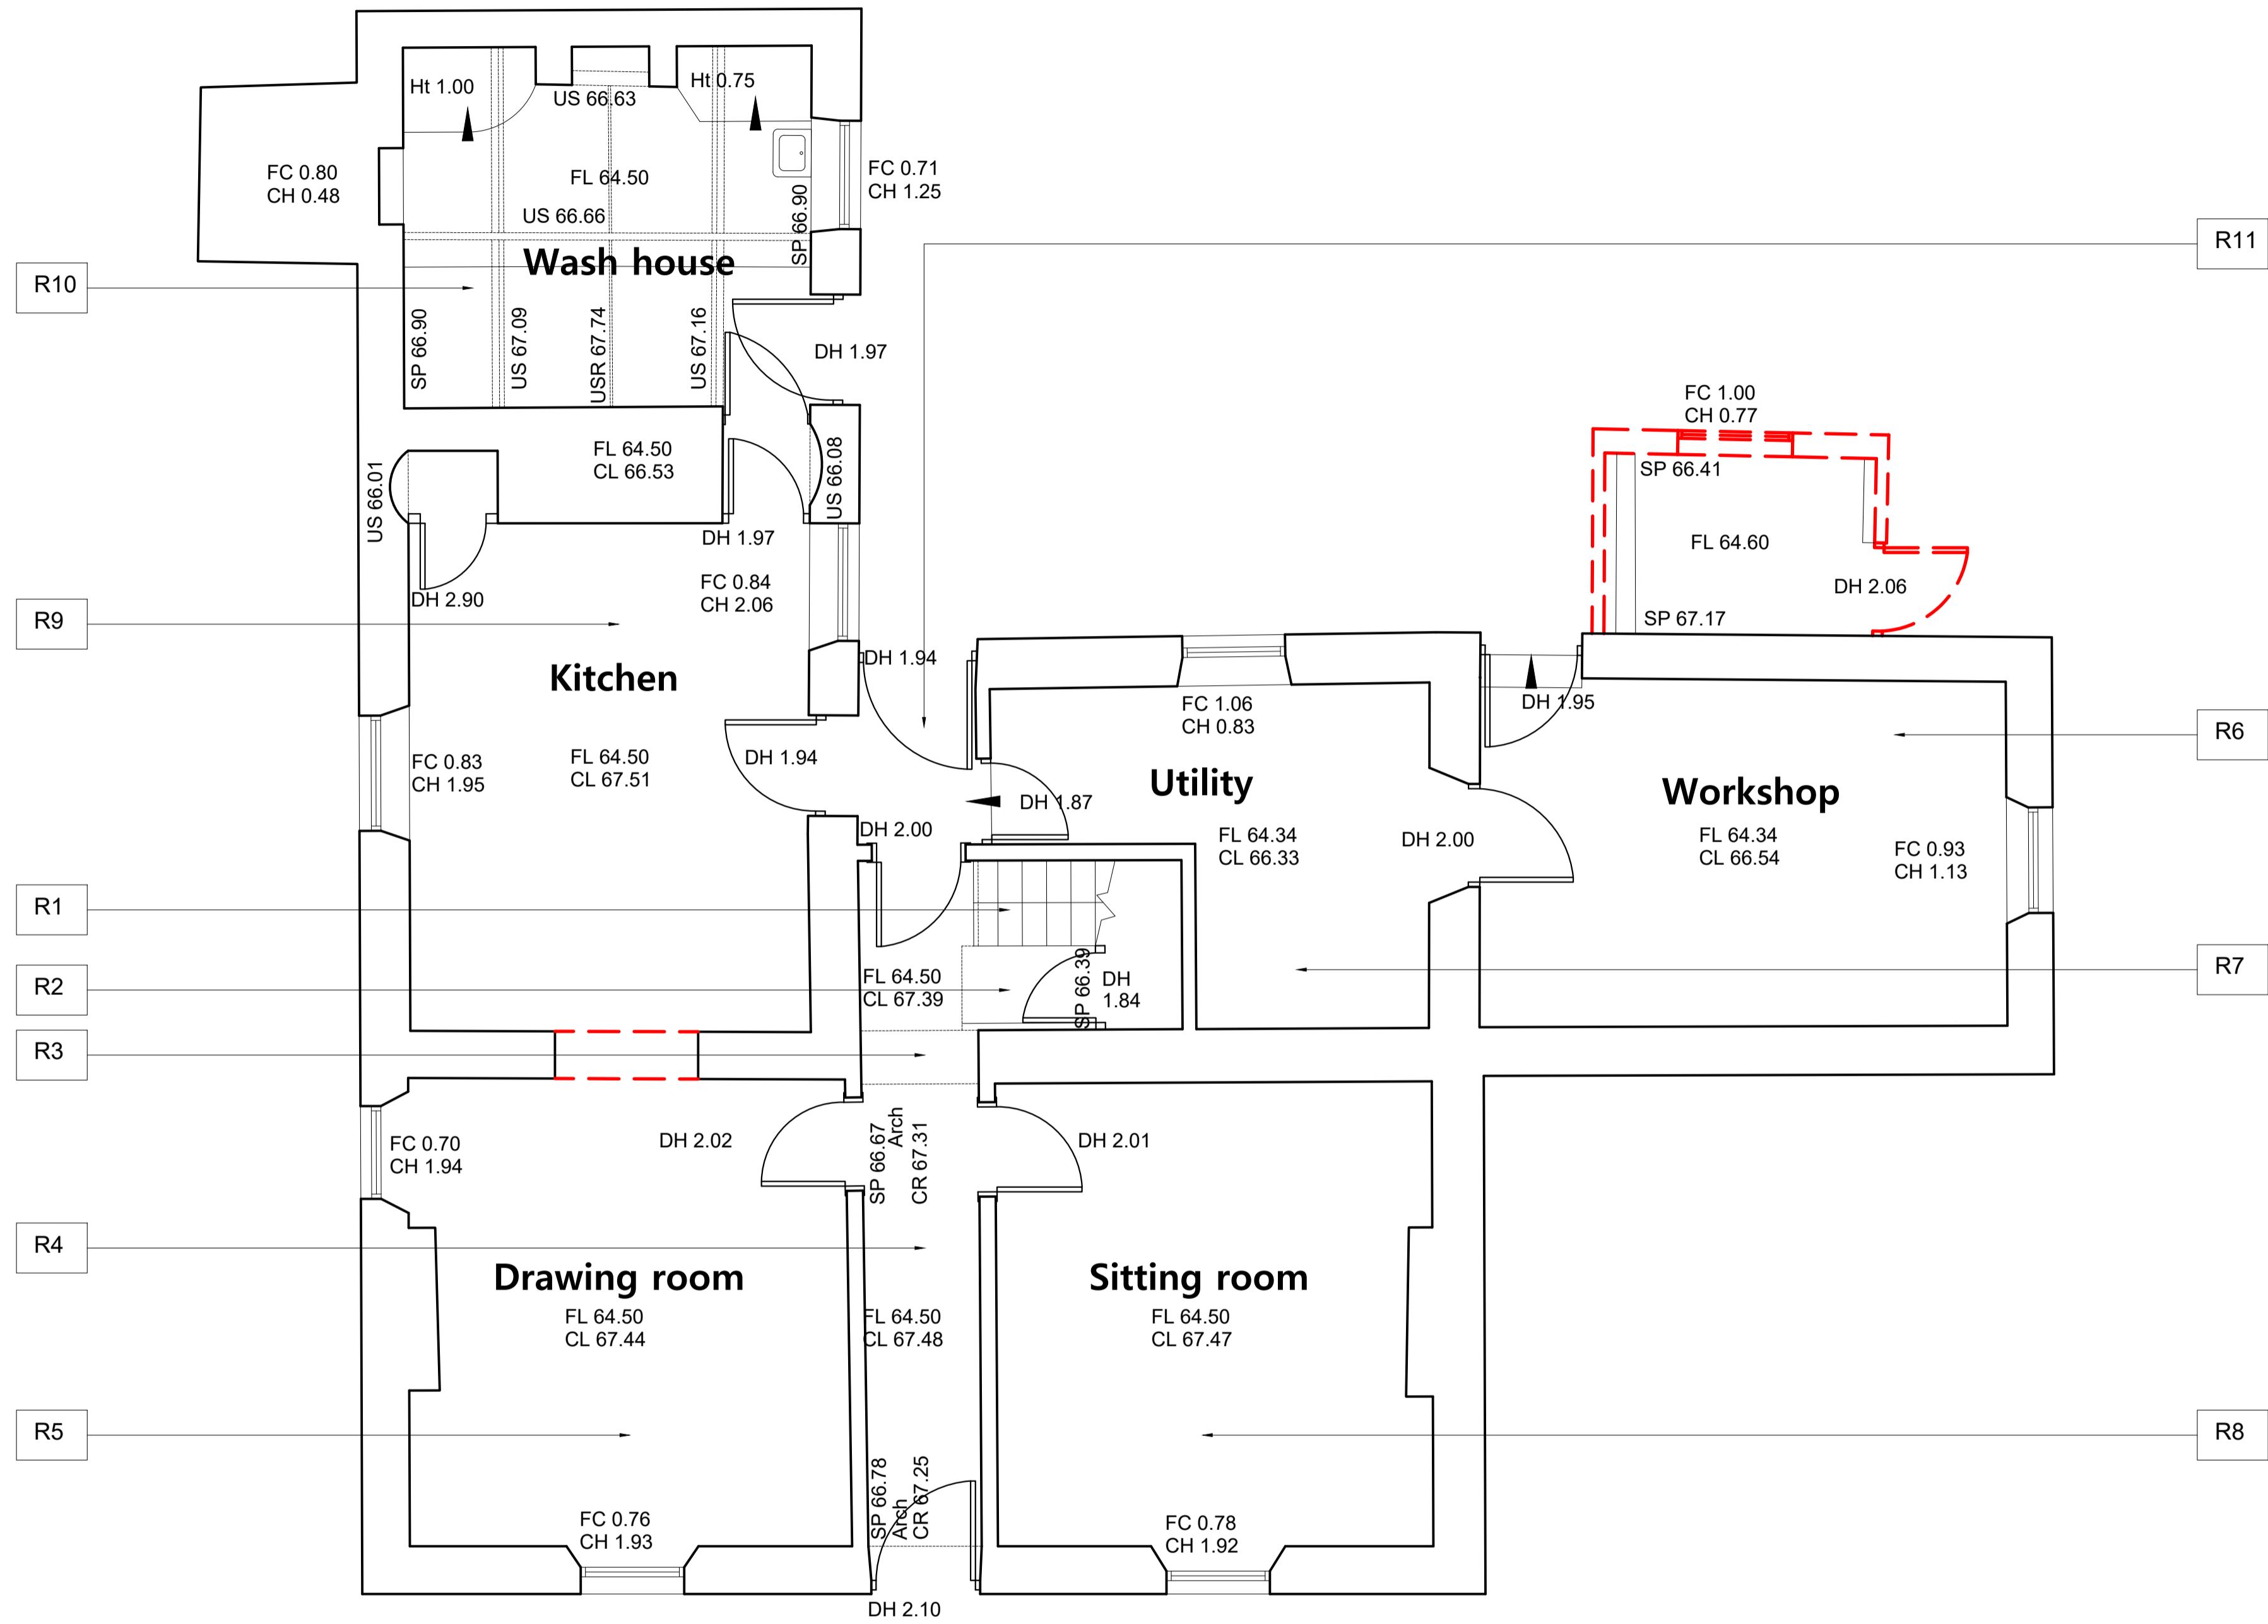
1.0 Main House

- R1** Clean and point stone flag floor. Carry out repair to sunk and cracked flagstone near door to the drawing room.
- R2** There is decay to the floorboards next to (and running in and below) the below stairs cupboard. Clear dirt and debris from between floor joists, allow for repairs to joists, and replace floorboards with new softwood boards to match existing.

- R3** Carry out plaster repairs to crazing lime plaster to arched soffit between corridor and stairwell.
- R4** The floor is from stone and has a number of open joints. Point floor in lime mortar. There is significant settlement of the flag stones below partitions, this should be checked by a structural engineer. Lift and rebed stone flags were sunk and carry out pointing to stone floor.

- R5** Overhaul and revive decoration to shutters on south elevation. In the southeast corner there appears to be movement - where the partition has dropped - this should be assessed by the structural engineer. Investigate from above and allow to install noggins in the top of the wall to allow plaster to be repaired from below.

- R6** To the east end of the ceiling the lath and plaster has failed. Remove lath and plaster ceiling and replace with breathable substrate and lime plaster finish. Remove wall paint finish.

- R7** The paint is flaking to the ceiling, remove flaking paint, skim ceiling in lime plaster.
- R8** Overhaul and revive decoration to shutters on south elevation. The ceiling is from plaster and has hairline cracking. Allow to skim in lime mortar. The south elevation has moved leaving a considerable gap between the ceiling and the wall. Allow to remove a section of lime plaster 1m wide and parallel to the wall to allow new laths to be fixed and the plaster to be repaired in lime plaster. Allow for installing noggins in the floor void above to secure laths. To the door reveal from the hall there is a section of damaged plaster to the south. Carry out repairs in lime plaster c1sqm. There is a significant structural crack between the spine and west wall which requires investigation by a structural engineer. Following structural repairs carry out replastering in lime mortar. C3sqm. To the west elevation behind the boiler modern plasters have sheared away from the wall. Remove modern plasters to reveal substrate. Allow to finish in lime. There is settlement of the stone flag floor, which should be investigated by a structural engineer. Lift a relay stone flags and point in lime mortar. The Aga is sat on a raised concrete plinth. The plinth and Aga will require removal and the floor should be repaired with matching reclaimed stone.

- R10** The ceiling has exposed rafters and the roof finish is felted on the underside. The walls are from masonry with a paint finish. The paint finish should be removed, and the walls insulated. There is some minor cracking to the south elevation to the west of the door. This may require Heli bar repairs as directed by a structural engineer. There is rot to the bottom of the boarding to the external door. Carry out repairs to door. Several of the stone flags have shattered and the floor will require repairs.

- R11** Stone slabs to the floor require pointing.

- Where necessary because of warping due to poor atmospheric conditions allow for replacing doors on a like for like basis.
- Carry out specialist survey of timber especially in the sitting room on the ground floor
- Remove wallpaper/ wall lining finishes to walls and ceiling and skim in lime plaster
- Remove carpet and underlay to floor, and allow to carry out repairs to the floor with new or reclaimed boards to match existing.
