PROJECT Stratfield Farm
OX5 1DL Kidlington

DWG TITLE Block B+C
Existing Elevations and Section

STATUS Planning and LBC

JOB/DWG No. 219-109

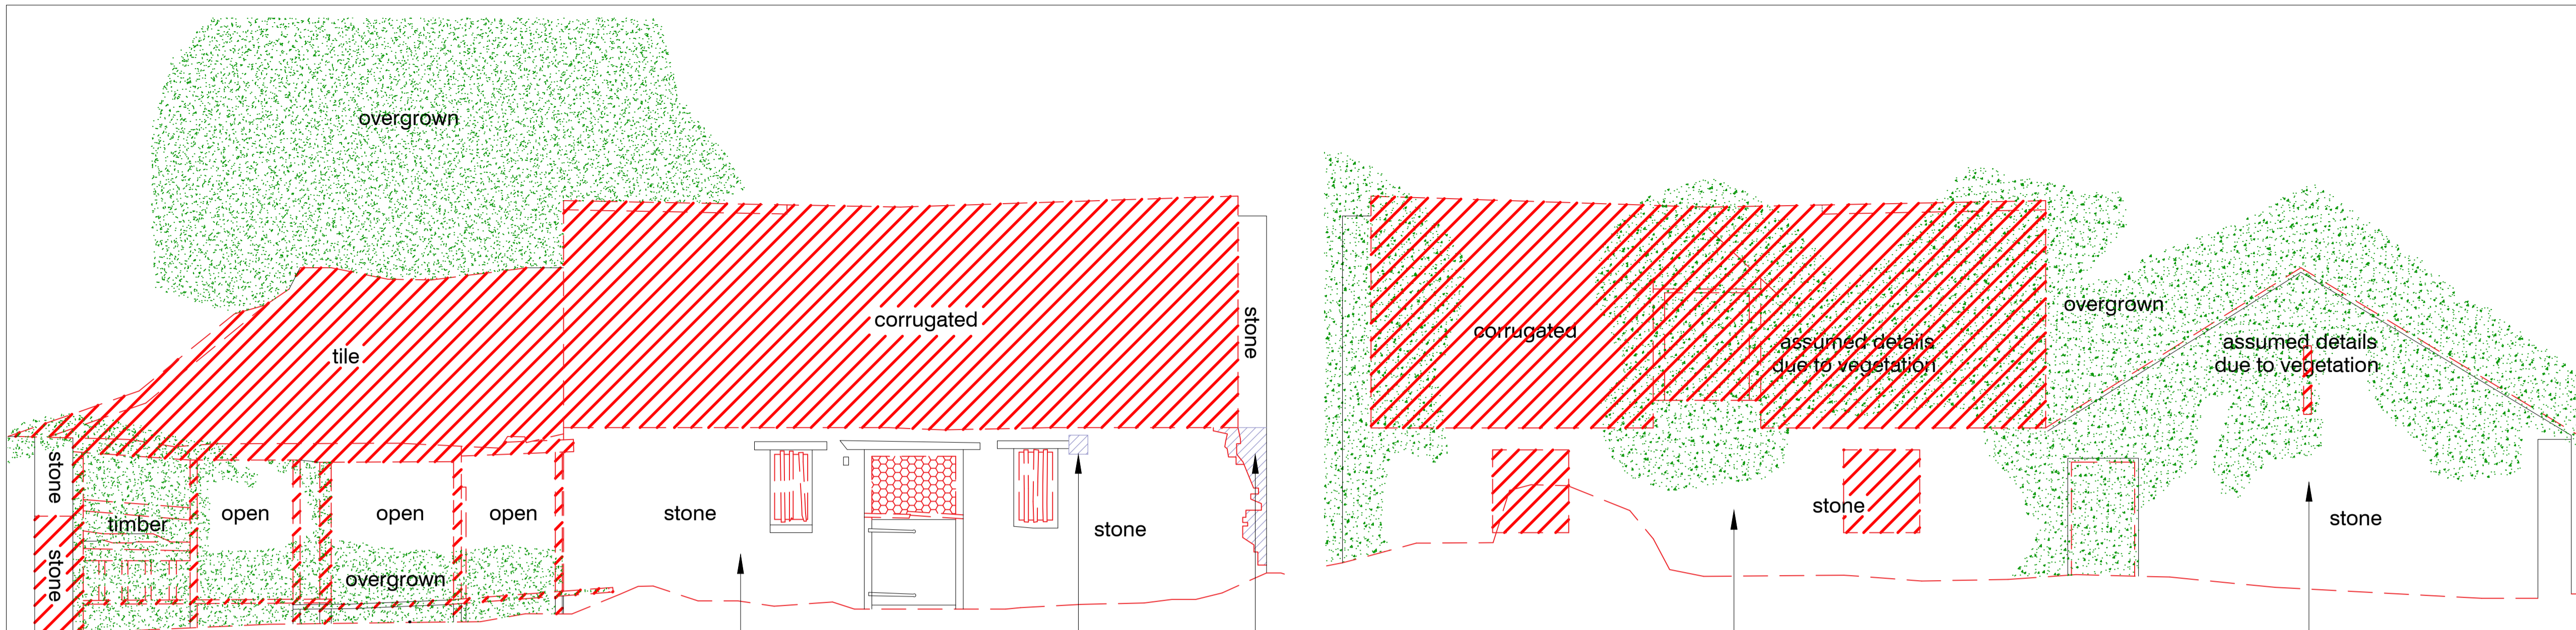
1.0 South Elevation

- R1** South elevation east window, rebuild 0.25 sqm of cracked wall.
- R2** Rebuild south east corner.
- R3** South wall repoint 100% of wall. Wall plate is displaced and moving outwards by at least 50mm, repair.
- R4** West gable wall, repair large vertical crack near the centre and repoint 100% of wall.
- R5** North wall, clean and repoint 100% of wall.
- R6** East gable wall, sides and top have failed and there is a large vertical crack towards the north end of the wall. Repair wall. Clean and repoint 100% of the wall.
- R7** Existing timber joists to be levelled and repaired. Replaced 10 no. where cracked. New timber boards to be installed on top.
- R8** West elevation wall repair top section of wall and repoint 100% of the wall.
- R9** West elevation, repair large crack at north west corner.

Generally, remove all vegetation from retained walls. Retain limestone rubble walling stone from demolished walls to be reused for repairs and new walls.
