PROJECT Stratfield Farm
OX5 1DL Kidlington

DWG TITLE Block G and H
Existing Plans

JOB/DWG No. 219-116

1.0 Existing Ground Floor Plan Showing Demolition

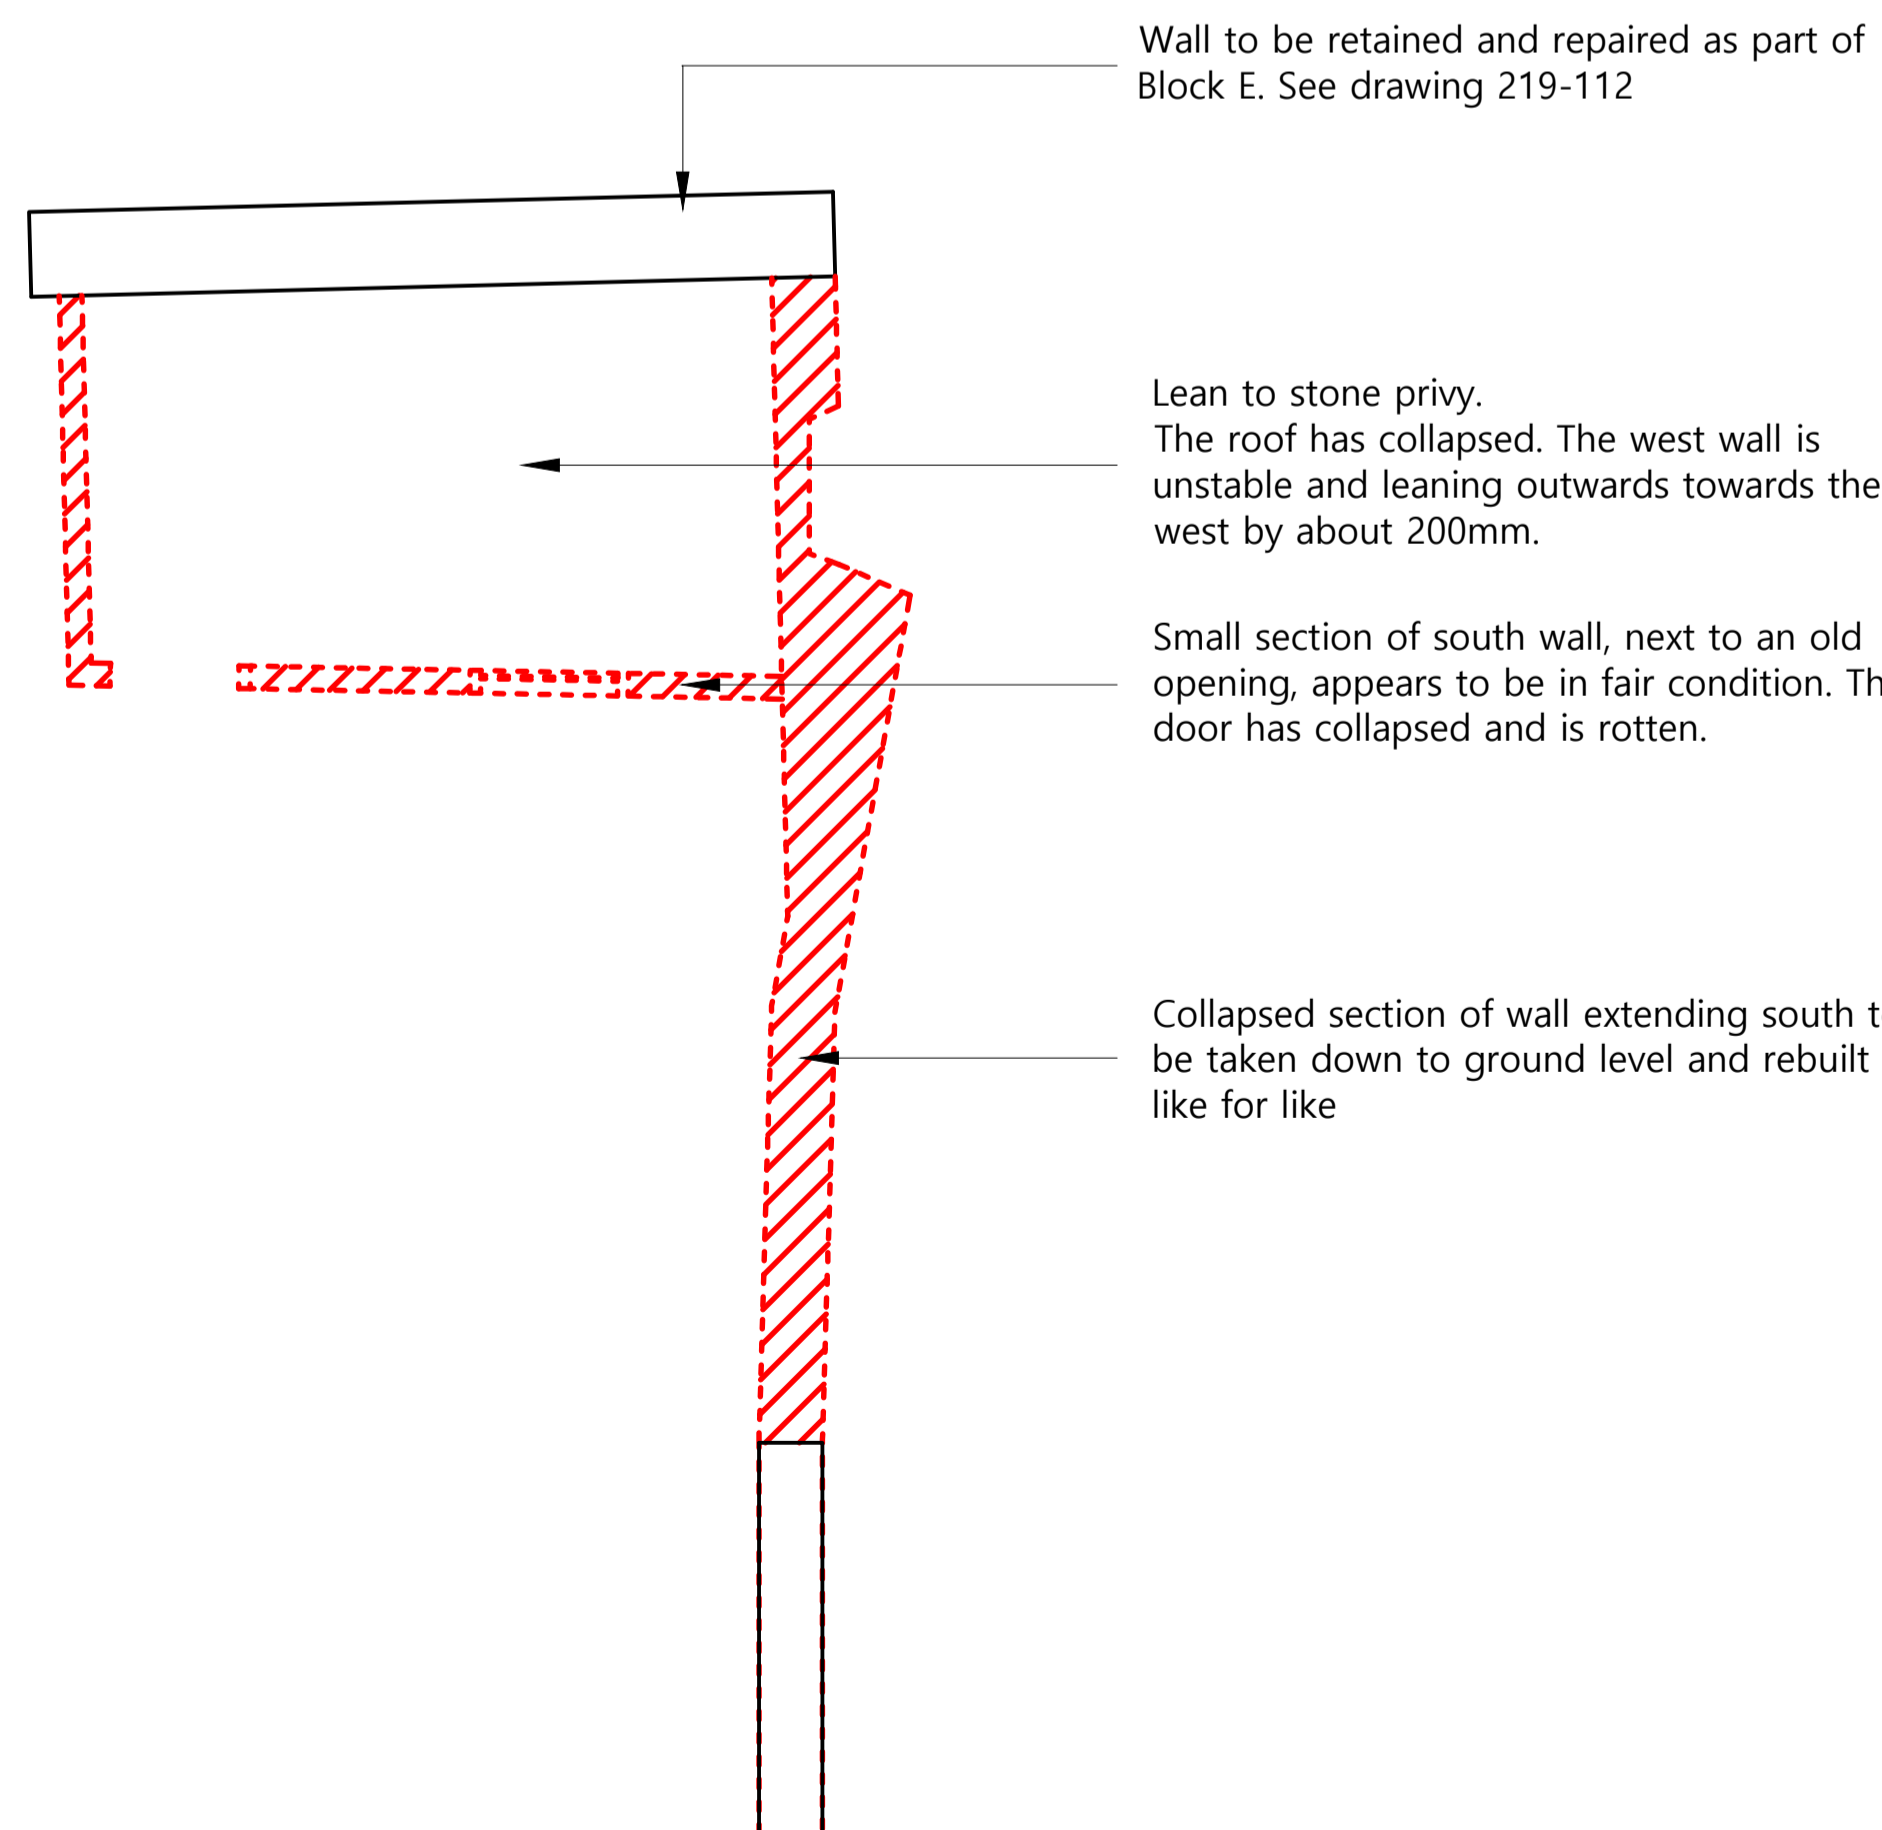
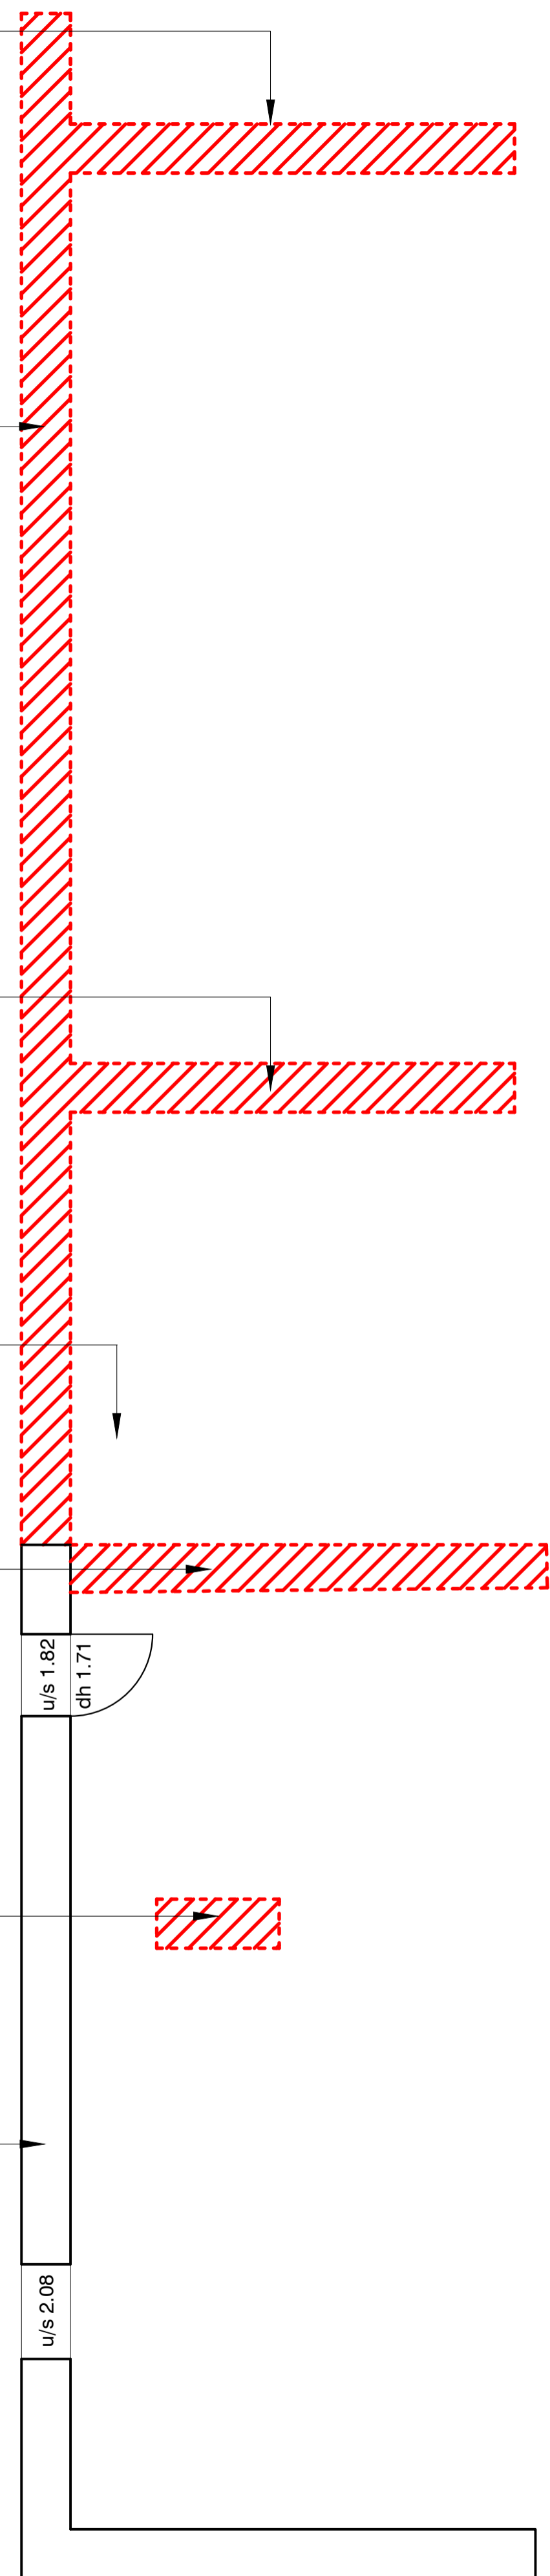
North gable wall largely intact coursed rubble limestone wall. Likely that the core of the wall has been washed away and that climbing plants have compromised the structure
Take down to ground level and rebuild like for like.

West wall. Coursed rubble limestone wall in largely ruinous state. Southwest section to the corner is intact but the remainder has missing sections.
Take down to ground level and rebuild like for like.

South wall. Coursed rubble limestone wall has been compromised by water ingress into the core of the wall. Visible structural movement.
Take down to ground level and rebuild like for like.

Interior overgrown. Fragments of possibly stone floor towards the southwest end, between the external wall and internal bay wall. Retain stone for reuse in repairs.

There is a low internal stone wall with cement pointing and badly rebuilt top section, with substantial root growth from the north side. Take down to ground level and rebuild like for like.

Small section of wall to be taken down to ground level and rebuilt like for like.

To be repaired and repointed
