## Stratfield Farmhouse, Oxford Road, Kidlington, OX5 1DL

## Structural Inspection Report

Prepared by: **Josh Lawrence MEng CEng MICE**  
Reviewed by: **Mike Wilford MEng CEng MSc MIStructE**  
Job Number: **27476**

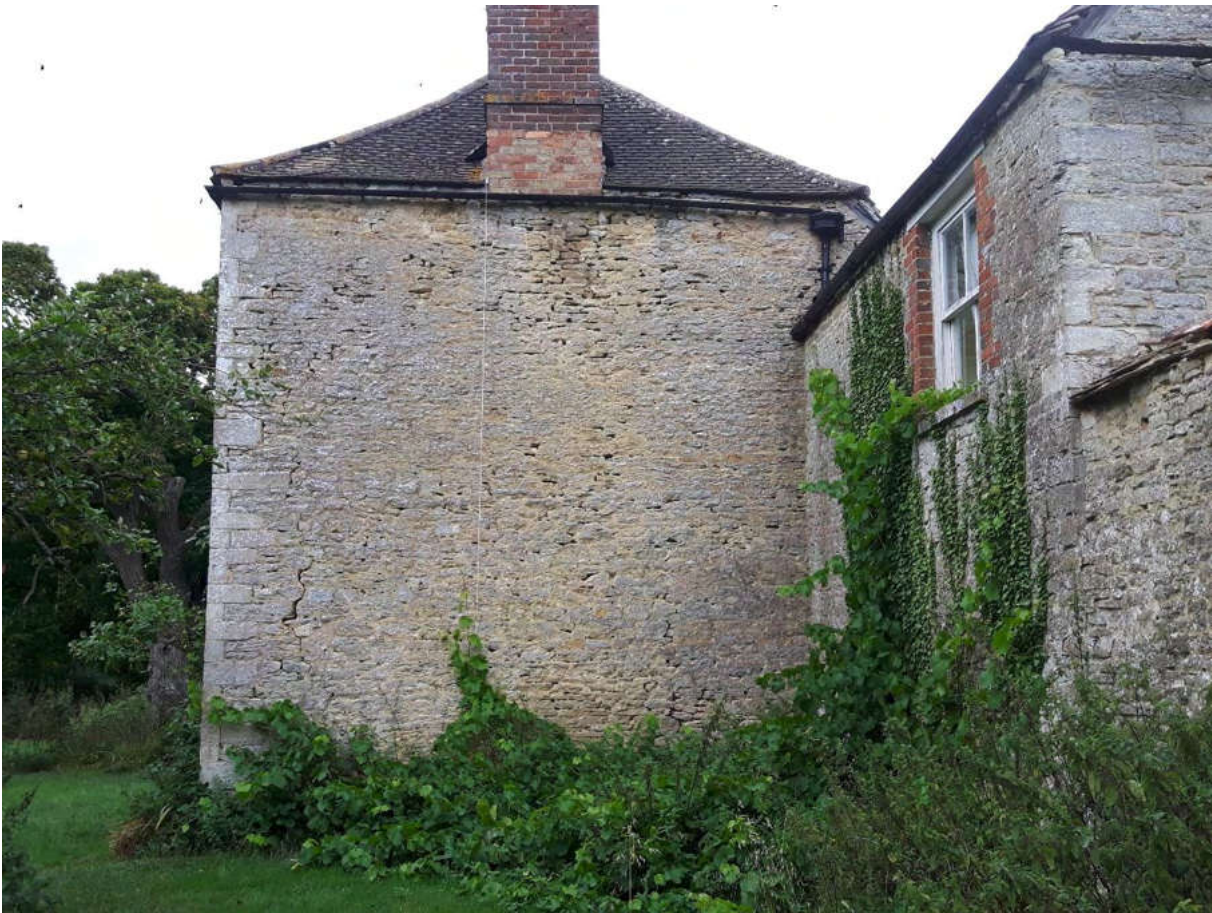
Photograph 1 - East elevation

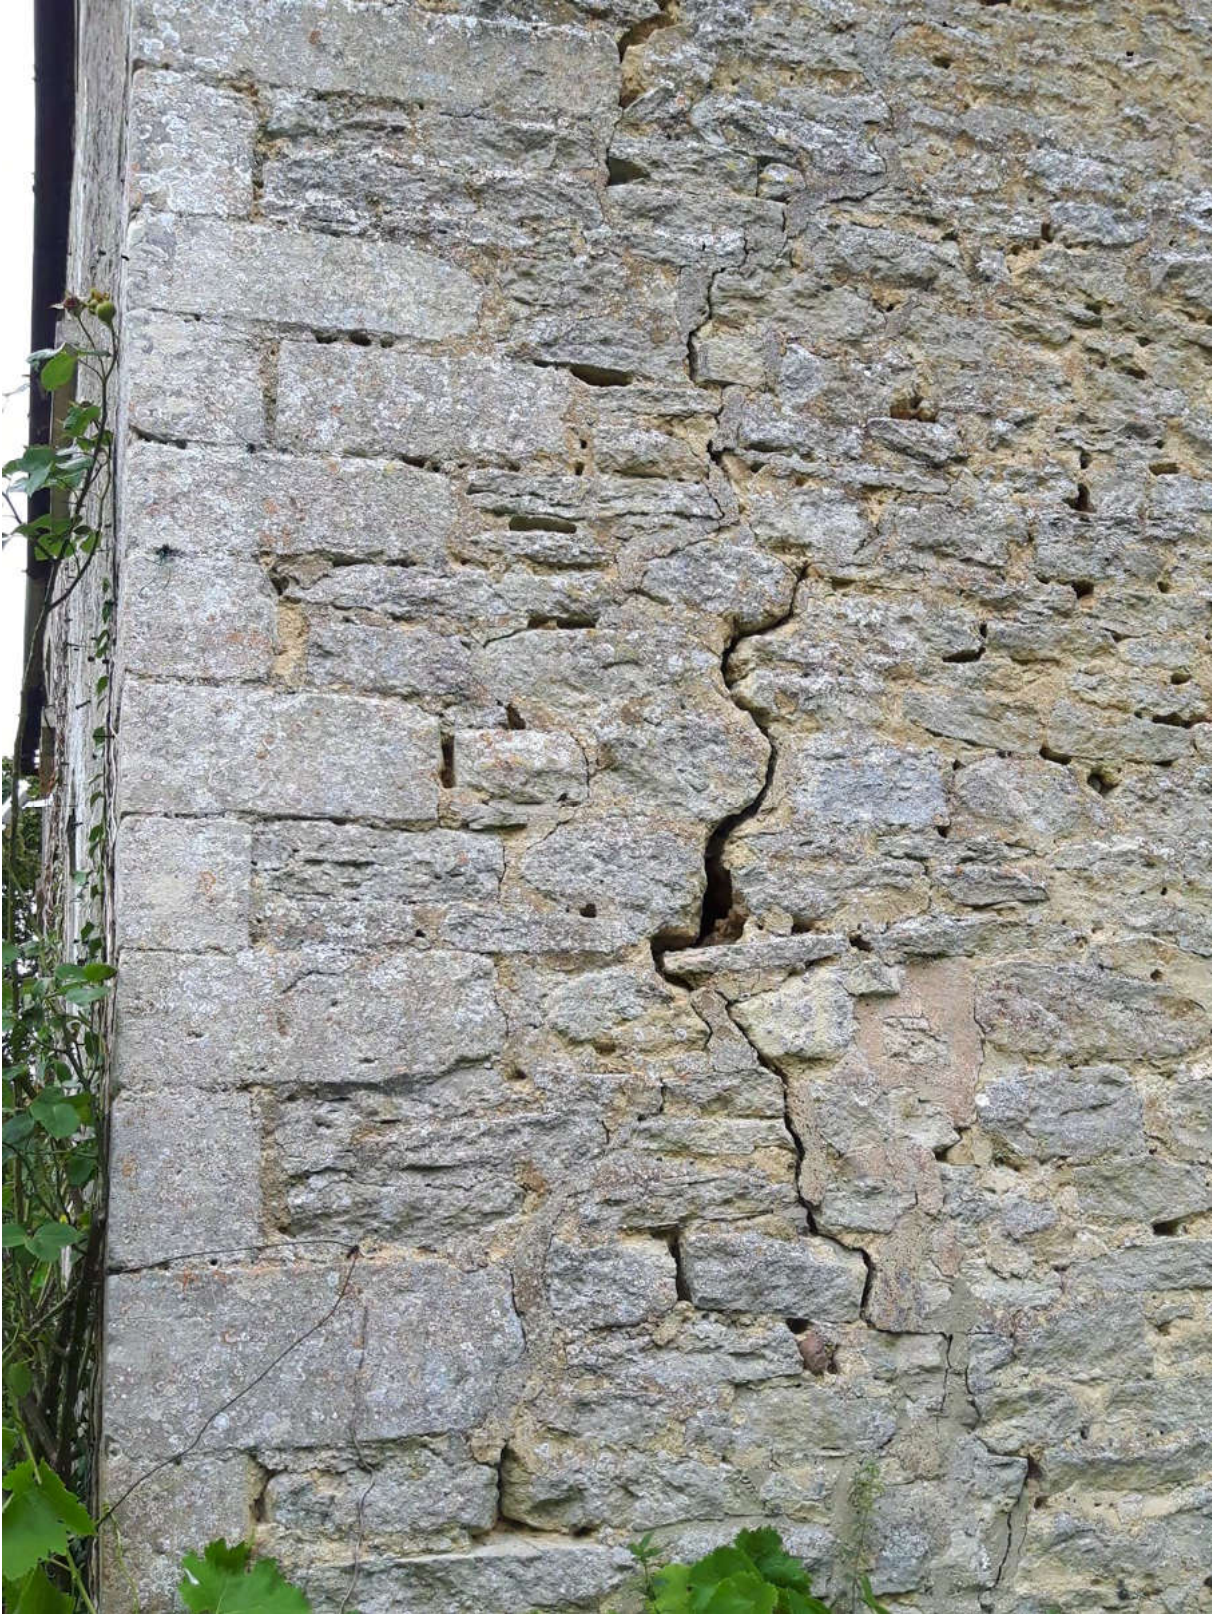
Photograph 2 - Cracking to east wall indicating relative movement with south wall

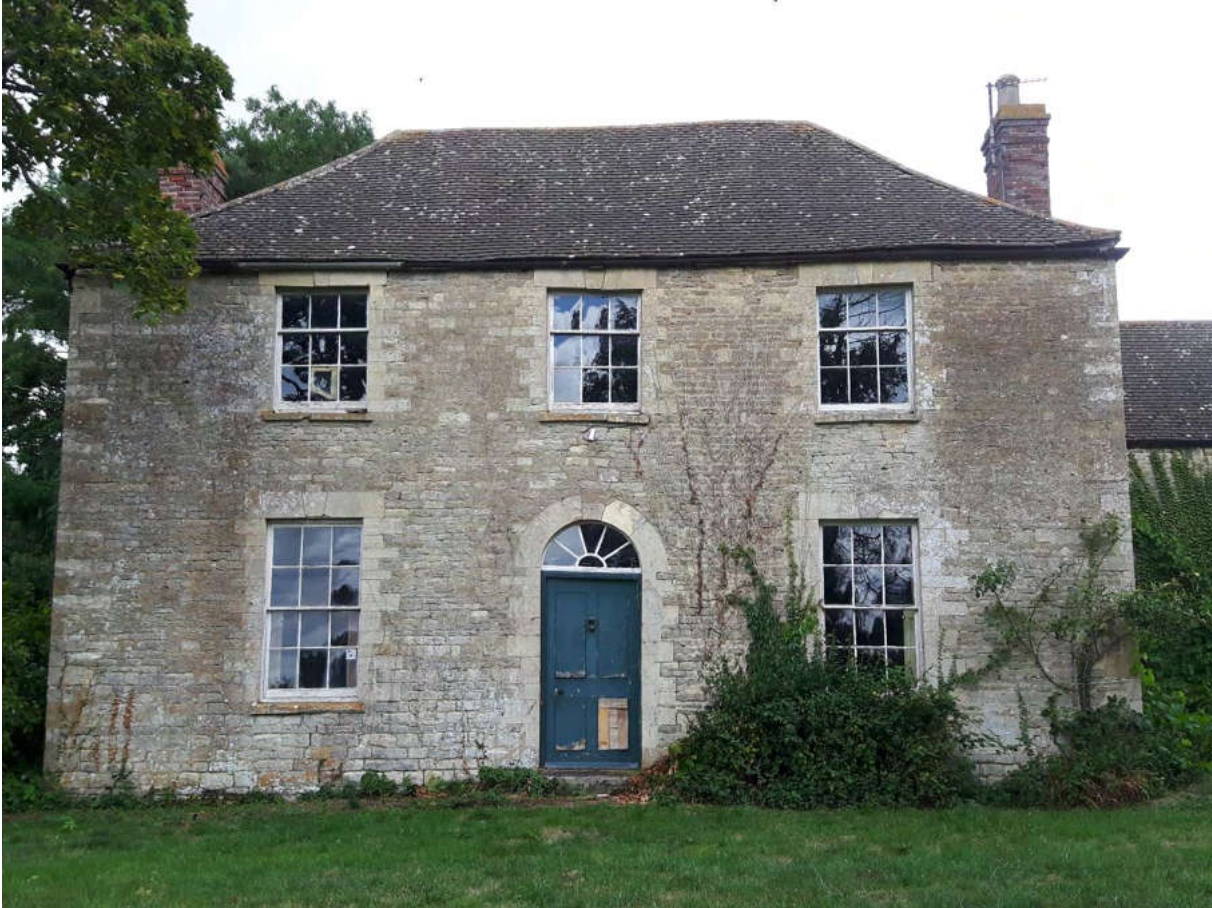
- i. The farmhouse is in extremely poor structural condition with extensive and severe cracking throughout.
- ii. Building elevations show clear signs of structural movement: lintels set on angles and extensive cracking to the stonework. The front door frame and stone arch on the south elevation has dropped on the east side. The south wall appears also to fall to the west generally.

Photograph 3 - South elevation

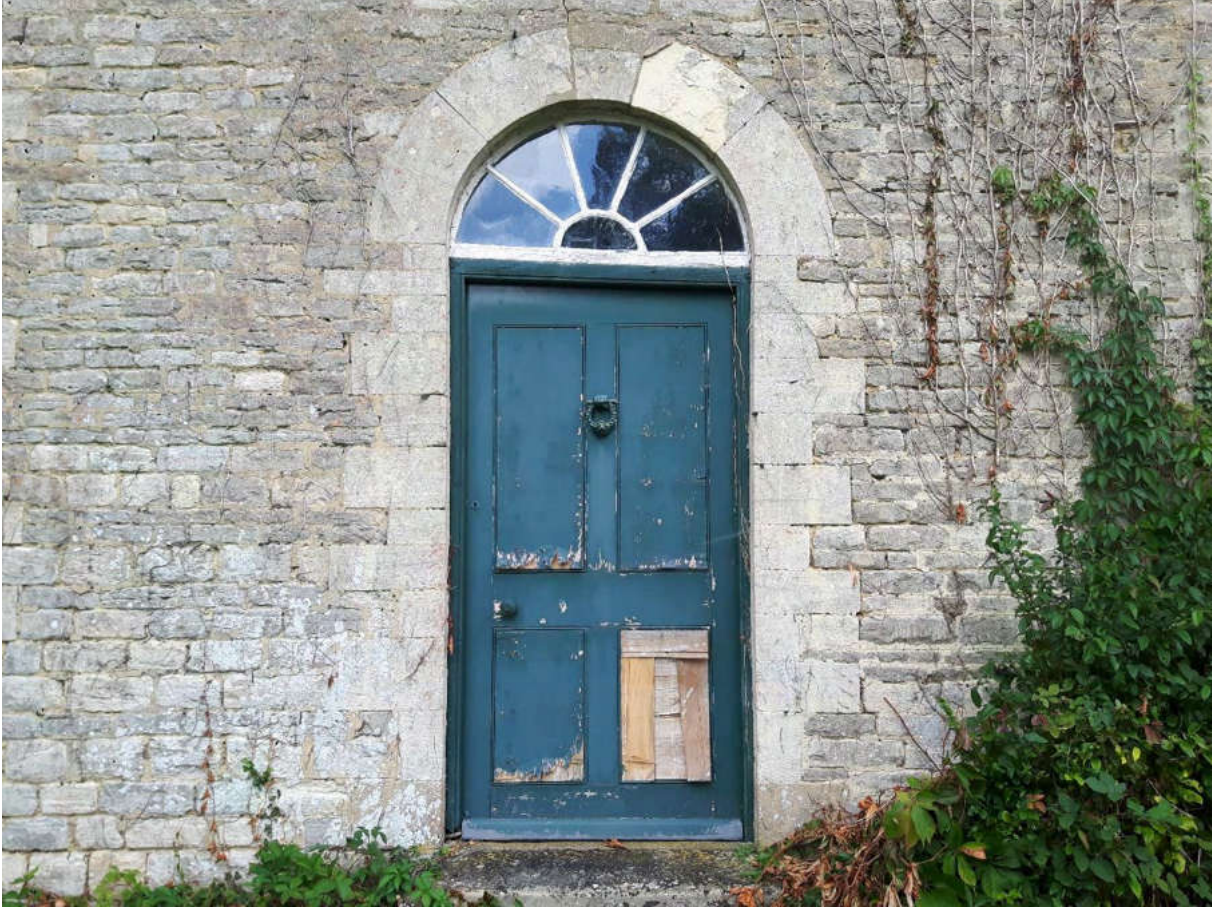
Photograph 4 - Differential movement through arch lintel

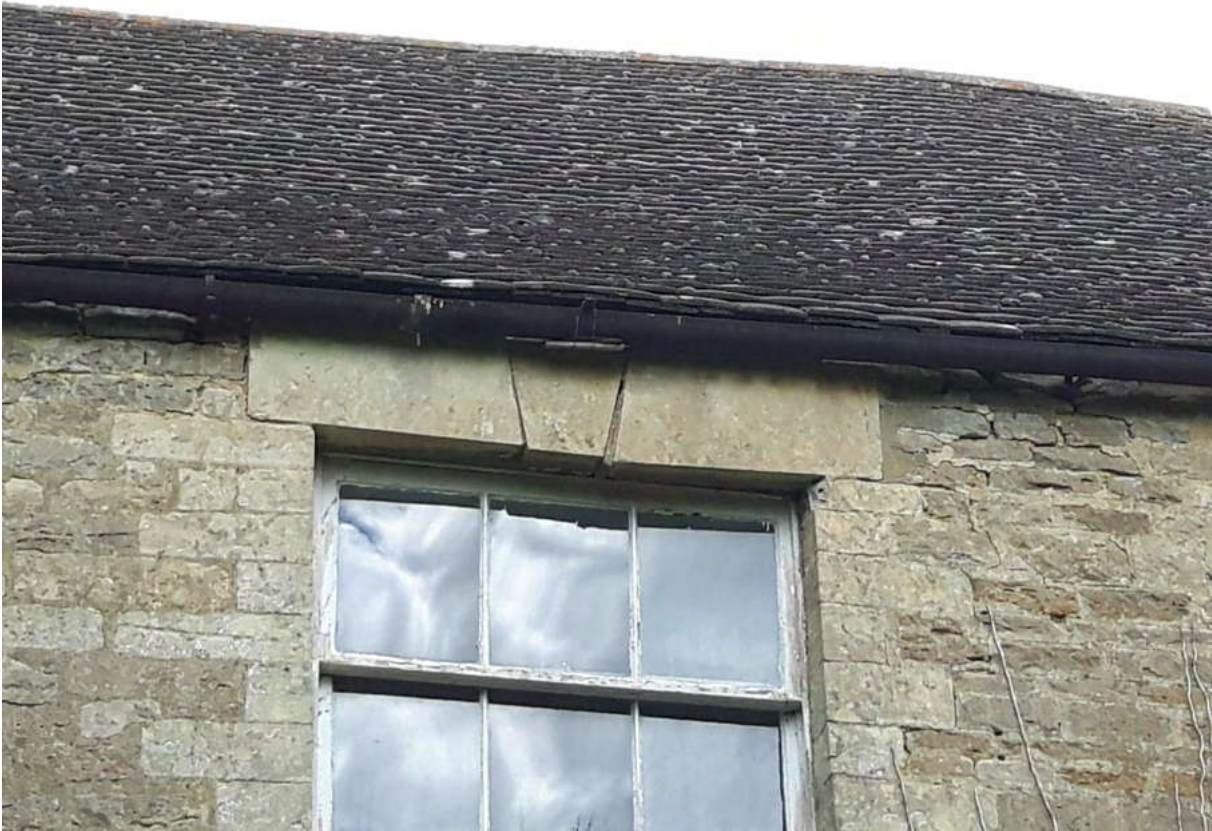
- iii. The west wall has extensive cracking and movement which can be seen in the lintels and bowing outwards of the roof eaves.
- iv. Many of the lintels have spread and keystone dropped following movement and cracking to the walls. Previous repairs to lintels are apparent.

Photograph 5 - Slipped keystone

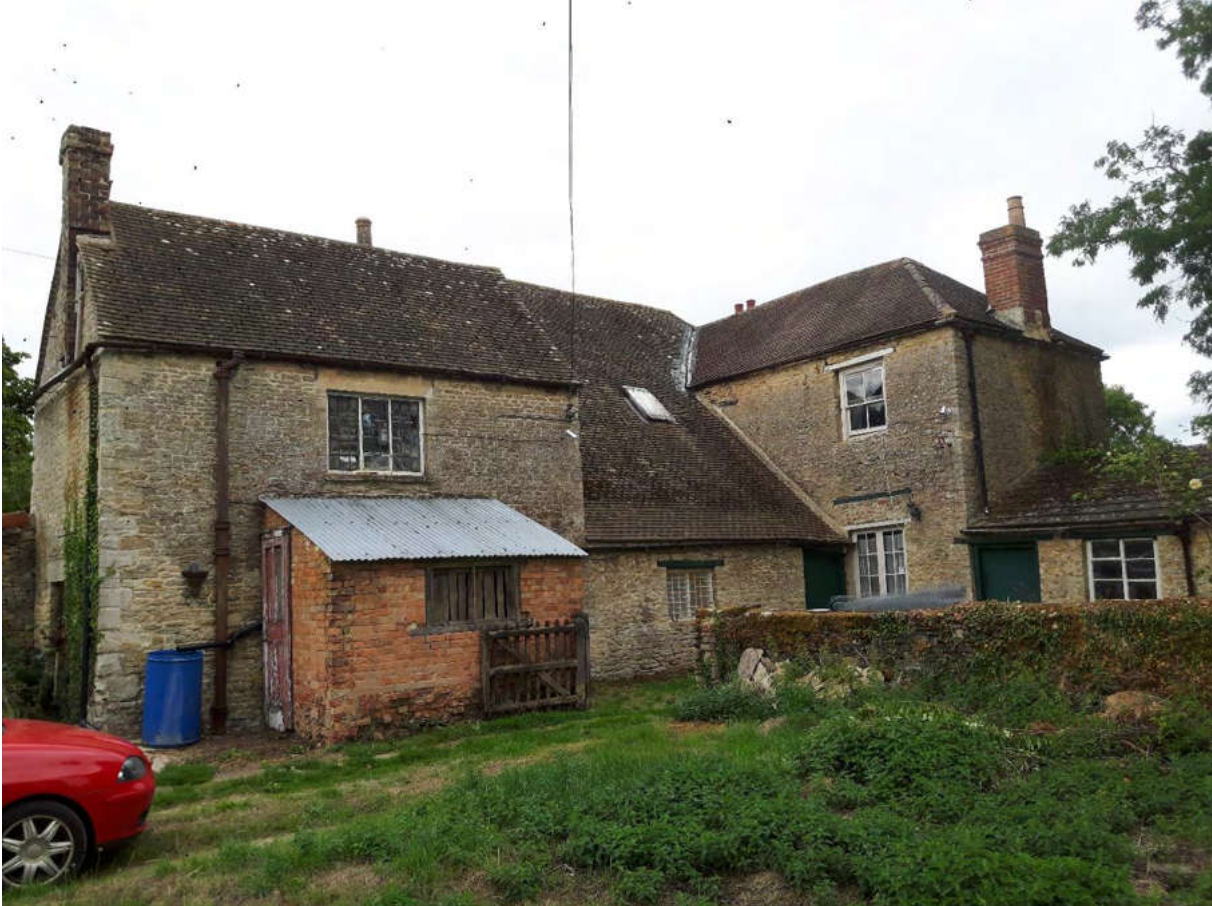
Photograph 6 - North elevation

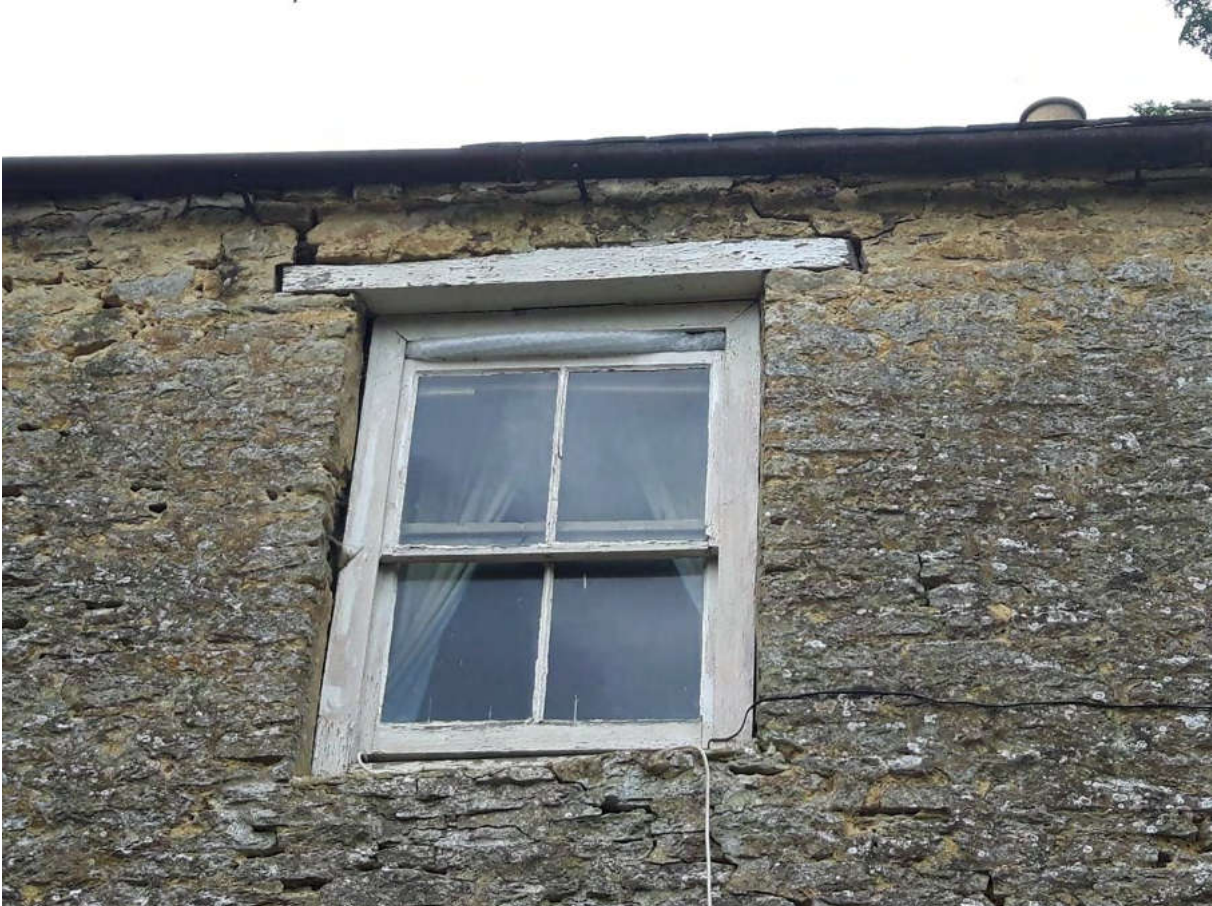
- v. The less prominent north and east walls have timber lintels which appear to have suffered some rot and the surrounding stonework cracked.
- vi. Internally the ground floor is uneven and falls markedly from the central hallway to the west. The same is apparent at first floor. The fall in the hallway does not correspond with the movement in the main door which suggests localised settlement issues.

Photograph 7 - Movement and cracking around timber lintel

The walls would be strengthened and restrained by means such as restraint ties and crack stitching. The spine walls are so severely damaged in places that removing parts and rebuilding would be required, and the internal and external walls can then be positively tied together to reintroduce the necessary restraint conditions. Lintels would be re-set where undamaged. Embedded timber should be removed throughout and infilled with new masonry and the timber lintels inspected need to be removed and replaced with suitable alternatives.

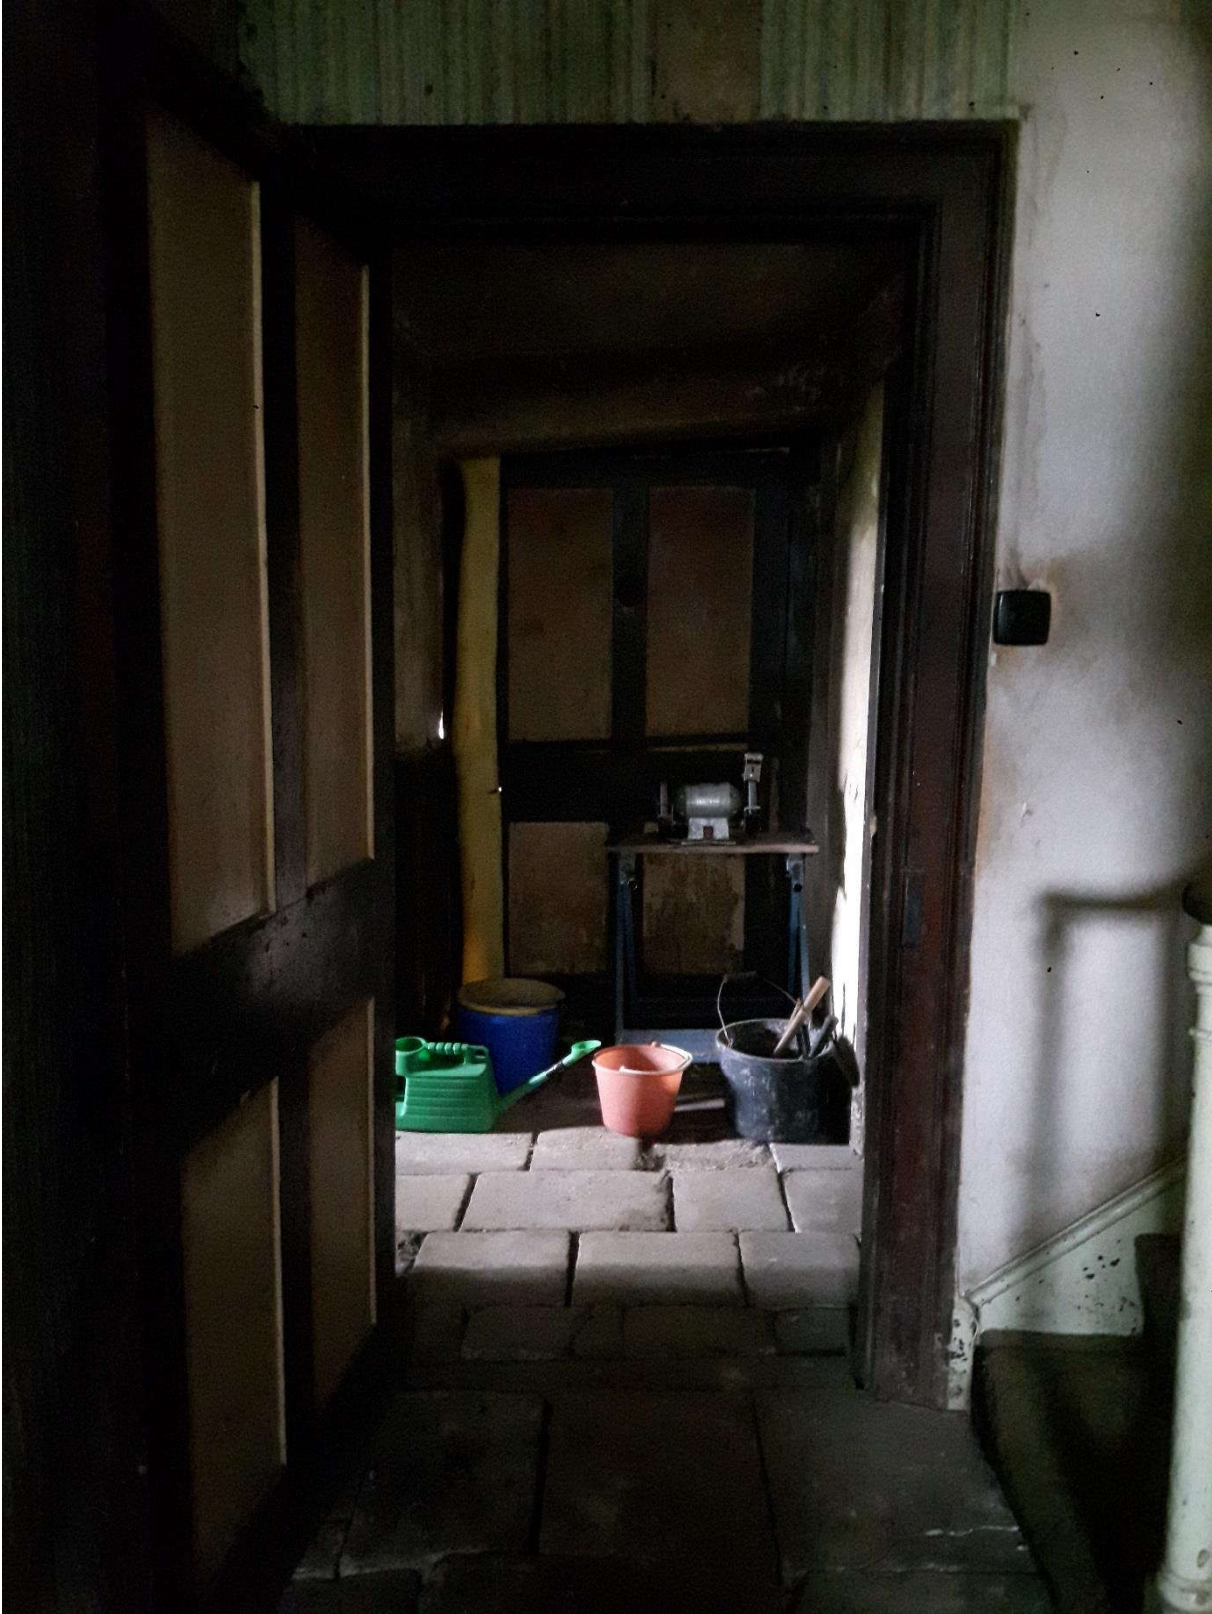
Photograph 8 - Main hallway floor relative to north door lintel

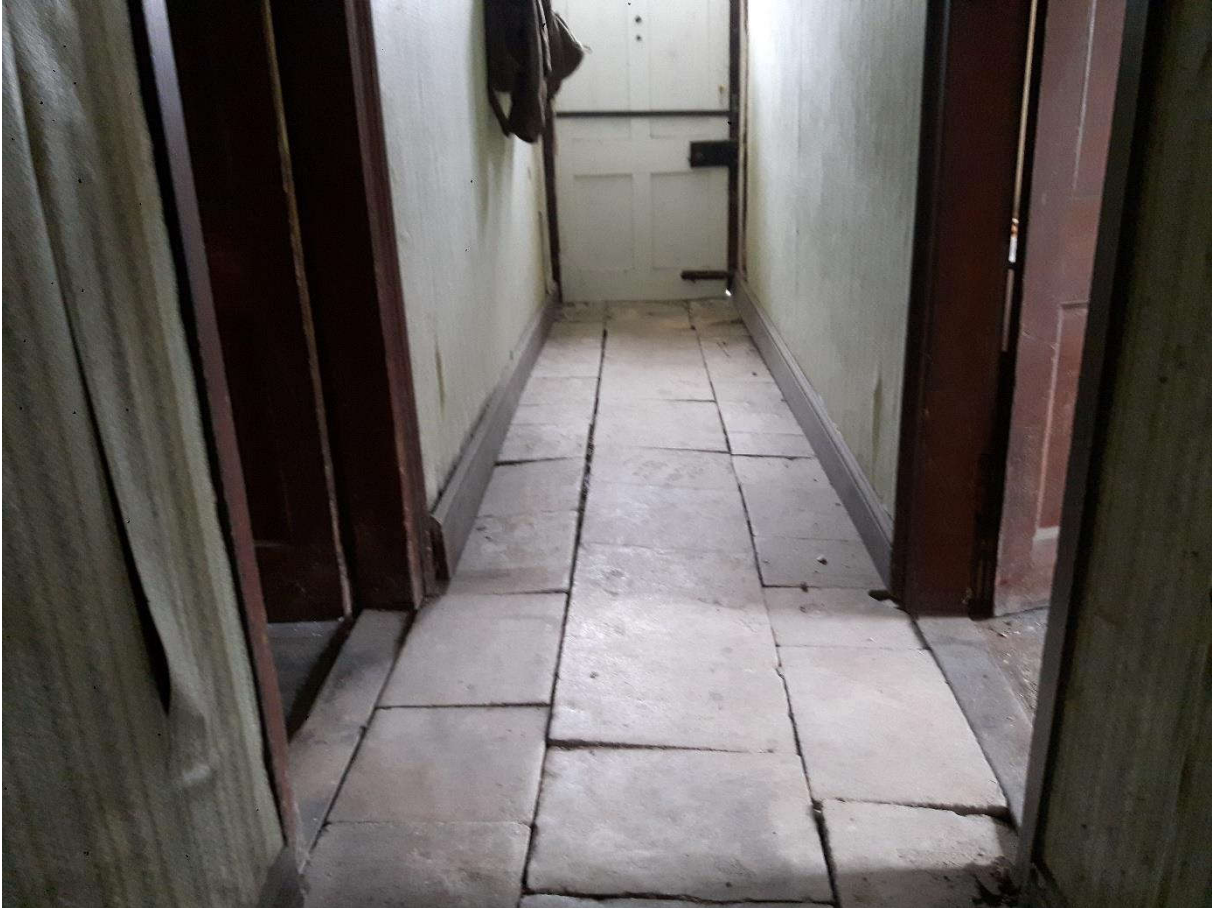
Photograph 9 - Main hallway fall towards west

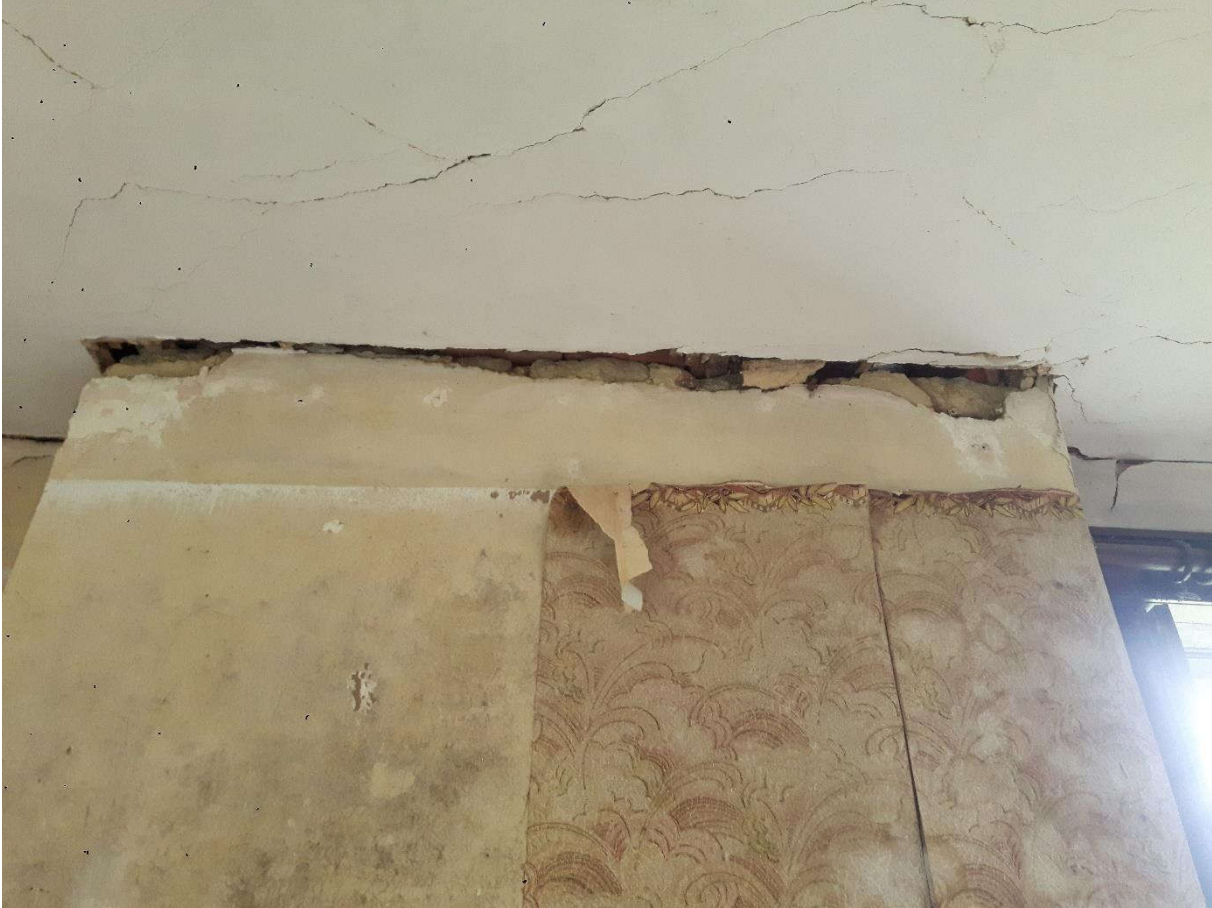
The movement of the west wall has caused a gap to open between the wall and floor. The first floor joists span parallel to the west wall and therefore the joist bearing on the spine wall should not be compromised by the movement.

Photograph 10 - First floor joist separation from west wall from below

The floor joists in the west rooms, where their ends are currently unsupported, would need to be removed and replaced or each of them spliced to extend their length. All floors and roofs, new and existing, would be tied to the walls with galvanised mild steel restraint straps.

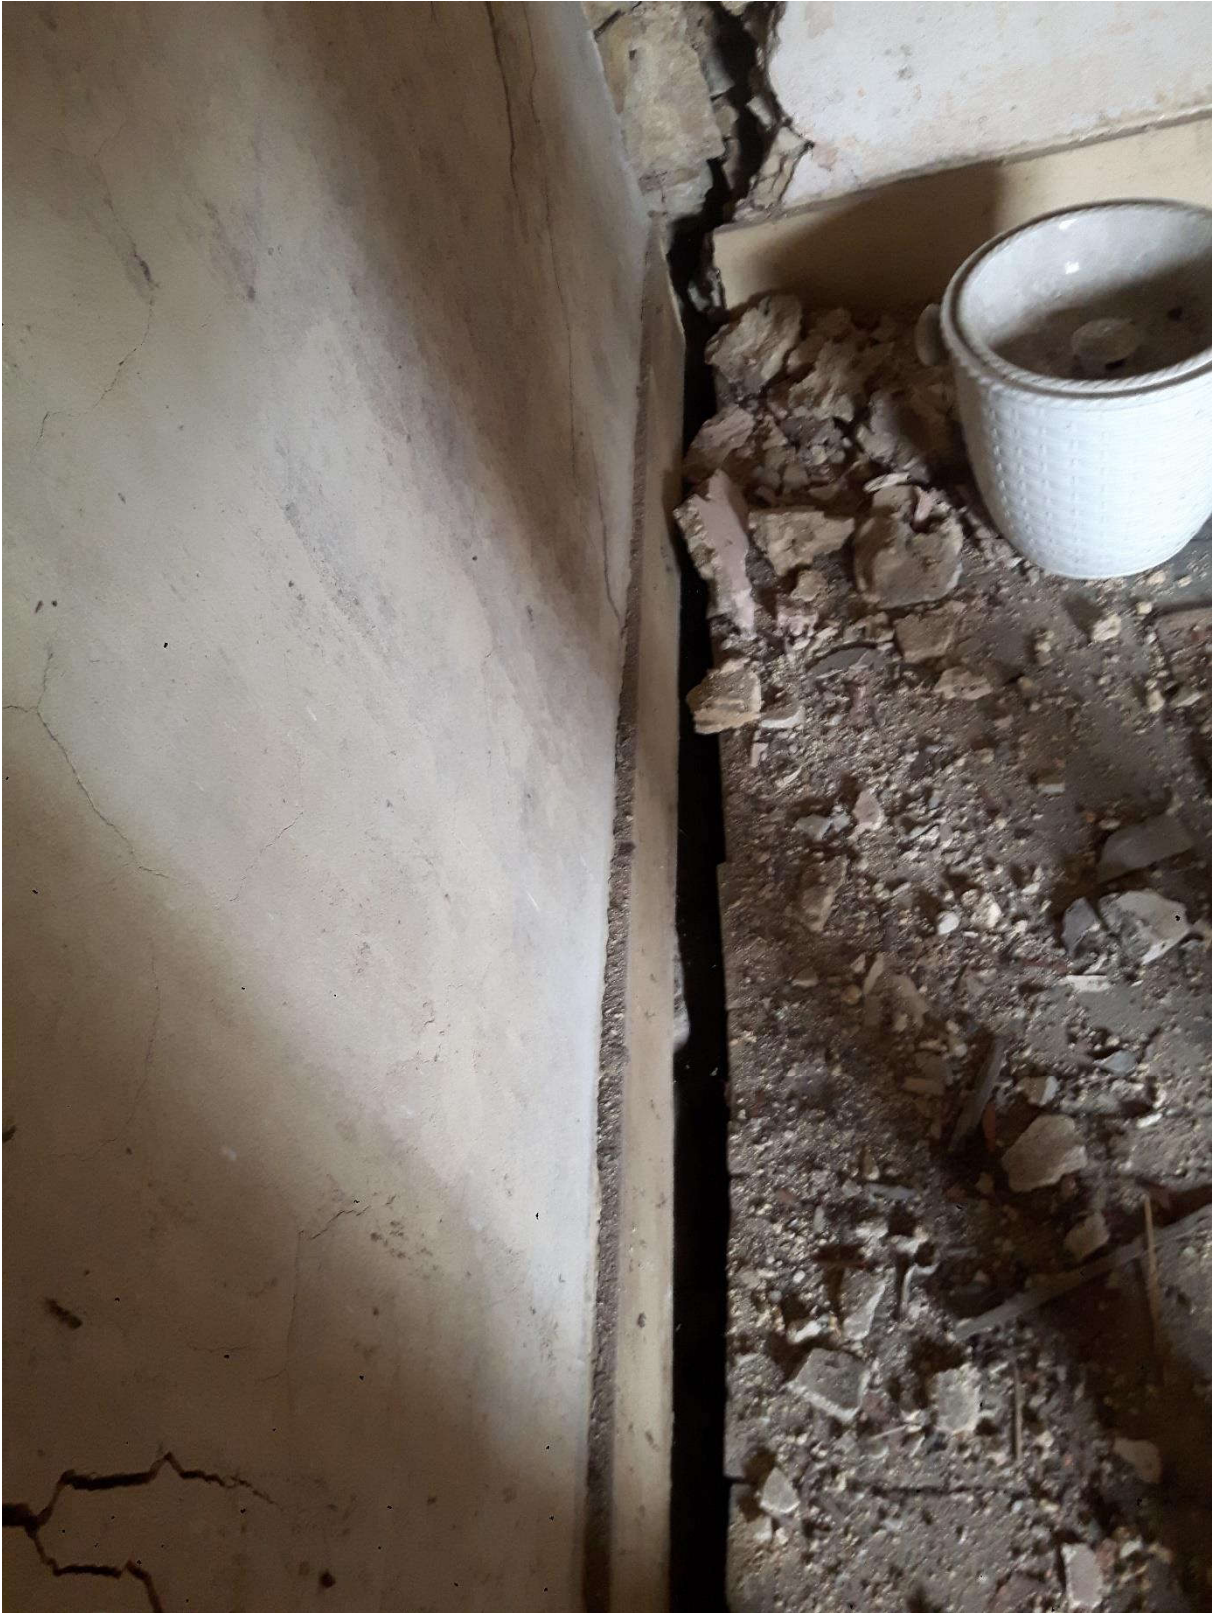
Photograph 11 - First floor joist separation from west wall from above

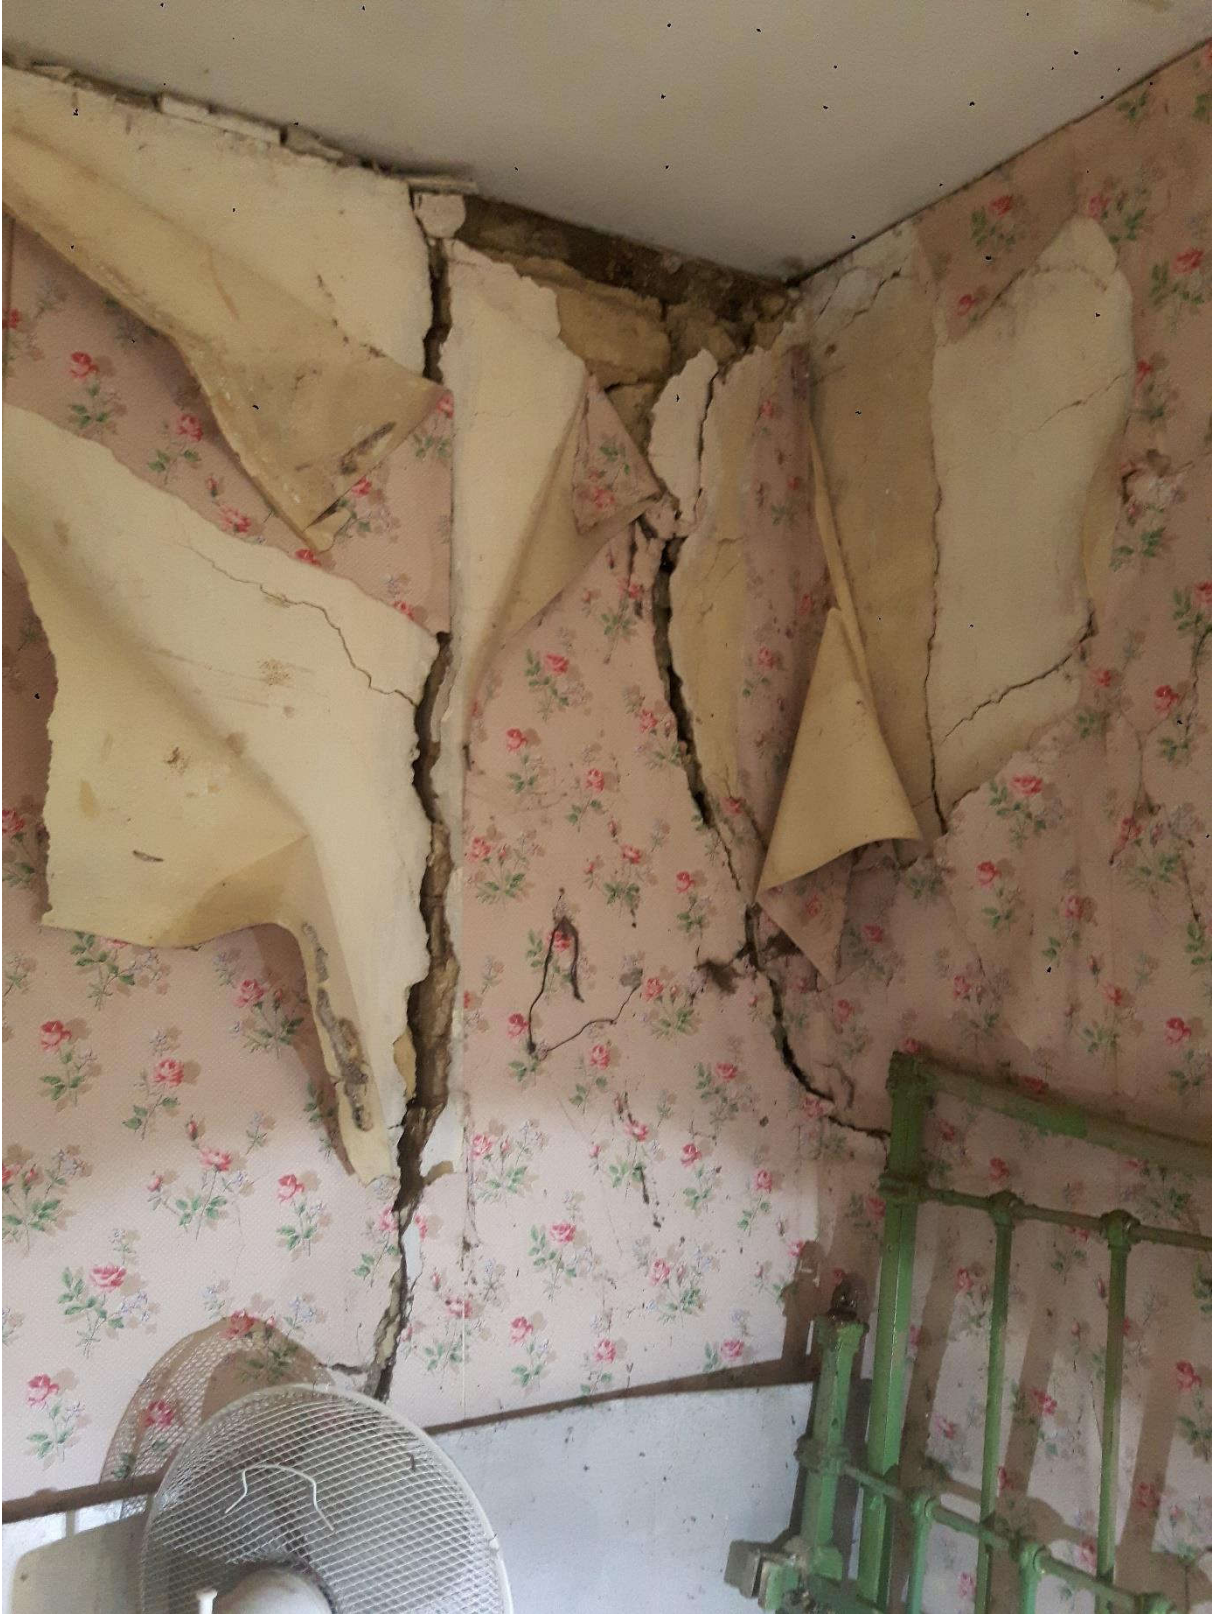
- vii. Timber joists were observed under the stair at ground floor, some with rotten joist ends.
- viii. There is extensive cracking in the internal walls at ground and first floor, particularly those on the west side. The spine wall and west wall have fully detached and the first floor separated from the west wall.

Photograph 12 - Severe cracking in first floor spine wall and separation from west wall

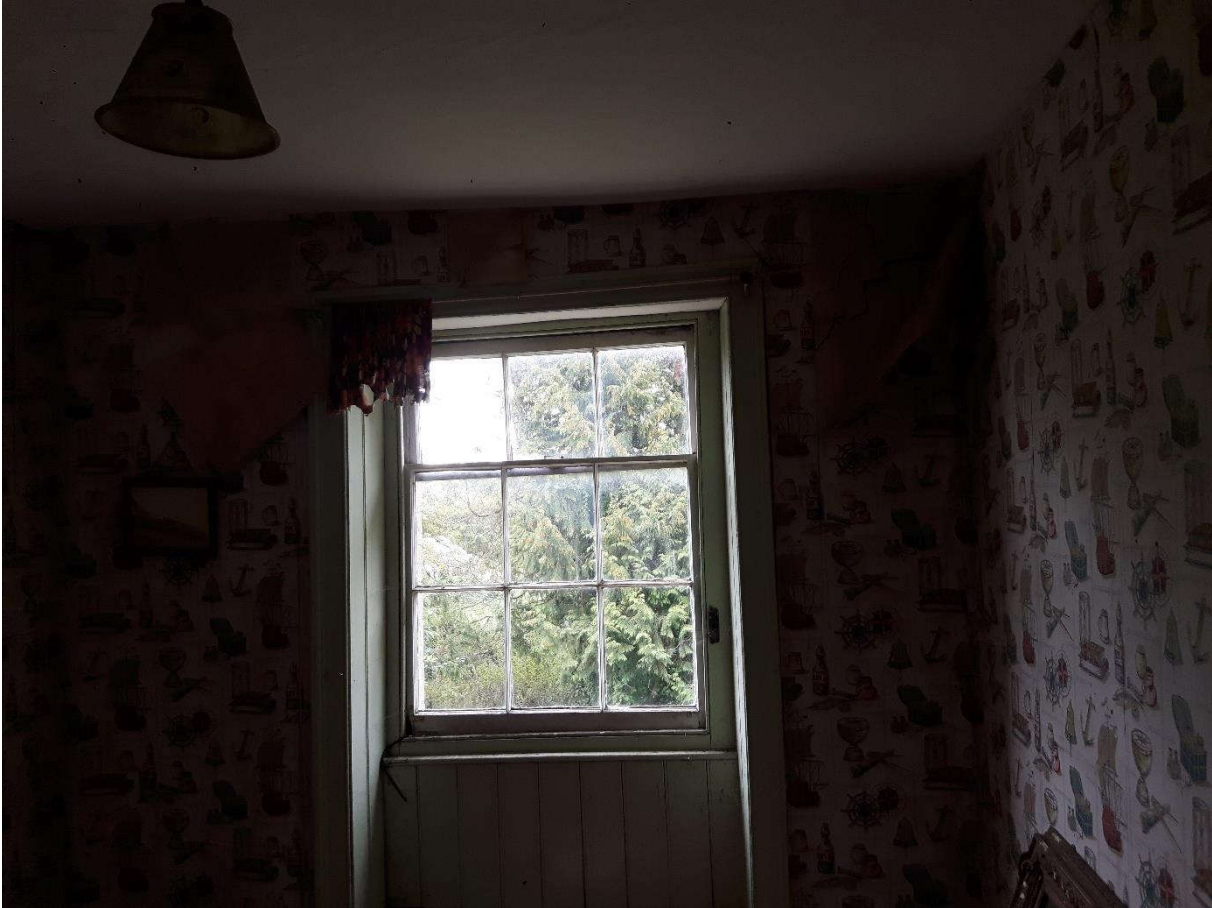
- ix. Lintel movement internally corresponds to the movement observed externally, as does the bowing of the west wall observed from the north west bedroom.

Photograph 13 - Internal lintel in south wall, central window over front door

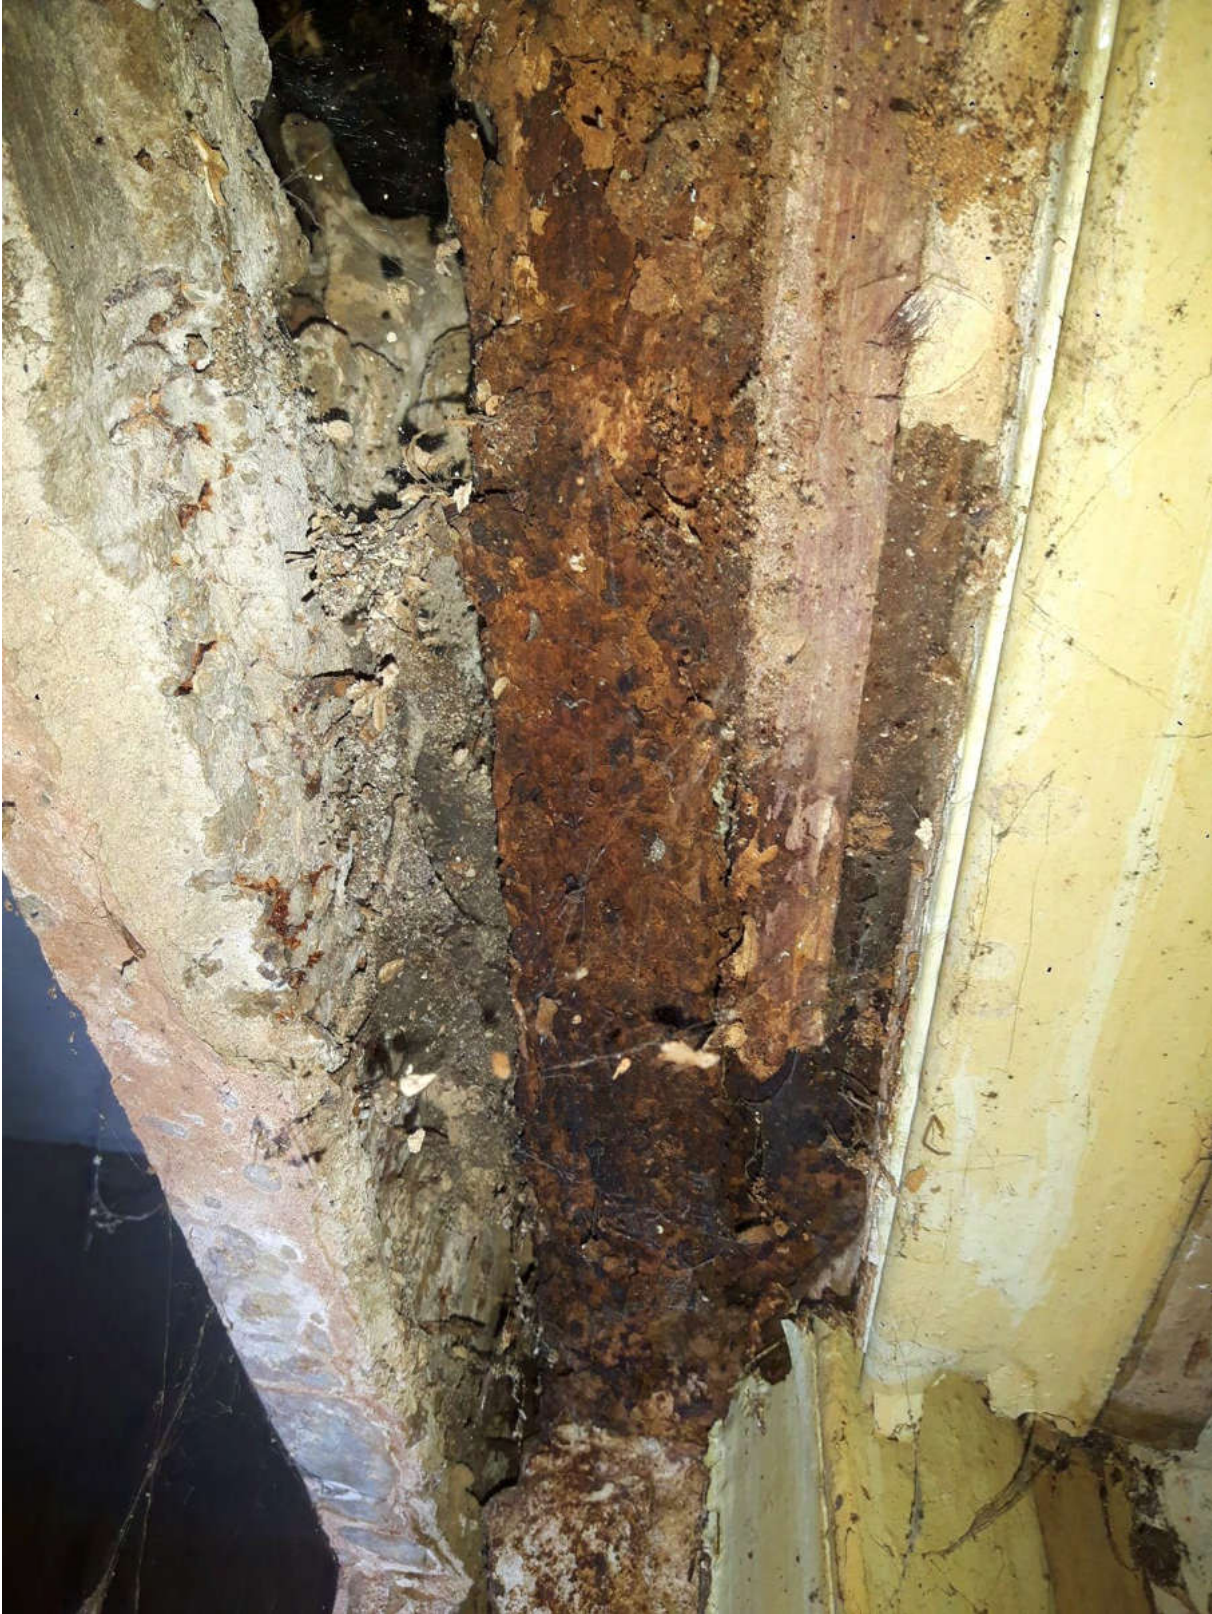
- xii. There is a large gap in the roof between the original roof and the catslide roof. The internal timbers in this location have rotten from weather exposure. Externally there is evidence of repairs in this location.

The movement in the west wall may also be responsible for the roof separating between the original building and the catslide roof.

Photograph 14 - Rotten timber beneath gap between roofs

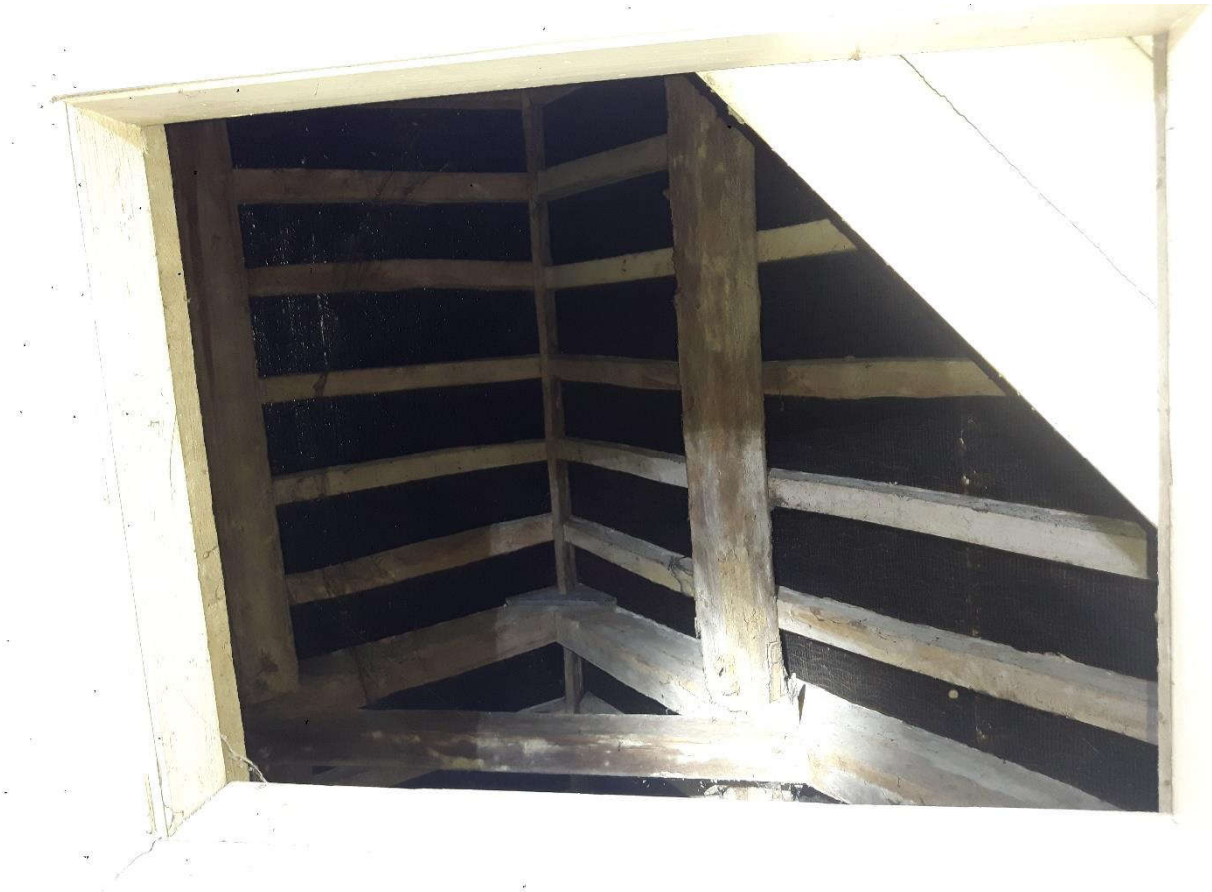
- x. The east part of the building is in much better condition compared with the west, both in terms of movement of walls and floors.
- xi. The roof structure was inspected in two locations and in both the timber rafters and purlins appeared in reasonable condition.

Photograph 15 - Roof structure showing primary rafters and ties forming A-frame

The roof structure form suggests the roof may be in reasonable condition, however this would be subject to inspection and further assessment.

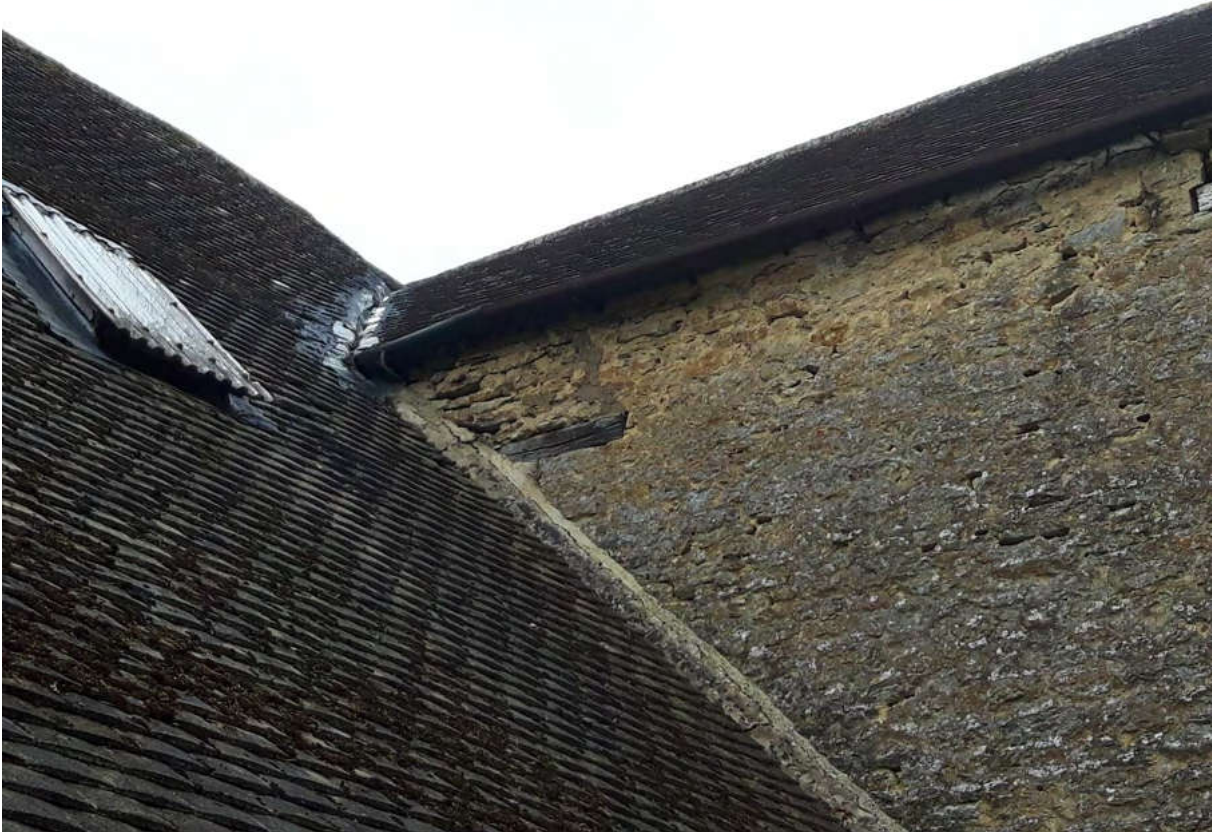
Photograph 16 - Junction between roofs with previous repair and embedded timber
