## Stratfield Farmhouse, Oxford Road, Kidlington, OX5 1DL

## Structural Inspection Report

Prepared by: **Josh Lawrence MEng CEng MICE**  
Reviewed by: **Mike Wilford MEng CEng MSc MIStructE**  
Job Number: **27476**

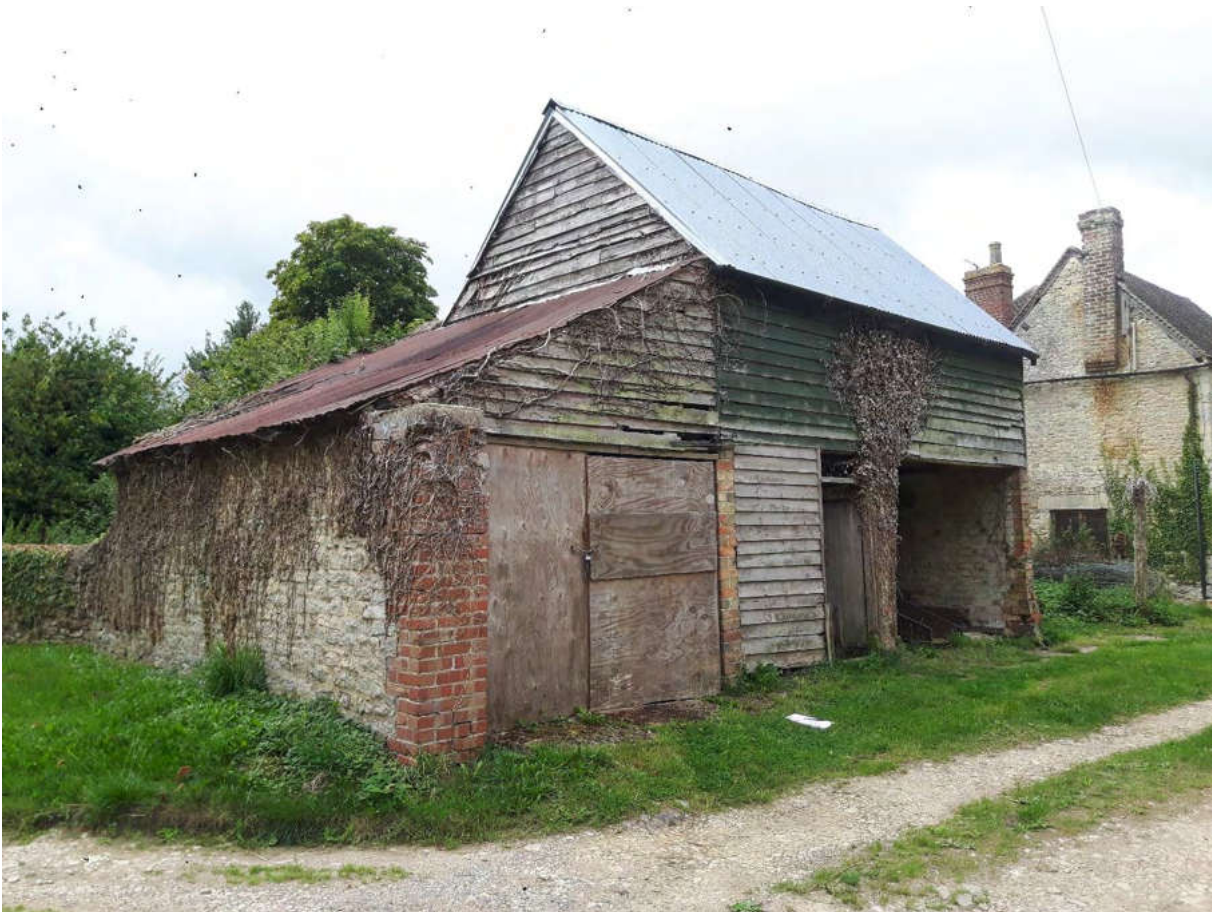
Photograph 17 - Block A, north elevation

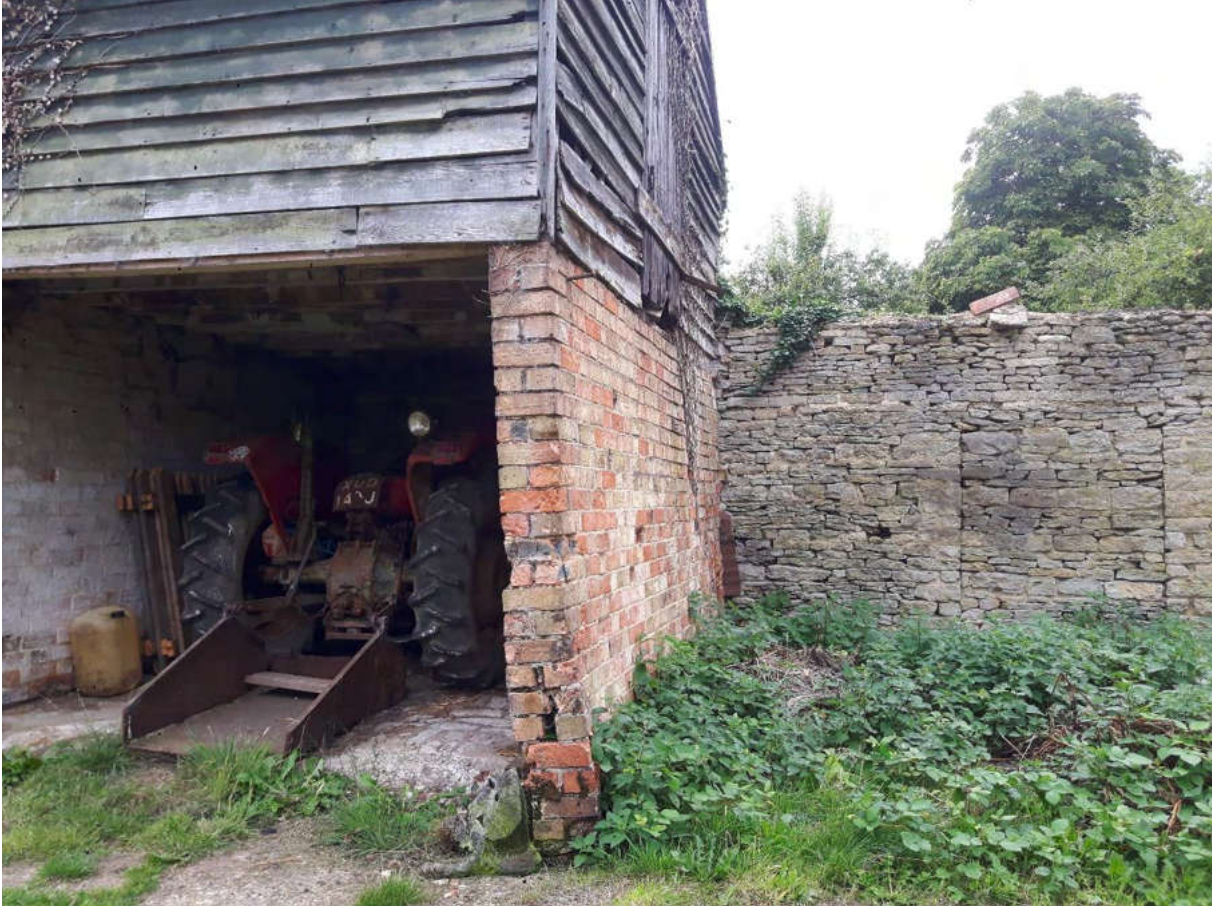
- i. 9inch solid brick wall on west elevation is leaning significantly, particularly at the base on the front elevation where a tree, now cut back to a stump, appears to have undermined the wall. The remainder of the wall further from the stump is much straighter.
- ii. The two other 9inch brick walls are in OK condition.
- iii. The east and south elevation has vegetation coverage which has penetrated the timber structure into the internal space.
- iv. Some rot in the first floor timber joists.

Photograph 18 - Block A, leaning wall and tree stump

Masonry including stonework is in reasonable condition except for the leaning wall which is repairable. The building has previously suffered from water leaks through the roof and cladding and the timber is rotten in places. Roof and floors should be surveyed by timber specialist to establish extent of rot. The floors may require local replacement of some of the joists, whereas the roof and walls would more likely need to be removed and replaced, although many of the timbers will be salvageable.

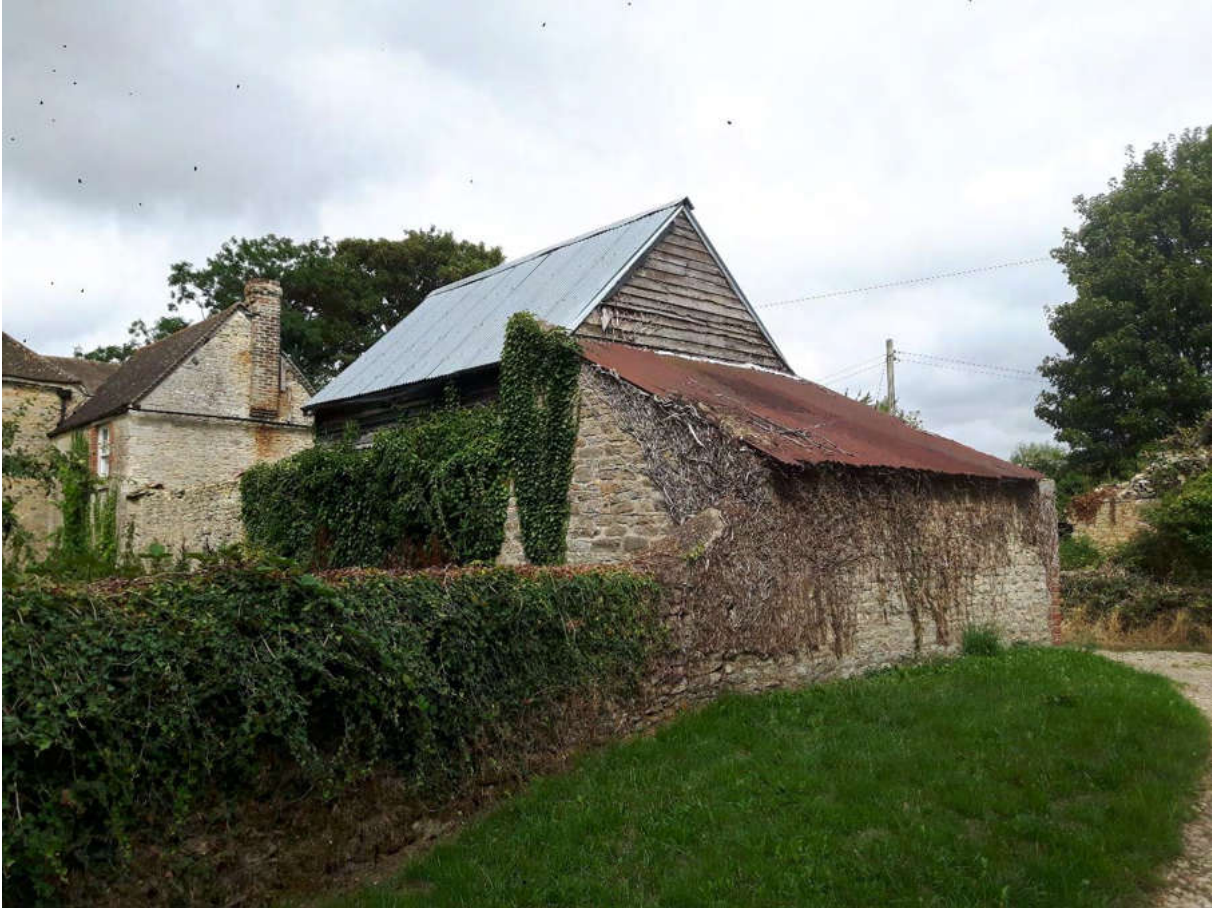
Photograph 19 - Block A, south-east elevation

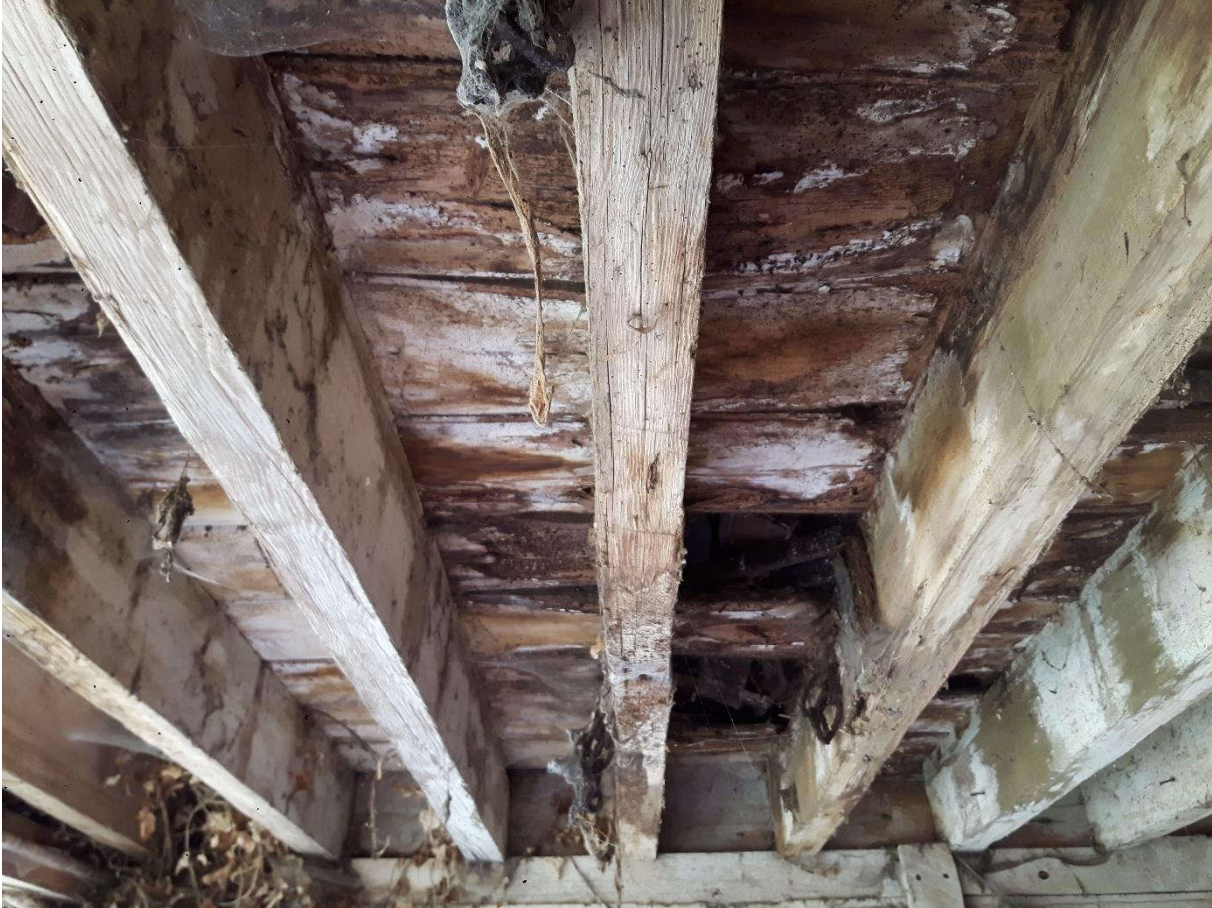
Photograph 20 - Block A, mezzanine timber joists, with rot damage

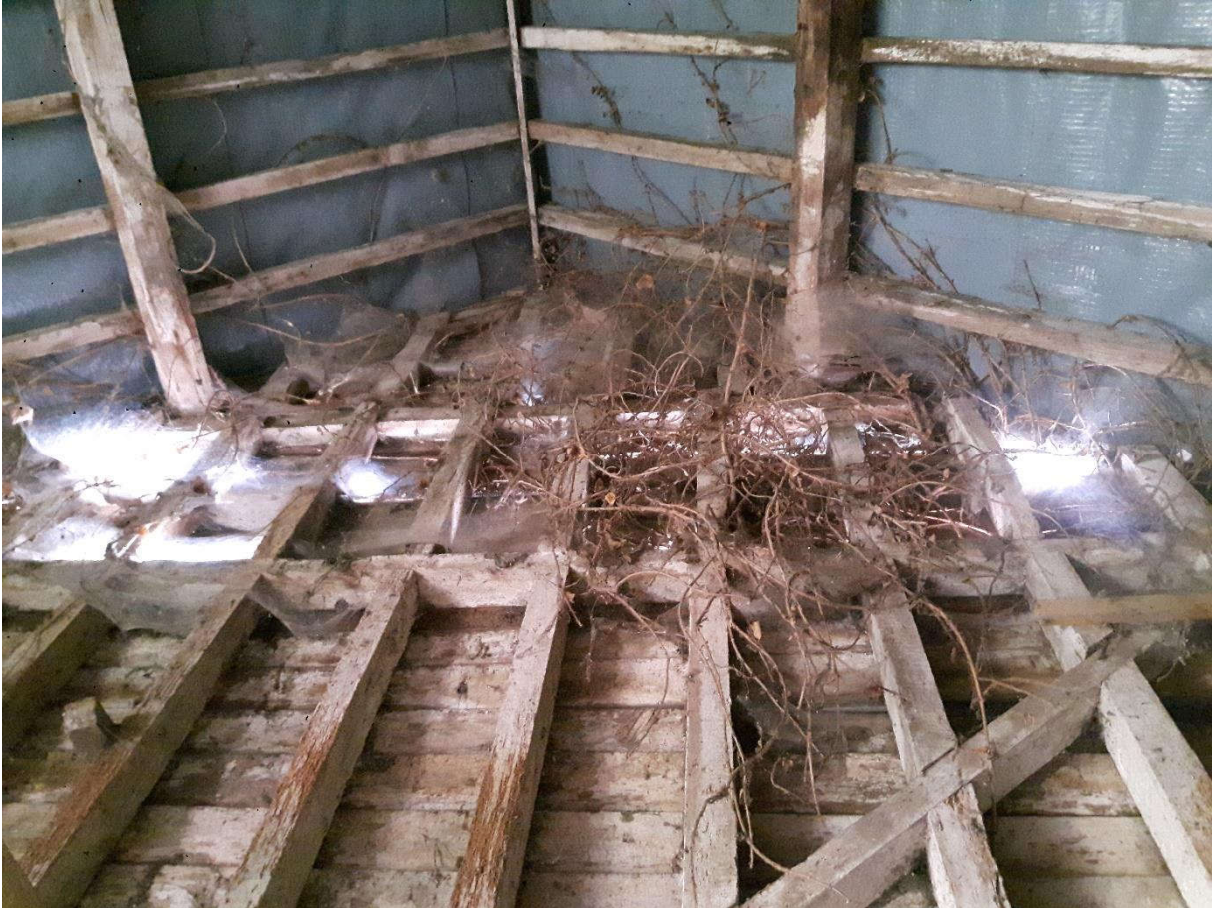
Photograph 21 - Block A, weather-boarded stud framing

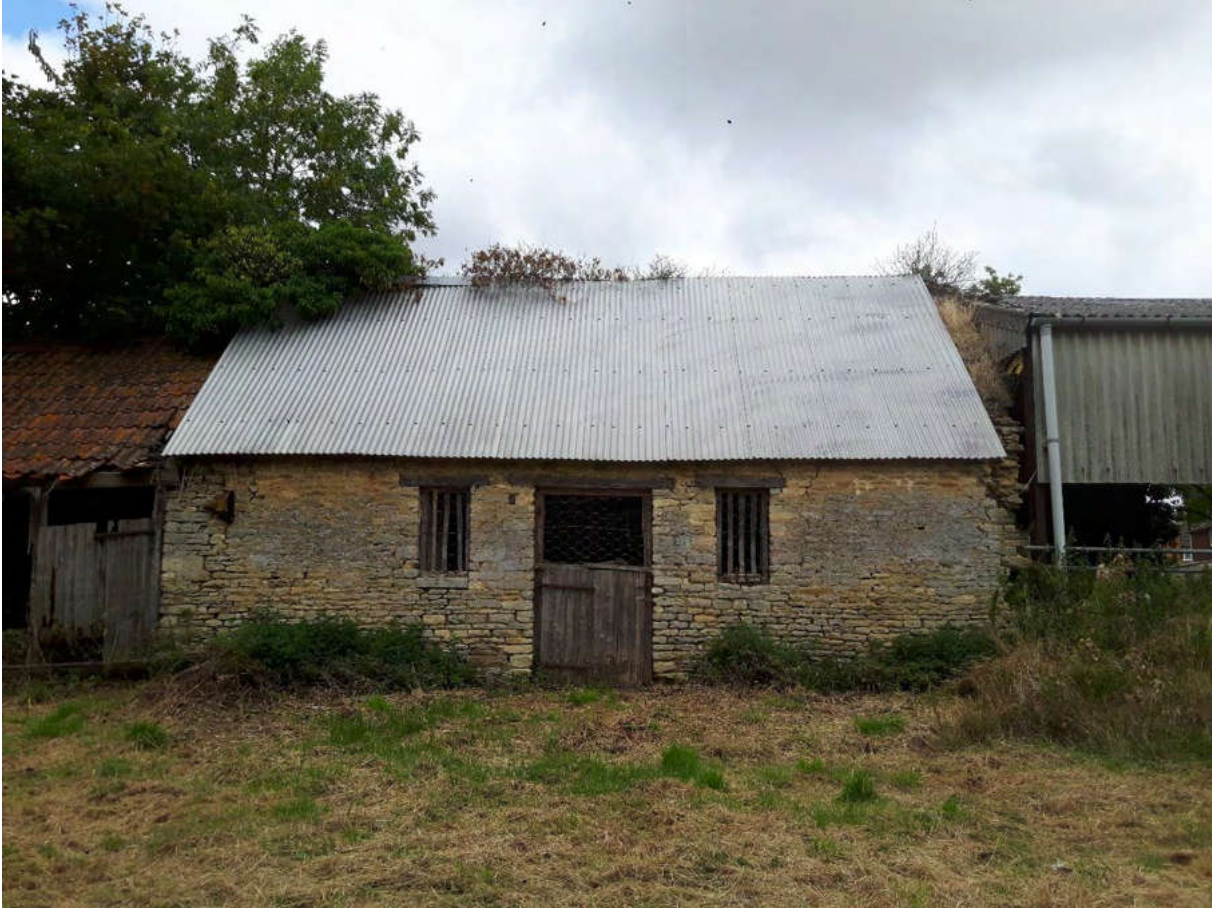
Photograph 21 - Block B, south elevation

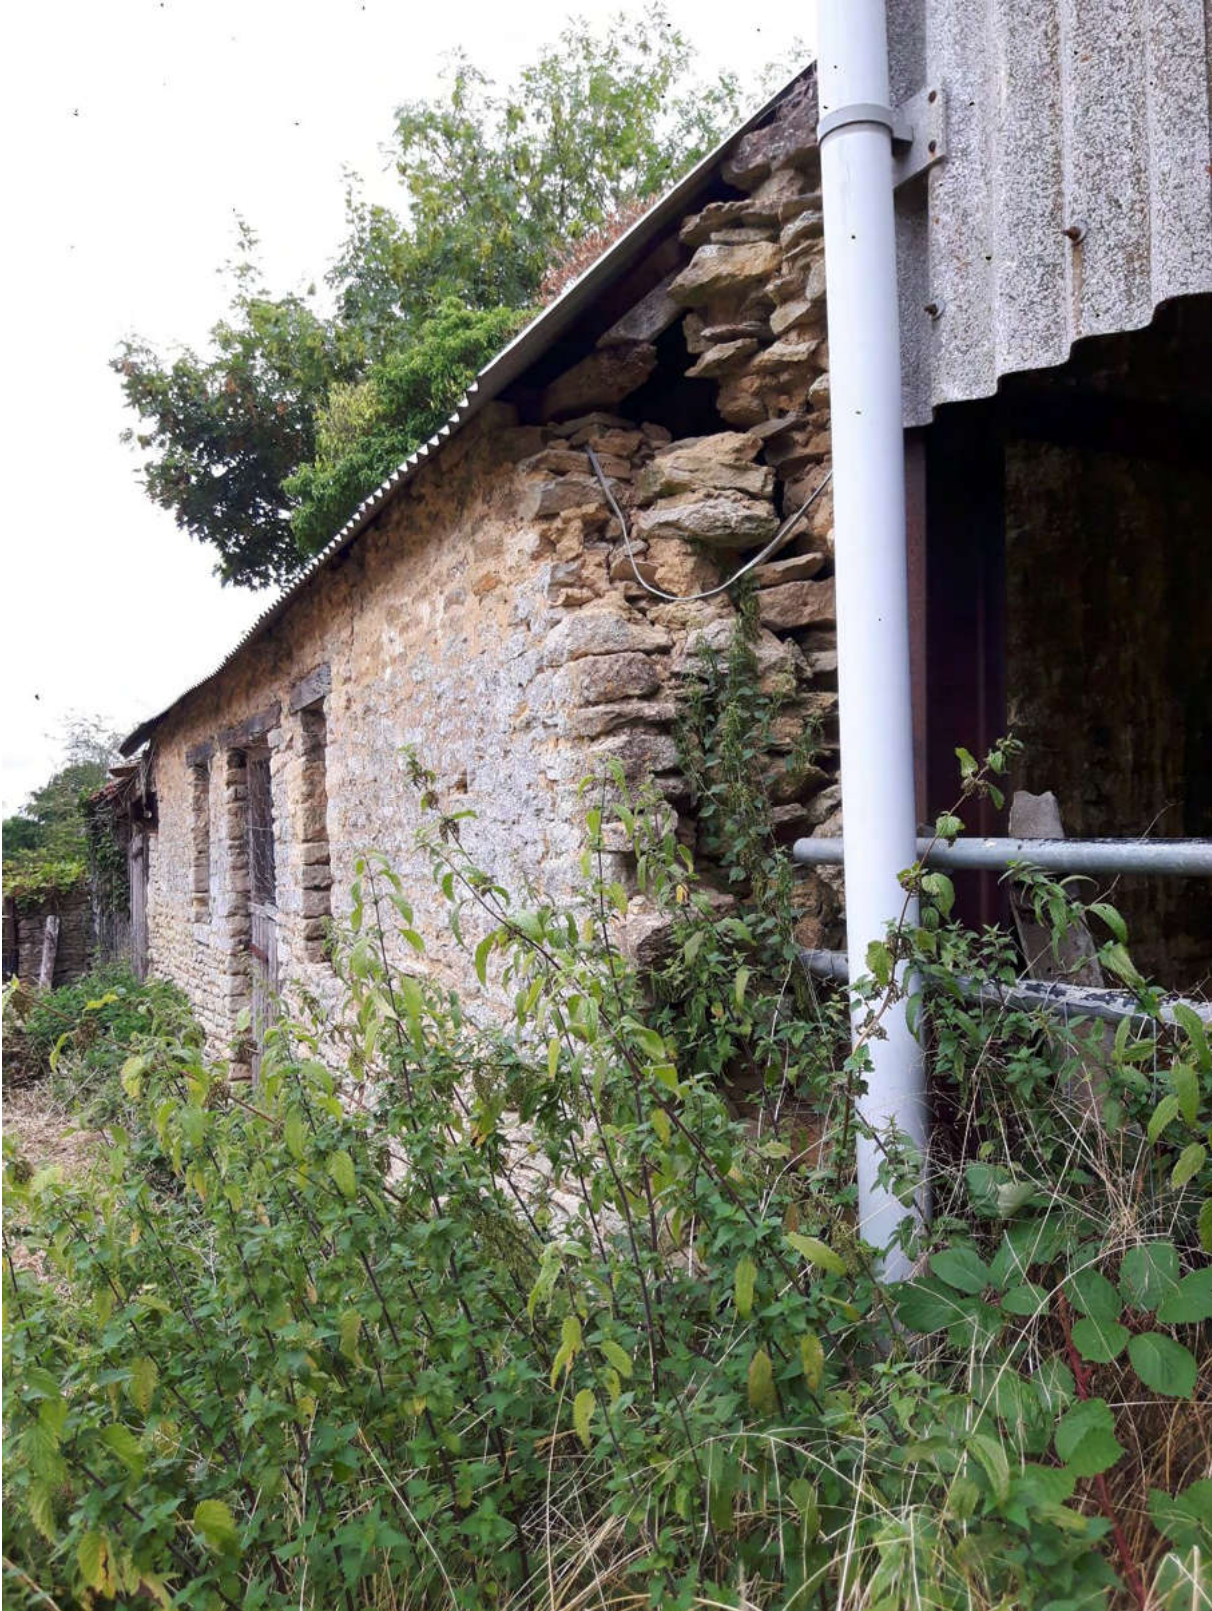
- i. Significant damage to corners of stone wall on east elevation which correspond to large cracks internally.
- ii. Timber ceiling joists are sagging between bridging beams and in some areas the floor above has collapsed. Cause is likely to be a combination of inadequate size for the applied loading conditions and water damage/ rot.
- iii. Bridging beams appear straight and in reasonable condition, although due to damage to joists should be surveyed by timber specialist for rotting.
- iv. Base of stone walls are in poor condition due to weather exposure and will need to be replaced extensively with new stonework or concrete.
- v. Ground floor is brick construction.

Photograph 22 - Block B, corner wall

The roof space was not accessible however the form of the roof and modern corrugated cladding suggests it may have been replaced in the past. The timber floor needs full replacement although the two bridging beams may be salvageable subject to a timber specialist survey for rot. The stone walls will need substantial repair, particularly to the corners of the east wall. The stonework at the base of the wall is soft and weak and will need to be replaced with new stonework or concrete. It may be that this would need to be completed using a typical underpinning methodology, and this should be weighed up against a full re-build of the affected walls, given that the timber structure over is also to be replaced.

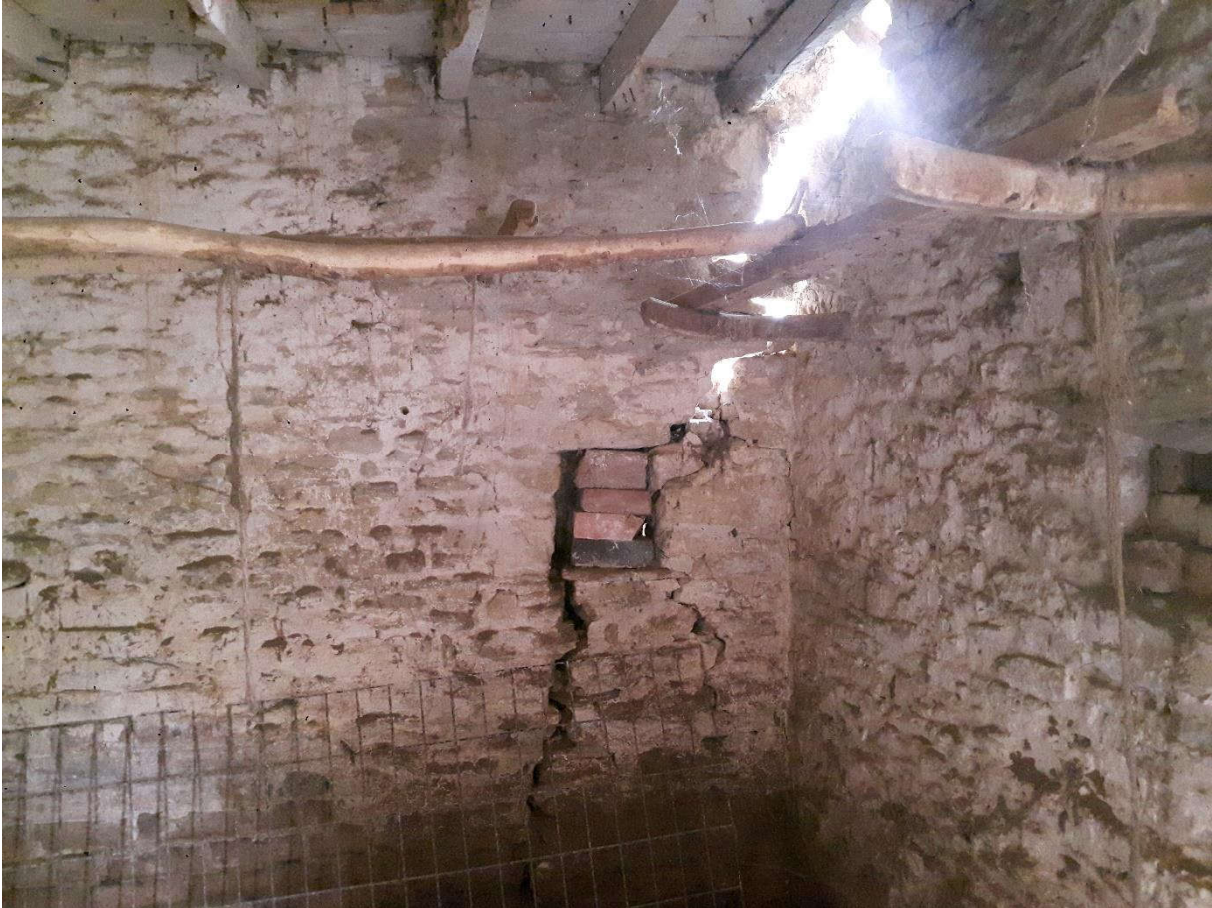
Photograph 23 - Block B, corresponding internal location to 22

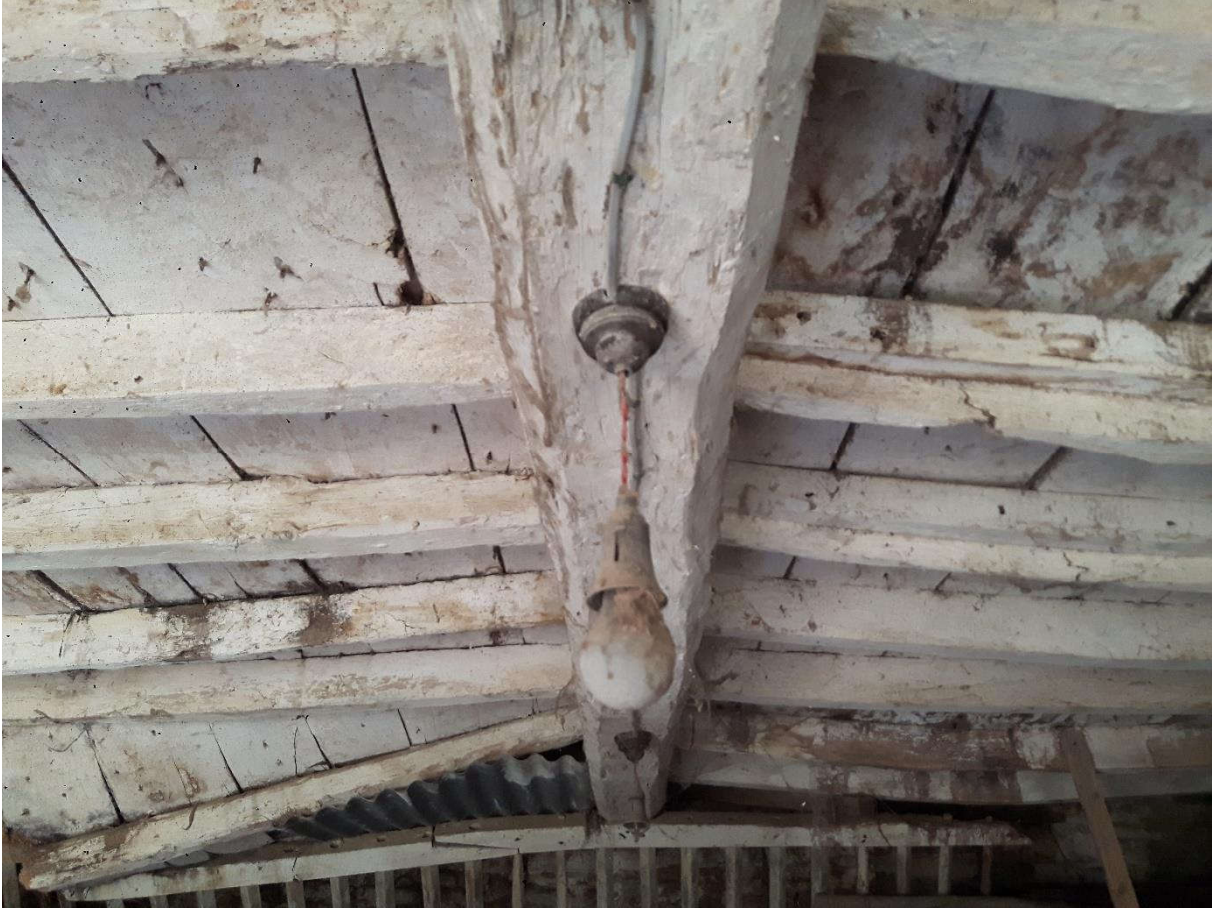
Photograph 24 - Block B, bridging beams and collapsed floor joists

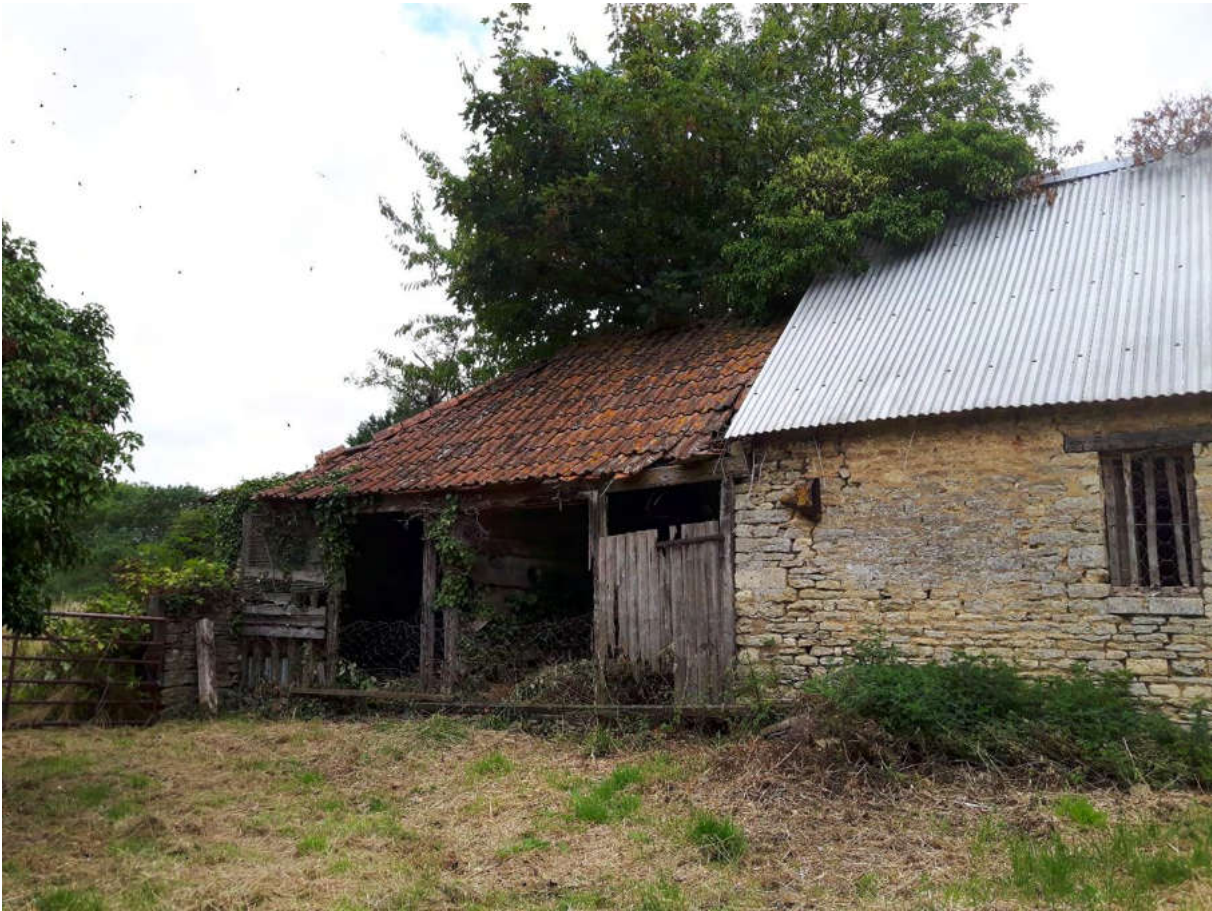
- i. Stone walls with cracking but generally in reasonable condition given condition of building generally.
- ii. Timber roof has collapsed substantially.

Photograph 25 - Block B1 , south elevation

The roof structure needs full replacement and the stone walls may be salvageable in part.

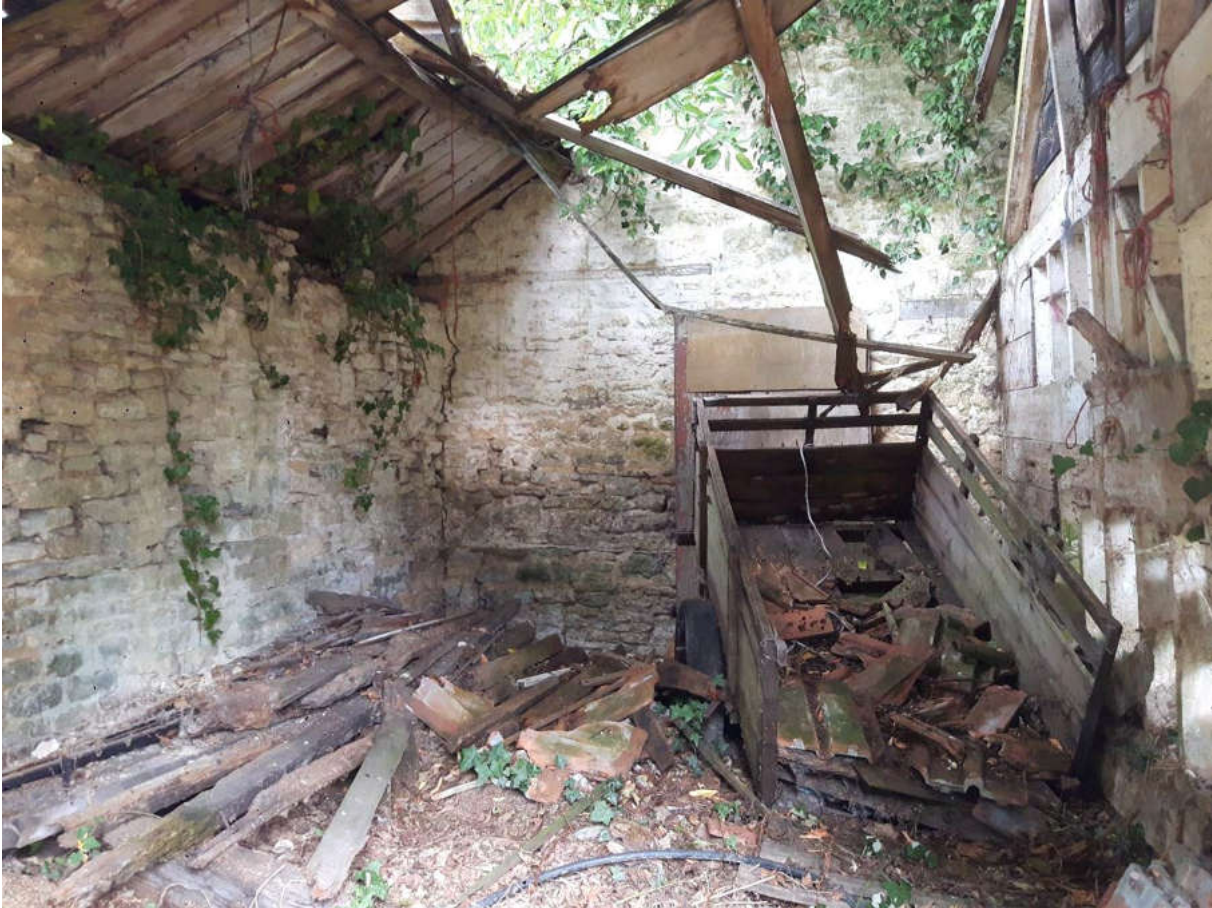
Photograph 26 - Block B1, internal

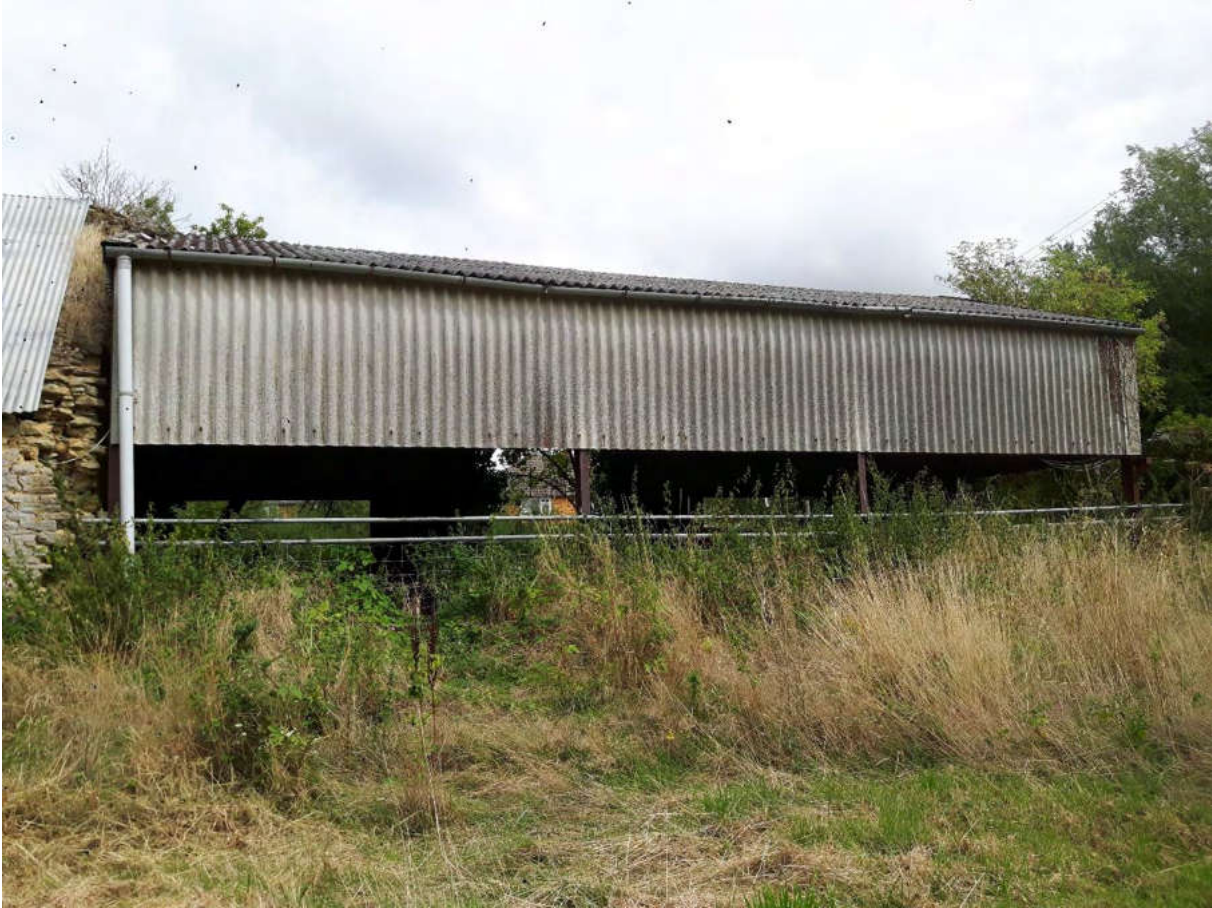
- i. Steelwork appears in generally reasonable condition except for some corrosion of the post bases.
- ii. There is no structural bracing of the steel posts except for some haunching and this may not be adequate, however the structure is partly open-sided and so wind loading is reduced.

Photograph 27 - Block C

Corrosion of steel column bases is a common problem with weather-exposed steelwork and free drainage around the base and frequent paint repairs are required in these instances. Steel columns can be spliced with new base sections to avoid full replacement.

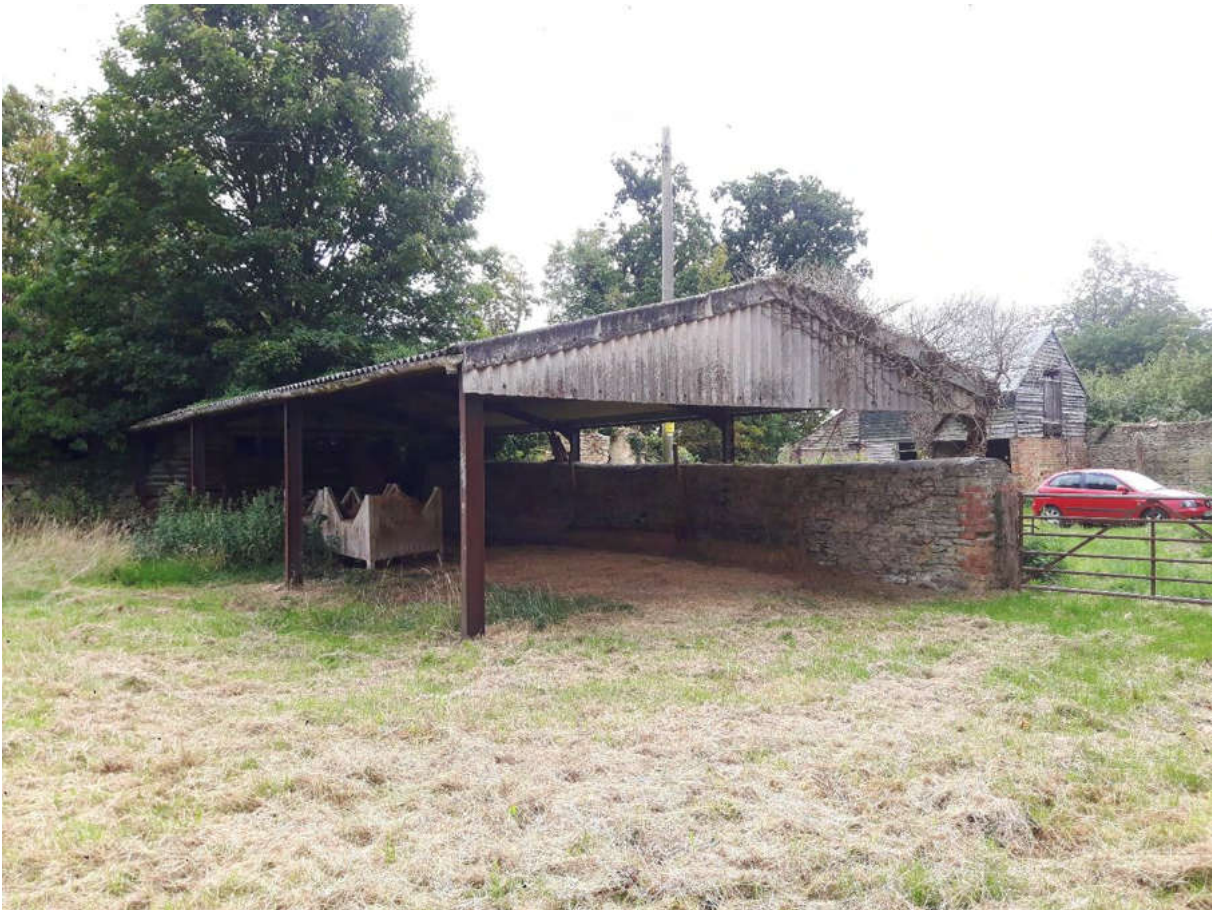
- i. Steelwork appears in generally reasonable condition except for significant corrosion of the post bases.

Photograph 28 - Block D

The same applies as with C, except the corrosion to the bases is more severe, with substantial reduction in steel section and end bearing capacity.

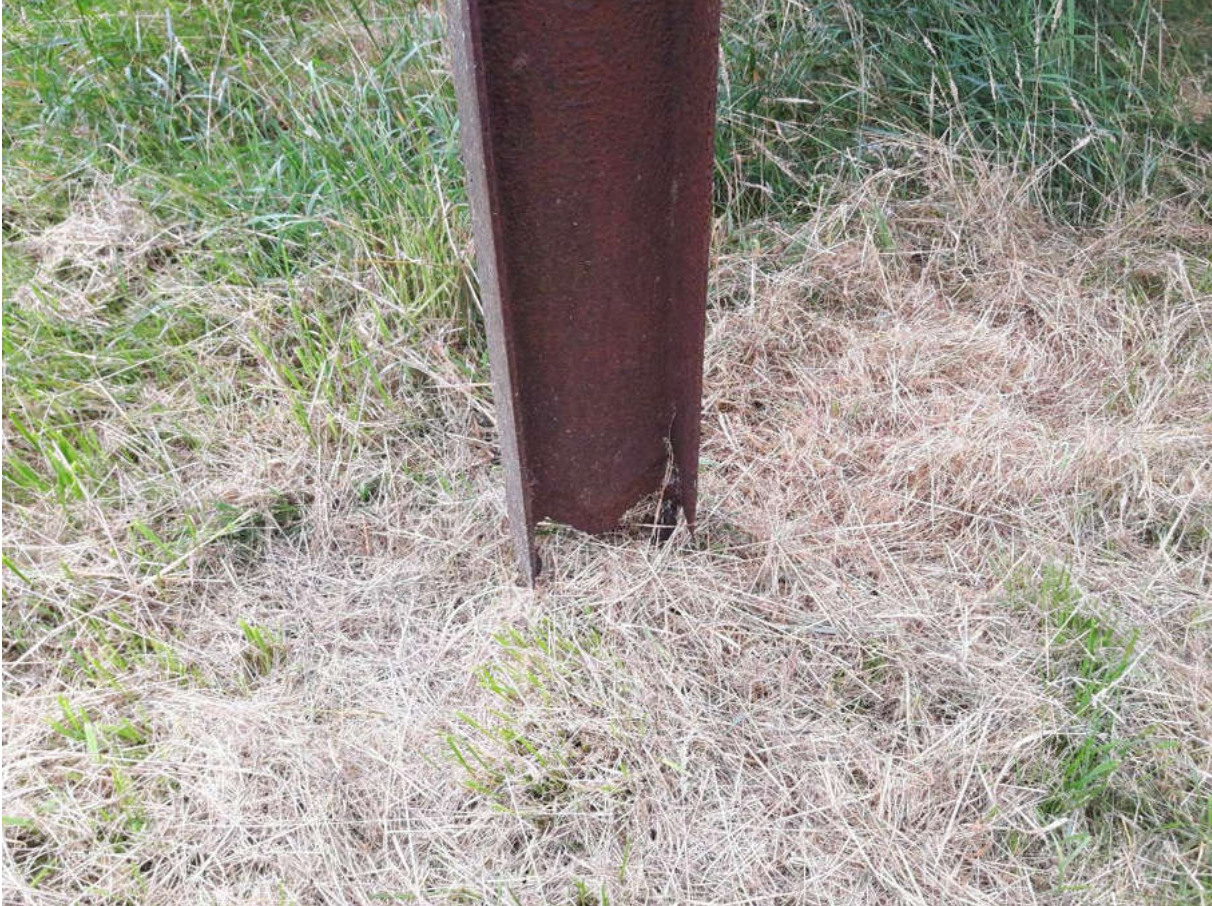
Photograph 29 - Block D, column base corrosion

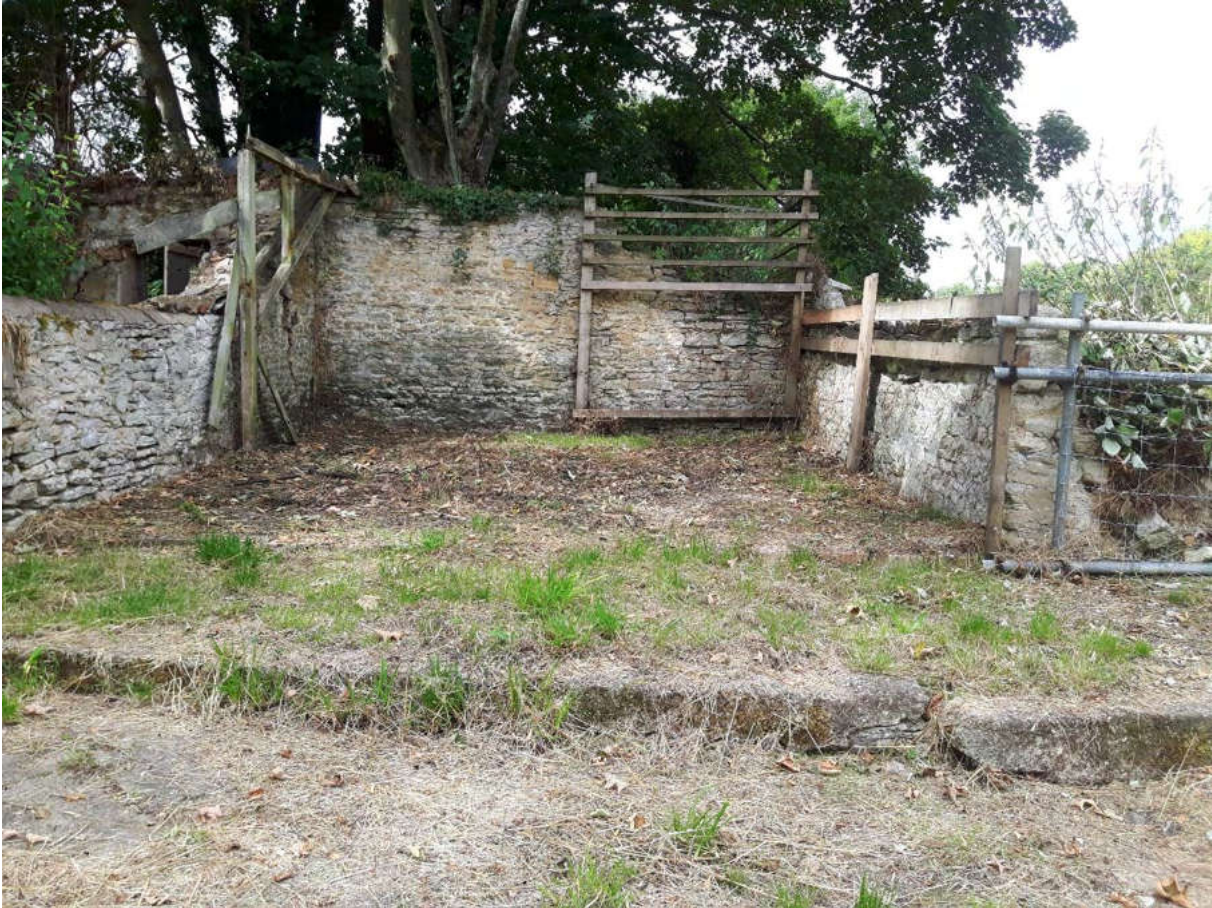
- i. Stonework in reasonable condition although substantially covered in vegetation.

Photograph 30 - Block E

Stone walls appear to be in reasonable condition and could be re-used as the structural walls to a new building on the same footprint, subject to assessment of the existing footings and ground conditions and load capacity to support a new building structure.

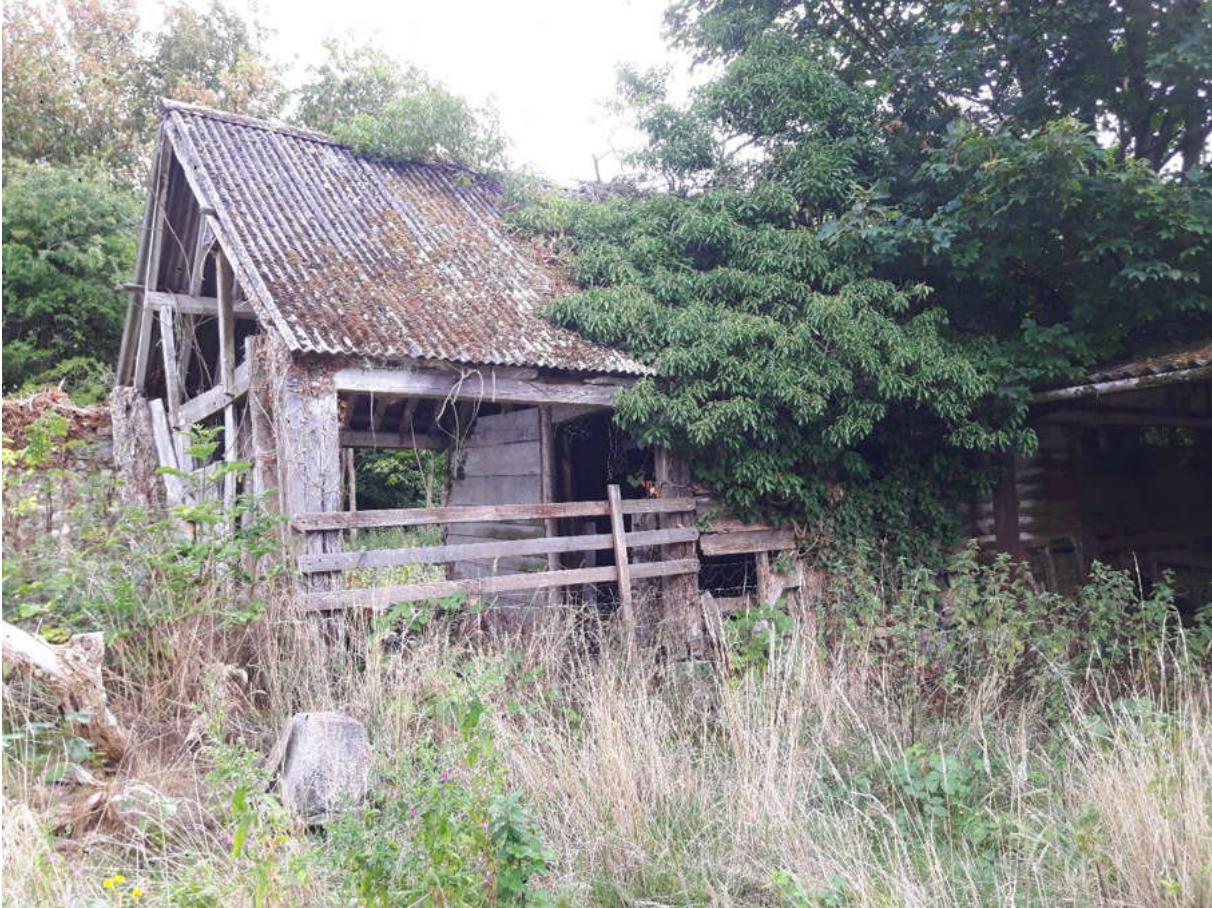
Photograph 31 - Block F, north west elevation

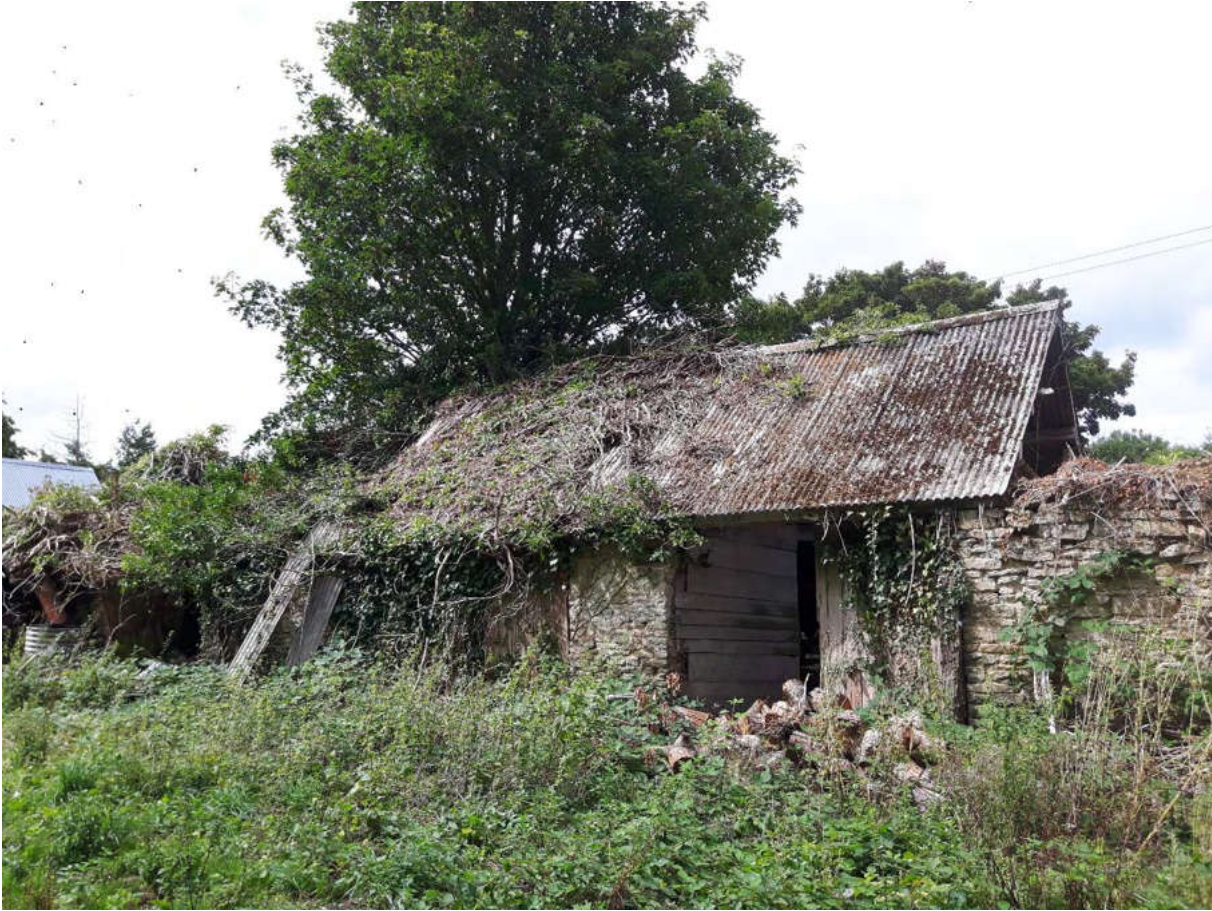
Photograph 32 - Block F, south west elevation

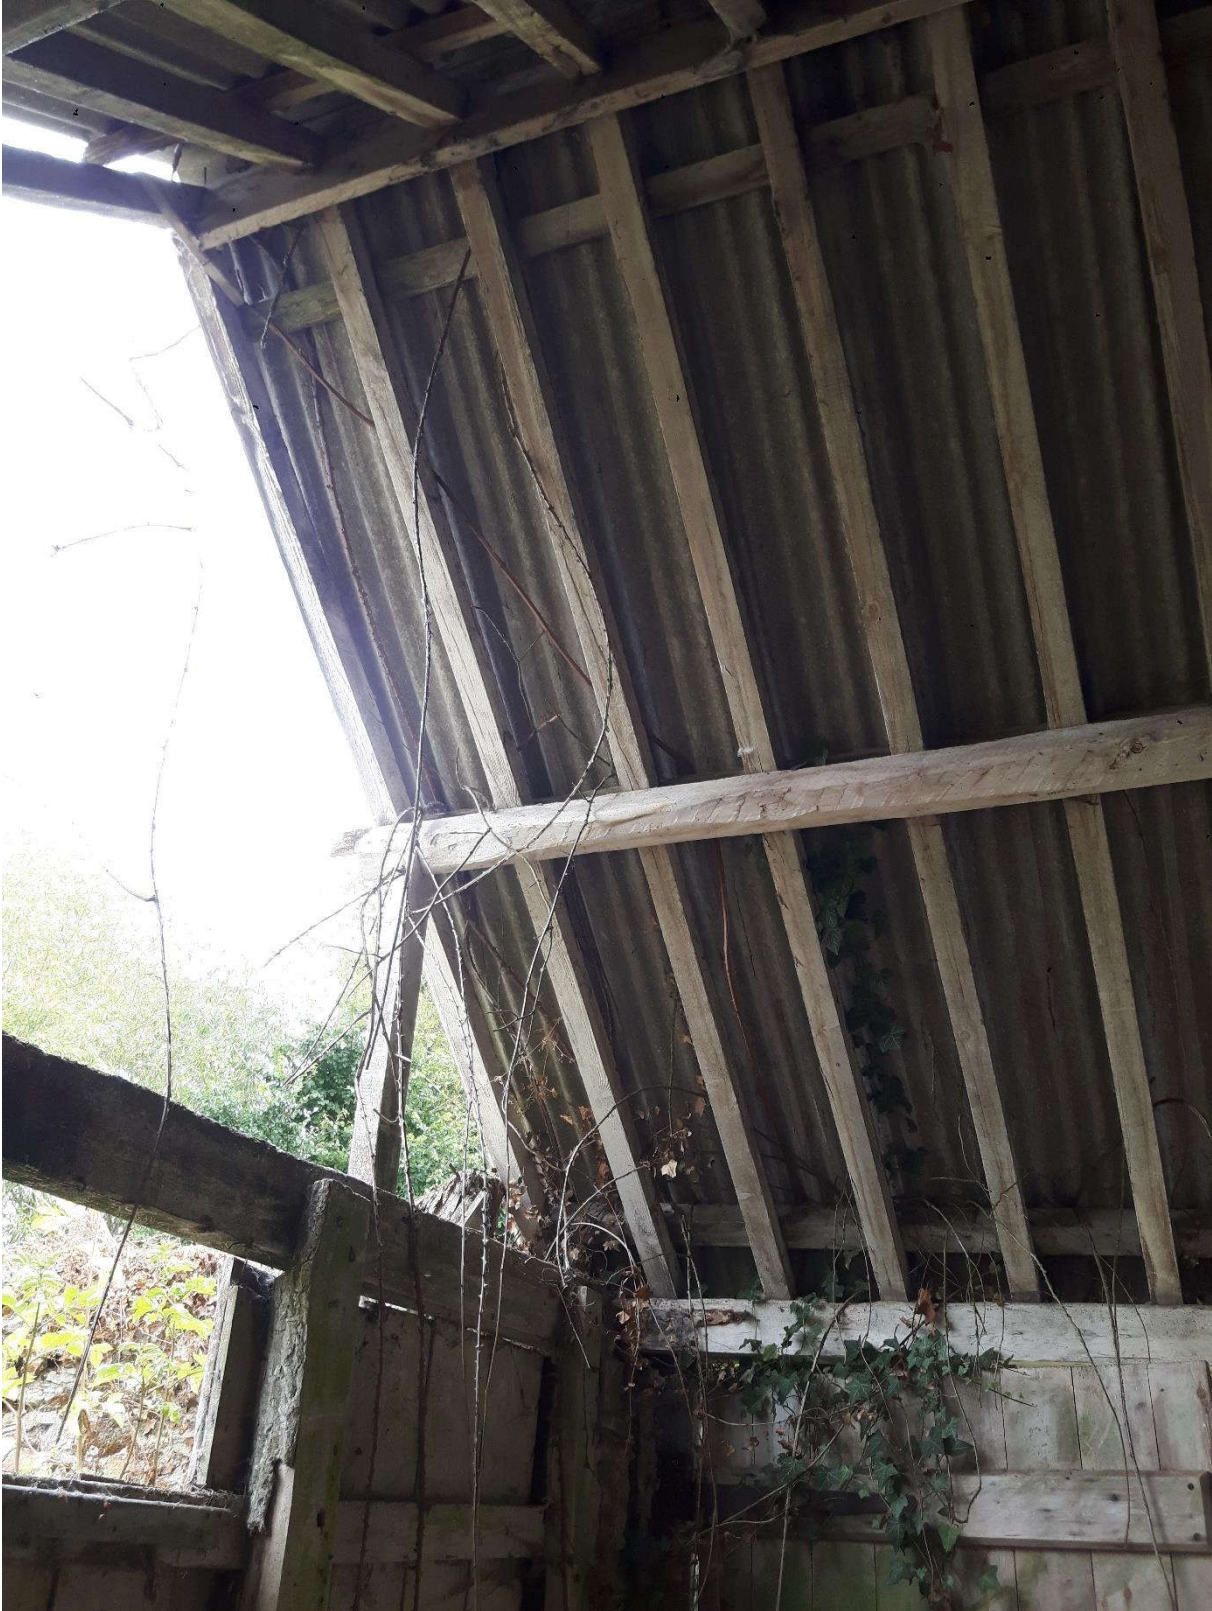
Photograph 33 - Block F, north bay
