## Stratfield Farmhouse, Oxford Road, Kidlington, OX5 1DL

## Structural Inspection Report

Prepared by: **Josh Lawrence MEng CEng MICE**  
Reviewed by: **Mike Wilford MEng CEng MSc MIStructE**  
Job Number: **27476**

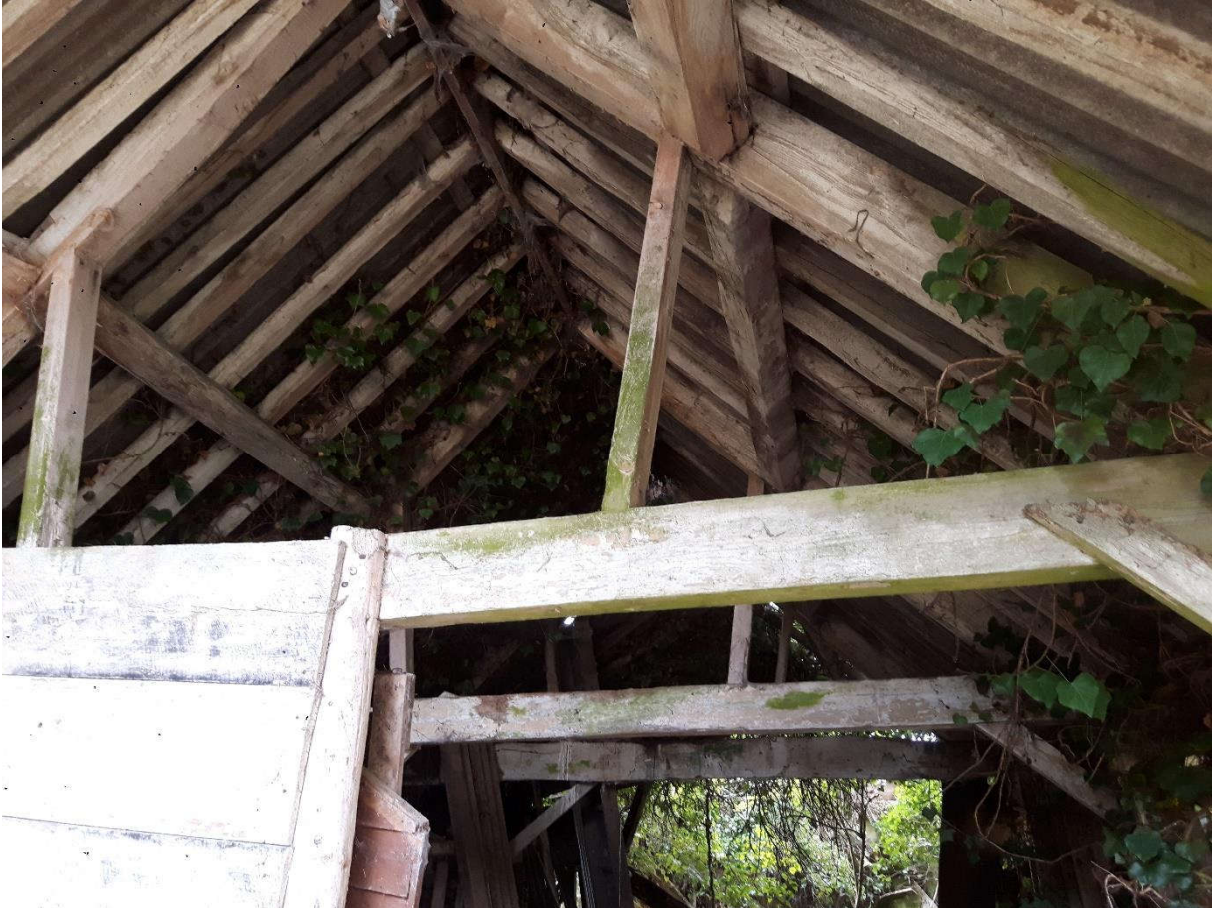
Photograph 34 - Block F, roof trusses looking south

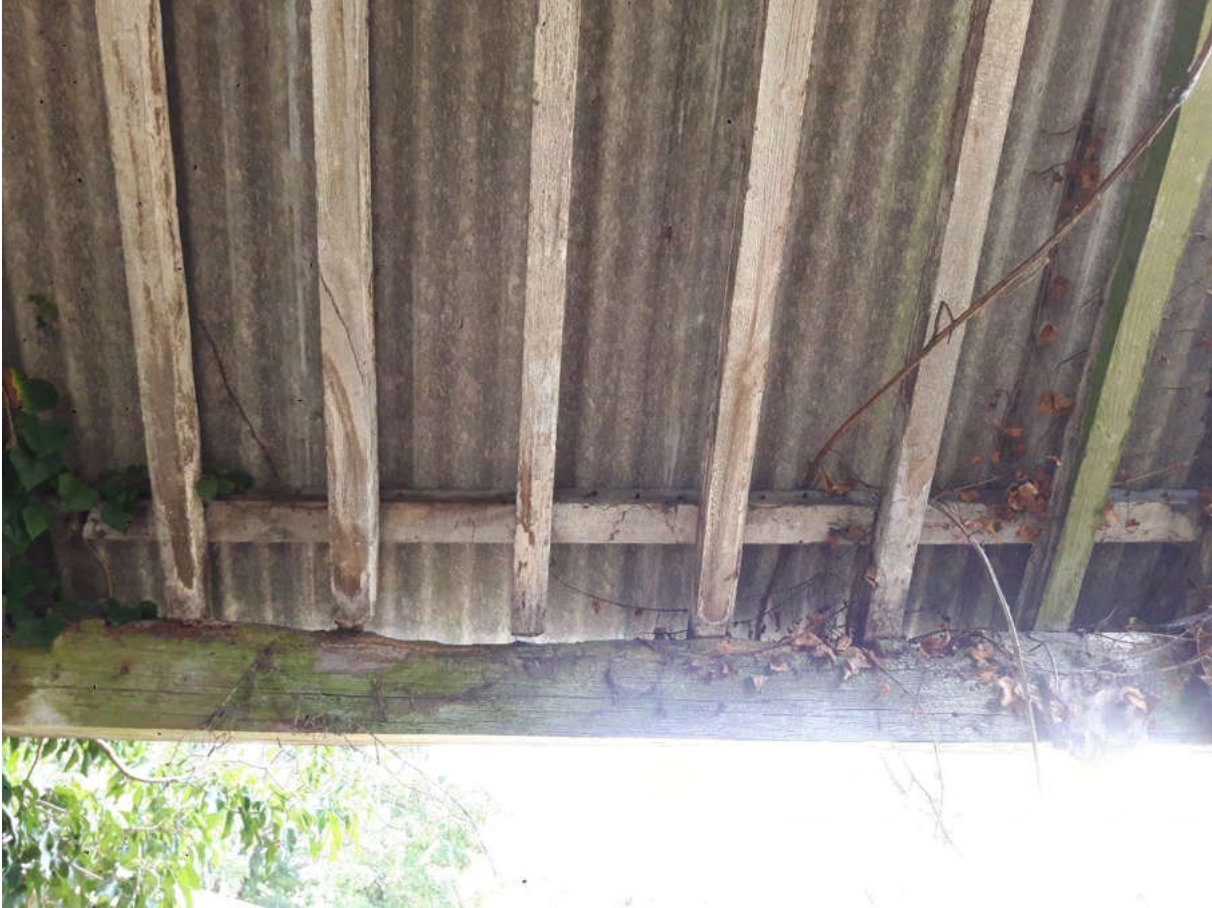
- i. Building structure in good condition to north, with stone walls and timber roof all sound.
- ii. Three bays of roof structure are in reasonable condition, with vegetation causing some damage to rafters towards the middle bays. The fourth bay is damaged severely by vegetation and a large tree growing internally. From this point south, the trusses and roof have fully collapsed.
- iii. Movement of roof eaves beam has resulted in detachment from rafters.

Photograph 35 - Block F, dropped eaves beam separating from rafters

Three bays to the north end could be retained, with some repairs and strengthening to walls and roof structure. The southern three bays would need significant repairs to stonework and a new roof structure.

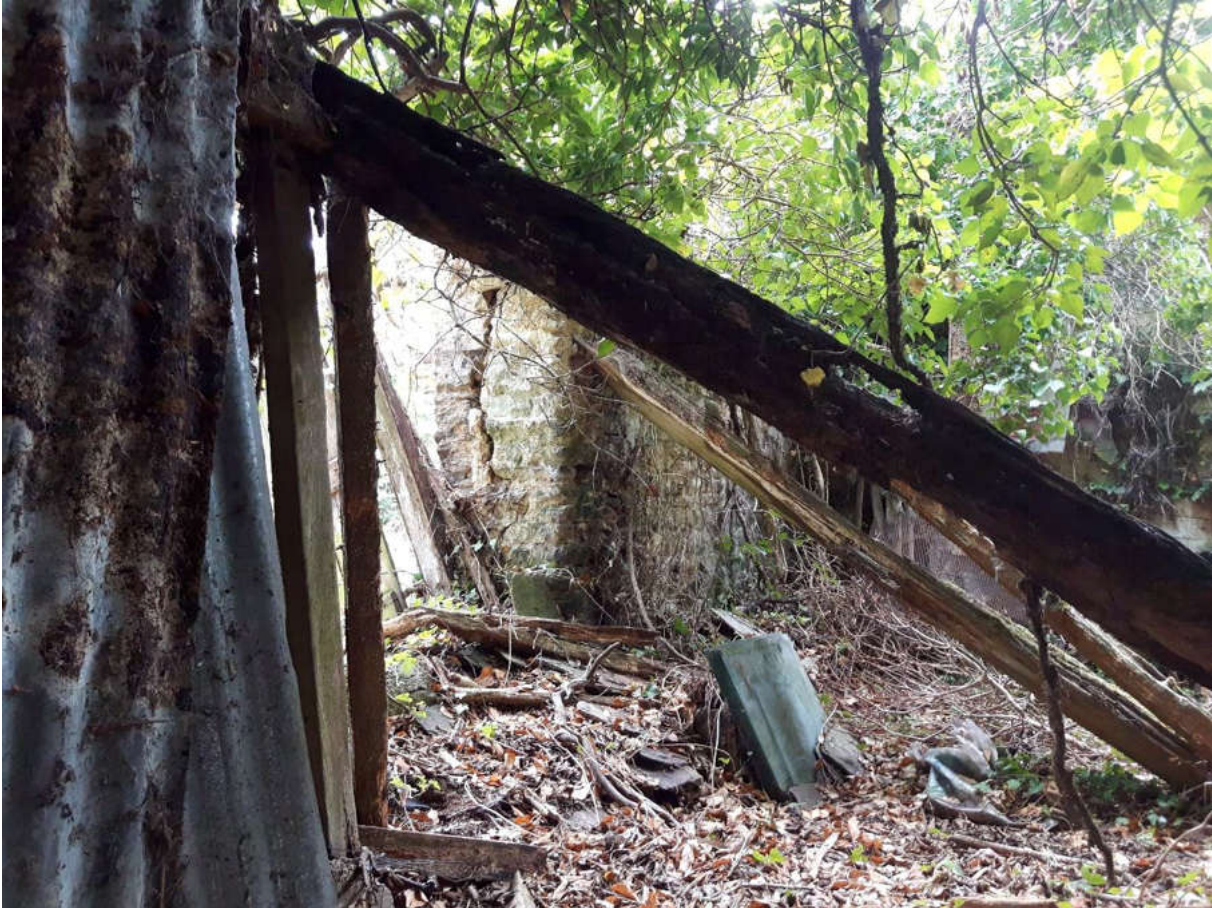
Photograph 36 - Block F, south roof collapsed
