# JAMES MACKINTOSH ARCHITECTS

## CONDITION SURVEY

Stratfield Farm Outbuildings, Kidlington, Oxford, OX5 1DL

May 2022

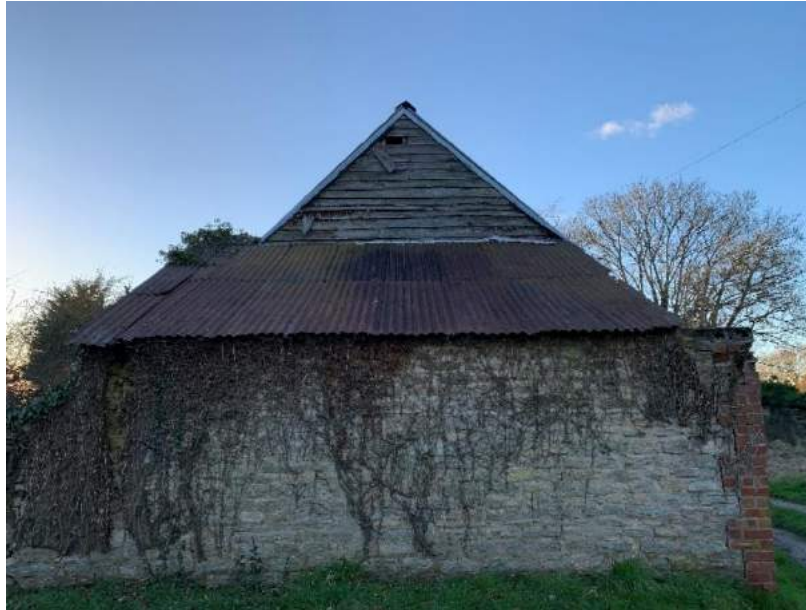
- a. North side. Corrugated metal roof in satisfactory condition. Ridge intact.
- b. East side. The lean to metal roof has corroded and failed. The timber rafters, which sit on wall, are exposed to the elements due to the roof being corroded. Roof structure requires replacing.

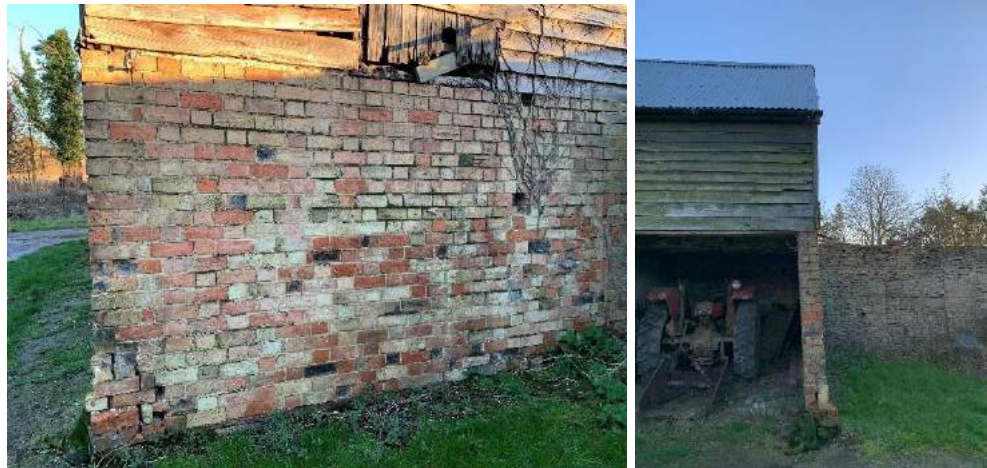
- a. North elevation. The upper section has horizontal timber weatherboarding, which has elements of decay and algae staining. The lower section is divided into 2 bays with brick piers. The brickwork in 1<sup>st</sup> and 2<sup>nd</sup> pier is fair, with some vegetation growth. The brickwork to the 3<sup>rd</sup> pier has decayed, potentially due to water damage from missing downpipe. The bottom section of the brickwork has been displaced due to a tree growing in the corner. The second bay has a horizontal infill panel with timber joists and a door to the right-hand side. The sole plate has decayed together with the bottom sections of the studs to the timber infill panel and the posts to the door and historical splice repair have decayed. The left-hand jamb will need replacing and the bottom section of the horizontal timber weatherboarding is missing and will require piecing in.

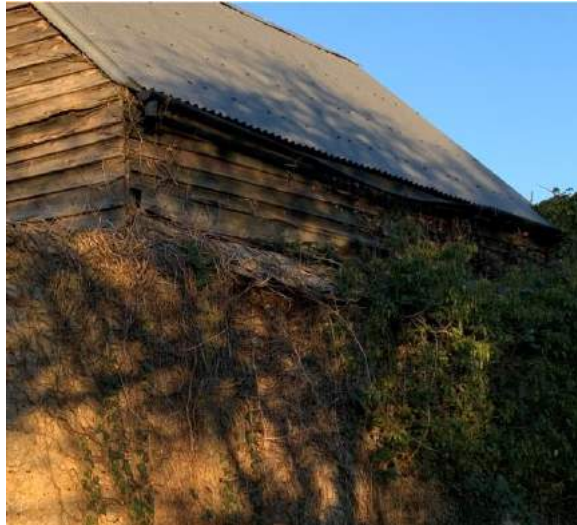
- b. West elevation. The lower section is built out of Flemish bond brickwork with narrow mortar joints, suggesting it to be Victorian brickwork, and is leaning heavily. The top of the gable is clad in horizontal timber weatherboarding with a high-level access door, blocked with horizontal boards. The timber weatherboarding has decayed, mostly towards the south, with some of the boards slipped. Two timber sole plates, one at the bottom of the brickwork and another under the door, have decayed and require replacing. The first floor should be jacked up to allow for replacement of the timber sole plate and rebuilding of the leaning brickwork underneath.

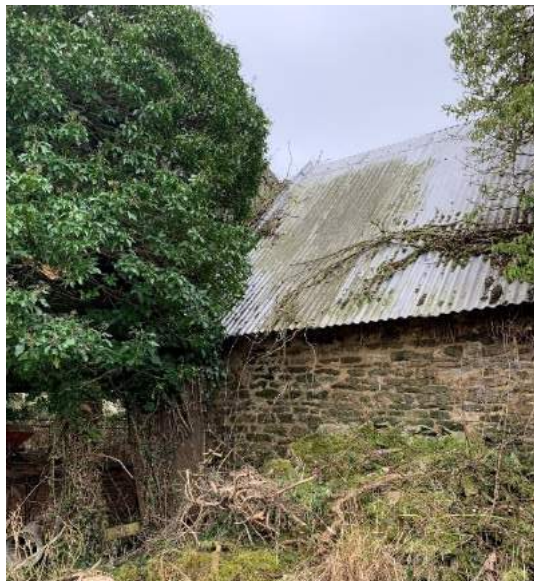
- a. South roof. Corrugated metal roofing running east to west. Ridge partially missing with trees and vegetation within the roof covering. The roof covering doesn't cover the east gable wall, which allows vegetation to grow on top and allows water inside. The vegetation should be removed and the roof covering replaced.
- b. North roof. Corrugated metal roofing running east to west with regular fixings at approx. 300 c/c to rafters underneath. The ridge is mostly missing with substantial amount of vegetation on top of the roof. The vegetation should be removed and the roof covering replaced.

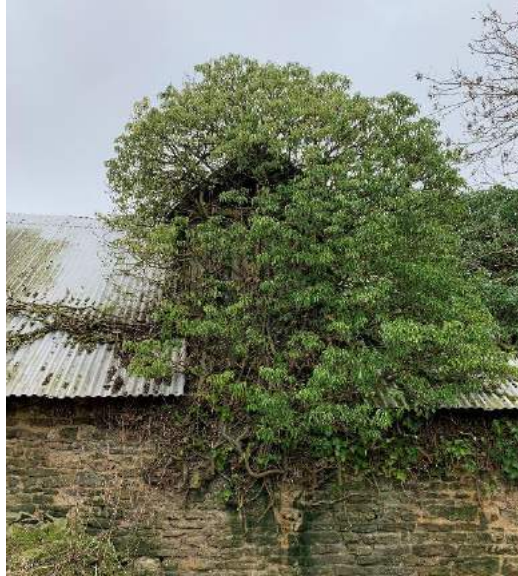
- c. Dormer on north side of roof. Inspected visually. The dormer appears to be a timber structure with rendered cheeks, timber posts to the front, with timber shutters and a gabled corrugated metal roof. The condition is poor. The vegetation should be removed, the existing timber structure repaired and re-roofed.

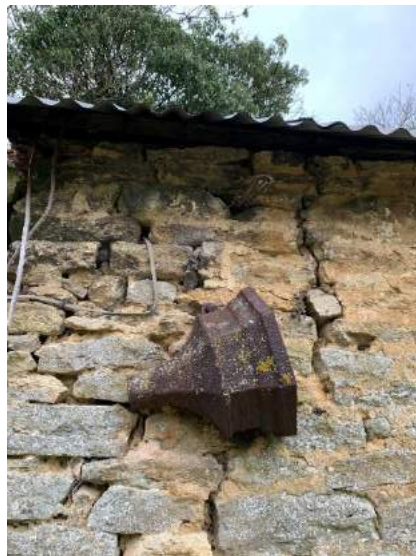
No gutters or water disposal system. An old hopper hangs off the south elevation but does not take water down from the current roof.

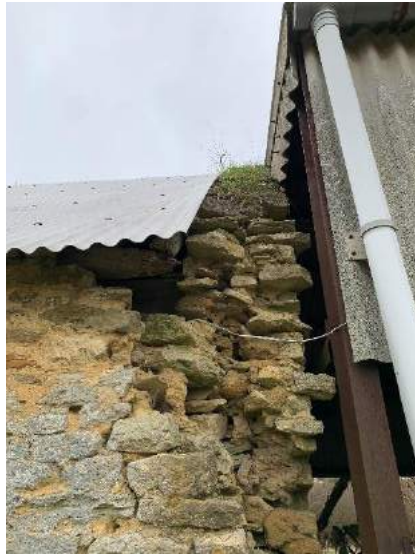
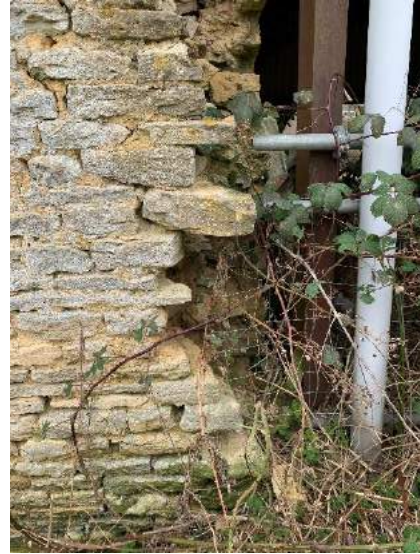
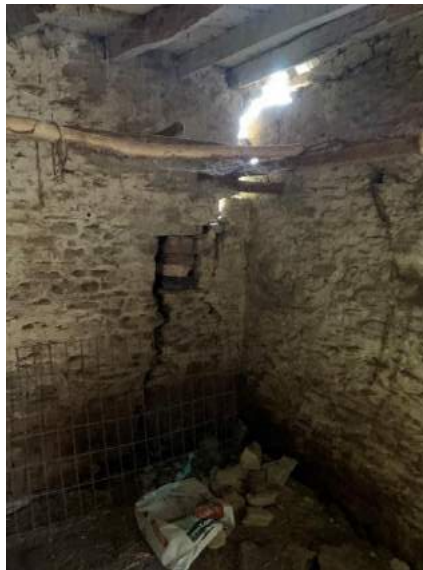
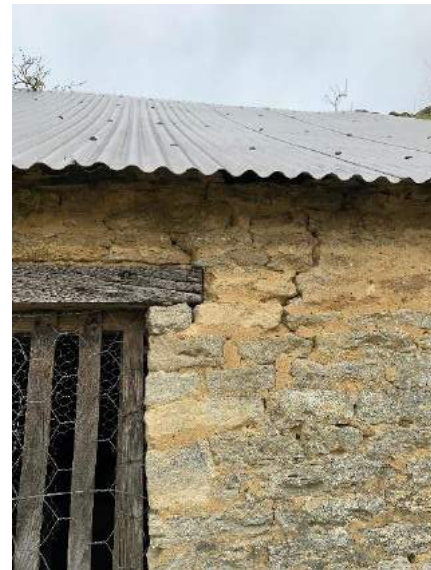
- a. South wall. The wall is from coursed rubble limestone. Externally the condition is fair, with some visible cracking to the side of the east window, near the lintel. There is movement where the crack is to the west of the window. Internally the condition is poor, there is visible movement in the east corner, where masonry is missing. There is

displacement between the wall plate and the rest of the wall, which is moving outwards by at least 50mm. There is a small niche near the eastern window. The wall requires 100% repointing and rebuilding of a small section (quarter of a meter squared) of cracked wall around the window, as well as rebuilding of the east corner and associated repairs.

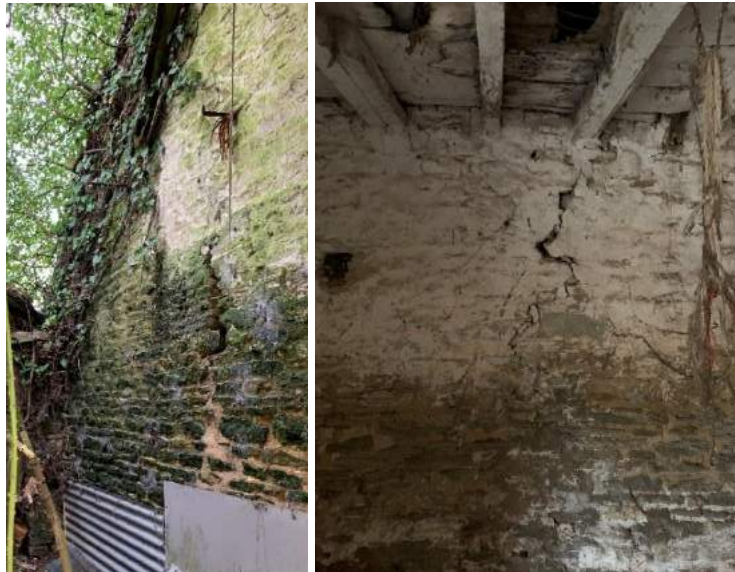
- b. West gable wall. The wall is from coursed rubble limestone. Externally, the wall is in fair condition with a large crack in the centre, potentially caused by water damage through poor pointing. There is a large amount of algae and moss growth on the external lower section of the wall. Internally, there is vertical cracking in the centre. A structural engineer should be engaged to advise on repairing the cracking. The stonework should be cleaned. All existing vegetation and ivy growth on the north side should be removed and 100% of the walls repointed.

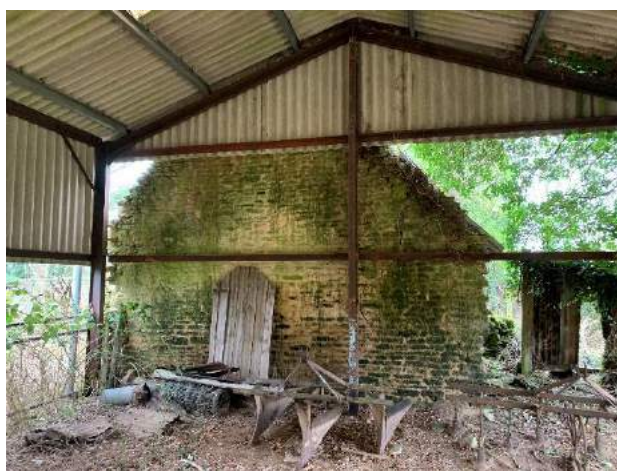
- c. North wall. The wall is from coursed rubble limestone with vegetation and root growth to the top section. The vegetation and tree growth should be removed to allow for repairs to the rubble wall. The elevation should be cleaned and repointed.
- d. East gable wall. The wall is from coursed rubble limestone with a large vertical crack towards the north end of the wall externally. The sides and top of the wall have failed with exposed stonework. Internally, the wall is in poor condition as the south corner is missing, causing cracking and displacement. Bricks have been inserted to prop the stonework. There is a dislodged stone under the joist to the north east corner. One small niche in the stone wall towards the south. A structural engineer should be engaged to advise on the method for repairing corners and cracking. The stone should be cleaned and repointed.

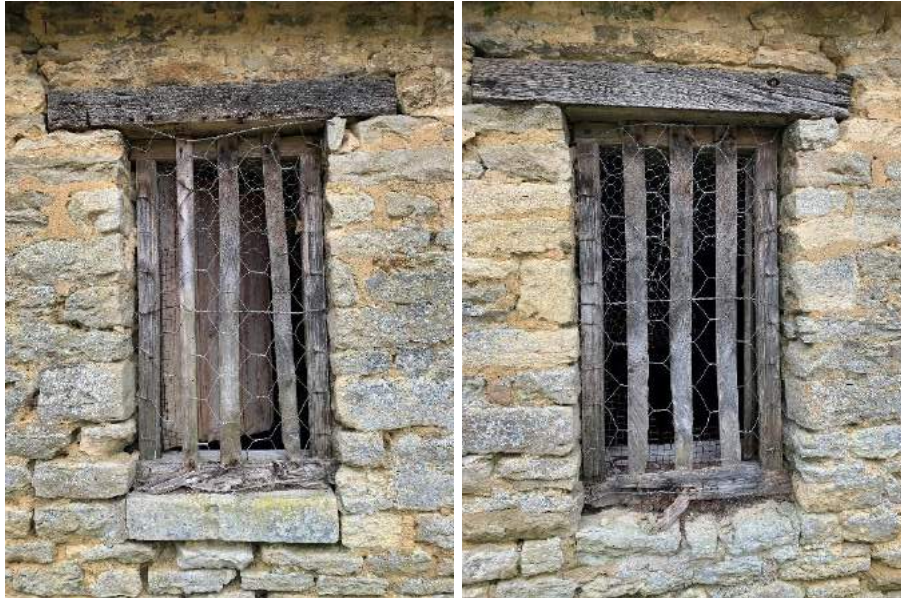
- a. Two windows with oak lintels on south elevation, either side of a stable door. Window 1 looking from west side has a stone cill. Timber frame is in fair condition, with top section in pine and

bottom in oak. The side frames have been profiled, while the rest of the window has vertical slats and chicken wire with an internal shutter. Window 2 looking from west is as Window 1 but has a rubble stone cill, with part of the internal shutter missing.

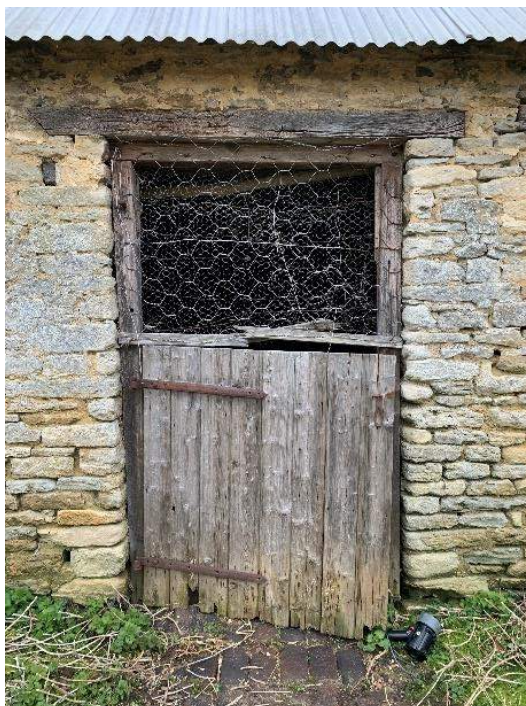
- b. Stable door with larger oak lintel in the centre of the south elevation. The door consists of a softwood timber frame with two jambs and a head section, but missing cill. Right hand side jamb is not fixed to structure. Holes for hinges suggest that the door had two sections. Top section is now chicken wire. Bottom section has a rotted stable door with T hinges. The right hand jamb should be secured.

- 5.2.5 Secure right hand jamb of existing stable door in Block B.
- 5.2.6 Carry out repairs to top section of wall in the west elevation, replacement of sole plate to south wall, as well as cleaning and repointing of north wall of Block B1.

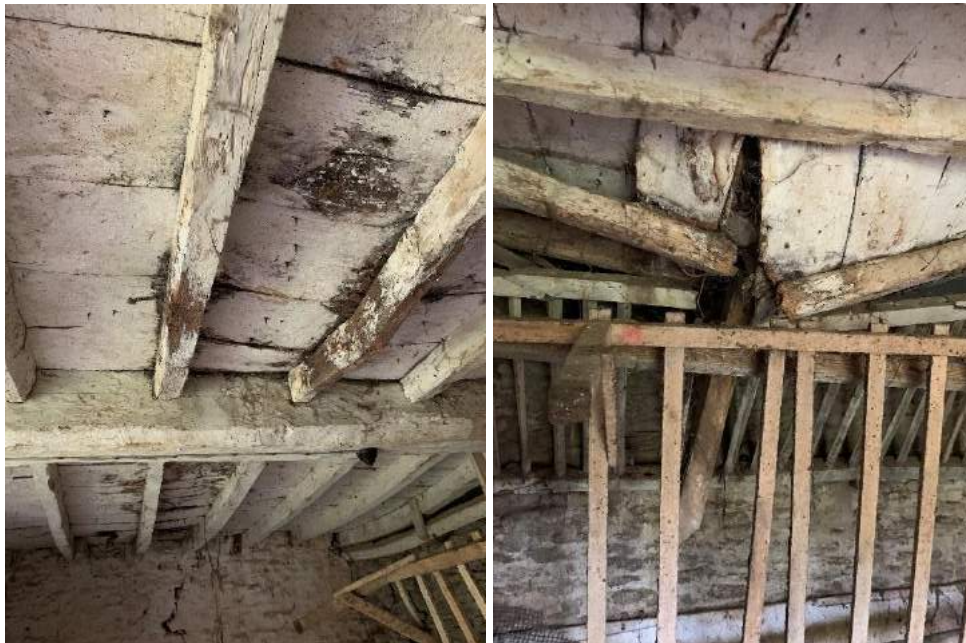
- a. Roof structure. Approximately 70% of ceiling timber boards have decayed from a roof leak and they have been boarded over with modern boards. Partial collapse of the ceiling to the north east corner with missing boards and roots of vegetation coming into the building. In the first bay from the North, 2 joists have bowed under pressure from the vegetation and another joist (3<sup>rd</sup> from south) has cracked. In bay 2 there is substantial collapse to the north side, which has damaged the hay rack on the back wall. Timber boards have failed due to leaks. From north, the first two joists have failed, the fourth joist is cracked, and the fifth water damaged. In bay 3 the visible 300 c/c softwood modern roof structure is in fair condition. From north, the fourth joist is cracked, the 5<sup>th</sup>, 6<sup>th</sup> and 7<sup>th</sup> are damaged by wood worm. The timber boards have been water damaged and have bowed significantly.

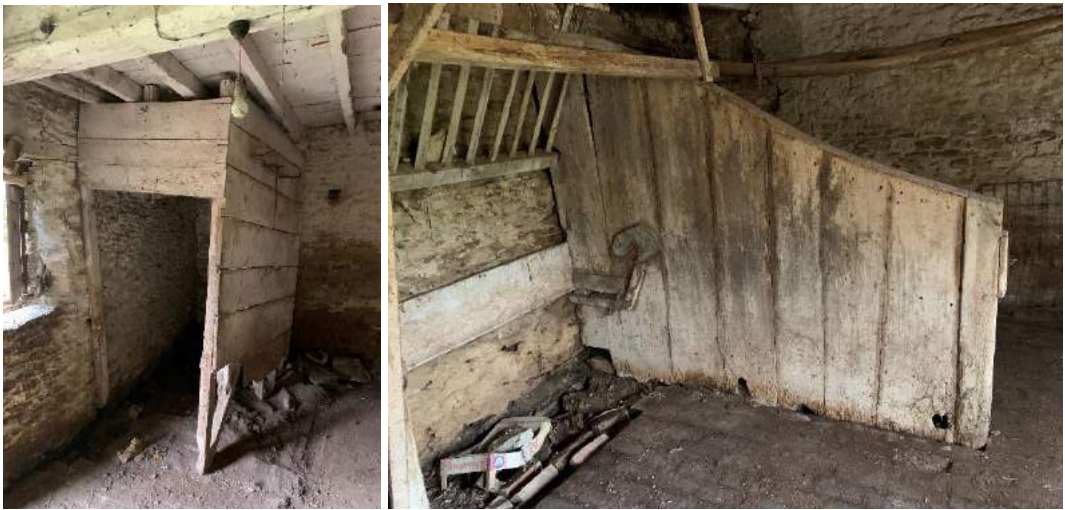
- b. Internal partitions. The south west corner partitions were presumably forming a store, constructed out of timber studs and limewashed timber boards. The partition is currently supported off a timber stud, which is secured to the south stone wall. One stud is missing at the base and the remaining ones are undermined and decayed, caused by sitting directly on earth. Another partition, which used to be a stable divider is in satisfactory condition. Constructed out of timber joists and vertical boards. The sole plate has decayed and bottom sections of the

boards facing east have decayed. There is one displaced board at the north wall on the west side.

- 5.4.11 Repair timber posts of the timber trough, sole plate and decayed studs of a timber partition inside Block B.

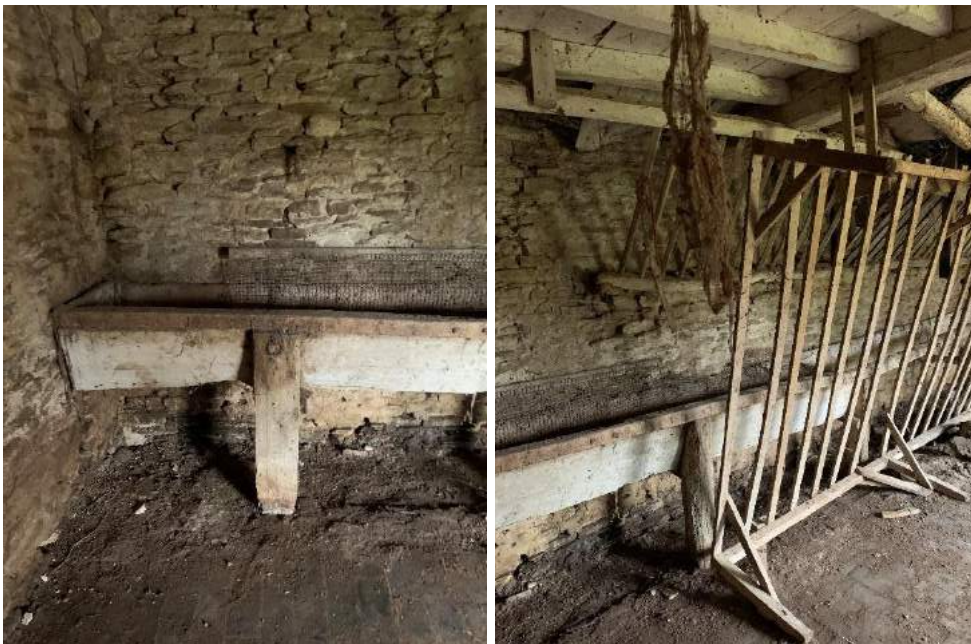
- c. Joinery. A timber trough runs along the north wall, with the best preserved sections to the west and east, with eastern side almost fully preserved with 3 softwood boards on tressels. The middle section has collapsed entirely and posts have rotted at the bottom. To the west, mainly the structure remains with 200x100mm vertical posts returned back to the north wall in poor condition. On 3 of the posts, cattlehooks have been preserved. There is also a haystack on the north wall, in overall fair condition, with a broken section in the centre caused by the damage to the roof.

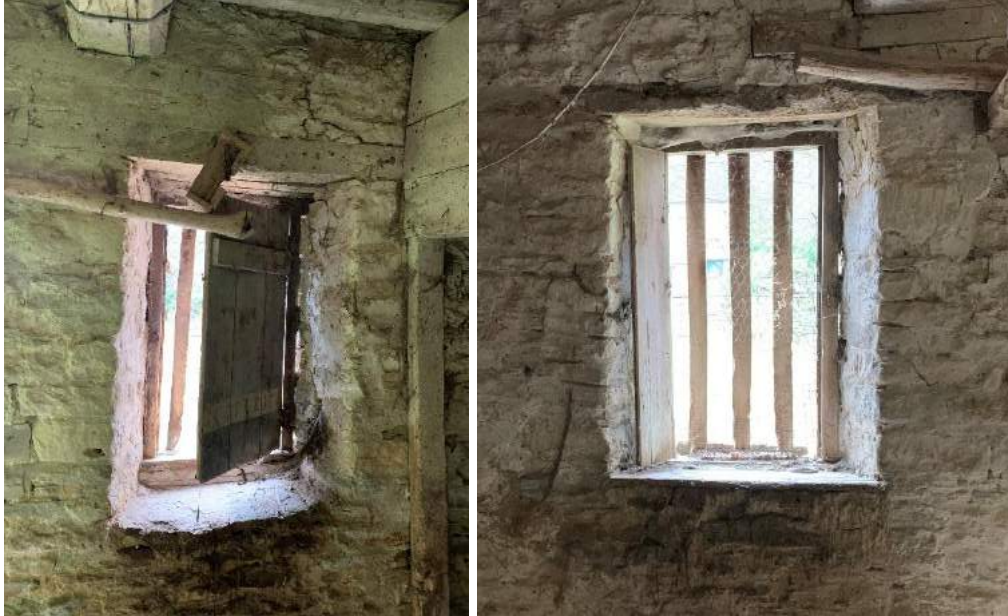
- d. Windows. Internally, window 1 has a relatively modern timber lintel and a missing cill. The timber lintel to window 2 is rotten and requires replacing. The timber cill has cracked and there is a small section of shutter remaining.

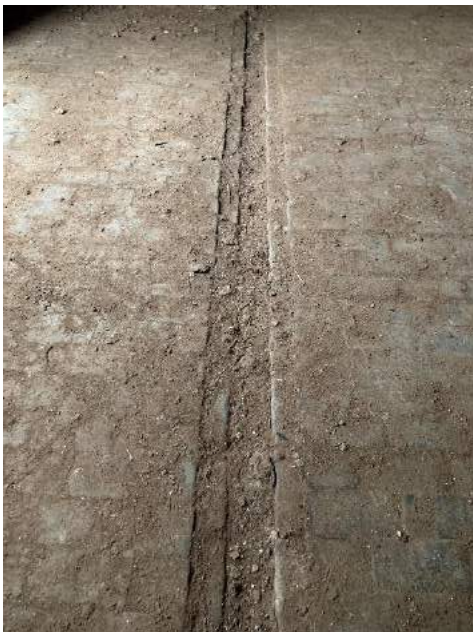
- e. Door. Internally, the central door has a timber lintel in satisfactory condition, with a hole in the masonry of the wall underneath, this requires repair.
- f. Paved Floor. Condition fair with areas of paving missing. There is a cattle gutter running west to east through the building. There is a section of earth to the north side, running all the way along the rear wall. Section of paving missing in the south west corner. Block flooring at the door threshold has been undermined due to level differences.

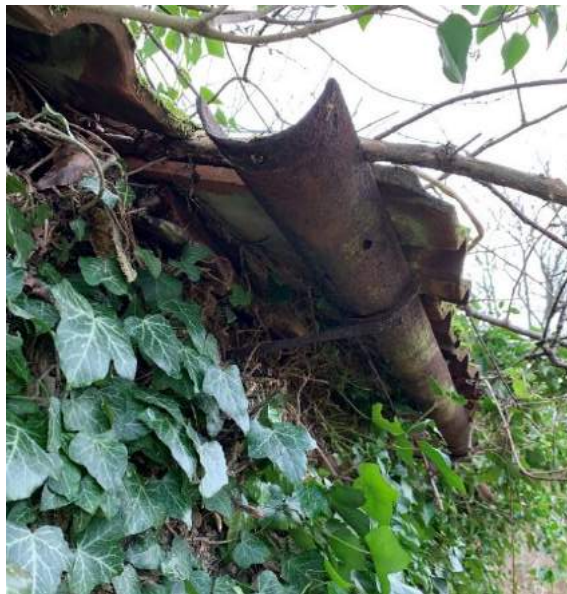
- a. There is a small section of gutter on rise and fall brackets left on the west elevation.

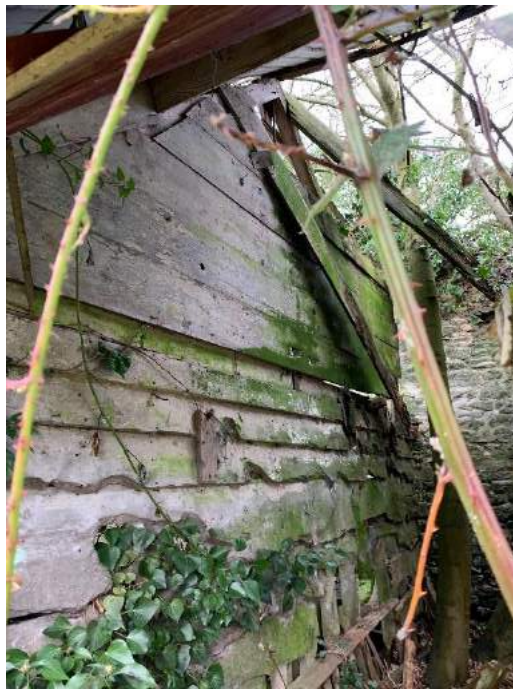
- b. West wall. Limestone wall with areas of missing pointing and deep holes. The corner between west and north wall has a large crack suggesting movement. A structural engineer should be appointed to advise on repairs.
- c. North wall. Limestone wall in fair condition, but requires cleaning and pointing.
- d. South wall. Timber framed with a stone plinth at the bottom. This will require a new sole plate.
- e. Internal partition. There is a central partition with a solid timber truss and timber posts with waney edged timber boarding to the sides. The boarding is rotten in several places and requires repair.

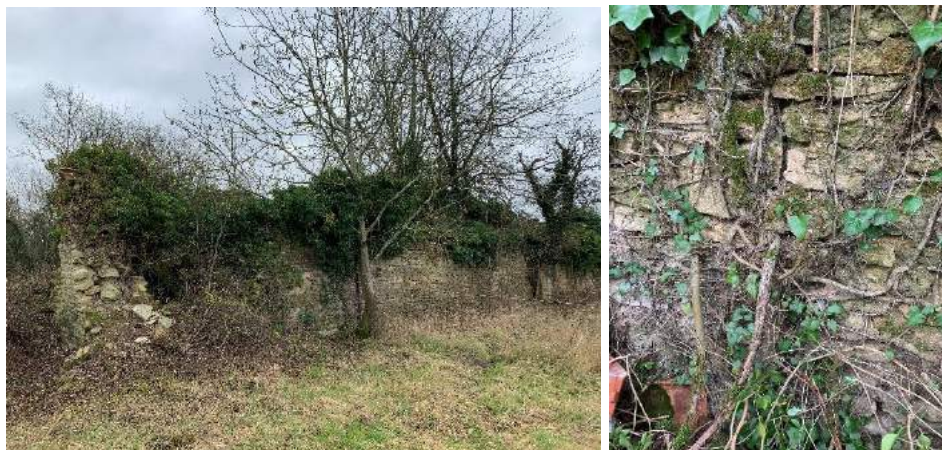
- a. The west boundary wall. Coursed rubble limestone wall, climbing plants and vegetation have caused the top sections to be dislodged, with sections missing. Missing section of wall towards the north corner. Internally, roots have established in the stonework and have compromised the structure.

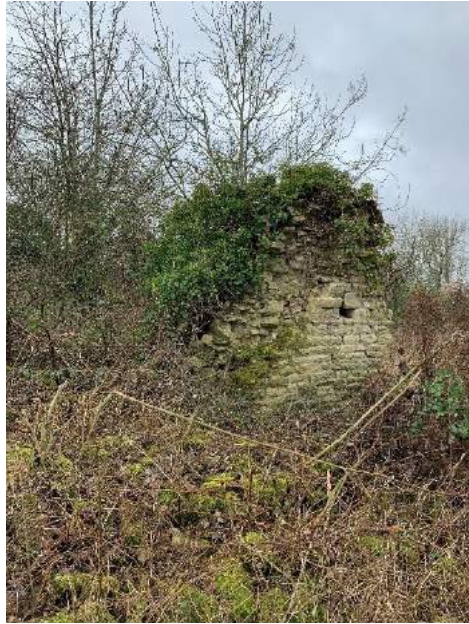
- b. North gable wall. Small section of coursed rubble limestone remains. The wall appears to be past its centre of gravity and is unstable.

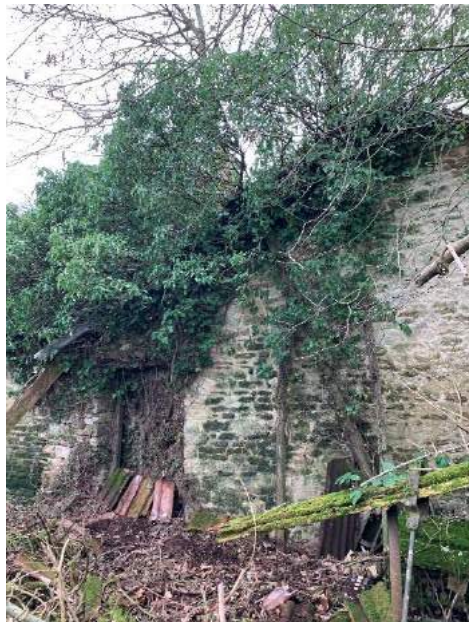
- c. East wall. Non-existent with no obvious remains. It is likely the building was open on this side.
- d. South gable wall. Looking from the inside of Block C, the wall is in a poor condition with some growth on the top of the gable wall. Invasive root growth will have compromised the wall and the core washed away as can be seen elsewhere and the structure requires re-building.

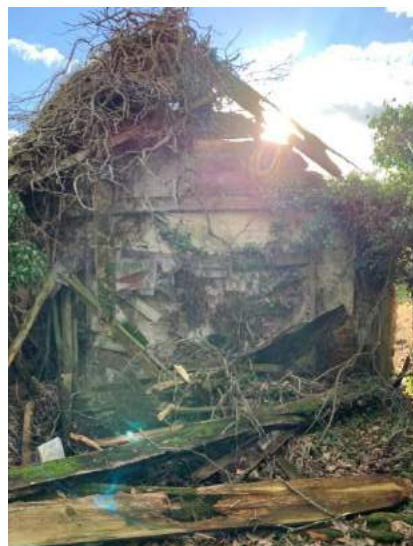
- a. West roof. Asbestos corrugated sheets, approx. 40% of the south end has collapsed, with the remaining section covered with vegetation. The roof covering requires replacement.

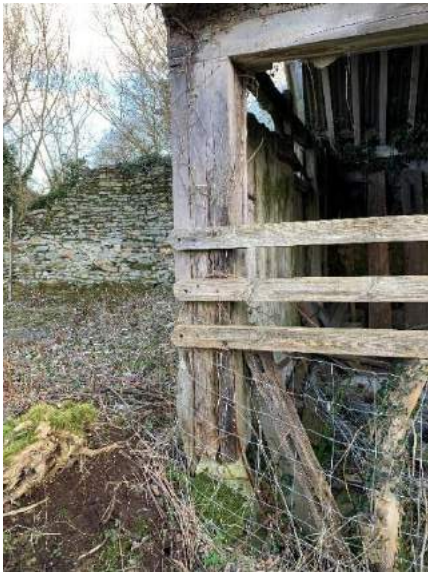
- Post 1. Timber post has split. It sits on a concrete saddle stone which has eroded quite significantly

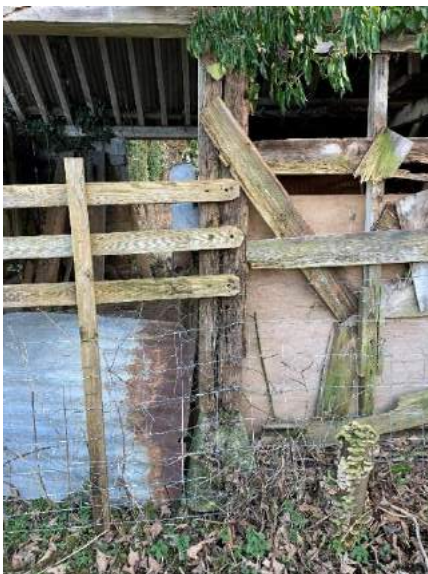
- Post 2. The timber post is in poor condition, the steel rod tying the post to the staddle stone has corroded. The staddle stone is in fair condition.

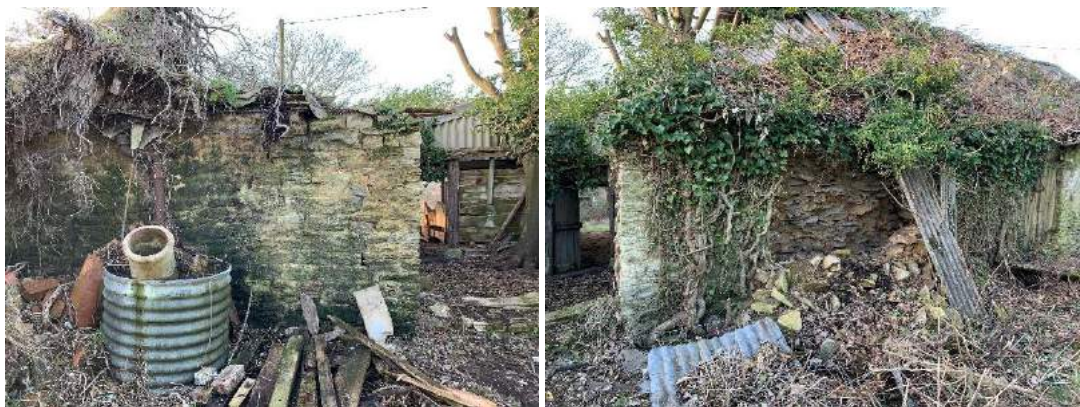
b. East Elevation. Towards the south, the wall is a stone rubble wall. Due to the wall head at the top being exposed, rainwater has washed away the mortar, which caused cracking and saturated the wall. The external and internal faces of stone have failed. Towards the north, damage due to vegetation and the washing away of the wall core has caused a large section of the external leaf to collapse. Further north, the stone wall is leaning outwards and there is substantial vegetation on the left section of the wall and missing stones on the top section of the opening. Towards the north there used to be timber double doors, with one timber post on the north corner still intact and the right section of the door still in place. The left section of the door is missing and the left post is on the ground.

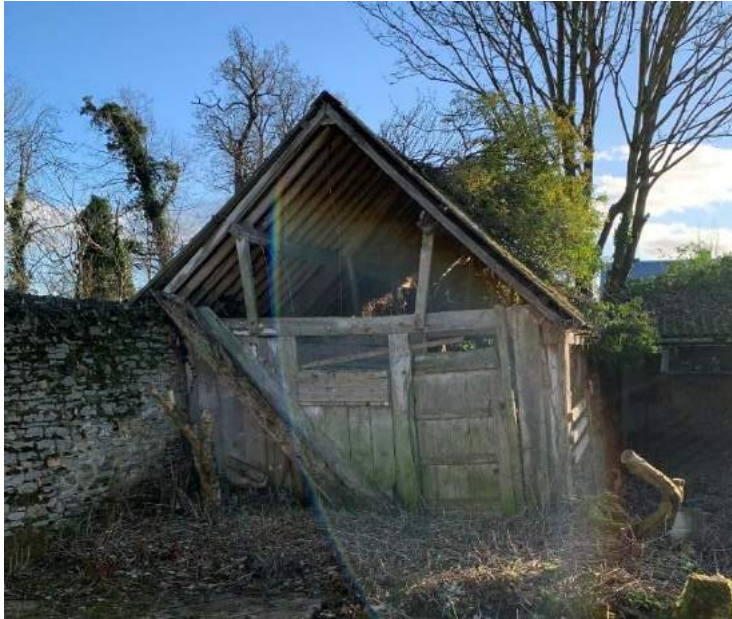
c. North elevation. Timber structure, which separates Block F from Block F1. It appears that the roof structure was cut short to allow space for Block F1. The rafters are exposed on the end with damage to the exposed west rafter. The truss seems to have been altered to create the end elevation, with timber boarding below. Timber boarding appears to be in fair condition with some damage and decay to the bottom sections which touch the ground.

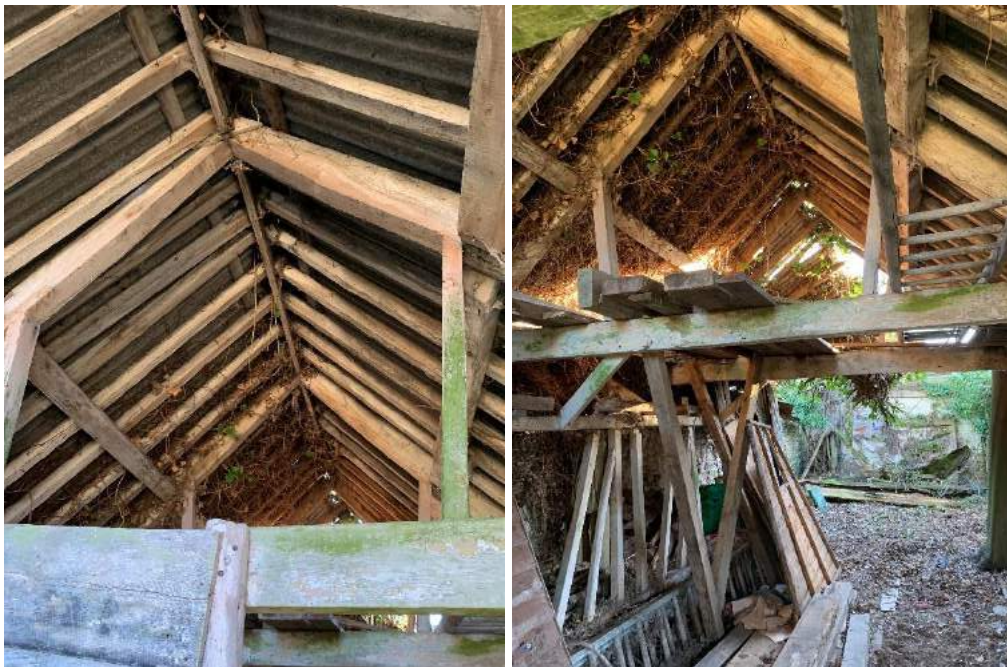
- a. Roof structure. The first 3 bays from the north are in fair condition and they could potentially be preserved. A structural engineer should be engaged to advise on repairs. The end of north bay requires a new truss. The remaining 3 bays to the south have collapsed and require rebuilding. The wall plate from bay 3 to 6 has been cracked by a growing tree and compromised. The truss in the south end has decayed and requires replacing. 2 remaining trusses are missing.

- 5.4.8 Relay existing cobble stone floor in Block A1.
- 5.4.9 Replace decayed truss in the south end of Block F.
- 5.4.10 Replace timber posts and weatherboarding in the west elevation of Block F.

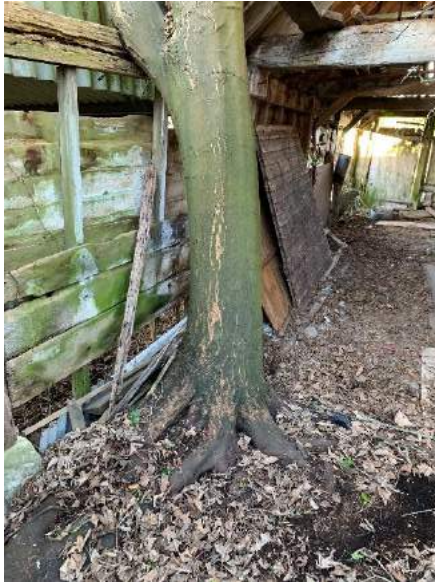
- b. Tree. There is a large tree growing inside Block F. This will need to be cut down in stages to prevent damage to remaining structure and grubbed out.

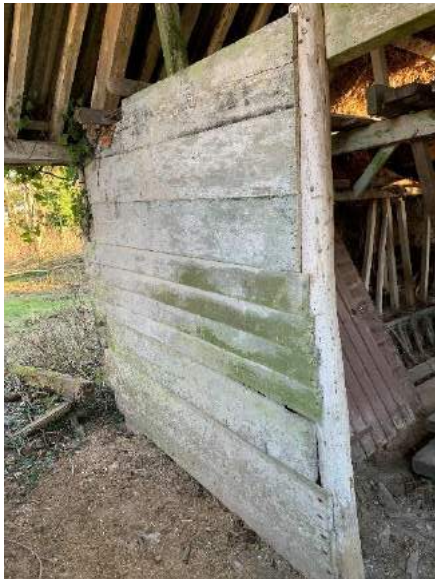
- c. Floor. Existing floor is not visible under a thick layer of earth and leaves.
- d. Internal partition. Existing partition under second truss from the north is a timber stud partition with a round post and horizontal timber cladding in satisfactory condition.

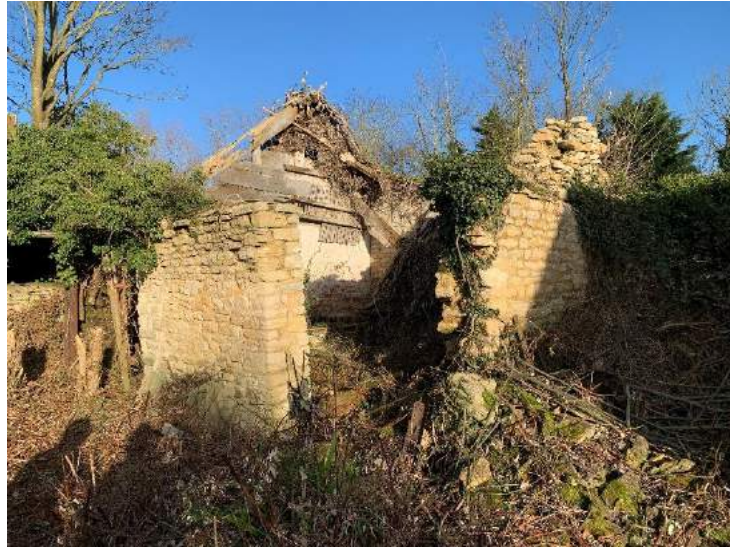
The small extension to Block F is in ruinous condition, without a roof. The west external wall is a limestone wall, leaning over 150mm, close to going past its centre of gravity. The top courses on the outside are damaged and require rebuilding. The south wall of the extension is from a coursed limestone wall. It is in fair condition with the exception of the top section, which appears to be loose stone. The loose stone should be removed and the gable rebuilt. The corner of the wall also requires rebuilding and is covered with plant growth. The east elevation is ruinous and not visible. On the east wall to the extension, there is a brick built lean to extension,

also is in ruinous condition, which presumably had a slate roof in the past but is now covered with metal panels. The structure requires rebuilding.

- 5.1.9 Remove loose stone on the south wall of Block F south extension.
- 5.1.10 Remove a tree growing within the footprint of Block F1.

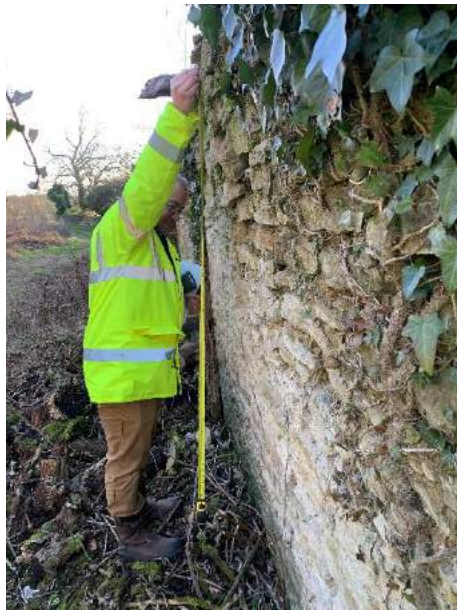
- a. West Elevation. Only 3 staddle stones remain, which appear to be concrete, in poor condition.
- b. East Elevation. The north side of the limestone wall has collapsed, and the remaining side appears to be leaning outwards with large openings within the top section of the stones and missing mortar.

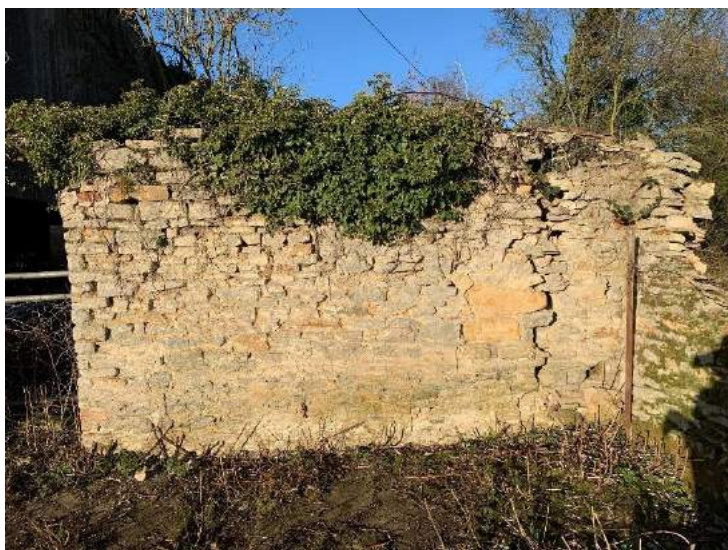
- d. North elevation. Coursed rubble limestone wall with an oak post on the top. The oak post has decayed, which has let moisture into the wall and compromised the integrity the wall, resulting in cracking to the left-hand side. The cracks and holes extend through the wall. Given the period of sustained deterioration, the wall should be rebuilt like for like.
