JAMES
MACKINTOSH
ARCHITECTS

Stratfield Farmhouse – Method statement for repairs

1.0 Introduction

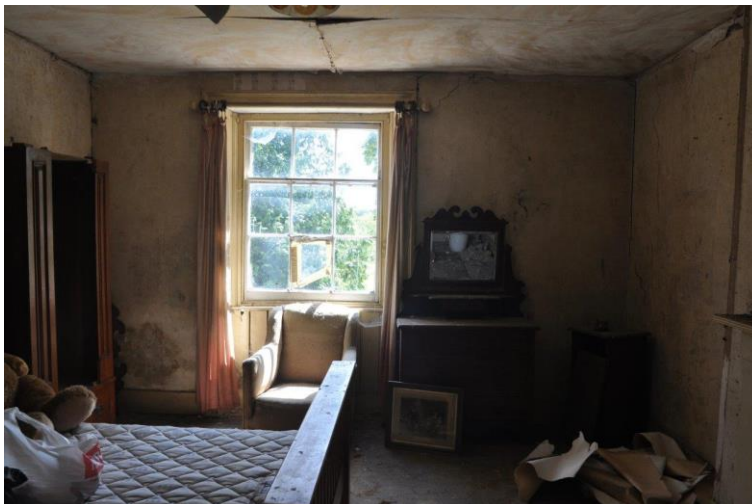
5.2.1 Bedroom 2

- a. Remove hardboard lining to ceiling and skim plaster in lime.
- b. There is evidence of damp on the external wall.
- c. There is cracking to the plaster on the west elevation - fill cracks in plaster. To the north of the chimney breast allow for repairing 2sqm of lime plaster with new lime plaster.

- d. There is severe cracking in the northwest corner, where the west wall has moved. Allow for Helibar system as directed by a structural engineer to tie spine wall to external wall. Allow for replastering 3 sqm of lime plaster on completion.
- e. There is a 25-50mm gap between the floorboards and the external wall. Allow for carefully lifting all floorboards and re-setting floorboard closing gaps in west wall.
- f. Clean existing fireplace and decorate hob grate and fire dog.
- g. Carry out repairs to weatherboarding below south window.

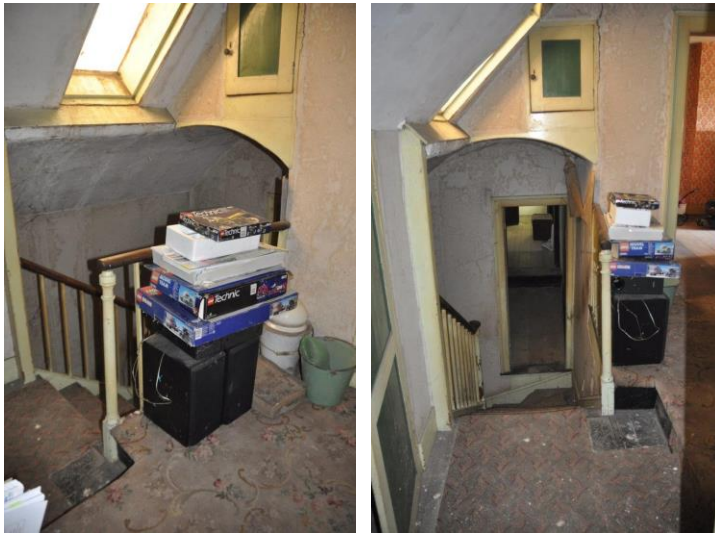
5.2.3 Landing

- a. There is damp around the rooflight in the north elevation. Replace existing rooflight with new conservation rooflight and address flashings.
- b. Fill cracking to plaster on the east elevation with lime plaster.
- c. Remove plasterboard and failed lime plaster finishes to sloping soffit on north elevation and renew with lime plaster on breathable substrate.
- d. To the west elevation, remove live plaster and gypsum plaster, consolidate stone and replaster in lime.
- e. Refix vertical riser to step to bedroom 1.

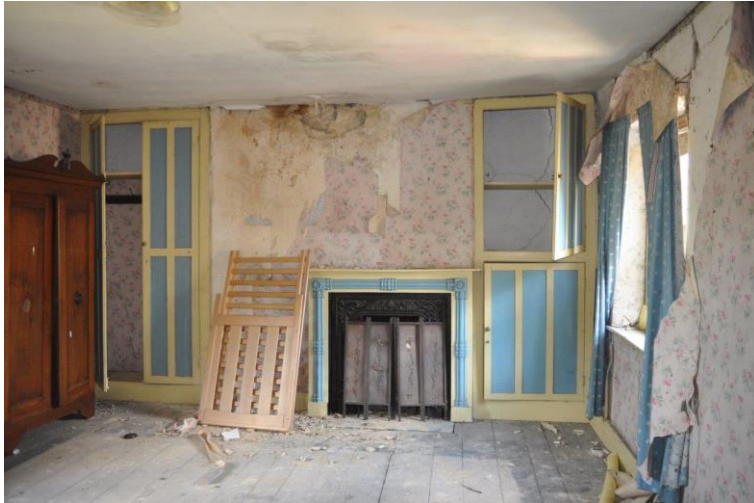
5.2.5 Bedroom 1

- a. On the north wall there is staining to the plaster above the fireplace, which may be coming through the chimney stack. Allow for removing 2sqm of plaster and pointing to the stonework and repointing and plastering in lime plaster.
- b. Carry out repairs to fixed joinery.
- c. There is movement to the southwest corner - this should be inspected by a structural engineer. In attic above, make up top of south wall with masonry and make good wall in lime plaster.

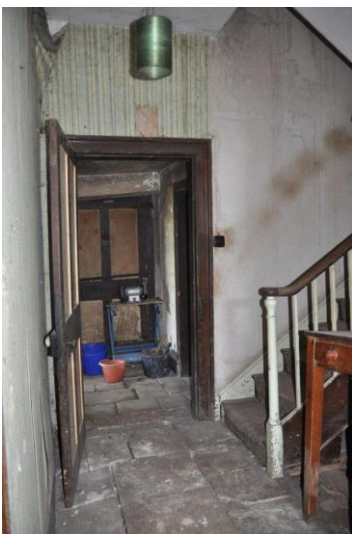
5.4.1 Stair

- a. Clean and point stone flag floor. Carry out repair to sunk and cracked flagstone near door to the drawing room.
- b. There is decay to the floorboards next to (and running in and below) the below stairs cupboard. Clear dirt and debris from between floor joists, allow for repairs to joists, and replace floorboards with new softwood boards to match existing.

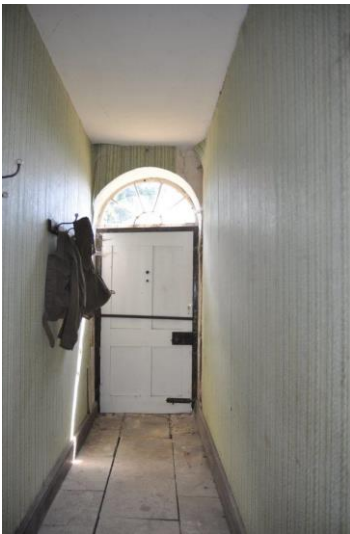
5.4.3 Corridor

- a. There is significant settlement of the flag stones below partitions, this should be checked by a structural engineer. Lift and rebed stone flags were sunk and carry out pointing to stone floor.
- b. Carry out plaster repairs to crazing lime plaster to arched soffit between corridor and stairwell.

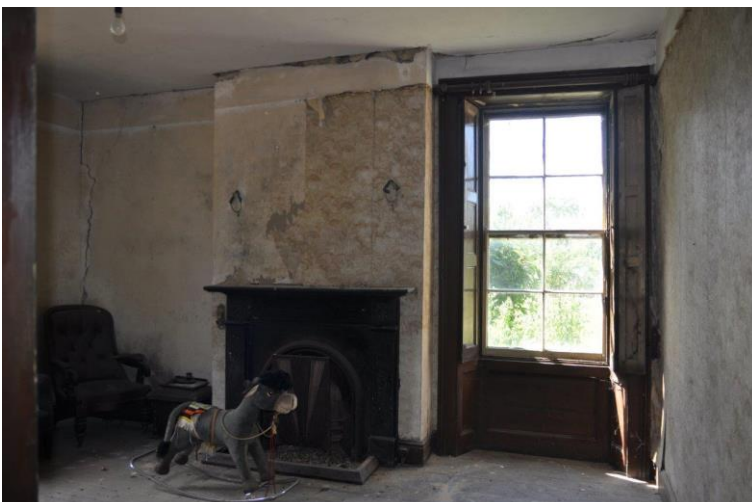
5.4.4 Drawing Room

- a. Overhaul and revive decoration to shutters on south elevation.
- b. In the southeast corner there appears to be movement – where the partition has dropped - this should be assessed by the structural engineer. Investigate from above and allow to install noggins in the top of the wall to allow plaster to be repaired from below.
- c. Fill cracking in southwest corner with lime plaster.
- d. Clean and decorate fire surround and cast-iron backing. Repair/consolidate masonry backing.

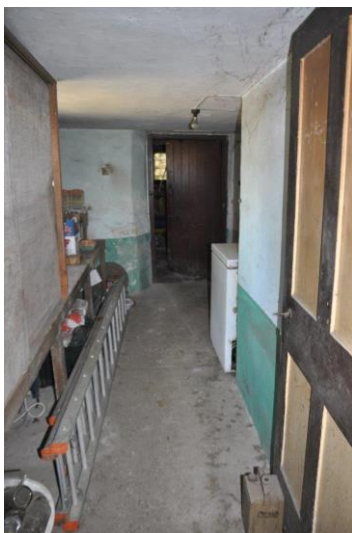
5.4.6 Utility

- a. The paint is flaking to the ceiling, remove flaking paint skim ceiling in lime plaster.
- b. The floor is from concrete

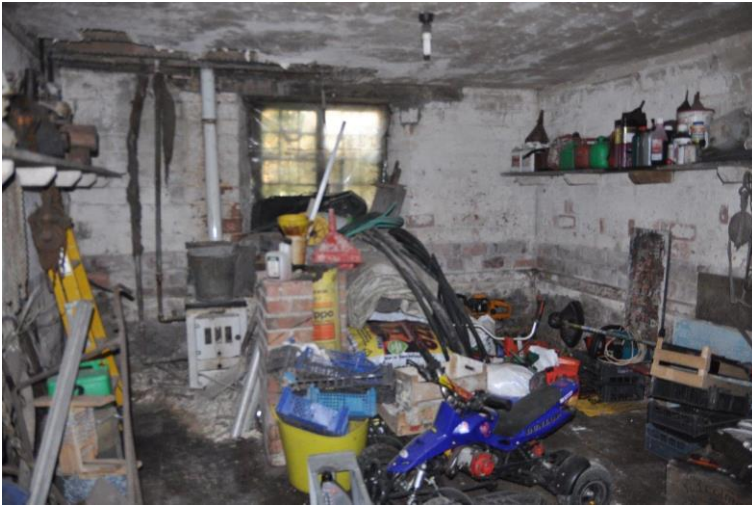
5.4.7 Workshop

- a. To the east end of the ceiling the lath and plaster has failed. Remove lath and plaster ceiling and replace with breathable substrate and lime plaster finish.
- b. The walls are from very deep bricks/brick on sides, with a paint finish. Remove paint finish and insulate walls as 2.0 above.
- c. There are stone flags to the floor.

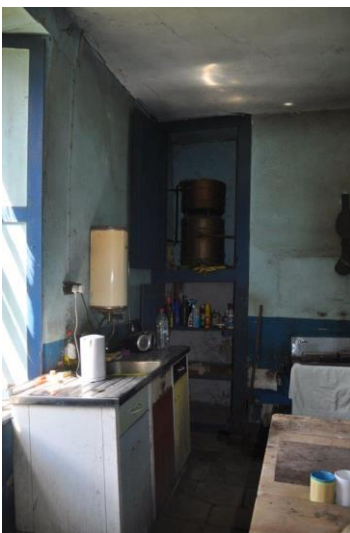
5.4.8 Kitchen

- a. The ceiling is from plaster and has hairline cracking. Allow to skim in lime mortar.

- b. The south elevation has moved leaving a considerable gap between the ceiling and the wall. Allow to remove a section of lime plaster 1m wide and parallel to the wall to allow new laths to be fixed and the plaster to be repaired in lime plaster. Allow for installing noggins in the floor void above to secure laths.

- c. To the door reveal from the hall there is a section of damaged plaster to the south. Carry out repairs in lime plaster c1sqm.
- d. There is a significant structural crack between the spine and west wall which requires investigation by a structural engineer. Following structural repairs carry out replastering in lime mortar. C3sqm.

- e. To the west elevation behind the boiler modern plasters have sheared away from the wall. Remove modern plasters to reveal substrate. Allow to finish in lime.

- f. There is settlement of the stone flag floor, which should be investigated by a structural engineer. Lift and relay stone flags and point in lime mortar.

- g. The Aga is sat on a raised concrete plinth. The plinth and Aga will require removal and the floor should be repaired with matching reclaimed stone.

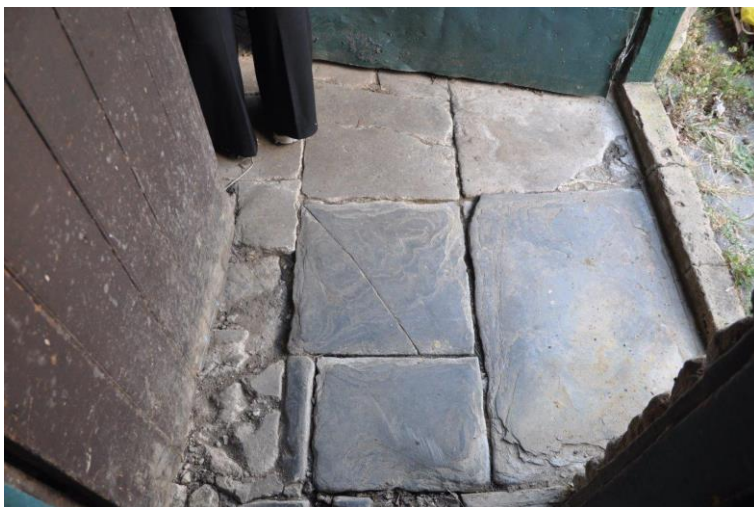
5.4.9 Back lobby

- a. The stone slabs to the floor require pointing.

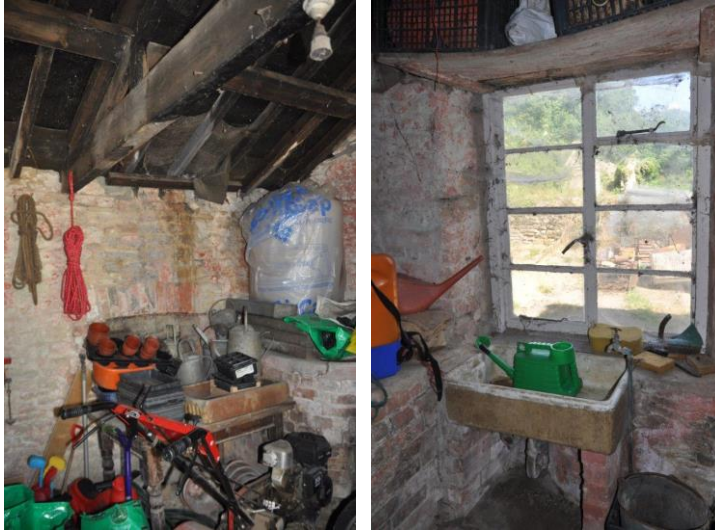
5.4.10 Wash house

- a. The ceiling has expose rafters and the roof finish is felted on the underside.
- b. The walls are from masonry with a paint finish. The paint finish should be removed, and the walls insulated as 2.0 above.
- c. There is some minor cracking to the south elevation to the west of the door. This may require Heli bar repairs as directed by a structural engineer.
- d. There is rot to the bottom of the boarding to the external door. Carry out repairs to door.
- e. Several of the stone flags have shatter and the floor will require repairs.
