DEMOLITION REPORT

SITE D1&EL1

MOD BICESTER

DEMOLITION REPORT - SITE D1 & EL1, MOD BICESTER, PIONEER ROAD, BICESTER

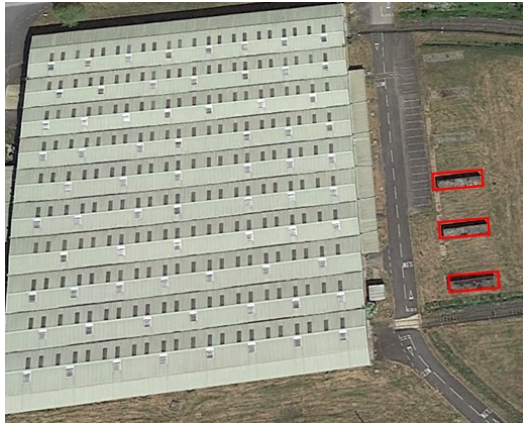
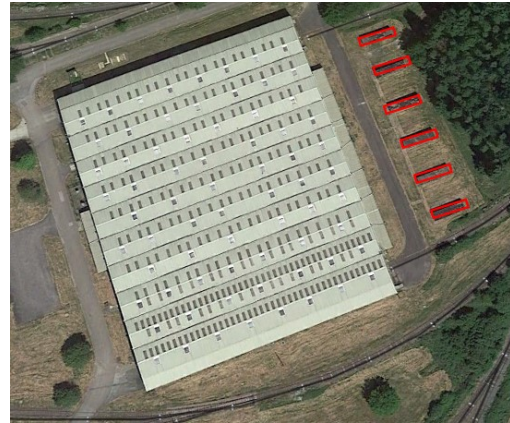
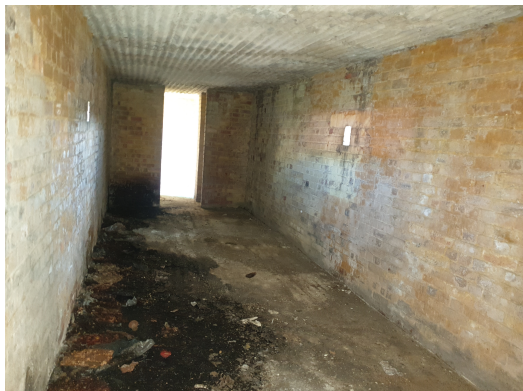
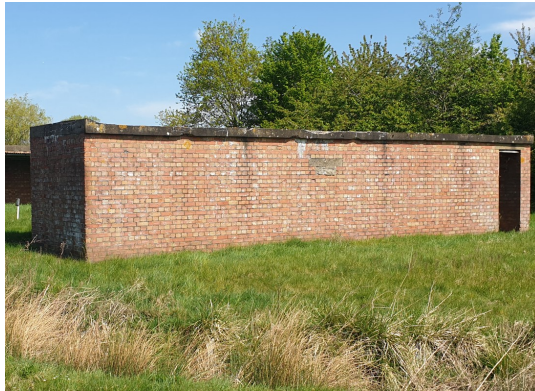
There are a number of small brick built air raid shelters to the east of D1 and D2 and these are shown on the images below:
