Canal Cottage, Thrupp

Structural Inspection Report

Job Number: 26242

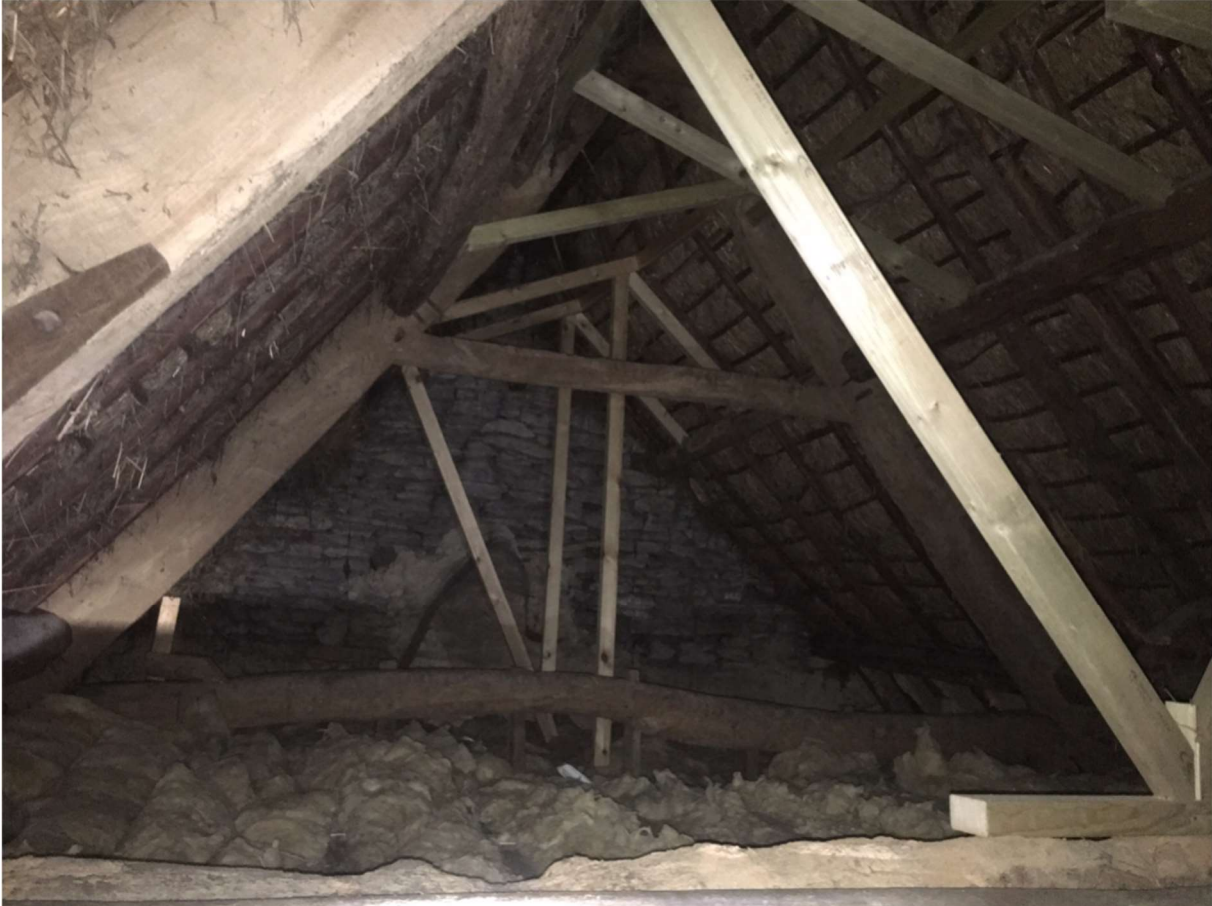
Photograph 1 - Original collar tie trusses and modern C24 strengthening props and purlins

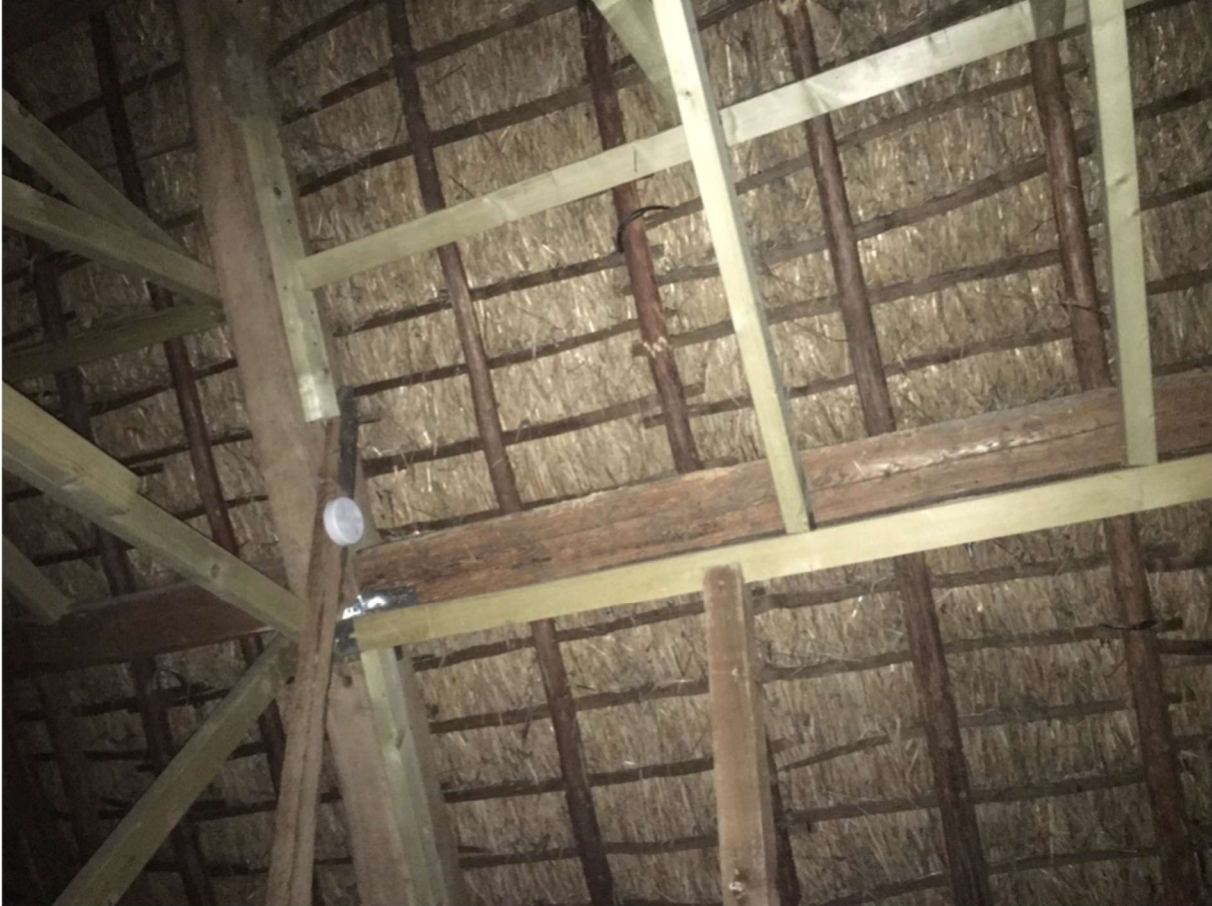
Photograph 2 - Modern C24 purlins an props support fir pole rafters

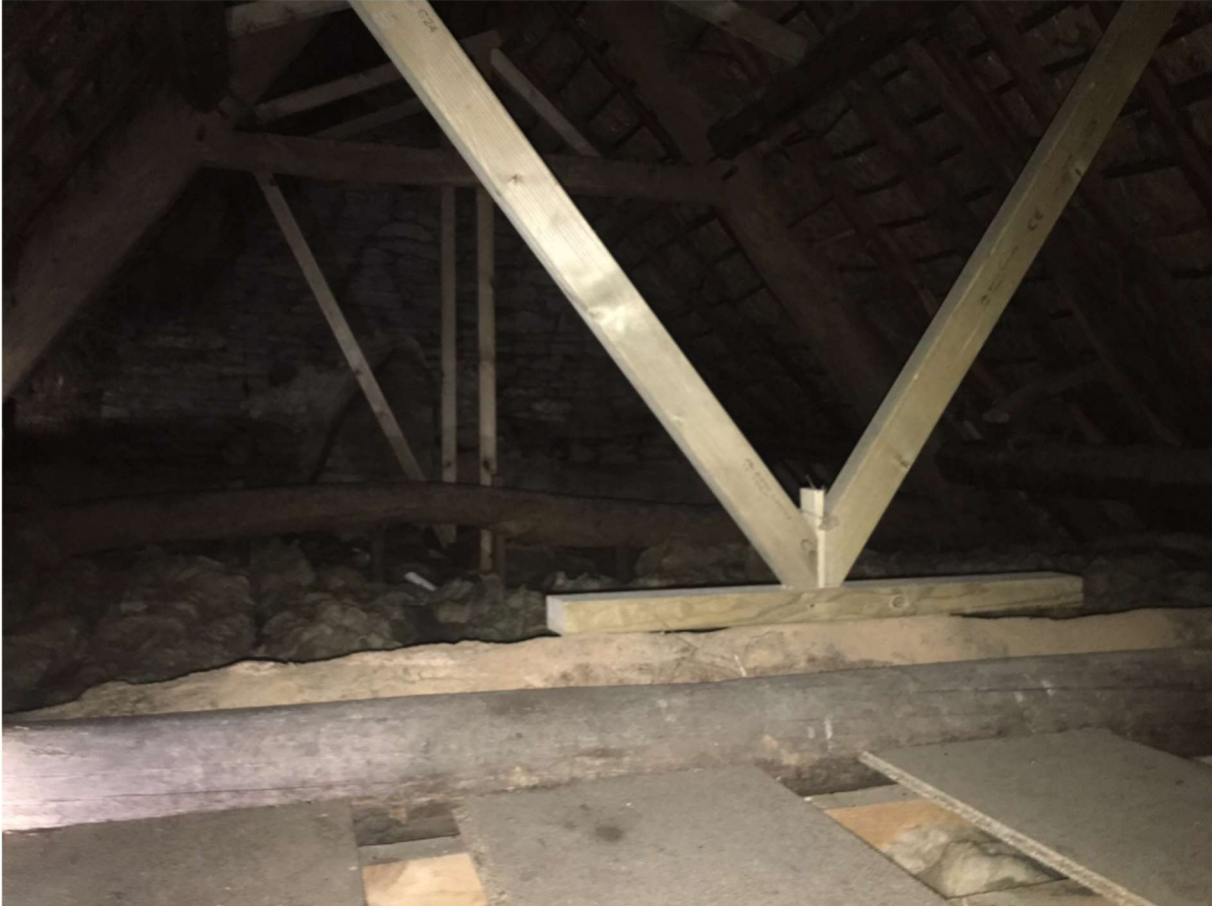
Photograph 3 - Truss 2 with modern bracing repair

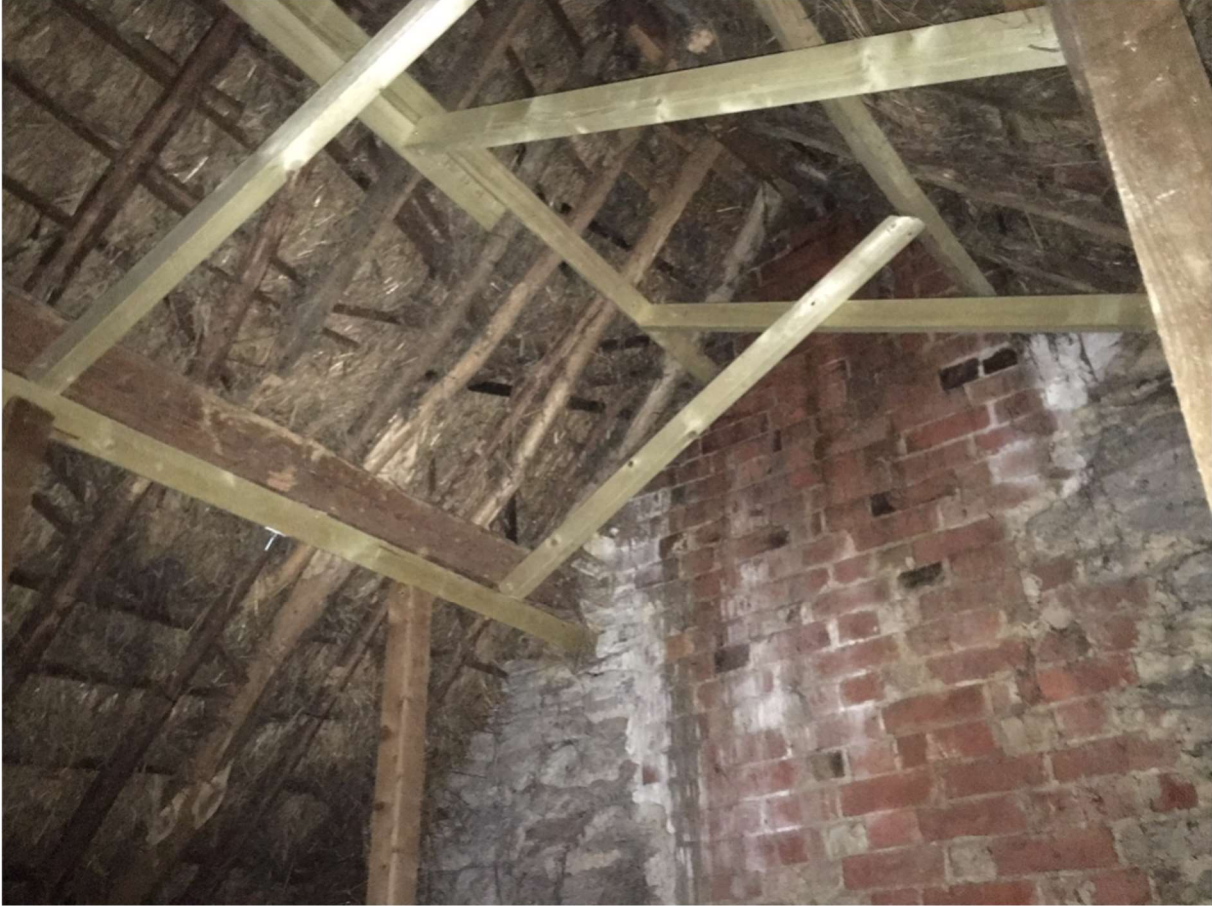
Photograph 4 - Modern C24 purlins and props

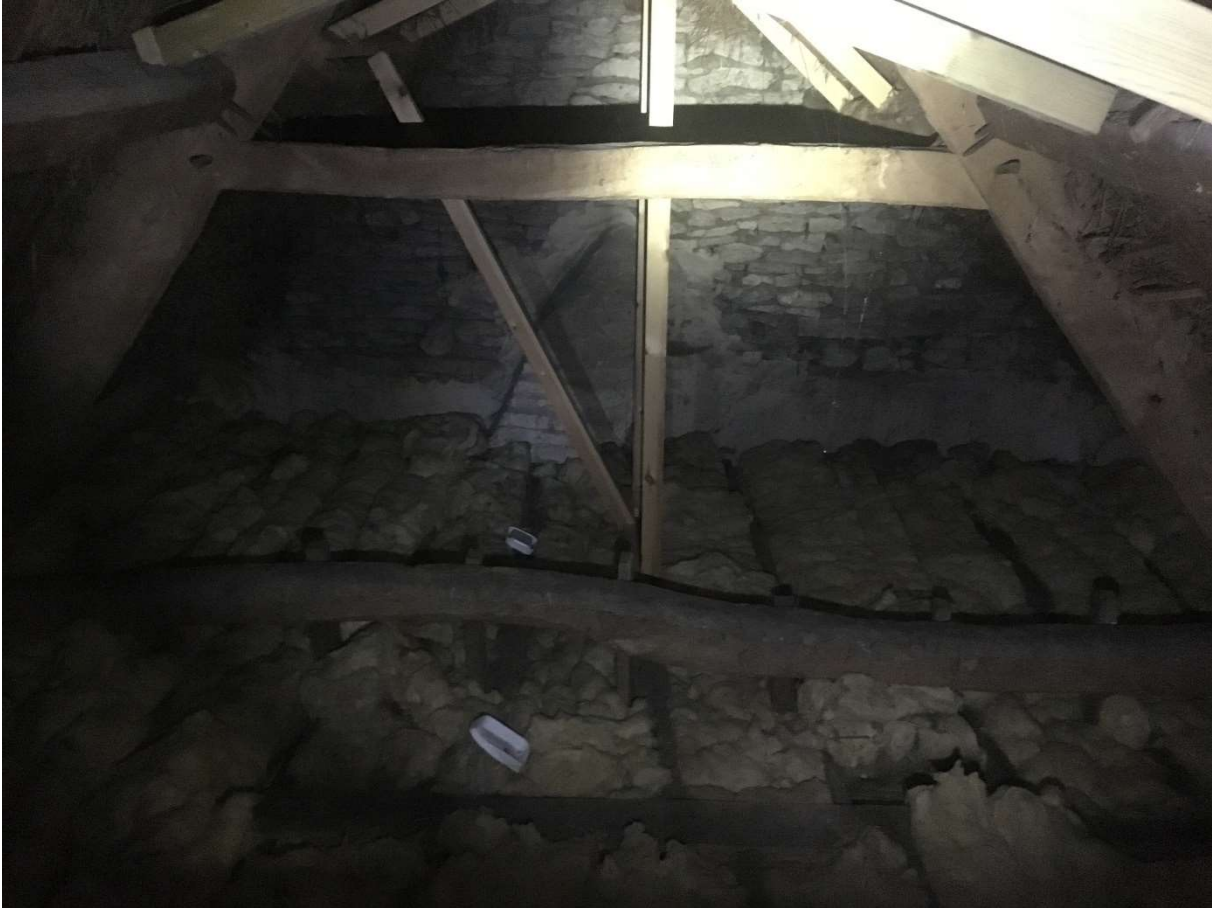
Photograph 5 - Truss 1 with modern C24 props beyond

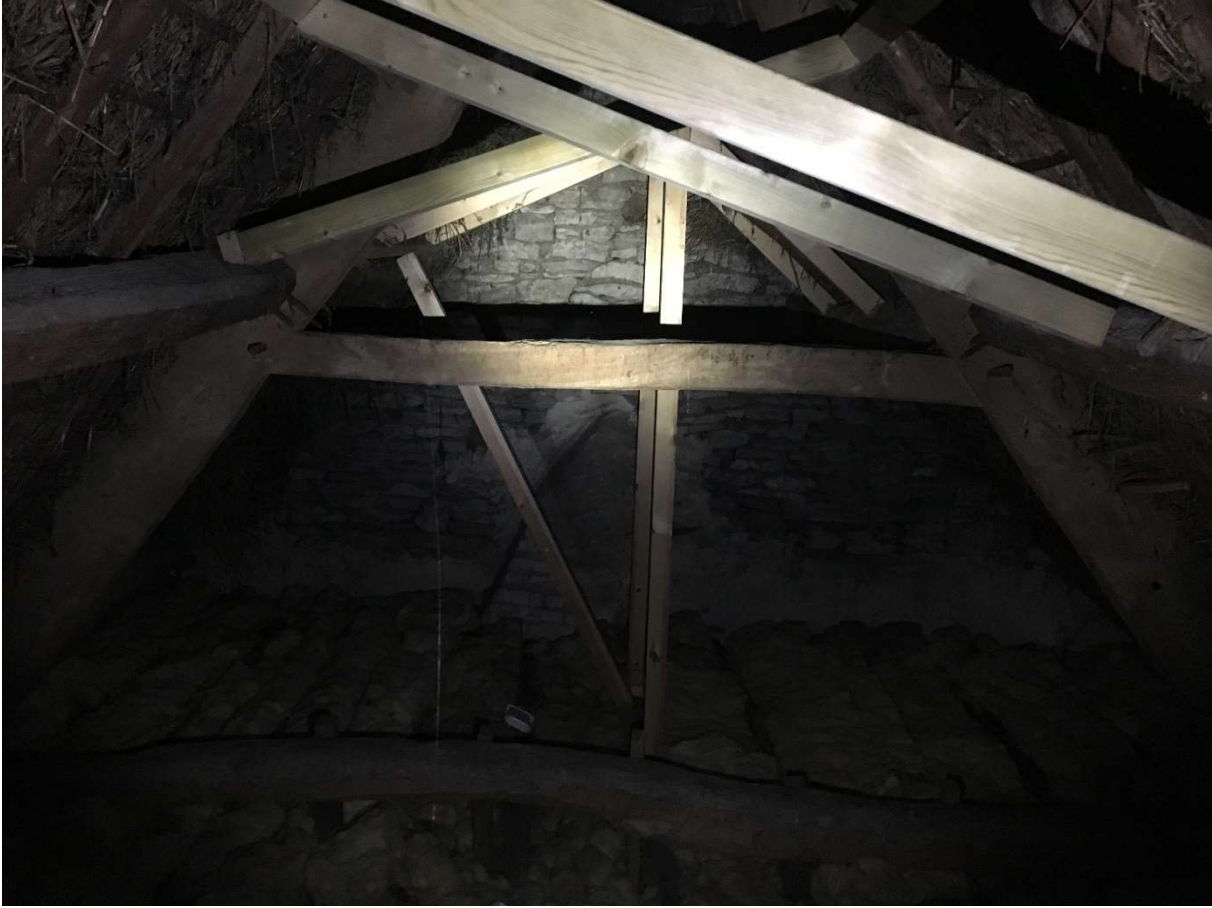
Photograph 6 - Modern C24 props

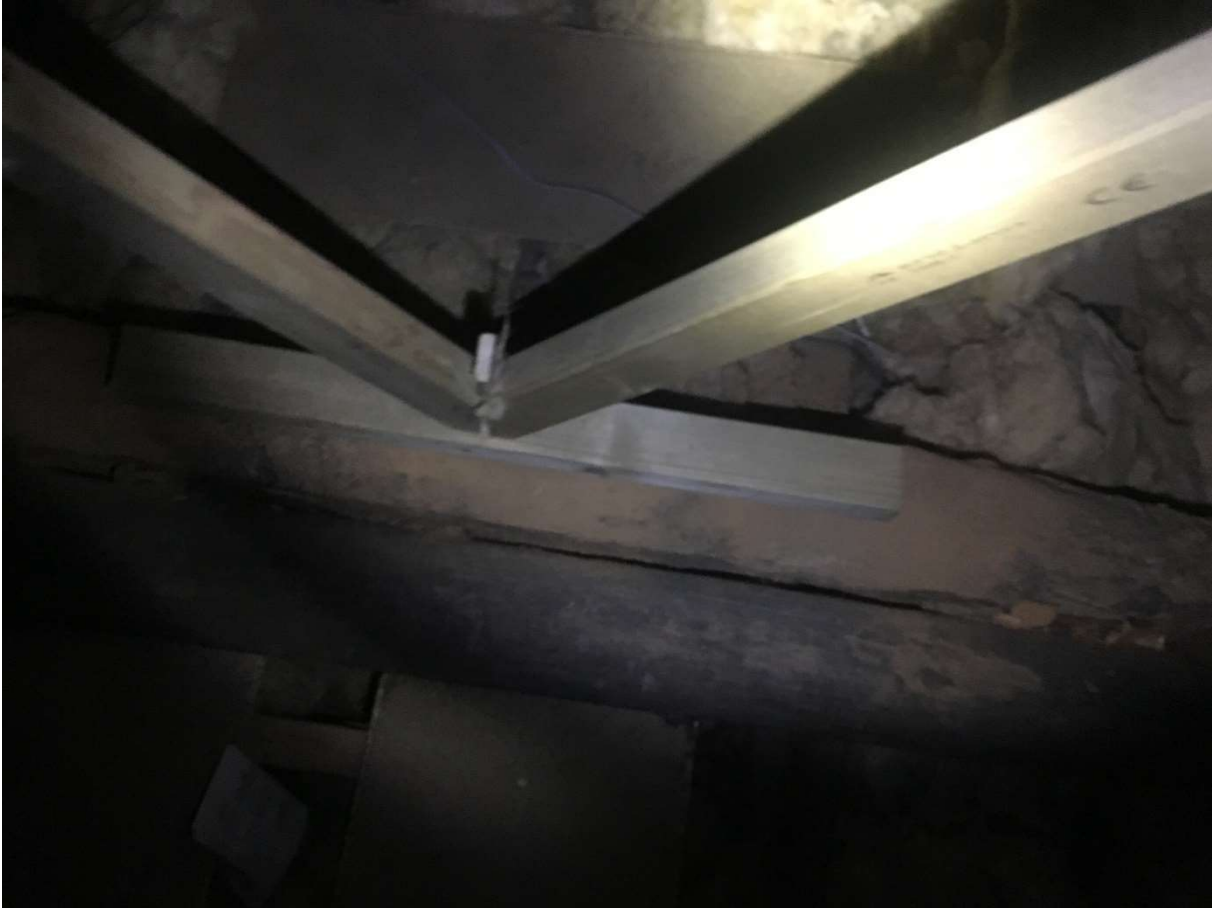
Photograph 7 - Truss 2 with modern bracing repair

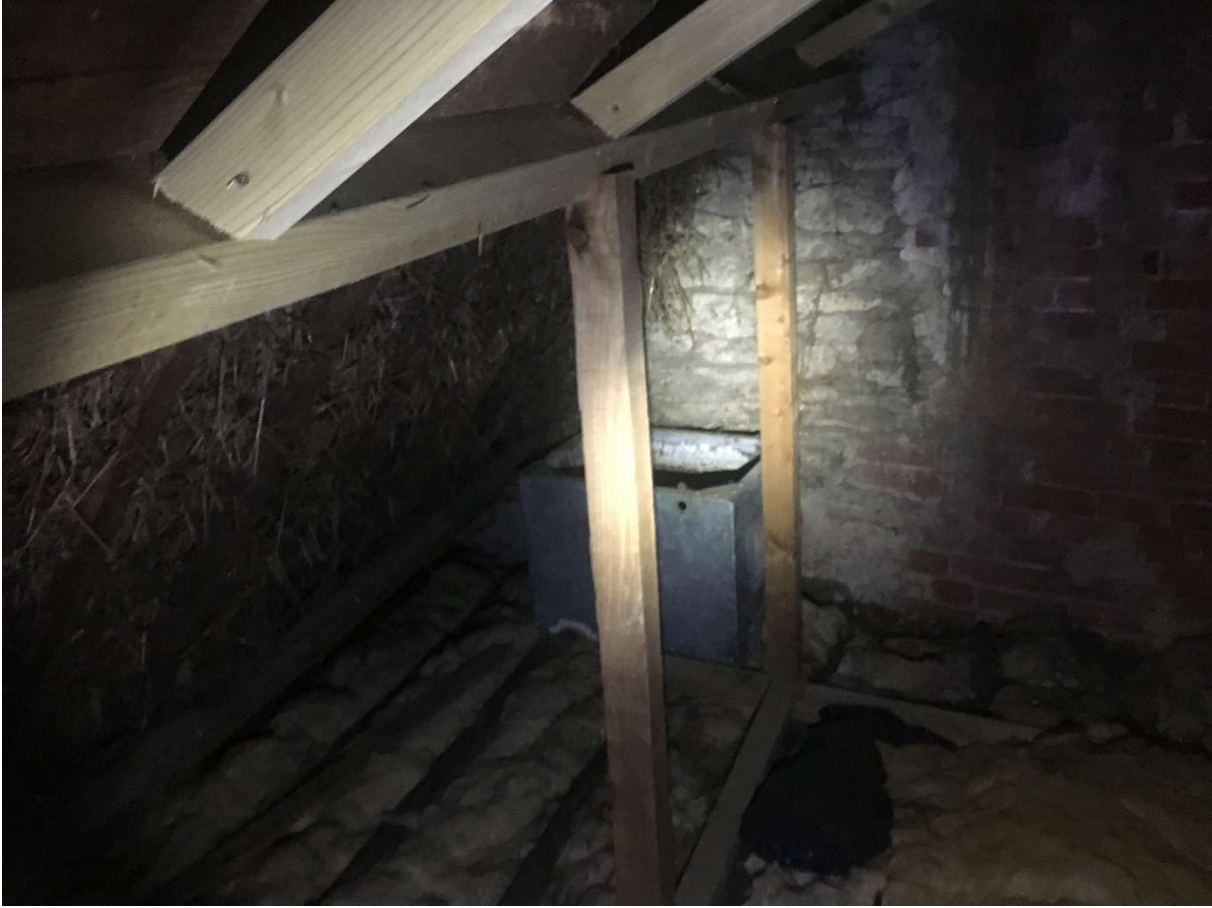
Photograph 8 - Modern vertical C24 props and purlin

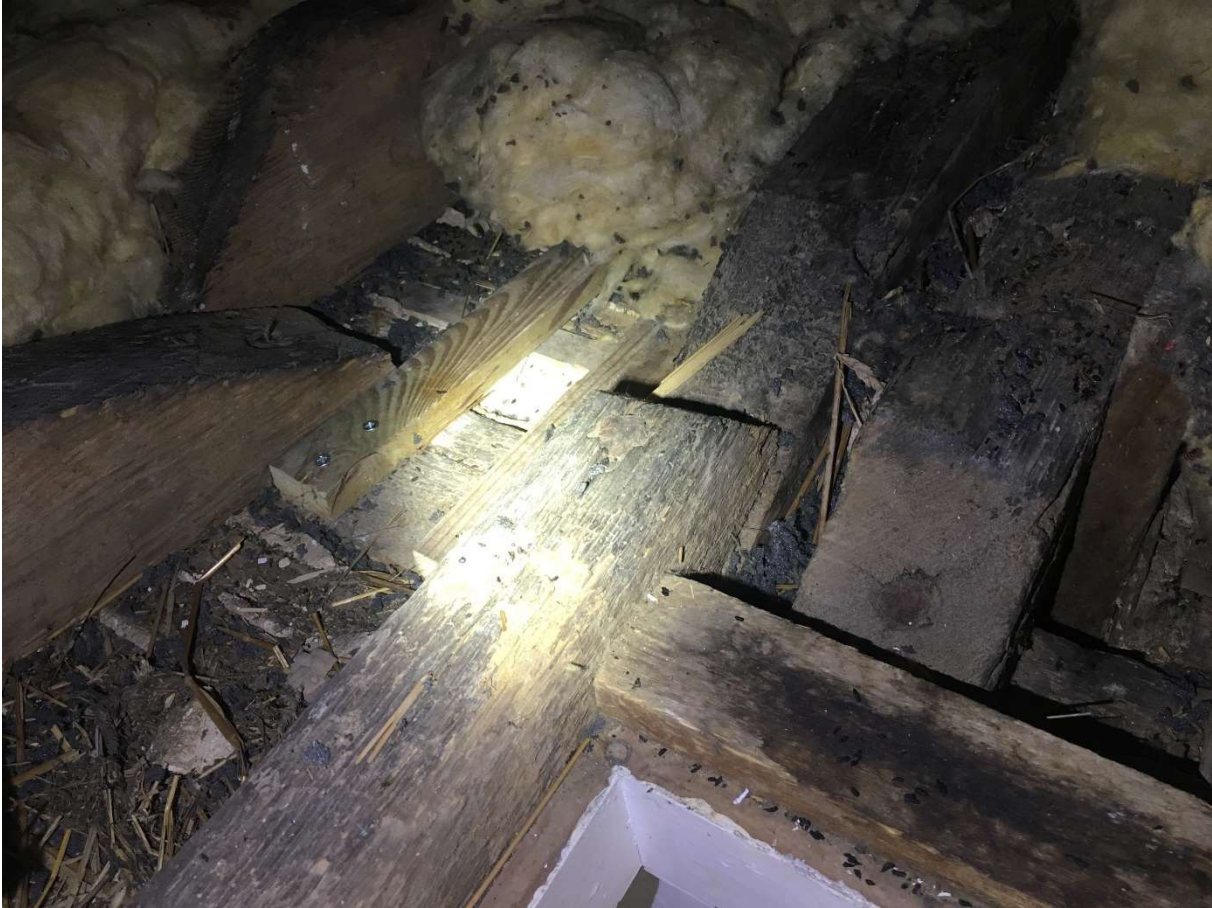
The attic floor appeared generally sound. 100mm x 75mm (4" x 3") timber ceiling joists span approximately 2.6m at 380mm centres (15") and are supported off the timber cross walls at first floor level.

Photograph 9 - 4" x 3" attic floor joists bear onto walls below

It is intended to refurbish the attic to habitable space. Building Regulations specify an imposed design load of 1.5 kN/m² for habitable rooms in single dwellings which is often more than the original structure was built for. Calculations suggest that although the existing 100 x 75mm timber ceiling joists are strong enough, deflections would be excessive. The floor can however be strengthened by adding new 100 x 50mm C24 joists between the existing joists to enhance the stiffness of the existing floor joists to within allowable deflection limits.
