**PERSIMMON HOMES DEVELOPMENT  
WYKHAM PARK, BANBURY  
SECTION 38 WORKS  
STAGE 1/2 ROAD SAFETY AUDIT**

SA 3981  
February 2023

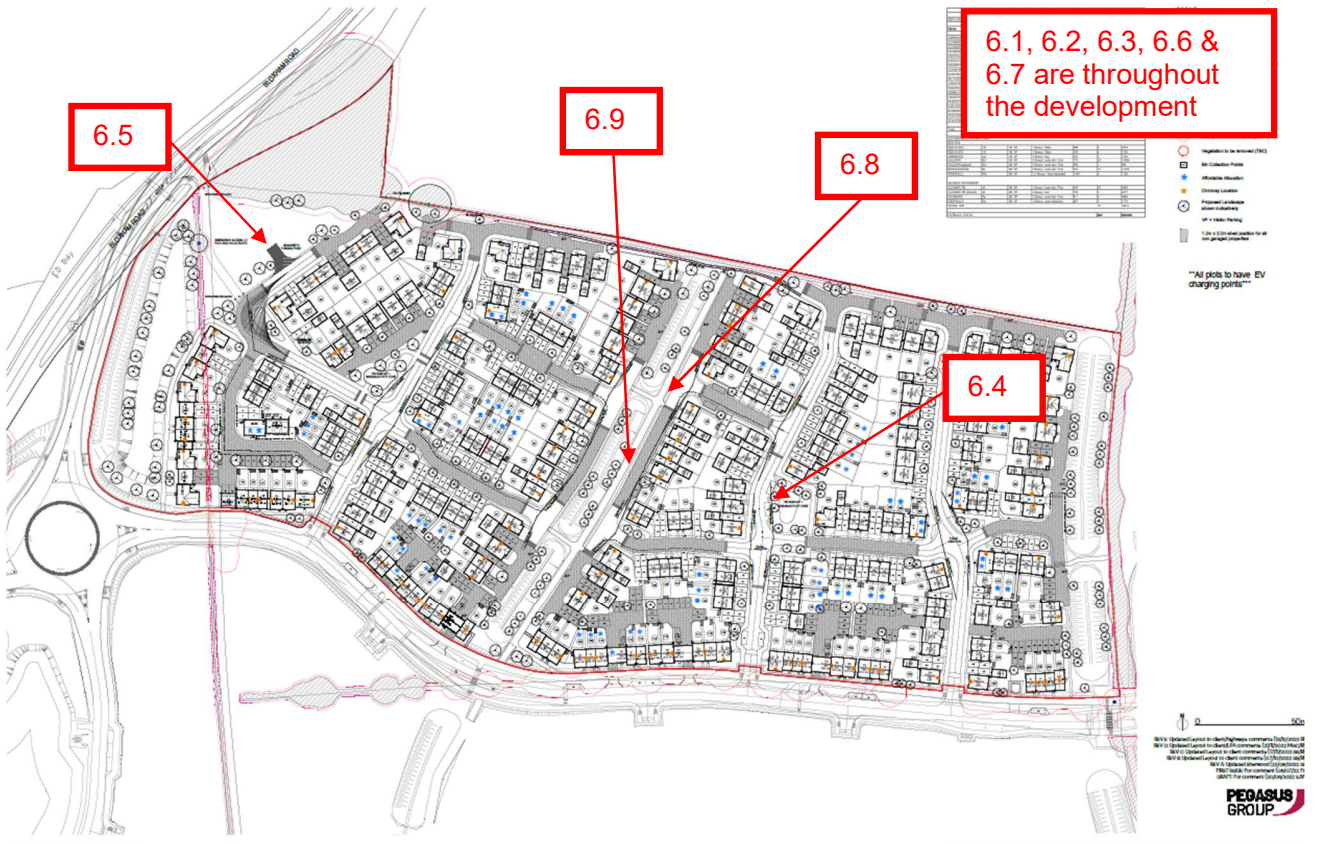
### **9.0 PROBLEM LOCATION PLAN**

There are several locations throughout the proposals submitted for audit where large vehicles, such as refuse lorries, are overrunning areas and footway. If a refuse lorry is overrunning a footway, then there will be a risk of collisions with pedestrians.

The drawings submitted for audit show very little in the way of traffic calming or speed control measures throughout the site. It is noted that there are areas of block paving, but these have flush kerbs either side and no change in level to slow down vehicles. There are long straight carriageways within the development on which vehicles could travel at excessive speed along, which will increase the risk of collisions through the site.

There do not appear to be any facilities proposed to inform pedestrians that they are transitioning from a traditional footway to a shared space carriageway where they may encounter vehicles. This is of particular concern to partially sighted users who may not be aware of the change of environment and could lead to an increased risk of pedestrians colliding with vehicles.

The visibility splay for the junction opposite plot 131 is shown through visitor parking bays and outside of the area being offered for adoption. If a vehicle were parked in these bays, then there will be a risk of a side impact collision due to the reduced visibility at the junction. If the boundary treatment of the private areas adjacent to the highway changed, then there will also be a risk of a side impact collision due to the reduced visibility at the junction.

The turning head by plot 29 is noted as being constructed as grasscrete. The majority of drivers will not realise that this area which appears to be grass is for them to turn in and may opt to reverse back down the road to the nearest junction. This will lead to a risk of other vehicles colliding with the rear of the reversing vehicles.

The drainage drawings submitted for audit show several attenuation features throughout the development adjacent to the carriageways. It is noted that some of these ponds are over 2.0m deep. If an errant vehicle were to enter the pond it may overturn as travelling down the side slopes (gradients unknown) and the occupants could drown if the ponds were holding water at that time.

The block paved shared space areas have 25mm kerb faces along the channel lines. These kerbs are above the recommended guidance of a 0-6mm kerb face for a crossing point, meaning pedestrians could potentially trip on them. This creates the further issues of whether these areas actually likely to operate as shared spaces as there is a clear channel line along the edges denoting a carriageway area for drivers of vehicles. If they are not treated as shared spaces by users, then the margins along either side of carriageways are, in most cases, not of adequate width to be a footway. In summary, the block paved areas are not shared spaces and are not wide enough to operate as traditional carriageway and footways. This could lead to pedestrians tripping on the 25mm kerbs or collisions with vehicle who think that they're on a carriageway rather than a shared space.

The footway running alongside the attenuation basins does not link into the wider footway network through the site. There are locations with links through to the adjacent carriageway but no uncontrolled pedestrian crossing points with tactile paving have been provided at these locations. These could lead to pedestrians tripping on full height kerbs or pedestrian collisions with vehicles whilst they are walking in the carriageways.

The footway running alongside the attenuation basins does not appear to have any fencing to prevent pedestrians falling into them. As the basins are over 2m deep in places there could be a risk of drowning. It is noted that the side slopes are between 1:3 and 1:4 but the gradient alongside the footway it is not clear.

It is recommended that all the carriageways are tracked with computer aided design software to ensure vehicles which will travel through the development regularly can do so without overrunning areas.

It is recommended that speed control measures be installed throughout the development.

It is recommended that clear guidance, such as tactile paving etc, be provided at the entrances to shared space areas to inform pedestrians of the change of environment.

It is recommended that all visibility splays are adequate for the speed of the road, are free of obstructions and are within land being offered for adoption so they can be maintained in perpetuity.

It is recommended that a traditional turning head is installed which is of adequate size to allow regular highway users, such as refuse lorries, to turn in without overrunning the adjacent footways.

It is recommended that some form of fencing is included in the design alongside the ponds.

It is recommended that either that the block paved areas are designed as true shared spaces without the 25mm kerb face or that the design reverts to a traditional arrangement of footways and carriageways, both of which would need to be of sufficient width to fulfil the roles.

It is recommended that this section of footway be integrated into the wider highway network with suitable pedestrian facilities at the access points.

It is recommended that the basins either be guarded or of a suitable gradient so that, if a pedestrian were to enter, they could climb out again unaided.
