HIGHWAY CONDITION SURVEY, CAMP ROAD

22/02692/DISC-Heyford Park

Phase 10-Discharge of conditions 22
(Construction Management Plan)

Heyford Park, Camp Road, Upper Heyford, Bicester

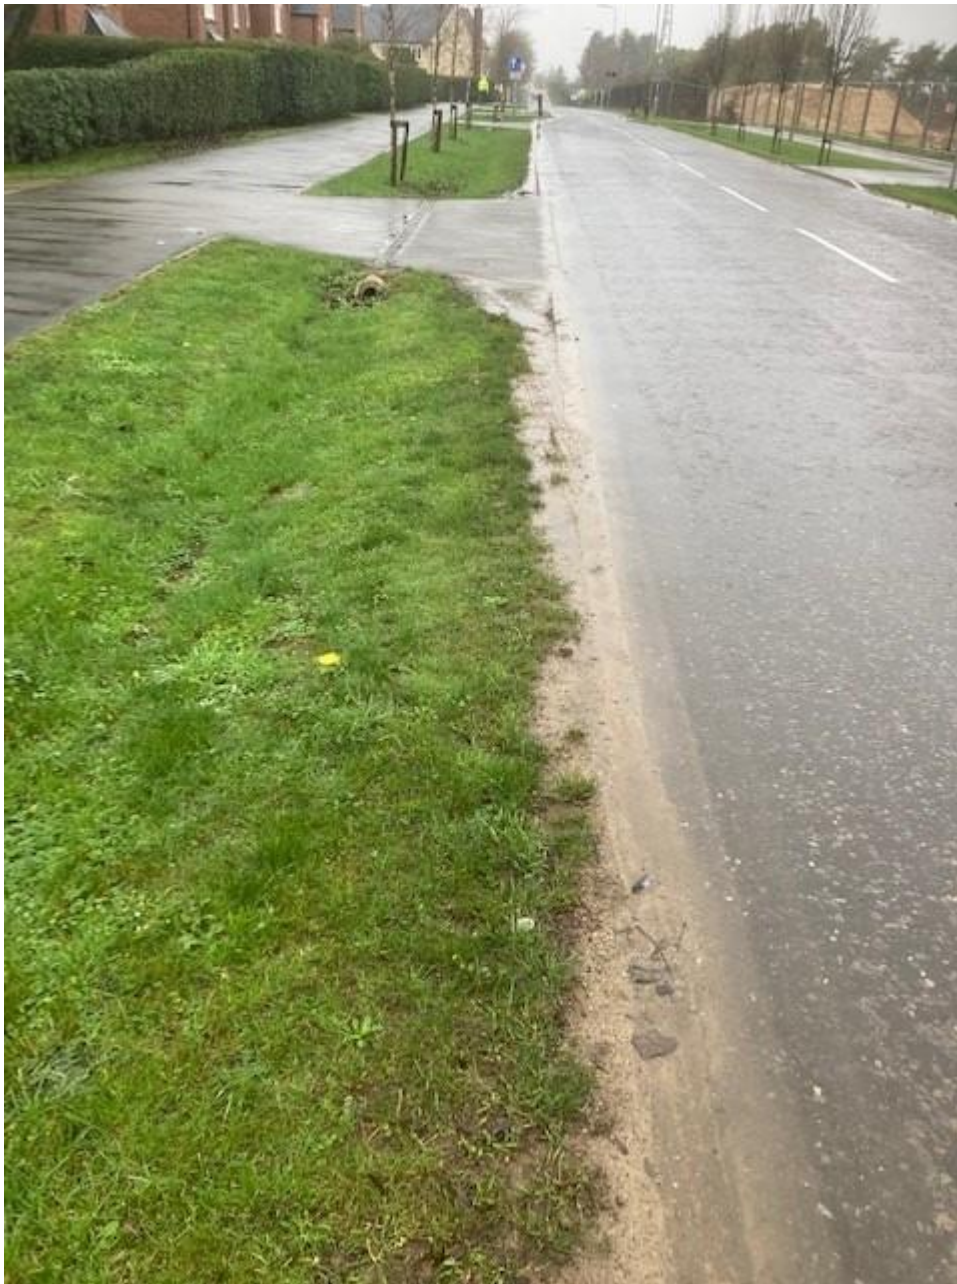
Photo 1

- Verge edge run over by traffic and landscaping damaged
- Entrance to driveway muddy as traffic has cut across landscaping

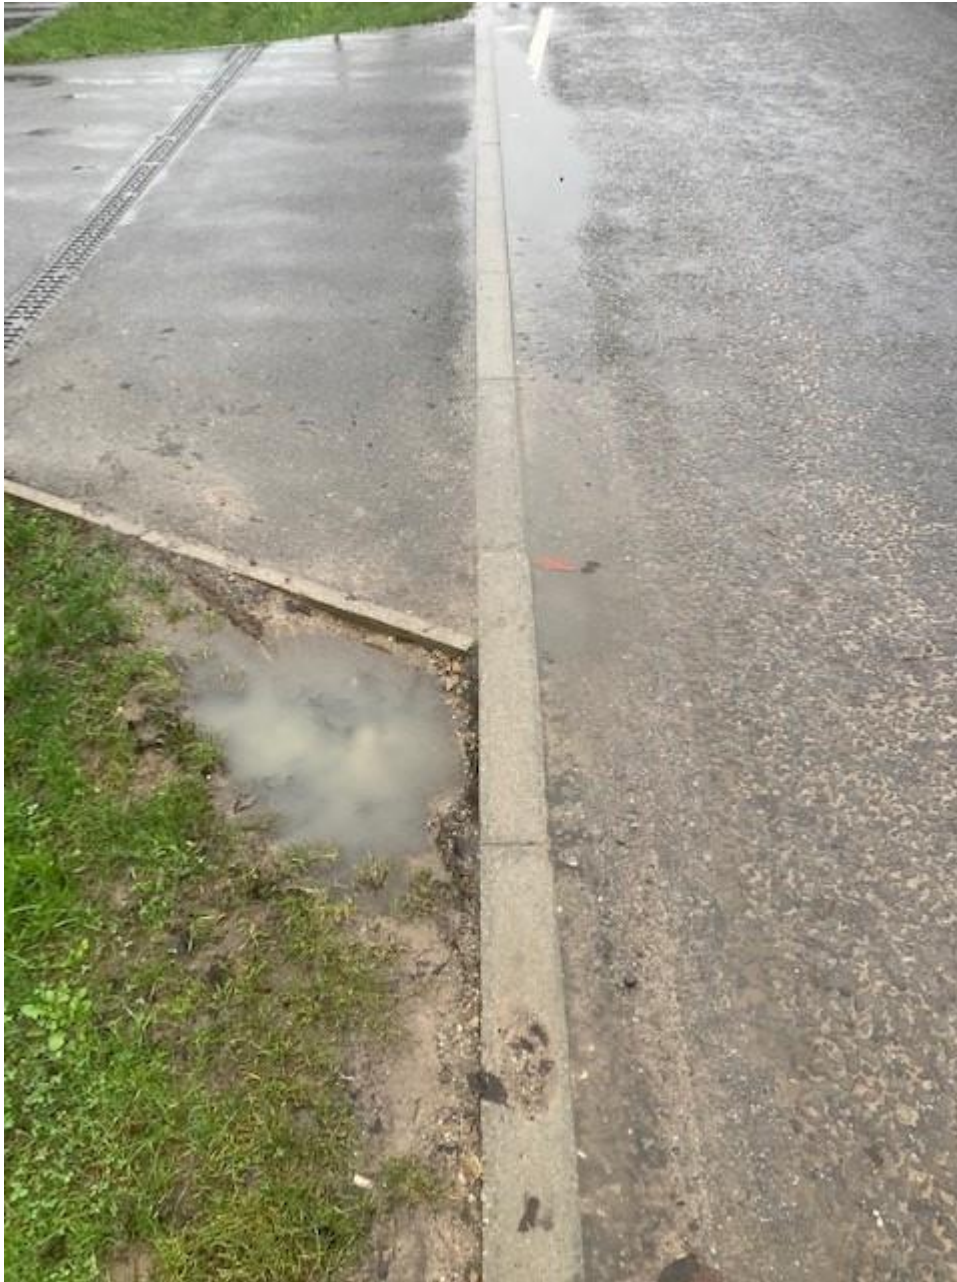
Photo 2

- Entrance to driveway muddy and landscaping run over and damaged

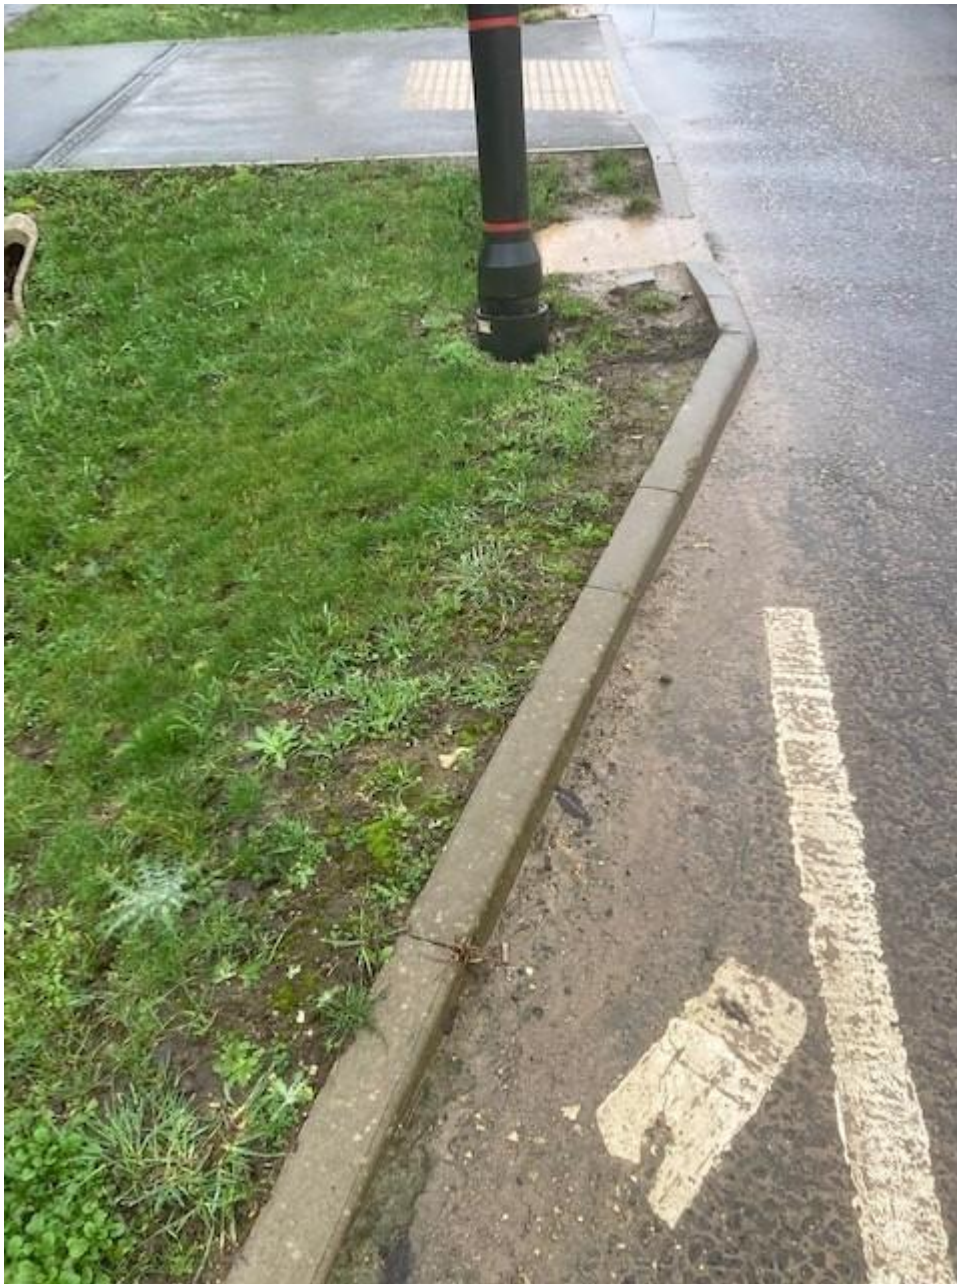
Photo 3

- Bollards damaged and leaning over – part out of base sockets
- Concrete drainage chute installed by road contractor- not as design drawing

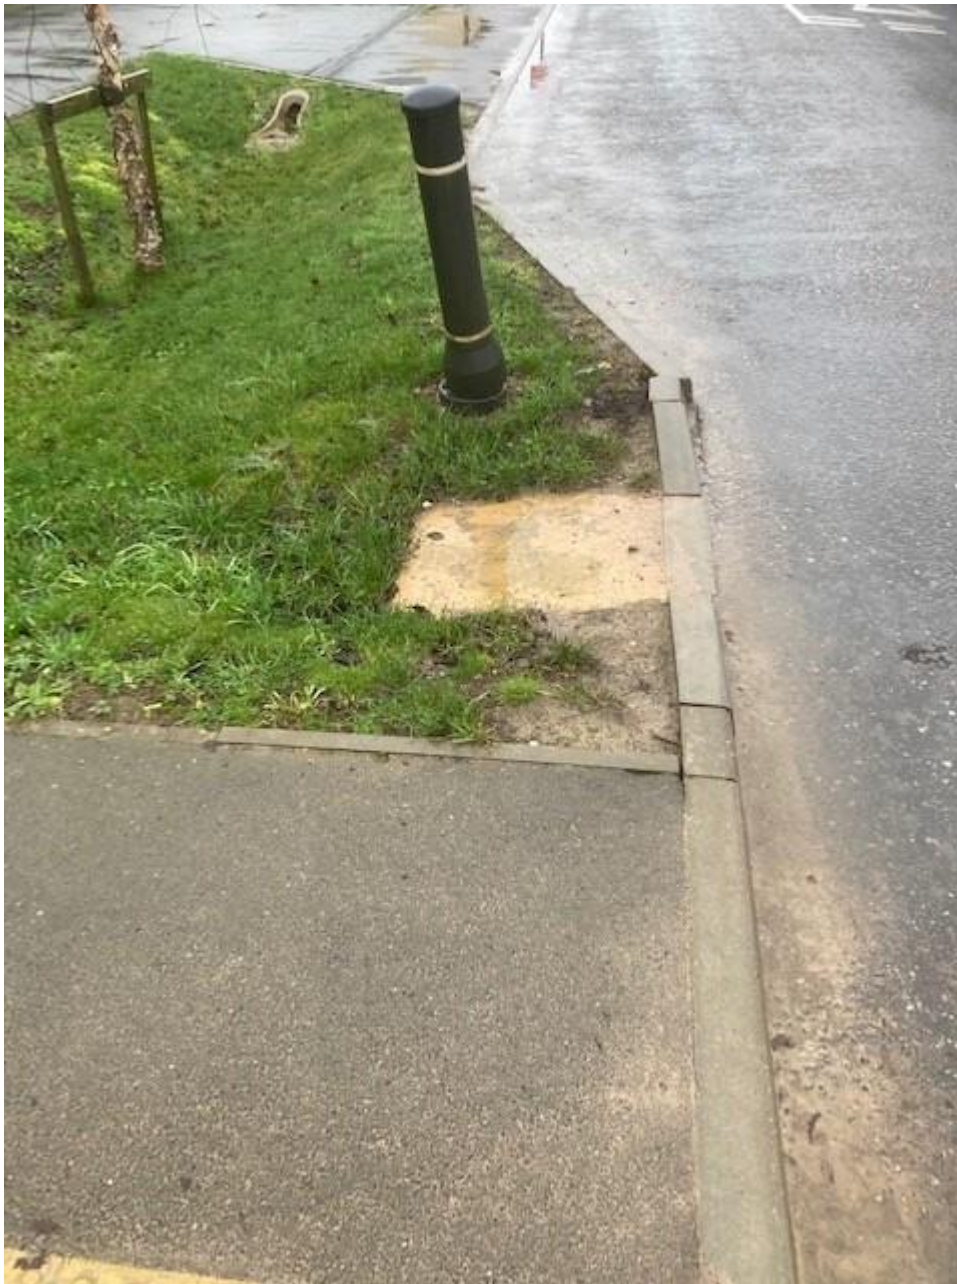
Photo 4

- Bollards damaged and leaning over – part out of base sockets
- Concrete drainage chute installed by road contractor- not as design drawing
- Kerbs damaged and misaligned

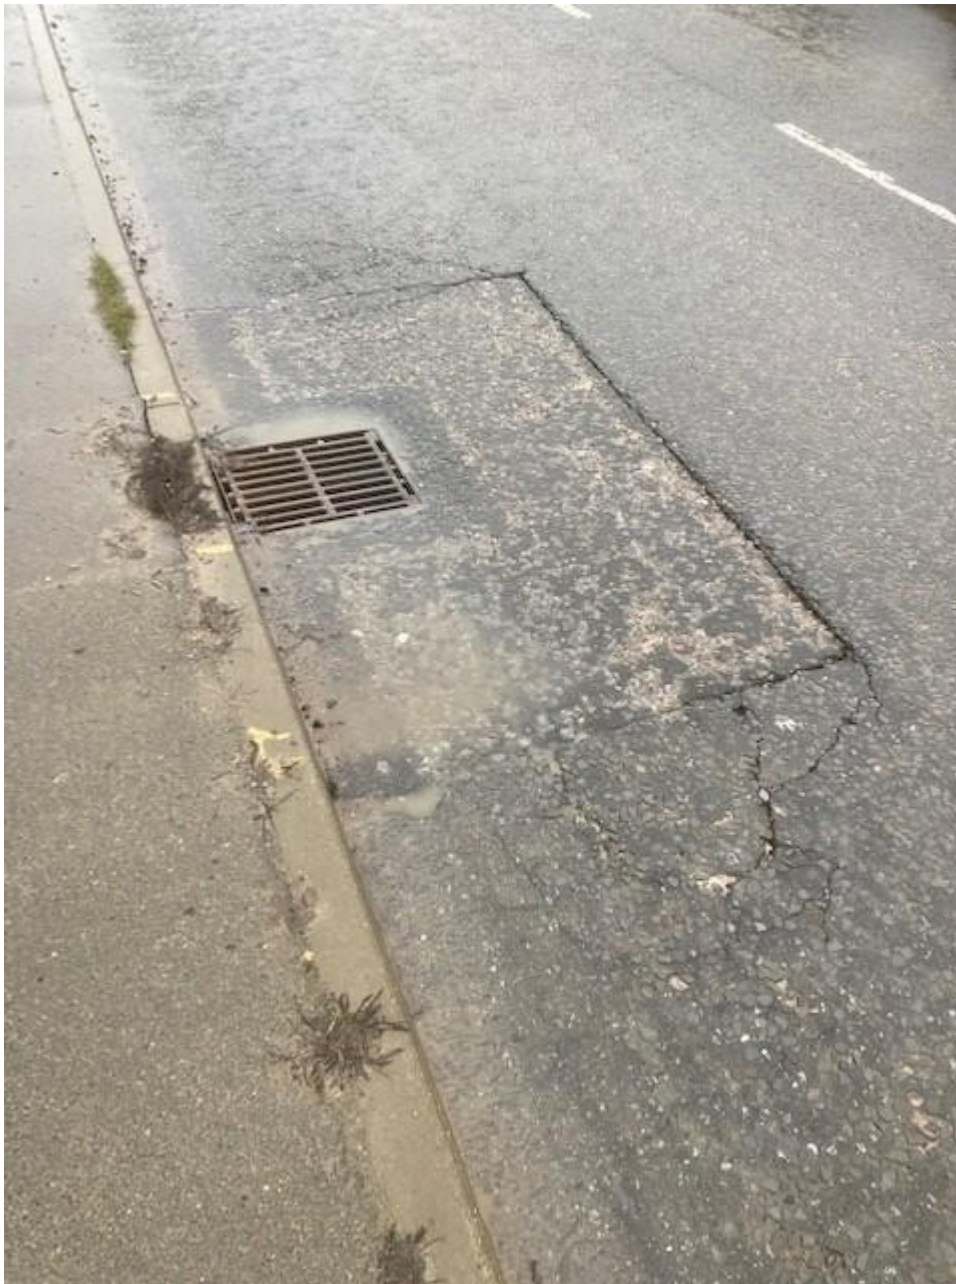
Photo 5

- Repair patch around gully is failing
- Original tarmac around patch is cracking
- Grass and weeds growing through kerb to path joint

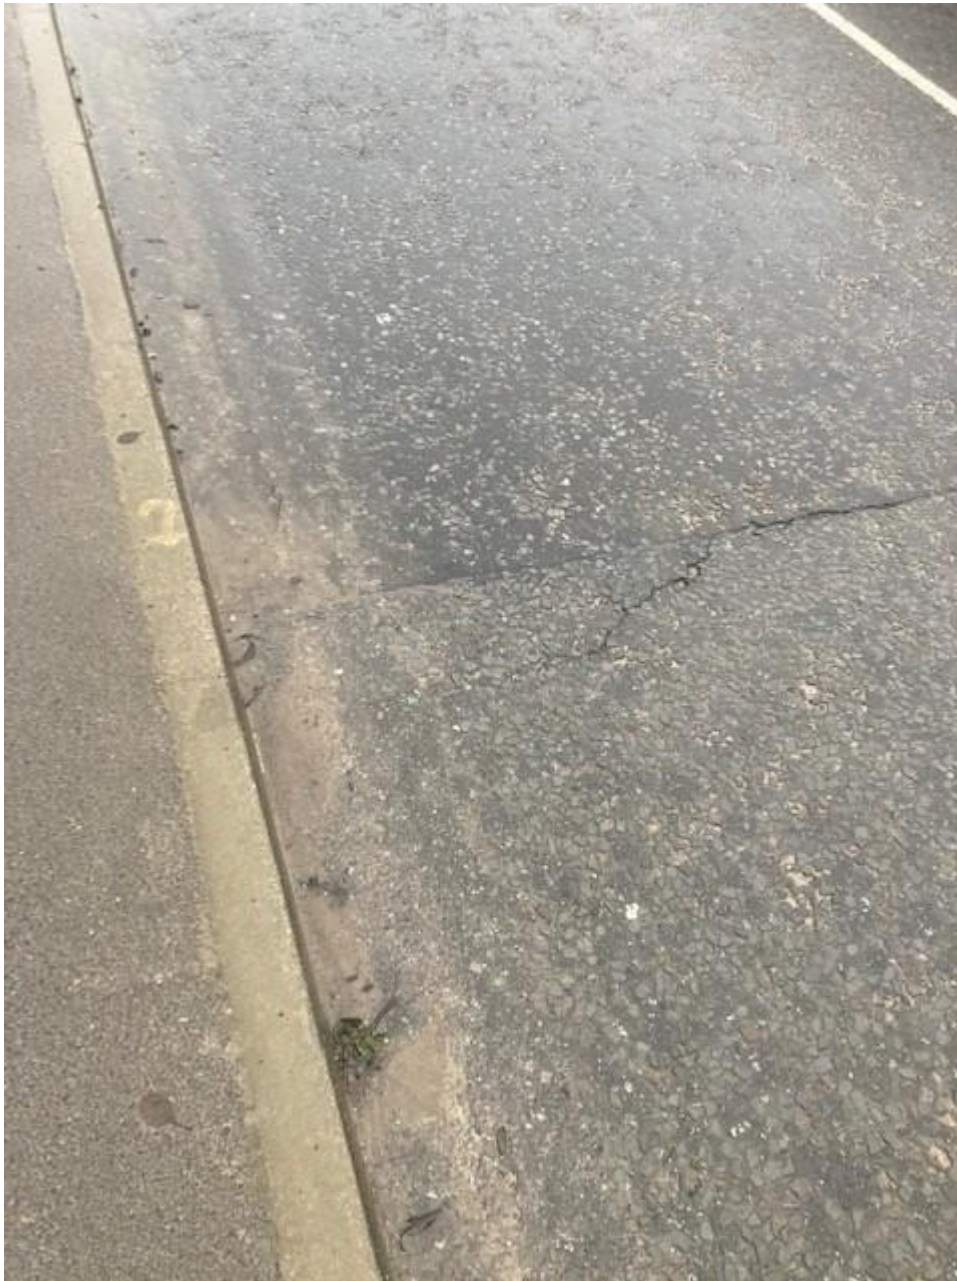
Photo 6

- Tarmac cracking adjacent to a construction joint
- Weeds growing at junction between road and kerb

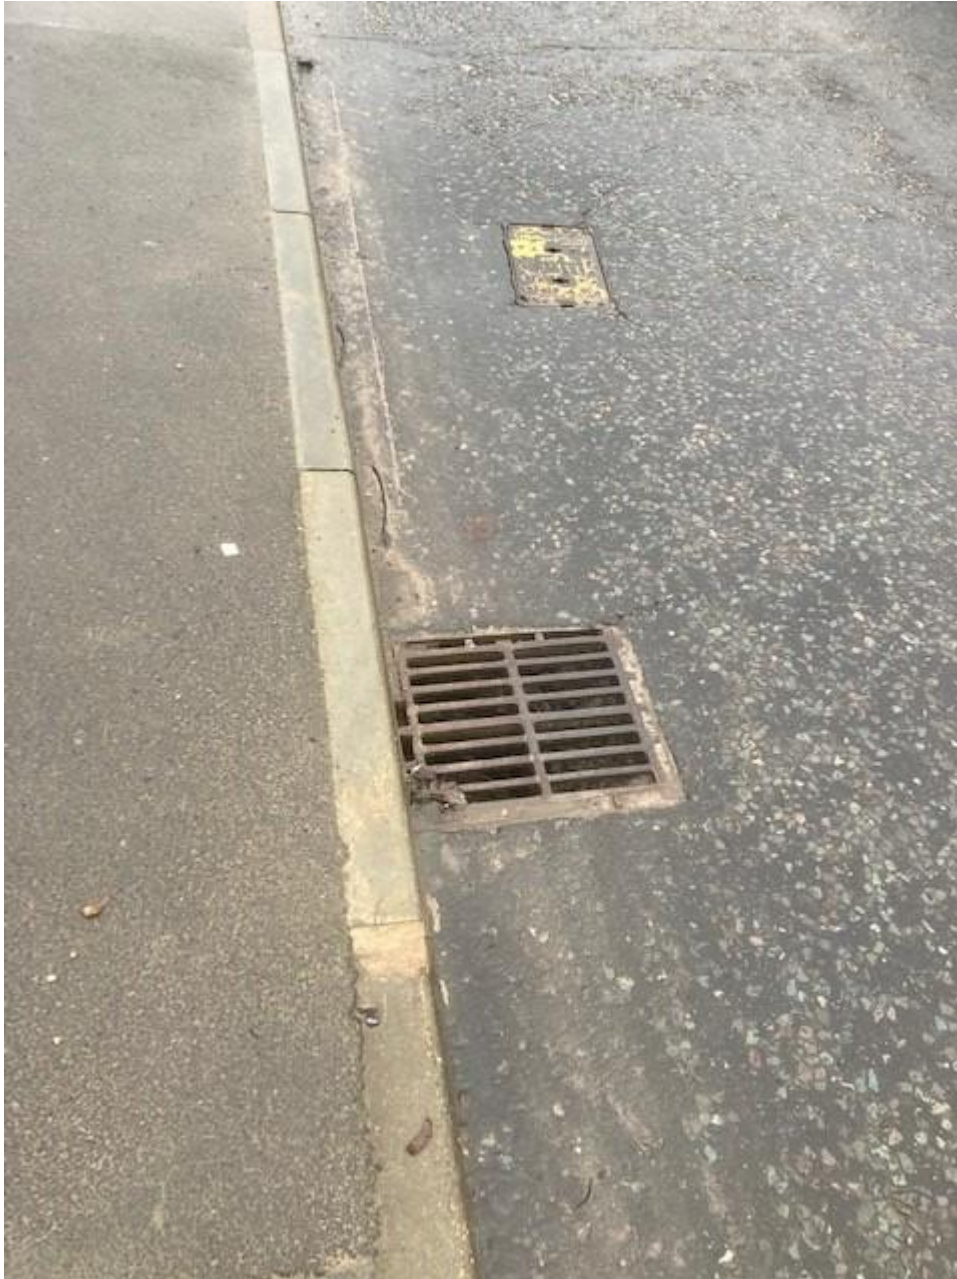
Photo 7

- Tarmac cracking around gully grating
- Damaged kerb repaired

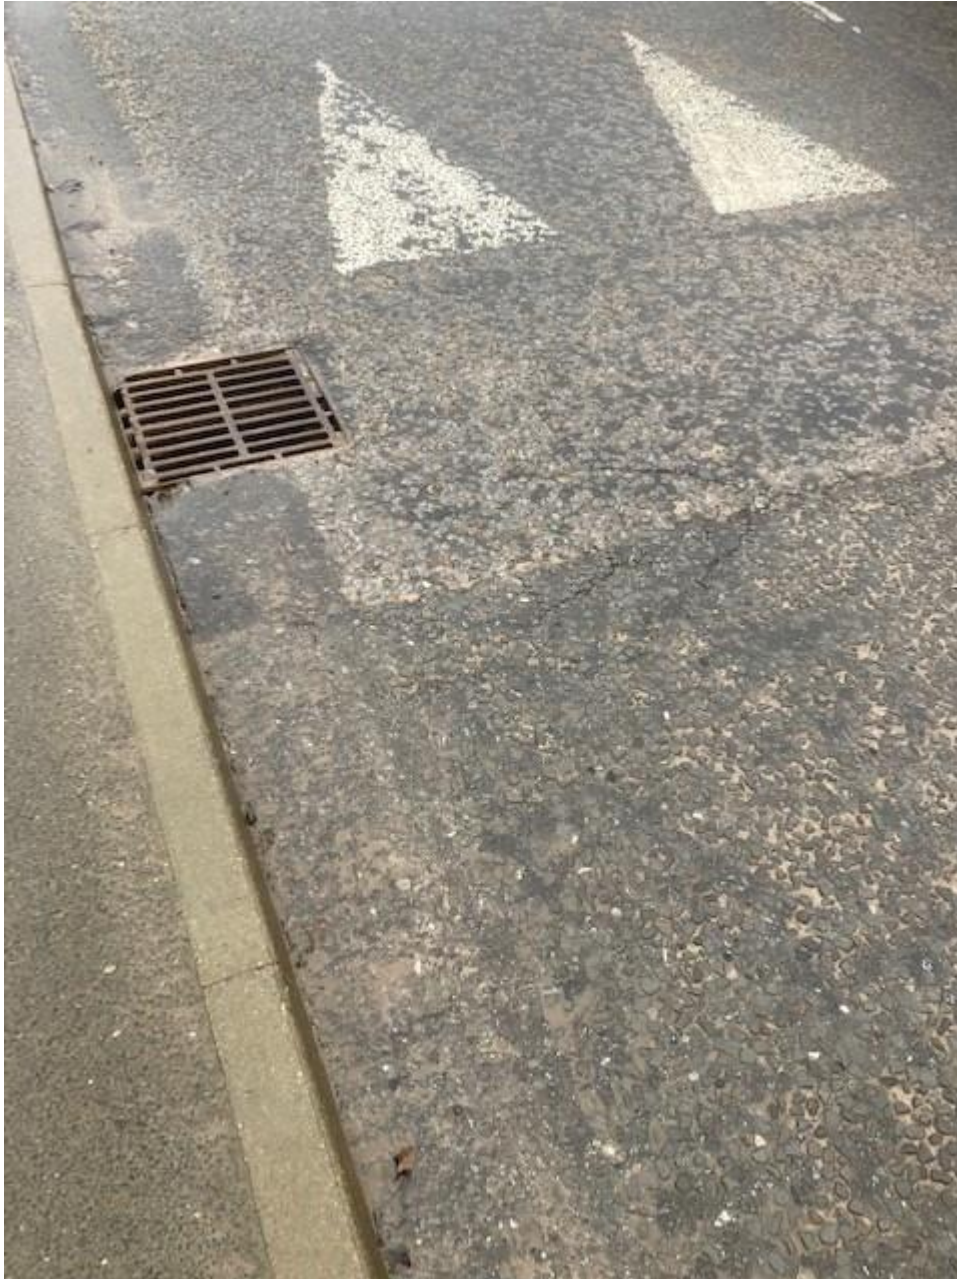
Photo 8

- Tarmac cracking at bottom of ramp

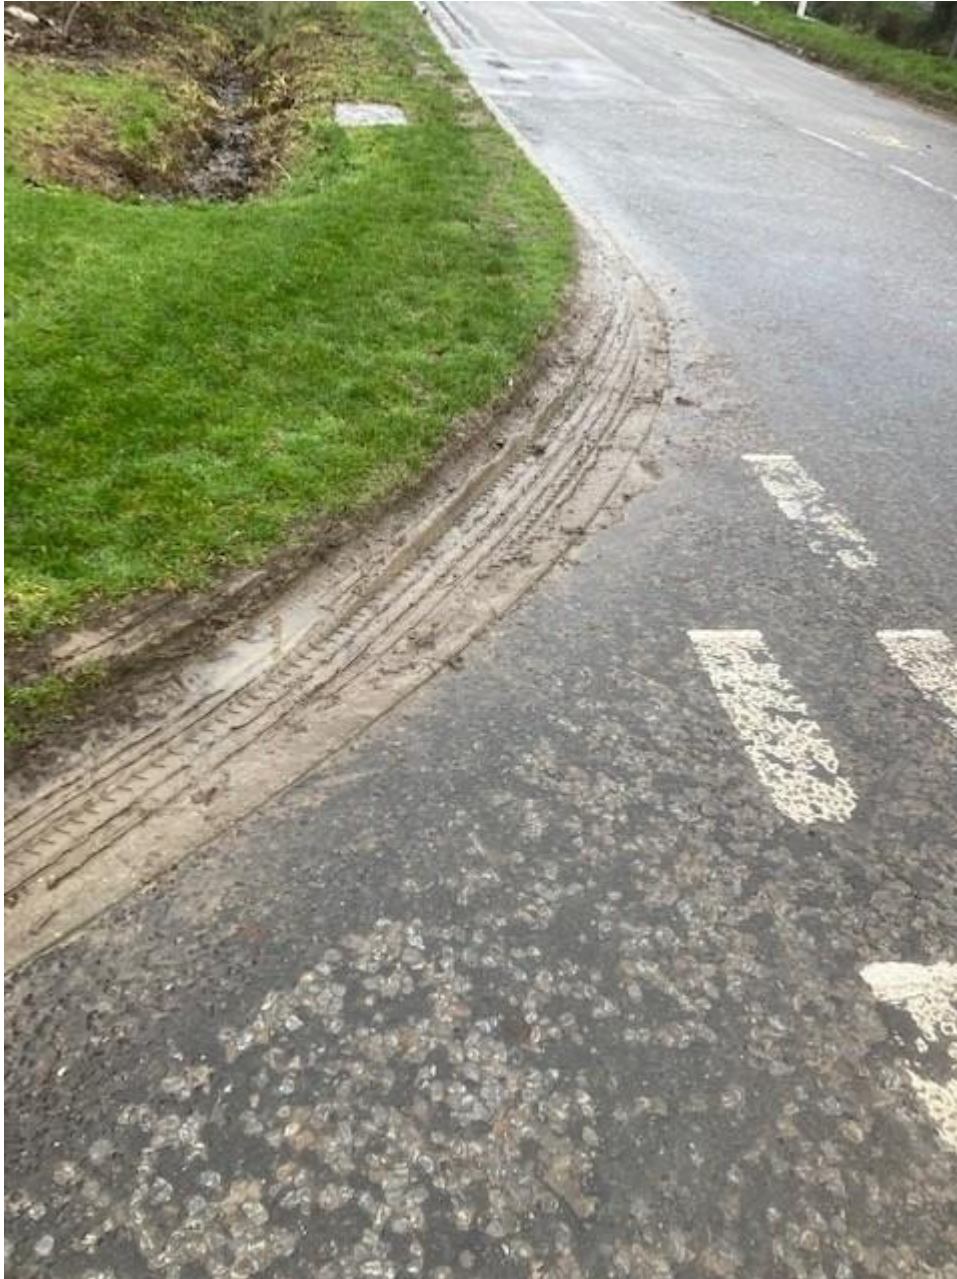
Photo 9

- Verge damaged by traffic overrunning the landscaping

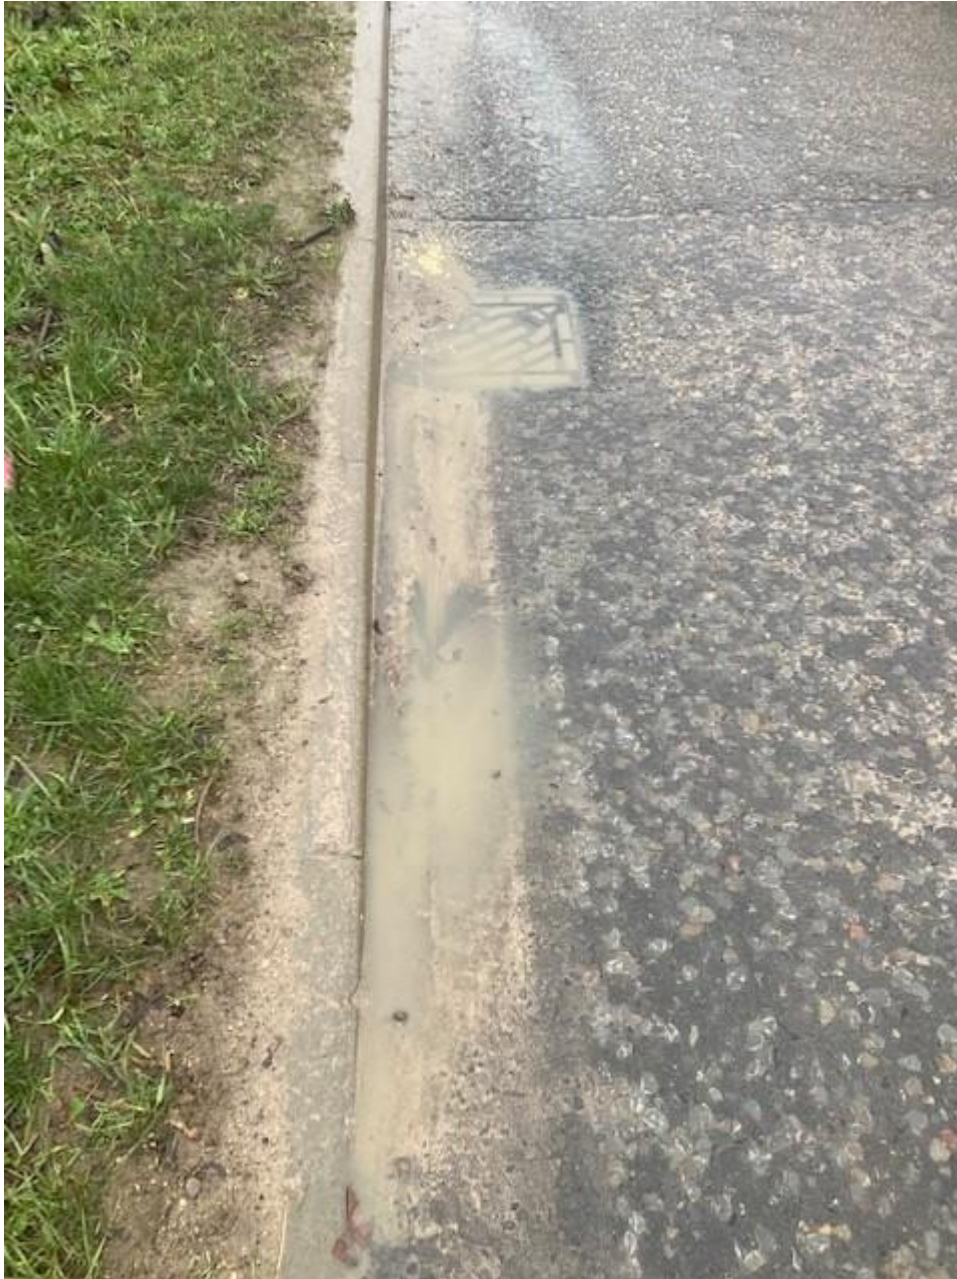
Photo 10

- Gully not draining and full of debris- no swale installed to collect gully runoff

Swale and gully connection due to be installed under a separate 278 Agreement in 2023

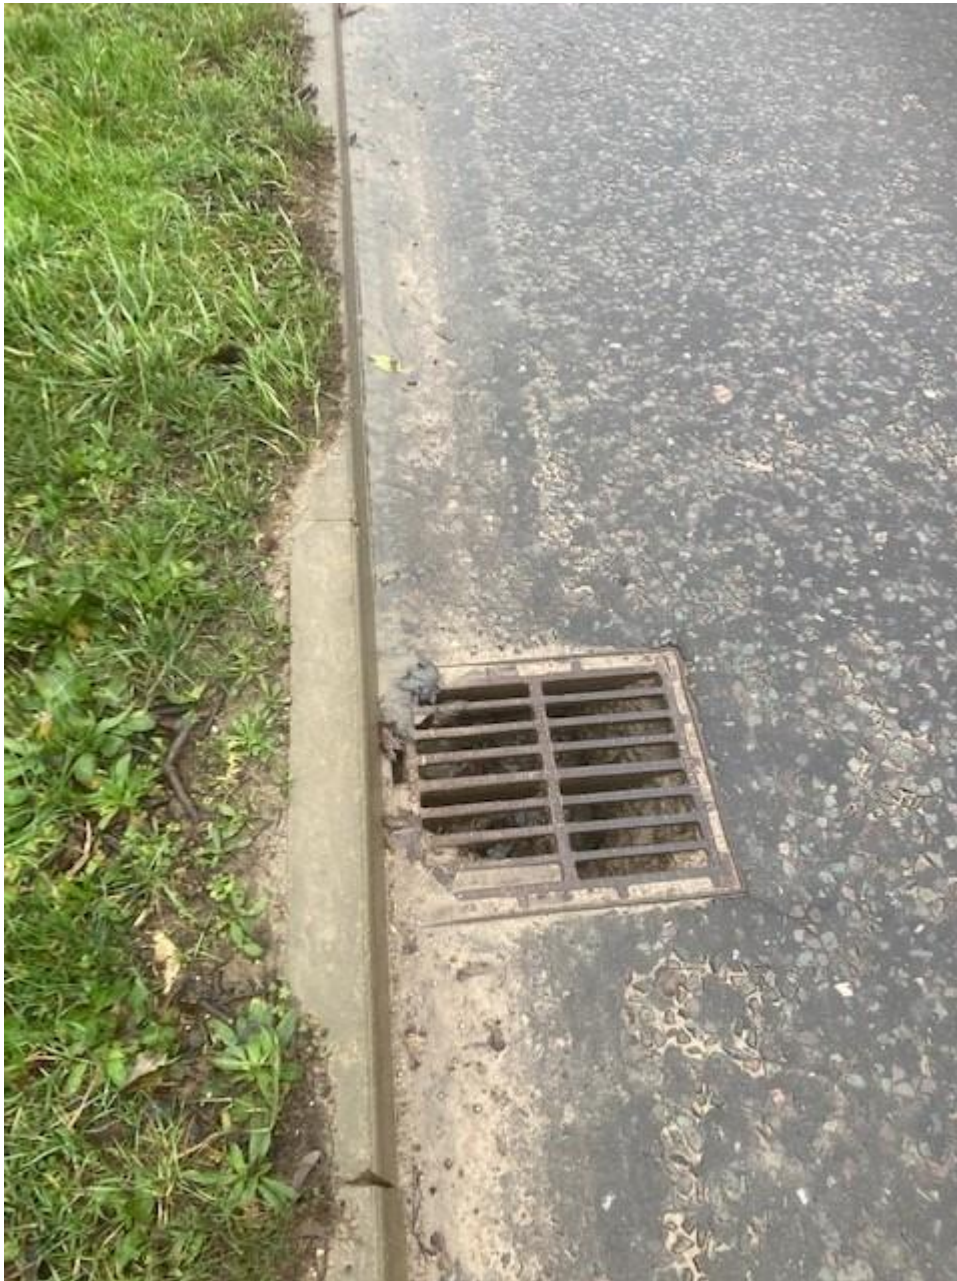
Photo 11

- Gully not draining and full of debris- no swale installed to collect gully runoff

Swale and gully connection due to be installed under a separate 278 Agreement in 2023

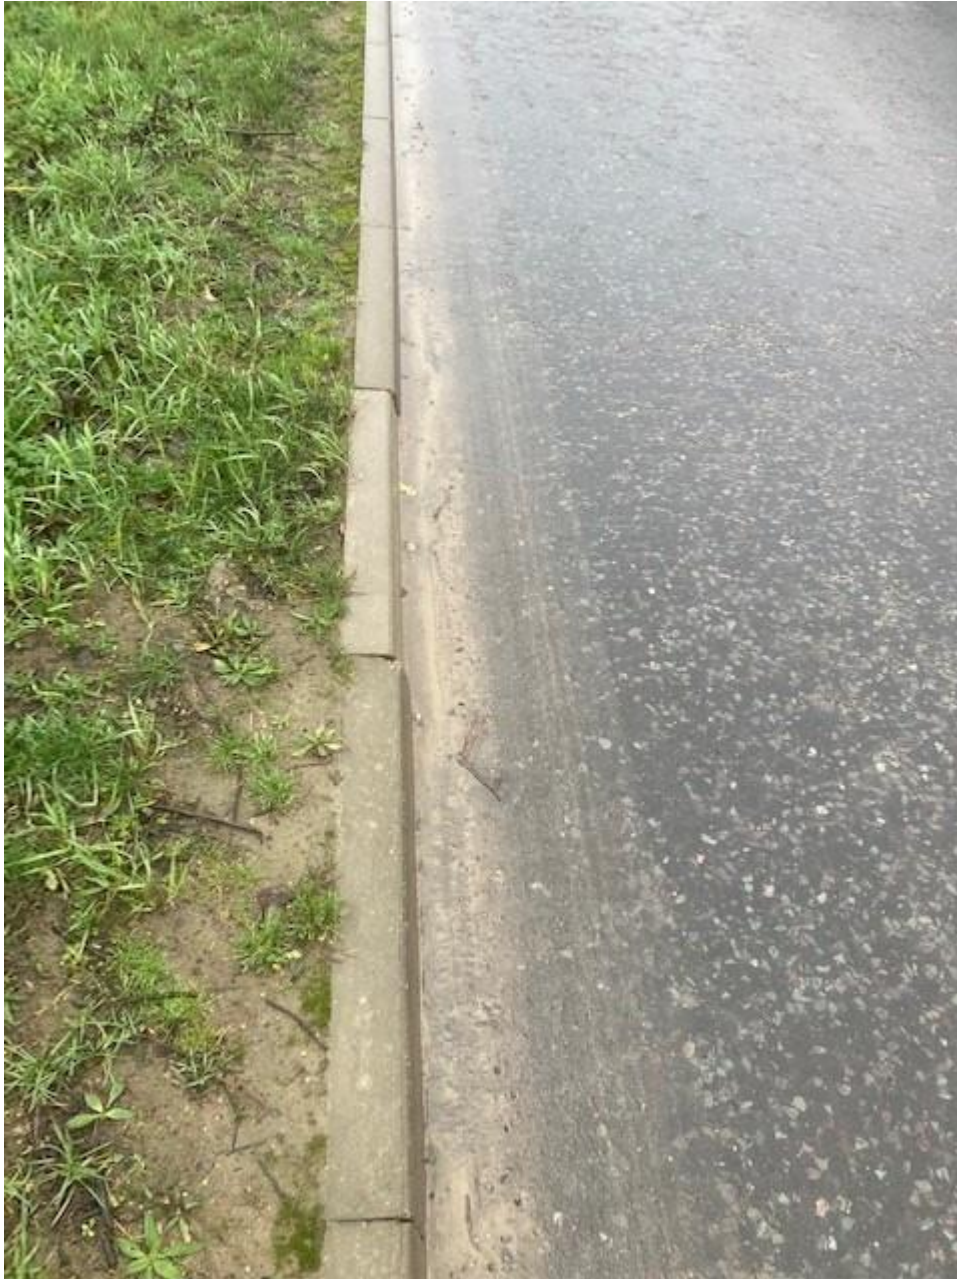
Photo 12

- Kerbs damaged and misaligned

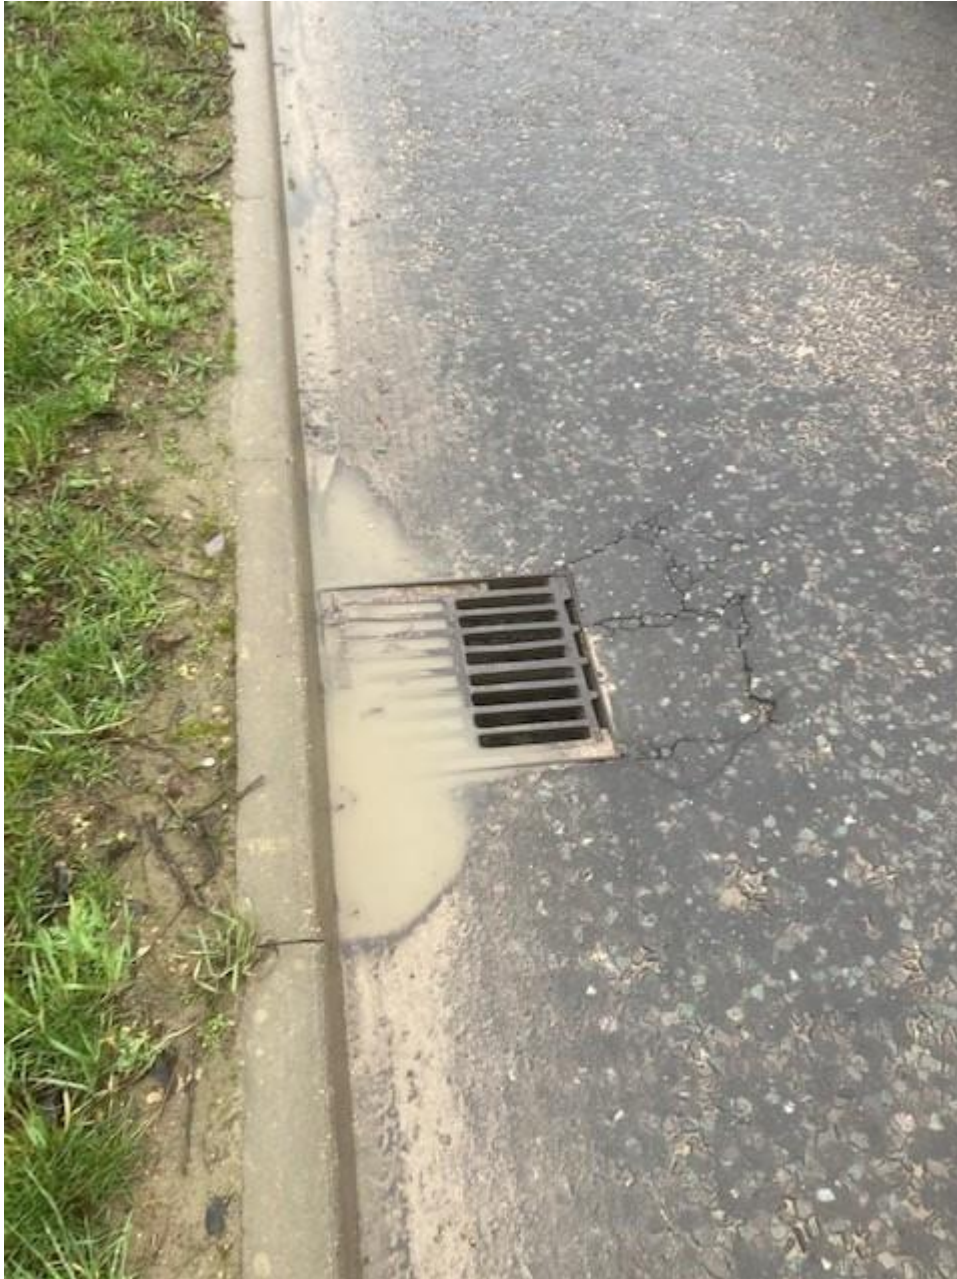
Photo 13

- Gully not draining and full of debris- no swale installed to collect gully runoff
- Tarmac around gully cracked
- Gully grating is sinking suggesting that gully pot under is collapsing

Swale and gully connection due to be installed under a separate 278 Agreement in 2023

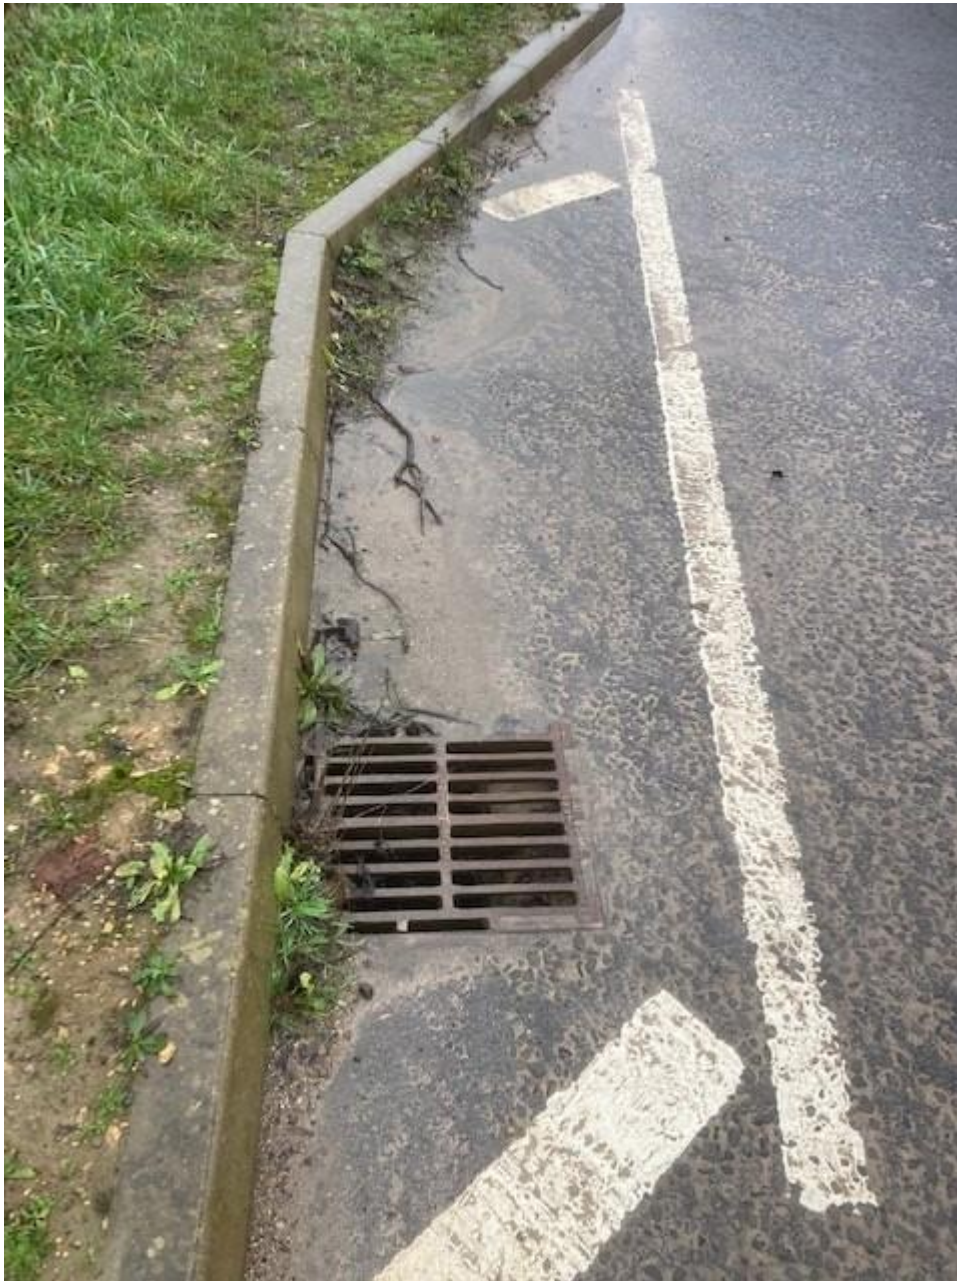
Photo 14

- Gully not draining and full of debris- no swale installed to collect gully runoff
- Weeds growing around edge of gully grating

Swale and gully connection due to be installed under a separate 278 Agreement in 2023

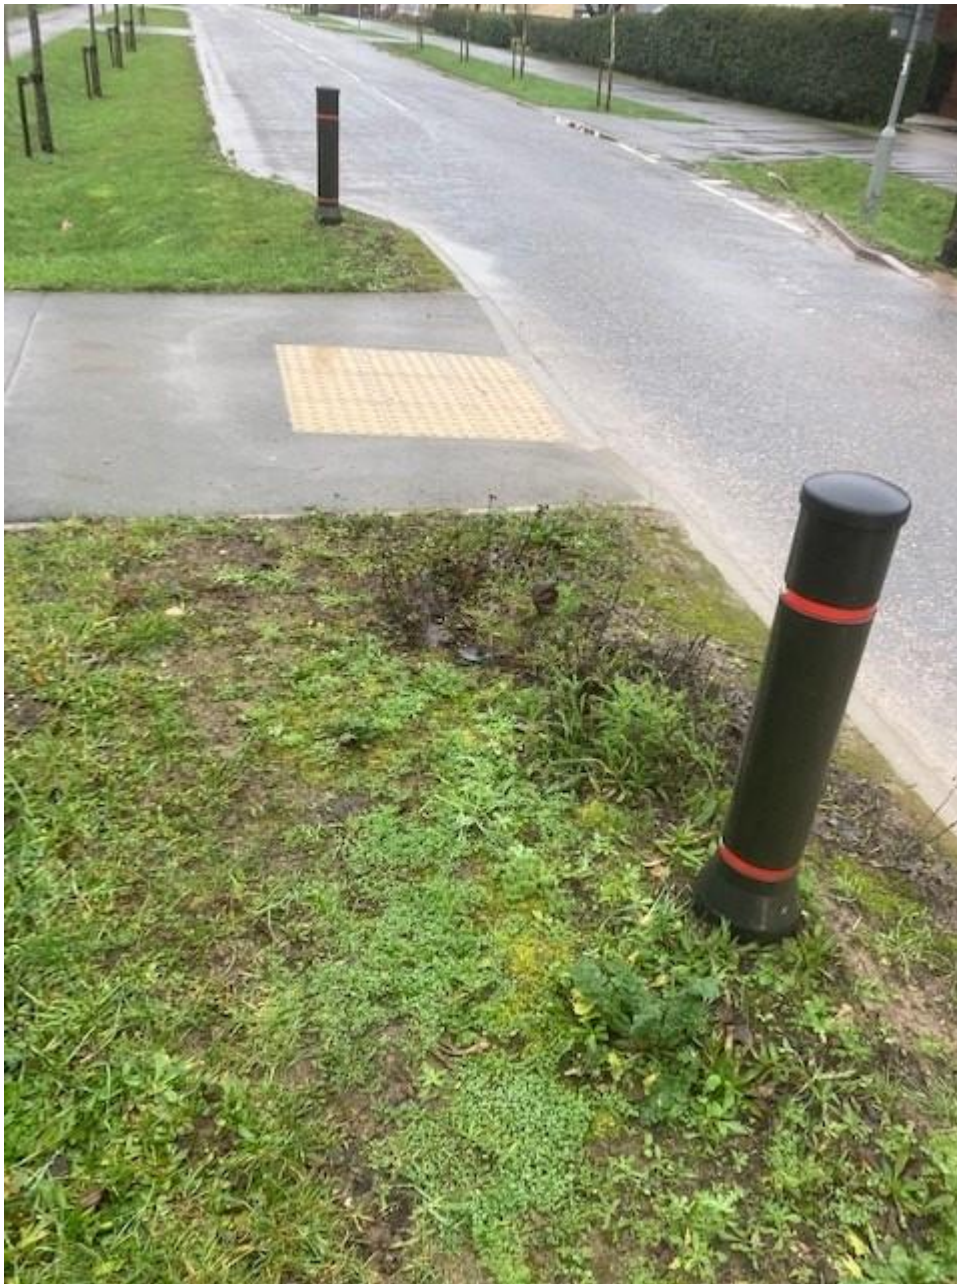
Photo 15

- Bollards leaning suggesting that base sockets are loose
- Landscaping just weeds – little grass evident

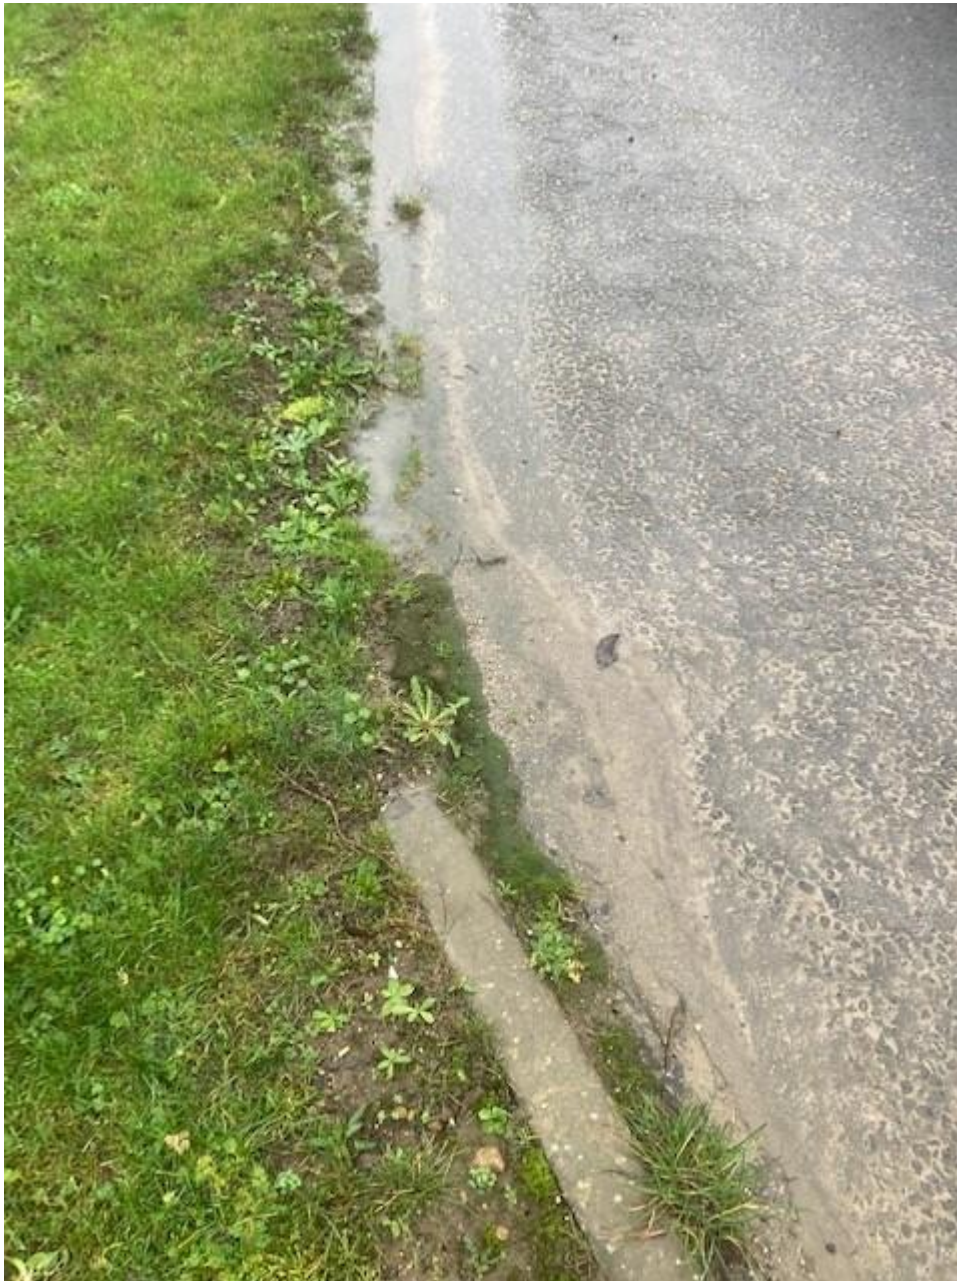
Photo 16

- Verge overlapping onto tarmac- preventing lateral drainage
- Weeds and grass growing at edge of tarmac

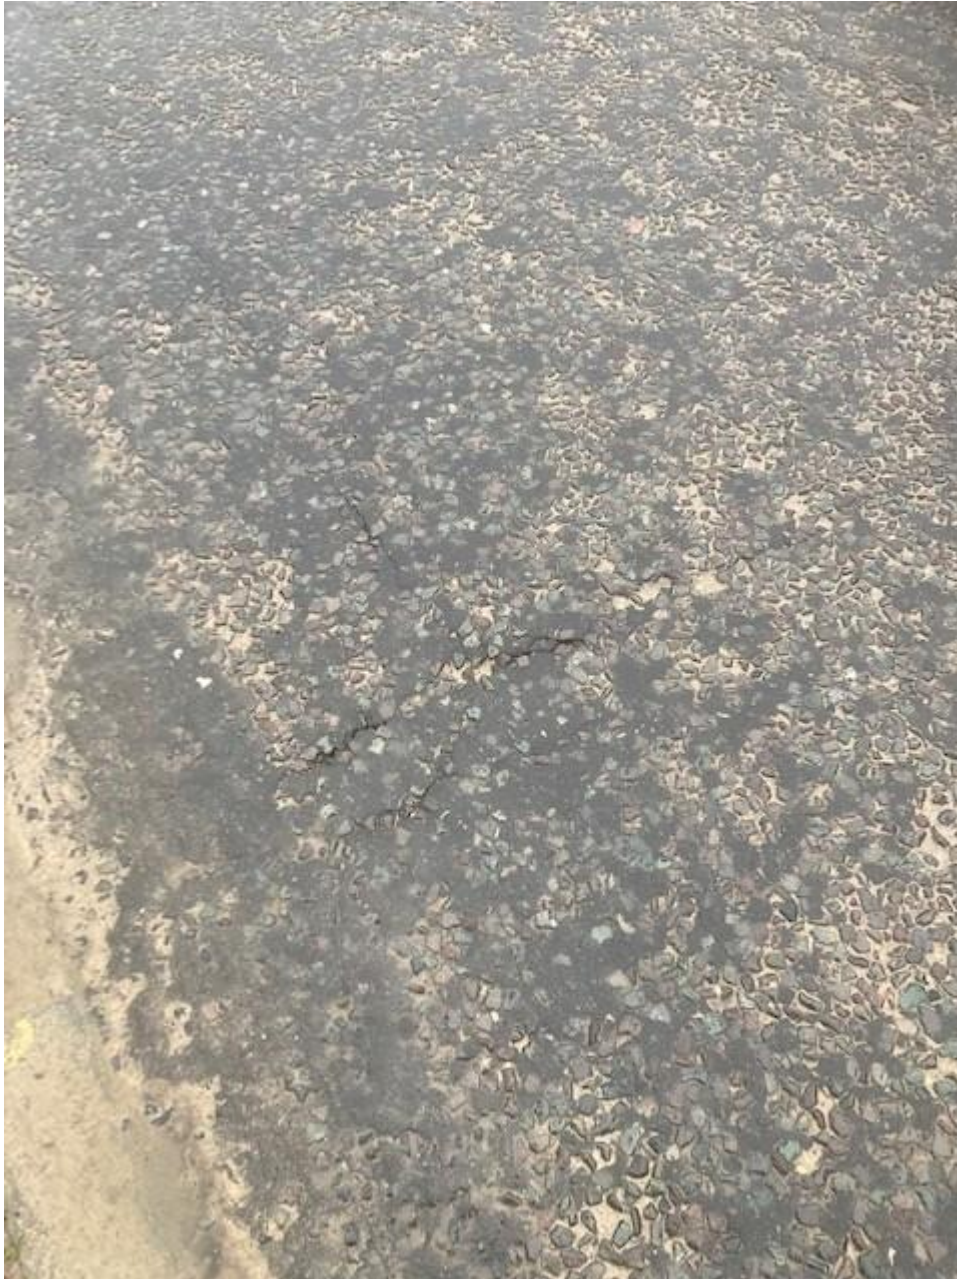
Photo 17

- Tarmac cracking

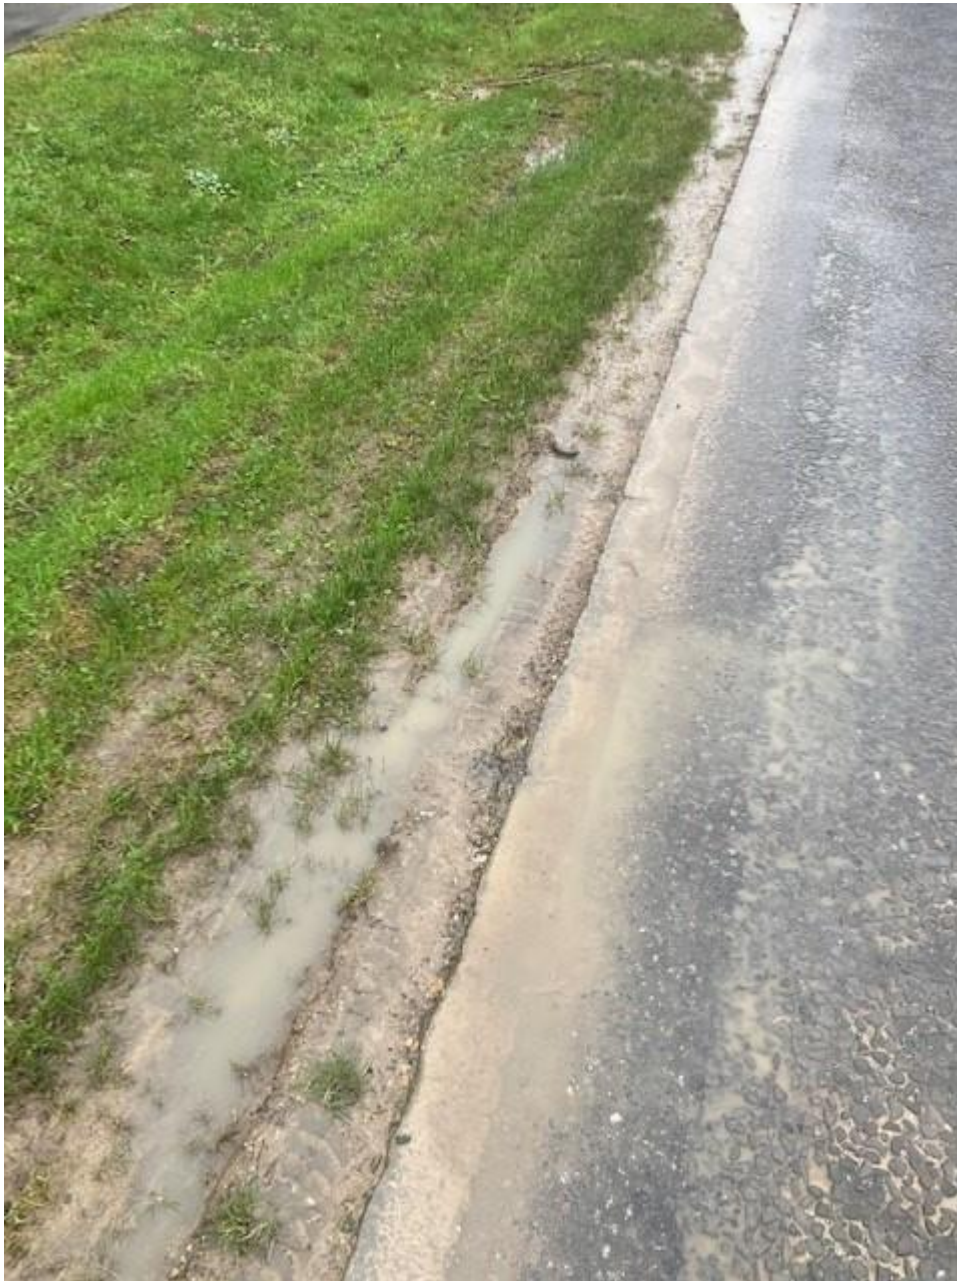
Photo 18

- Verge damaged by vehicle tracks
- Kerb appears to be higher than tarmac preventing lateral drainage
