HIGHWAY CONDITION SURVEY, CAMP ROAD

22/02692/DISC-Heyford Park

Phase 10-Discharge of conditions 22
(Construction Management Plan)

Heyford Park, Camp Road, Upper Heyford, Bicester

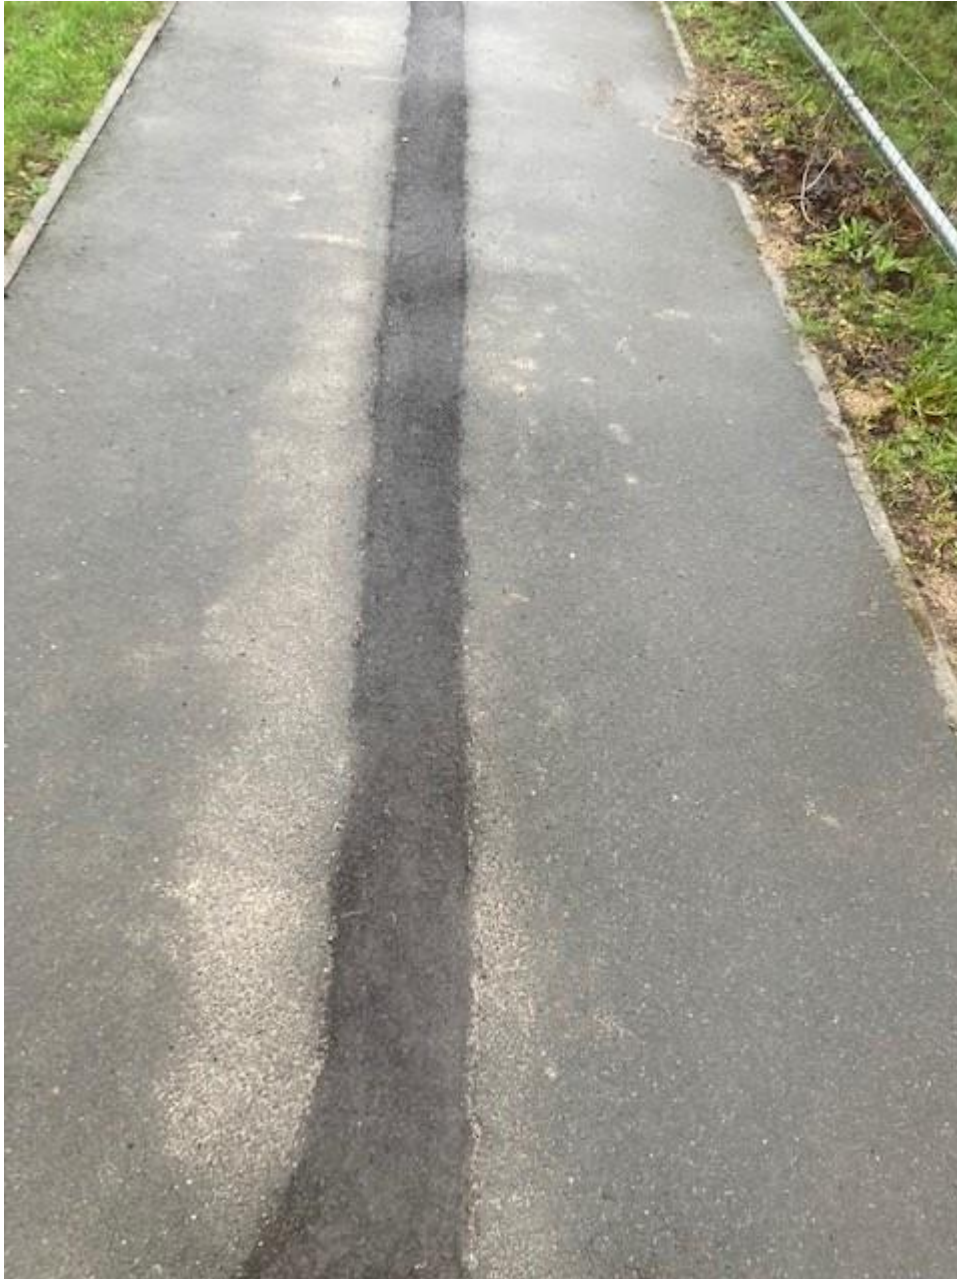
Photo 19

- Utility works in footpath

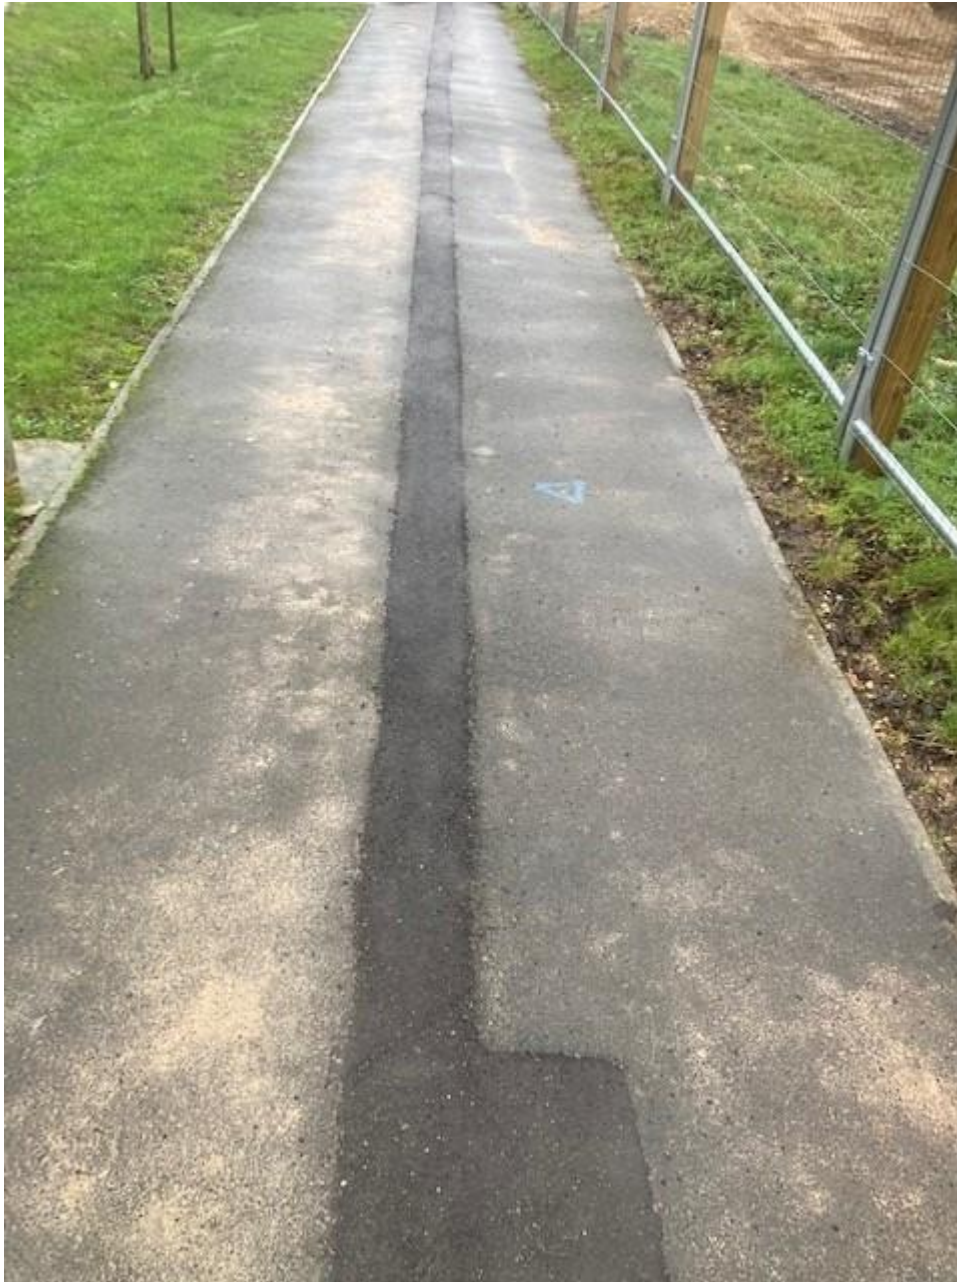
Photo 20

- Utility works in footpath
